**Chevron Richmond Refinery  
February 2019 Flaring Causal Analysis Report**

Causal Analysis Report

February 2, 2019  
Refinery Power Outage

Refinery Flare Event – Cause Investigation Report

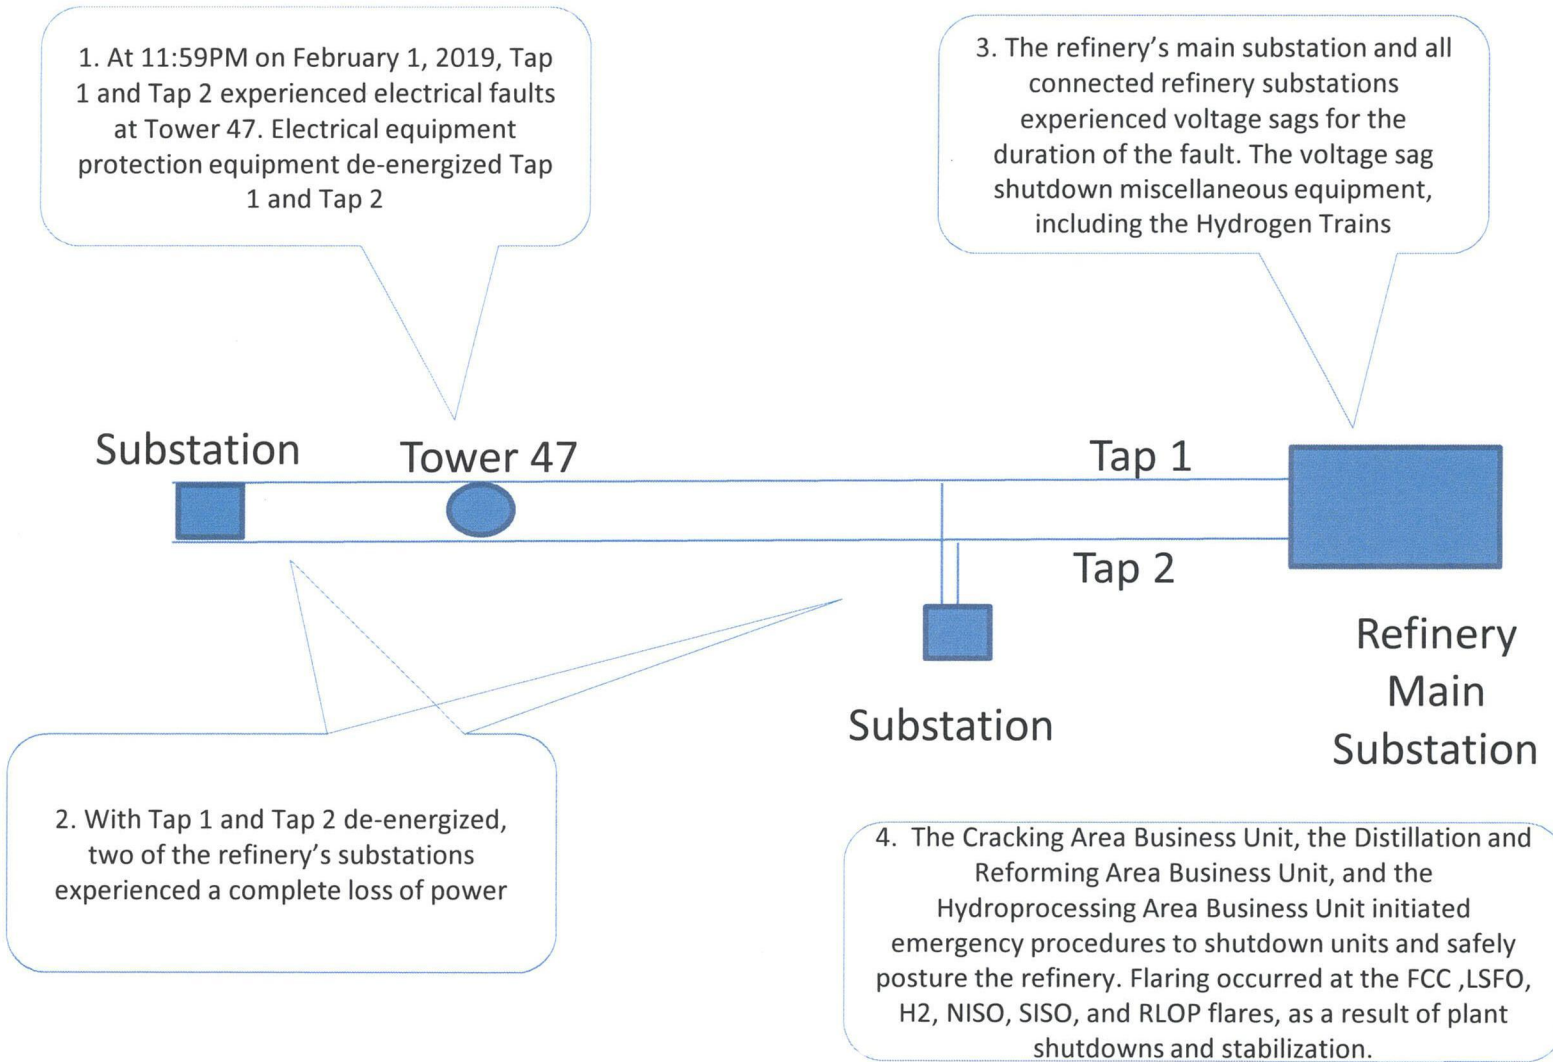
# Refinery Power Outage

On February 1, 2019 at 11:59PM, a pair of redundant 115kV overhead electrical transmission lines (“Tap 1” and “Tap 2”) experienced electrical faults. At 11:59PM, Tap 1 experienced a phase-to-ground and then phase-to-phase fault. An automatic action by electrical system protection equipment isolated Tap 1 within 0.13 seconds. 0.14 seconds later, Tap 2 experienced a phase-to-phase fault and electrical system protection equipment de-energized Tap 2 within 0.12 seconds. With both Tap 1 and Tap 2 de-energized, two of the refinery’s substations experienced a complete loss of power, resulting in the shutdown of all electrically powered equipment in the Distillation and Reforming Area Business Unit and the Cracking Area Business Unit. During the electrical faults, high currents flowed through the refinery’s main 115 kV substation. Consequently, the refinery’s main substation and all connected refinery substations experienced significant voltage sags for the duration of the fault. The voltage sag shutdown miscellaneous electrical equipment, including the induced and forced draft fans at the Hydrogen Trains. Safety systems immediately shutdown the Hydrogen Trains and, without manufactured hydrogen available, all hydroprocessing units initiated emergency procedures to safely shutdown. Flaring started at 12:00AM on February 2, 2019 at the FCC, LSFO, and Hydrogen Plant (H2) flares. Subsequent flaring occurred at the North Isomax (NISO), South Isomax (SISO), and RLOP flares. Flaring also occurred due to an electrical fault on an overhead compressor in the Distillation and Refining Area Business Unit.

A root cause investigation found that Tap 1 and Tap 2 on the 115kV transmission line experienced electrical faults at Tower 47. Through consultation with subject matter experts and in conjunction with the root cause analysis, it is believed that a combination of venting and atmospheric conditions at the location of the transmission line enabled the electrical faults experienced during the events. Primary conditions of interest are steam and hydrogen vents and weather conditions. The contribution of the atmospheric conditions individually is not known with certainty.

Vent gas flow originated from process units in the Distillation and Reforming Area Business Unit, the Hydroprocessing Area Business Unit, and the Cracking Area Business unit.

The refinery has identified the following prevention measure as having a high probable effectiveness to reduce the likelihood of a recurrence of a flaring incident resulting from the same root cause and contributing causes: Relocate the hydrogen vent further away from Tower 47.

The prevention measure is feasible and has been implemented. The hydrogen vent relocation completed on April 17, 2019.
