BEFORE THE HEARING BOARD
OF THE
BAY AREA AIR QUALITY MANAGEMENT DISTRICT
STATE OF CALIFORNIA

APPLICATION FOR VARIANCE

The use of a long reach specialized excavator to demolish a 200' tall blimp hangar where the roof, with non-friable asbestos felt paper, is in need of demolition to eliminate the risk of building collapse.

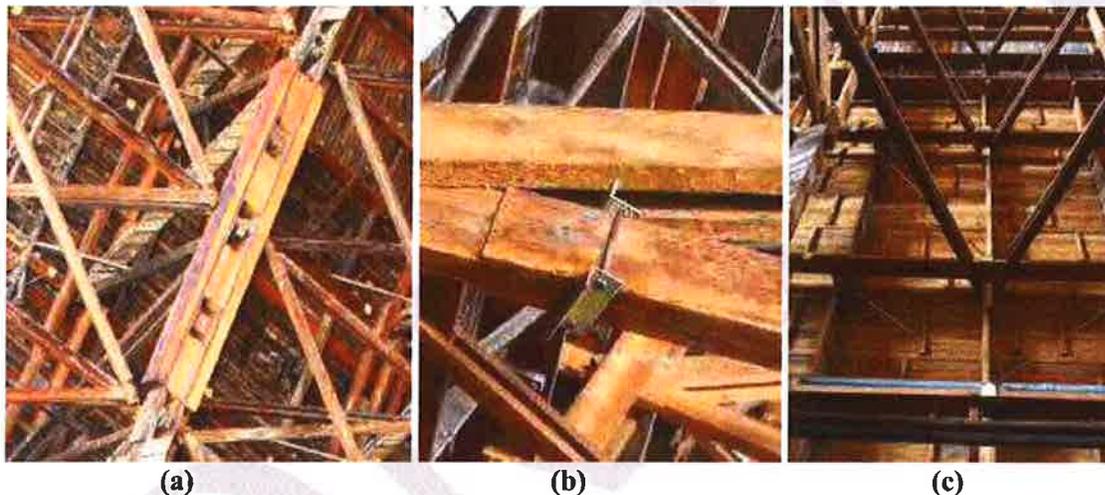
Figure 3. Retrofit techniques observed throughout Hangars 2 and 3 (a) Strengthening of arch chords by addition of glulam bypass members (b) Clamps and stitch bolts to close small cracks (c) Replacement of wood sag braces with steel cables and bolts.

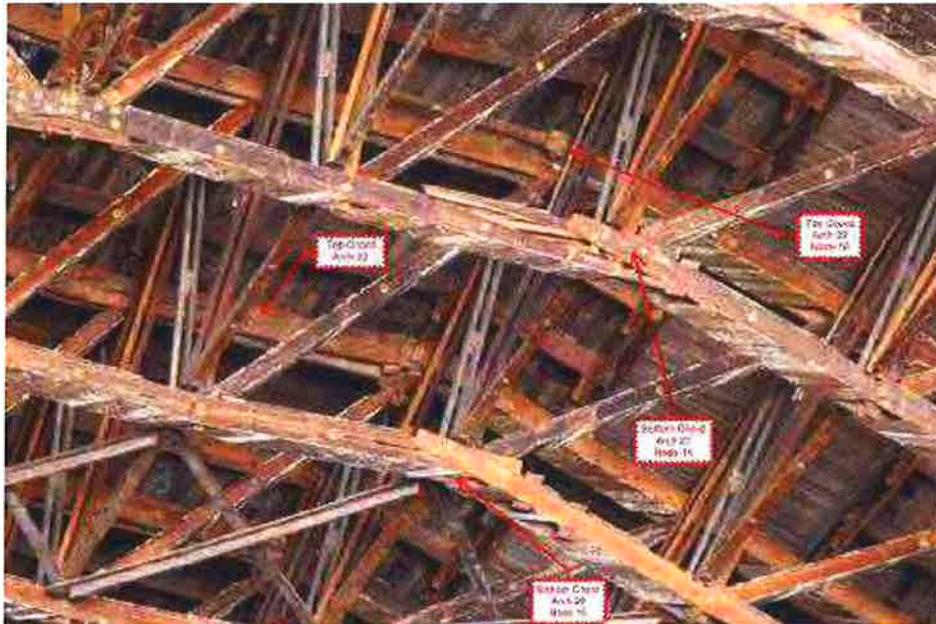
Figure 4. Observed cracks and distortion of the timber arch bottom and top chords in Hangar 3.

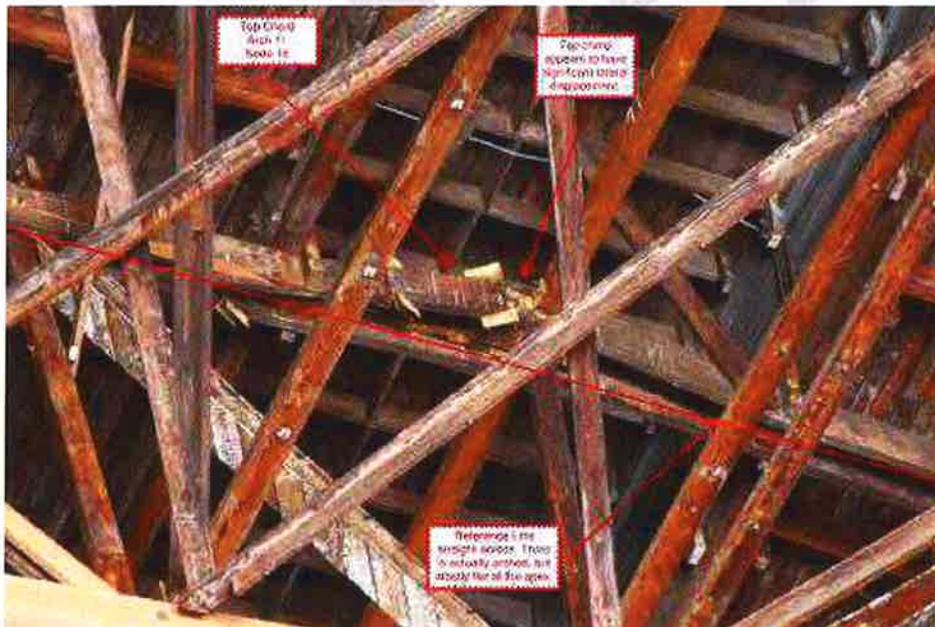
This general observation is emphasized in Figure 5 with the relative lateral displacement between the apex of the arch and a theoretical reference line connecting adjacent arch nodes. Similar results are also displayed in Figure 6 for the top chord of arch 18.

Figure 5. Relative lateral displacement between arch apex and reference line for Hangar 3 single arch.

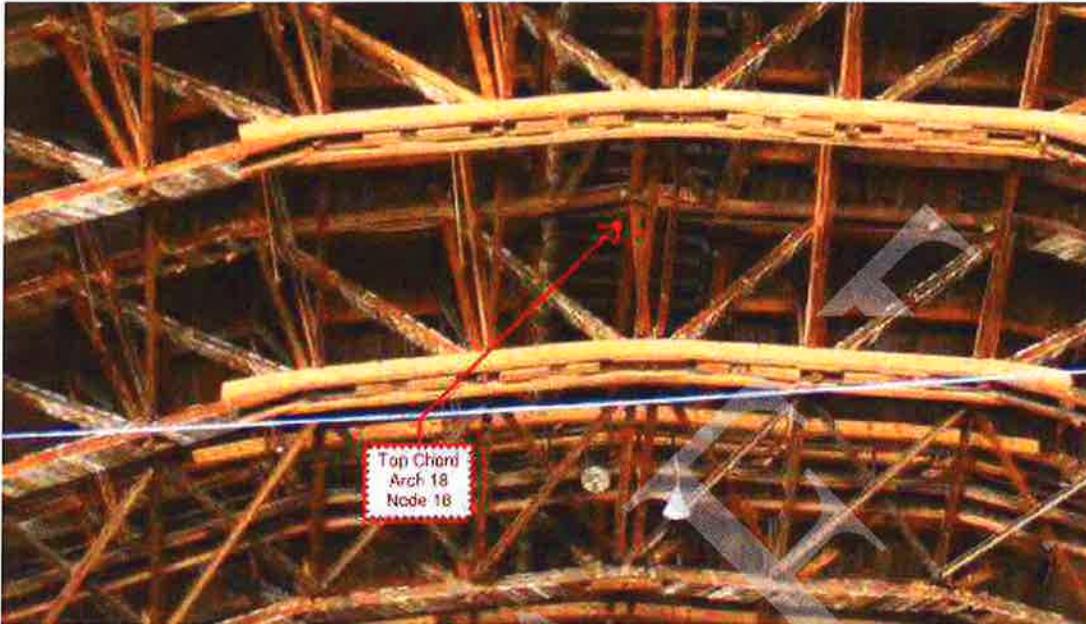
Figure 6. Observed cracks and lateral displacement of arch top chord in Hangar 3.

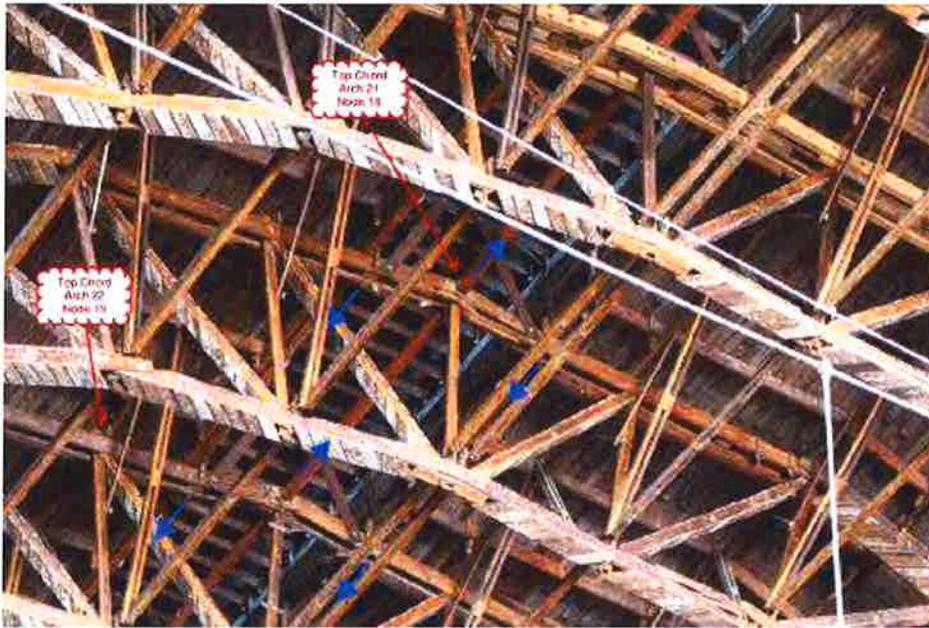
In addition, it was observed that the apex of numerous arches contain a consistent trend of node 18 displacing relative to the adjacent nodes supporting the monitor (exterior protrusion of the hangar at the apex outer chord). This is displayed in Figure 5 for arch 11, Figure 6 for arch 18, and Figure 7 for arches 21 and 22. The latter contains blue sketch-up arrows displaying the relative lateral displacement of the nodes, where node 18 appears to display south. It is unknown whether or not if all of the observed cracks and distortions propagated from the 1995 retrofits or if their origin emanated within the past couple of months.

Figure 7. General trend of relative lateral displacement at the arch apex top chord in Hangar 3.

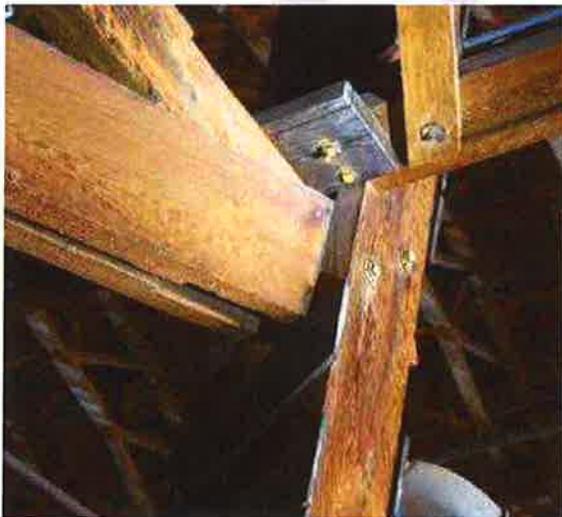
Figure 8. Example location of end split in cross brace member within Hangar 2.

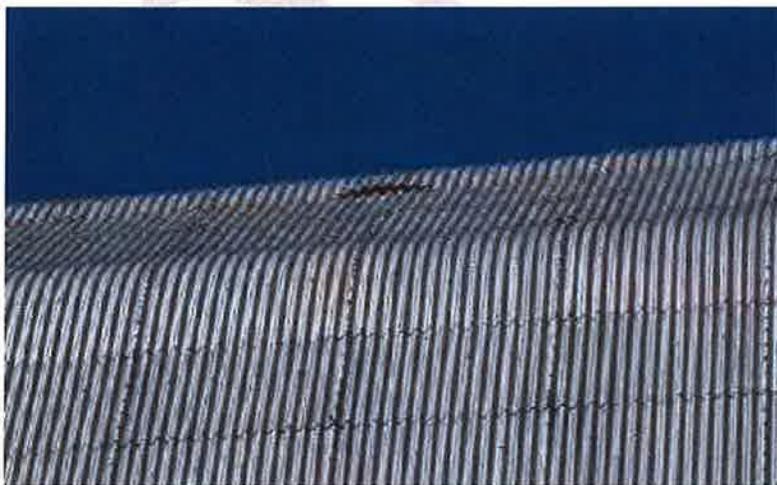
While on the recent site visit, it was also observed that the doors on the southwest corner of Hangar 3 were open while all other doors between both hangars were closed. Therefore, future observations must verify if the doors are operable. In addition, the existing corrugated aluminum sheathing was detached at various locations along the roof of Hangars 2 and 3, as shown by example in Figure 10.

Figure 10. Example location of detached corrugated aluminum sheathing on roof exterior of Hangar 2.

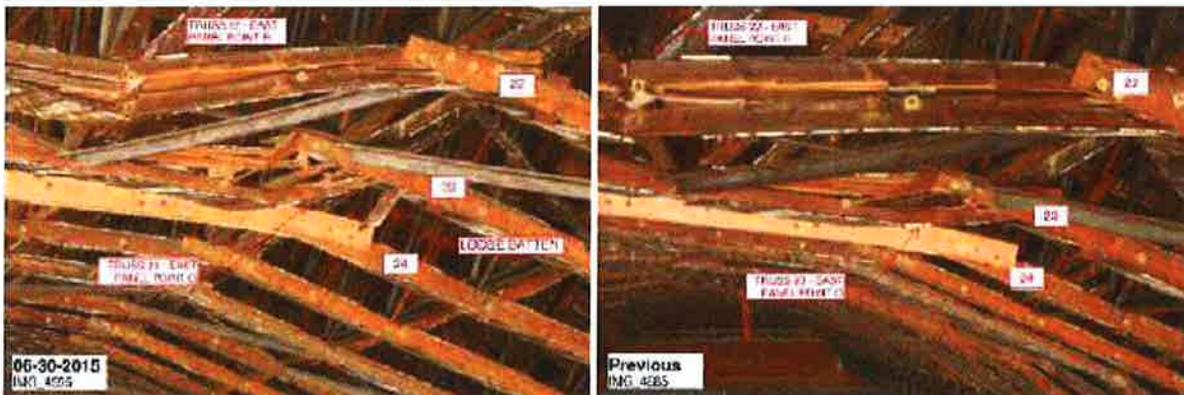
Figure 1. Truss damage progression at Trusses 22 and 23 East near Panel Points R and O.

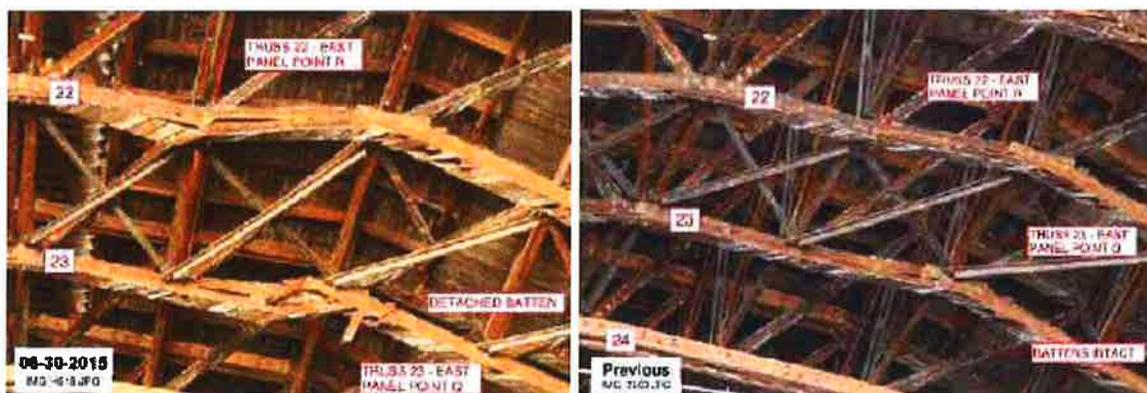
Figure 2. Truss damage progress at Trusses 22 and 23 East near Panel Points R and Q.

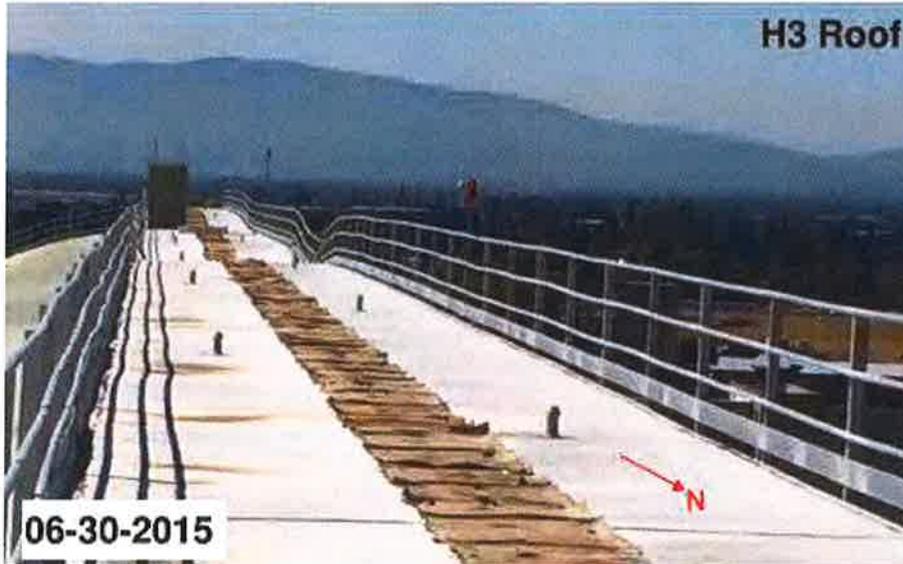
Figure 3. Damage observable at ridge line from building exterior.

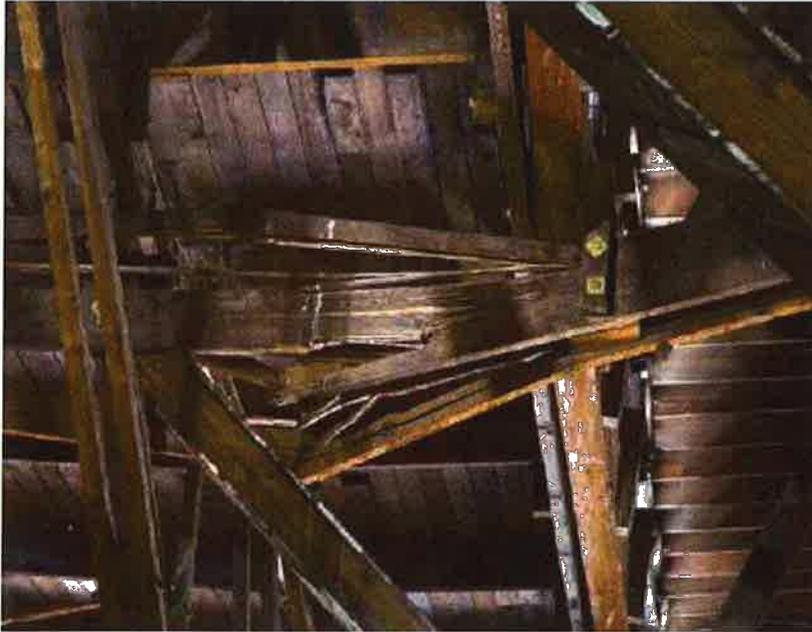
The following photos (Figure 5, Figure 6) demonstrate the severity of existing damage and the immediate danger of partial structure collapse.

Figure 5. Broken top chord near roof monitor at top of truss

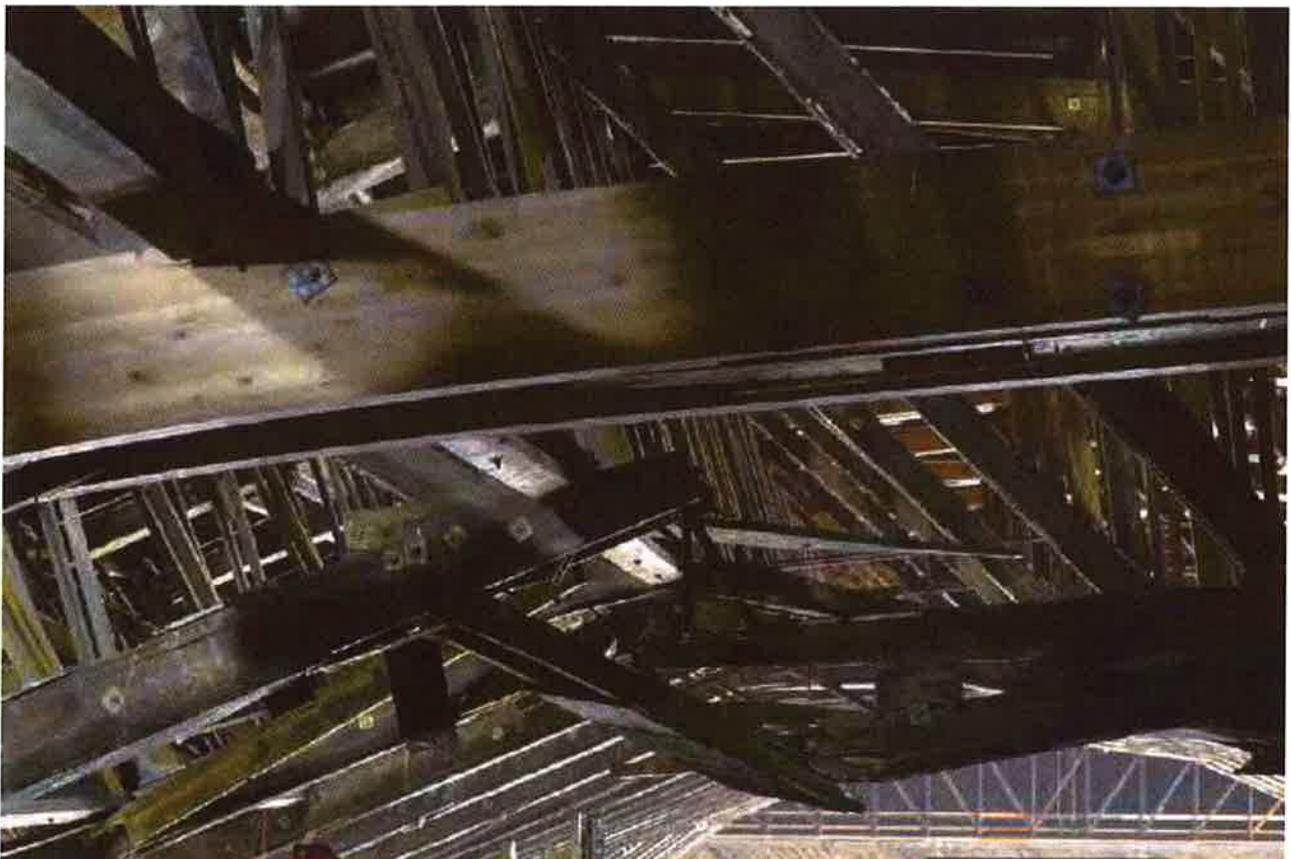
Figure 6. Broken bottom chord near top of truss.

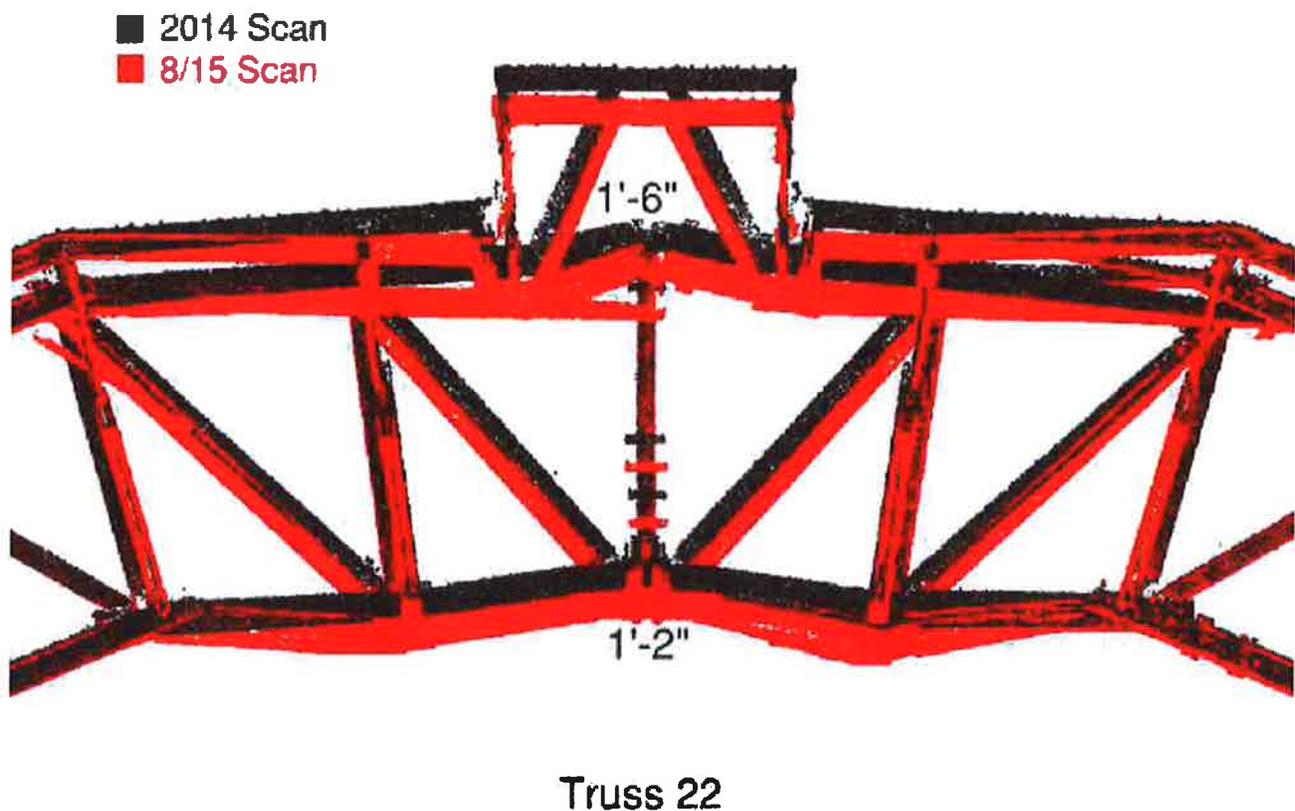
Quantitative measurements of the truss deflections were taken from successive point cloud surveying of the hangar interior. The damage progression is shown in an example processed image from the 3D point cloud scans taken in 2014 and 2015 (Figure 7). In that figure, the black portion represents the actual position of Truss 22 between Panel Points Q-West and Q-East in 2014, while the red portion shows the position in August 2015. The measurements on the image show the increase in downward deflection between the surveys. A summary of deflections at Panel Point S indicate zones of damage concentration (Figure 8).

Figure 7. Approximately 18" of additional deflection observed between 2014 and 2015 point cloud surveying scan at top of truss.

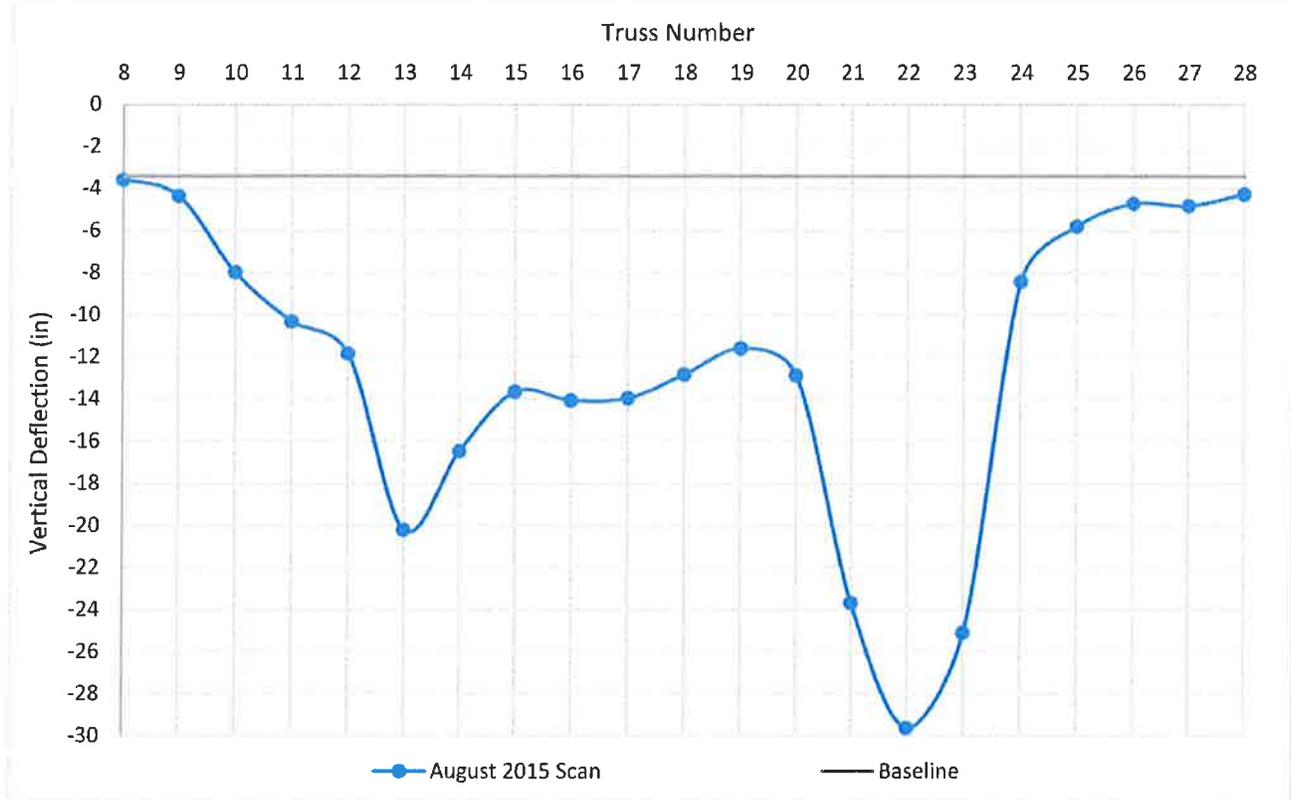
Figure 8. Deflections relative to baseline at Panel Point S.

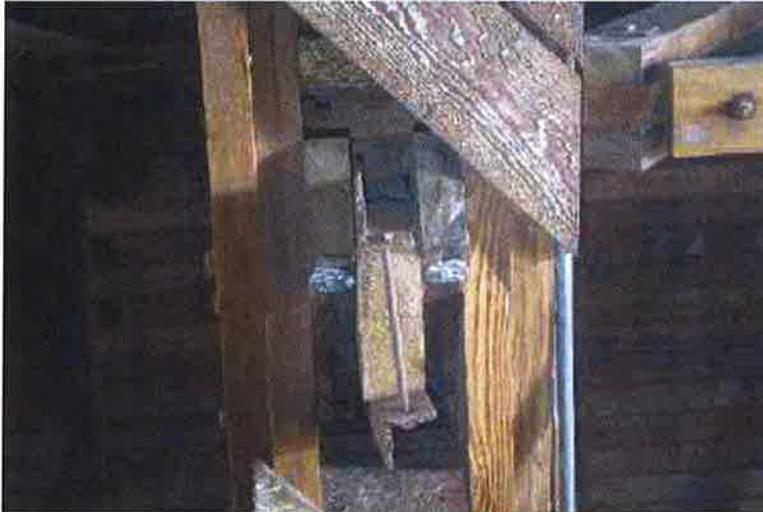
Figure 17. Example of new minor connection strengthening stitch bolts adjacent to existing angle clamp.

Permanent minor connection strengthening consists of stitch bolts at wood arch truss connection ends, and clamps at splits along the lengths of members (Figure 17). These have been installed in areas which require strengthening as part of the jacking sequence and emergency truss repair installation.

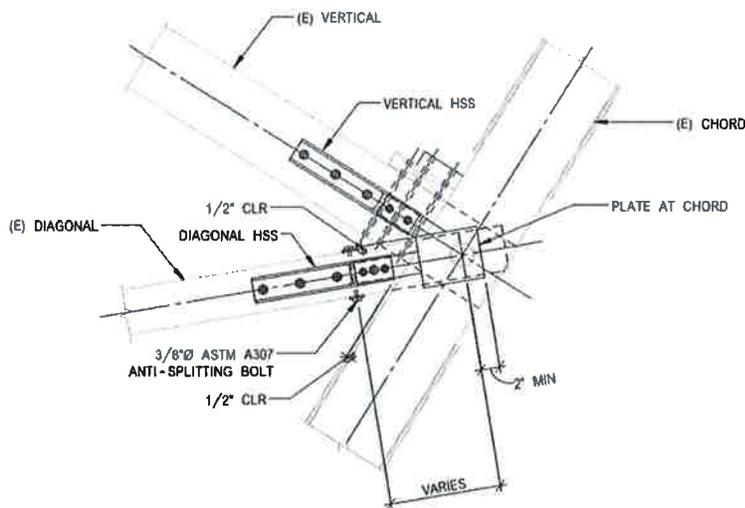
Figure 18. Permanent major connection strengthening.

Permanent major connection strengthening consists of galvanized and painted cut HSS steel tubes, steel plates, and bolts (Figure 18). These items are currently being fabricated and coated and are pending installation. This type of repair will be installed in locations of severe damage within truss panel point connections, where the connection is damaged, but the timber is in fair condition outside the connection zone.

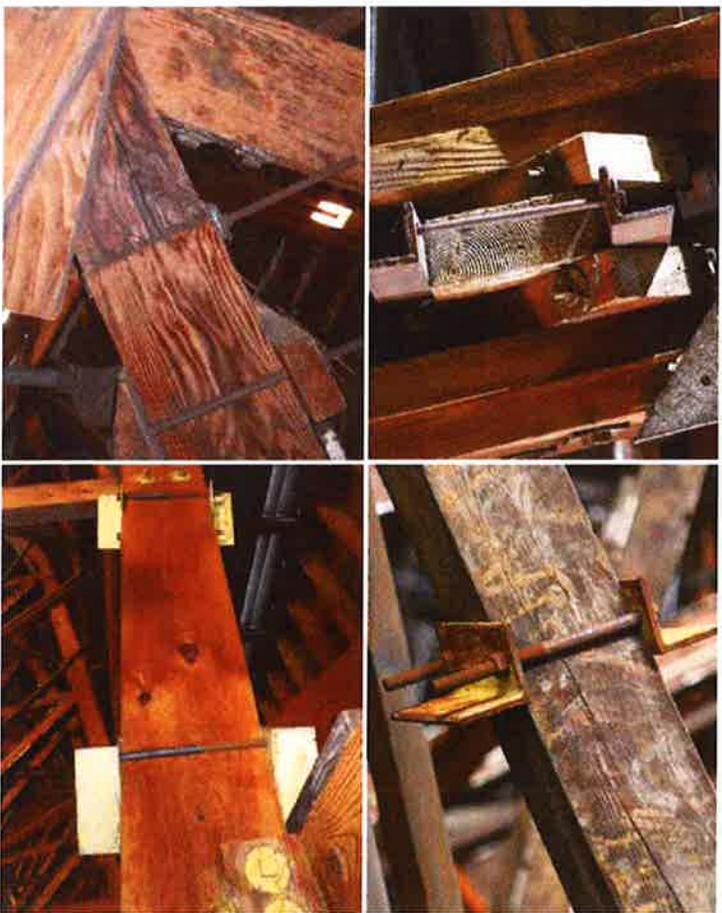
- Standard repairs for Navy maintenance included steel clamps and stitch bolts to fix minor splits
- "Maintenance Procedure for Timber Trussed Structures" Department of Navy Bureau of Yards and Docks, 1944
- Repairs occurred periodically throughout the service life of the hangars
- Navy records indicate that Timber Structures performed an inspection of the hangars in 1954
- The extent of these repairs is not fully documented
- Minor repairs have been documented at **541** members in H3 (many still undocumented)

Minor repairs made during Hangar 3 service life

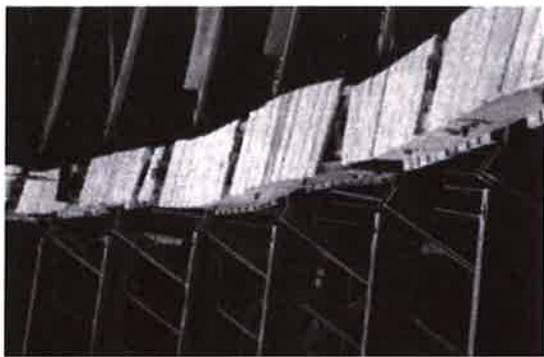
Buckled chords (left) and glulam strongback repairs (right)
-“Restoration of Navy LTA (Lighter than air) Hangars”, Donal Neal, 1996

- Major glulam repairs were made in 1981 to correct buckling observed in truss chords
- Glulam strongback members were installed to re-align chords, but load path remained in the original members
- Major repairs made to **49** members
- Struts added at each arch at node 18 to brace top of truss, with rod cross-bracing added at the north and south ends of the hangar
- Minor repairs were also made with clamps and stitch bolts. Many 1x6 purlin ties were replaced with steel rod ties

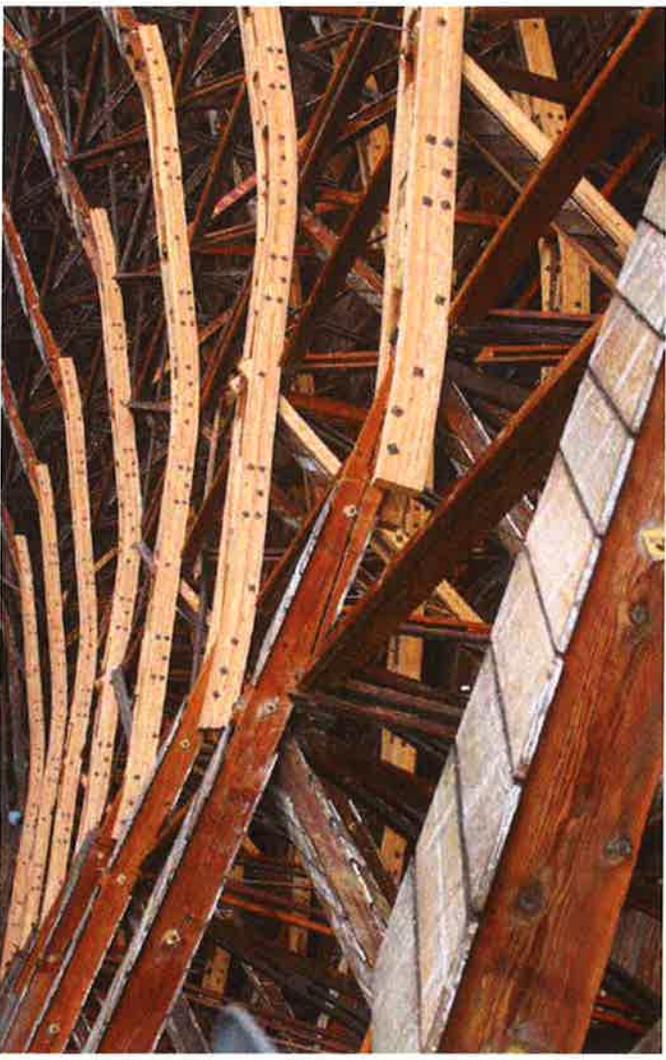
1993 glulam sister repairs to chord members in critical zone

- Continued deterioration of Hangar 3 necessitated further glulam repairs in 1993
- Repairs consisted of glulam strongbacks for buckling, and multi-chord glulam sistered members
- Many of these repairs were made in the critical zone where the most severe deflections and damage were later found
- Major repairs made to **75** members
- Sistering repairs also made to roof support purlins and minor clamp repairs were again performed on arch trusses

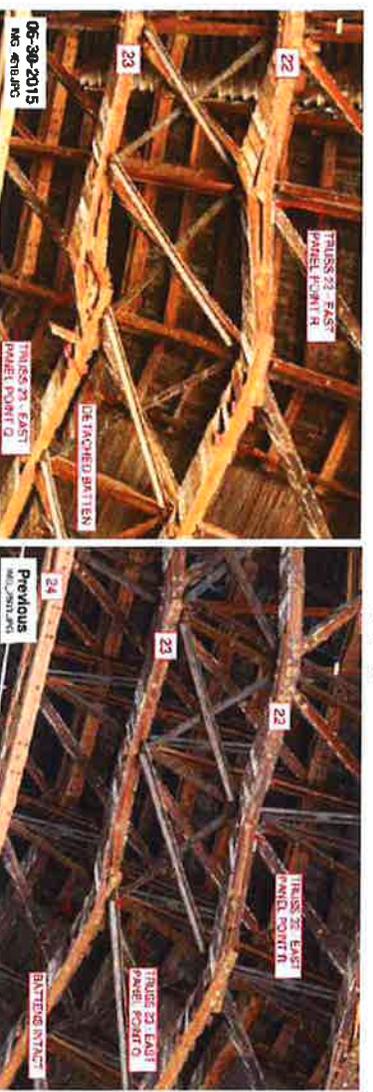
Photos of damage progression

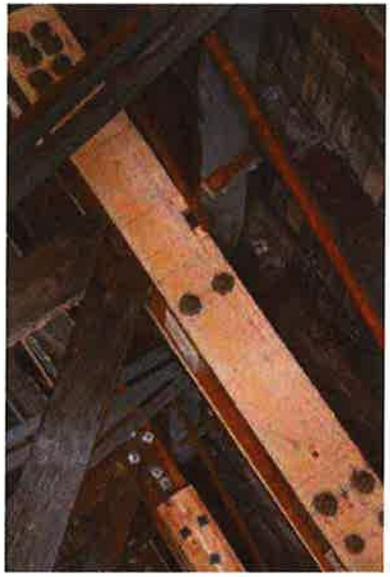
Chord sister repair installed prior to exoskeletons

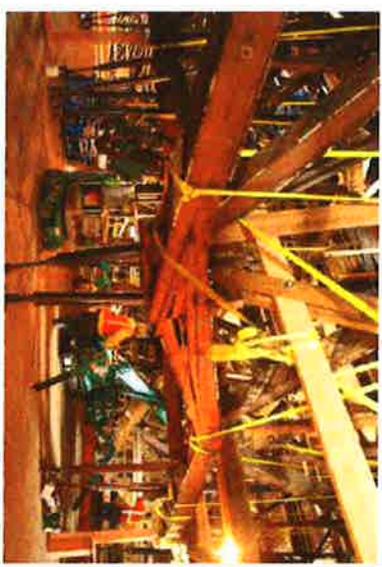
Temporary strapping on chord marked for removal and replacement

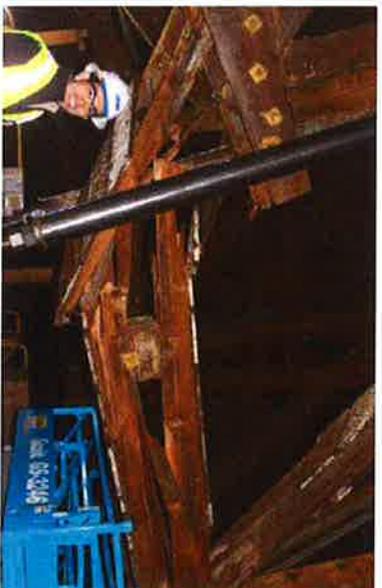
Damaged chord member viewed from access tower

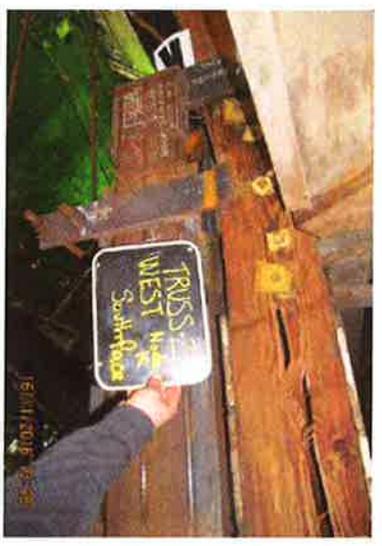
Chord damage at node K after exoskeleton install

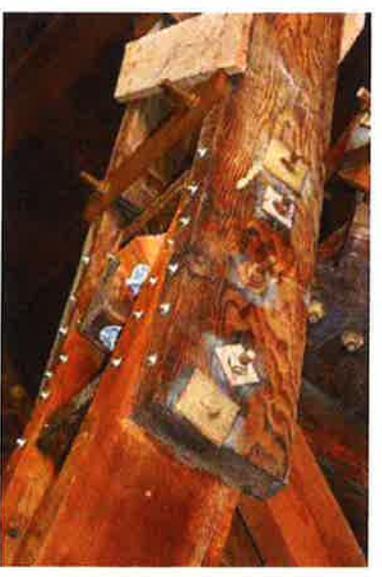
Preemptive screw and clamp strengthening on undamaged chord at node K
