Causal Analysis Report

Chevron Richmond Refinery  
Reportable Flaring Events

February 7-8, 2019  
Start-up of Hydrogen Plant Train 1 (S-4449)

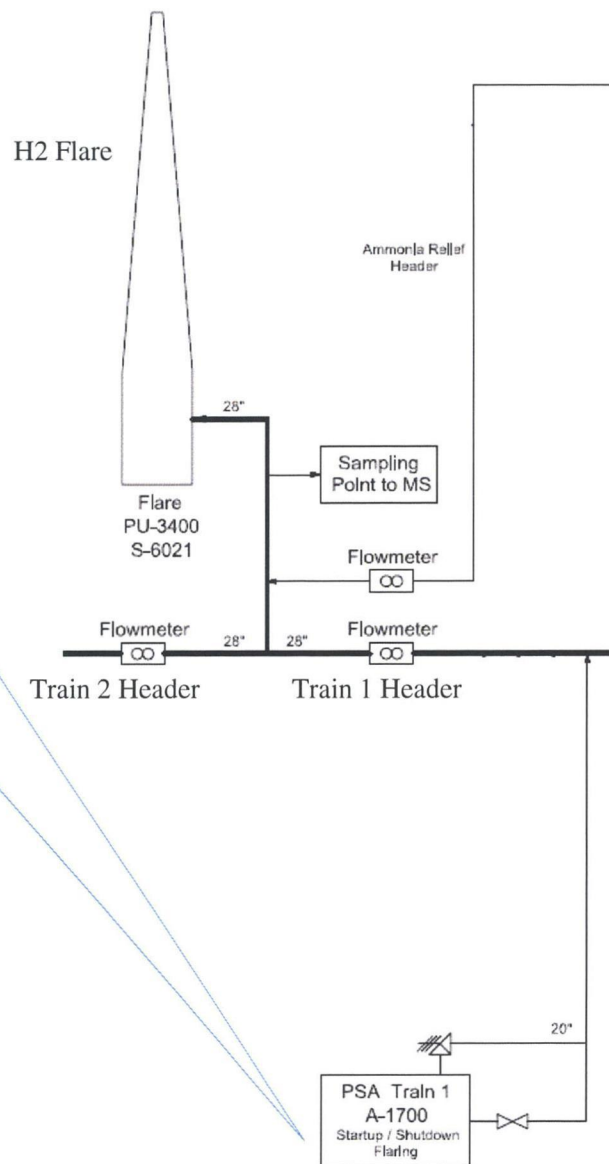
# Hydrogen Plant Train 1 Start-up

Hydrogen Plant Train 1 began to start-up at approximately 9:06PM on February 7, 2019. Start-up procedures include routing flows to relief and the Hydrogen Plant flare does not have a water seal or flare gas recovery.
