Causal Analysis Report

Chevron Richmond Refinery  
Reportable Flaring Events

March 5, 2019 – April 12, 2019  
Start-up and Commissioning of Hydrogen Plant Train 2 (S-4450)

Refinery Flare Event – Cause Investigation Report

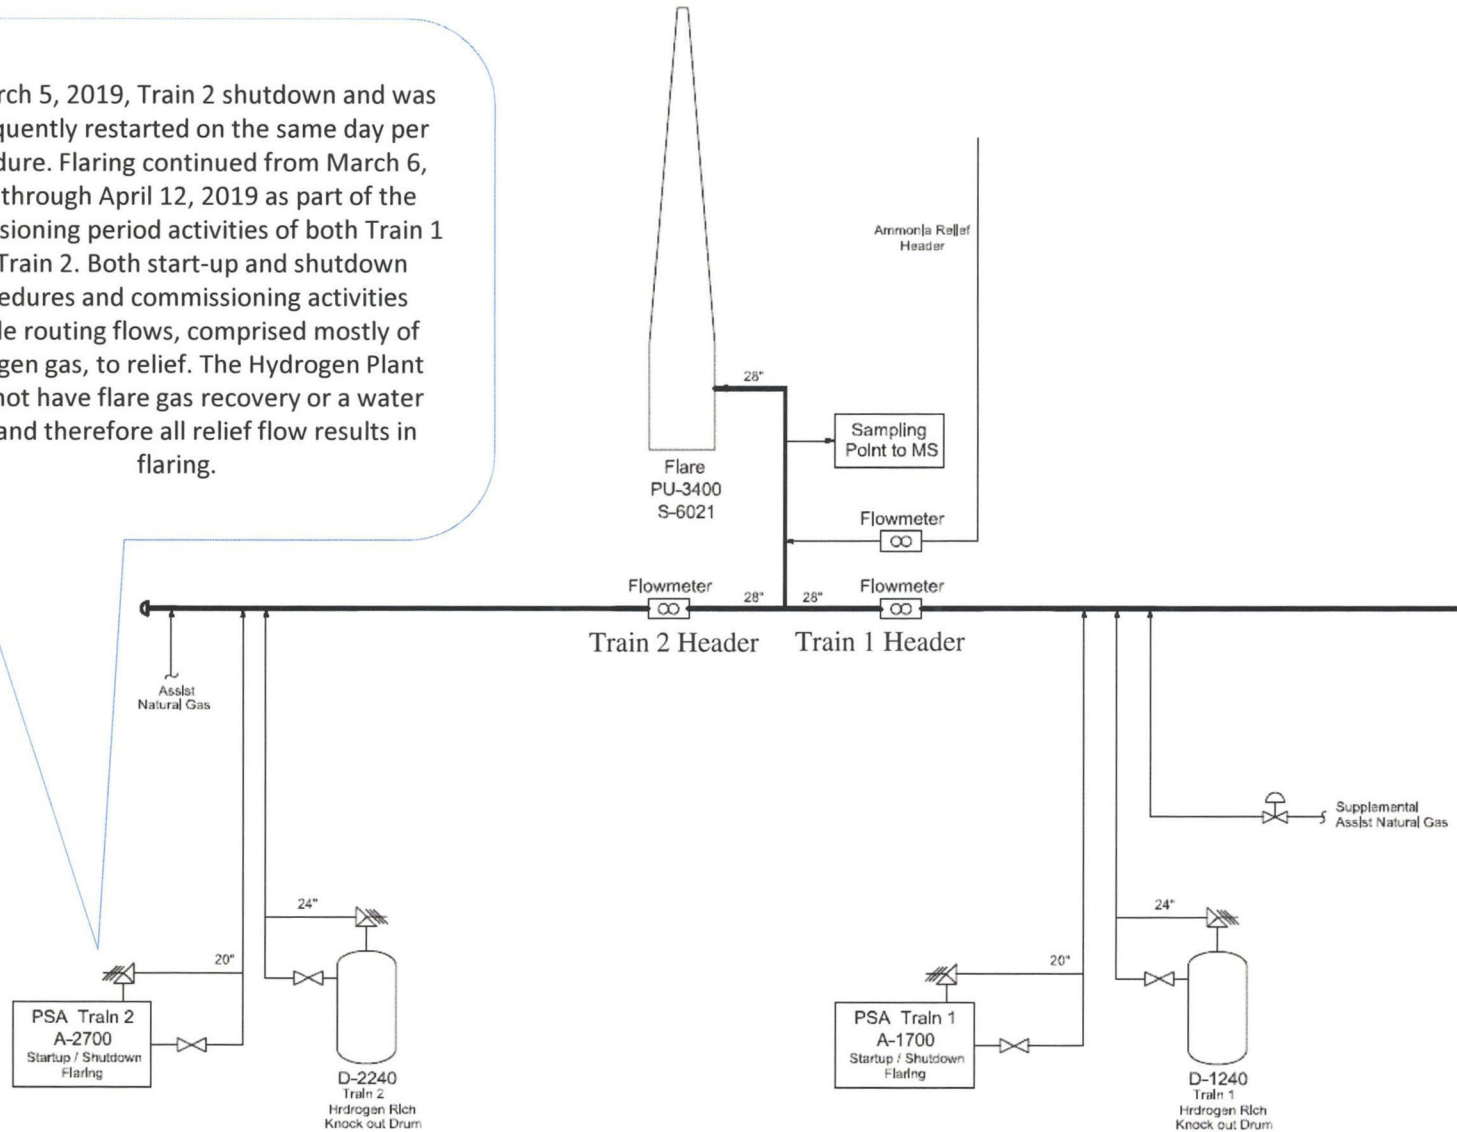
# Hydrogen Plant Train 2 Start-up and Commissioning

On March 5, 2019, Train 2 shutdown and was subsequently restarted on the same day per procedure. Flaring continued from March 6, 2019 through April 12, 2019 as part of the commissioning period activities of both Train 1 and Train 2. Both start-up and shutdown procedures and commissioning activities include routing flows, comprised mostly of hydrogen gas, to relief. The Hydrogen Plant does not have flare gas recovery or a water seal, and therefore all relief flow results in flaring.
