**Chevron Richmond Refinery
April 2019 Flaring Causal Analysis Report**

Chevron Richmond Refinery
Reportable Flaring Events

Unplanned Shutdown of TKC Unit Due to Level Indication Malfunction

Refinery Flare Event – Cause Investigation Report

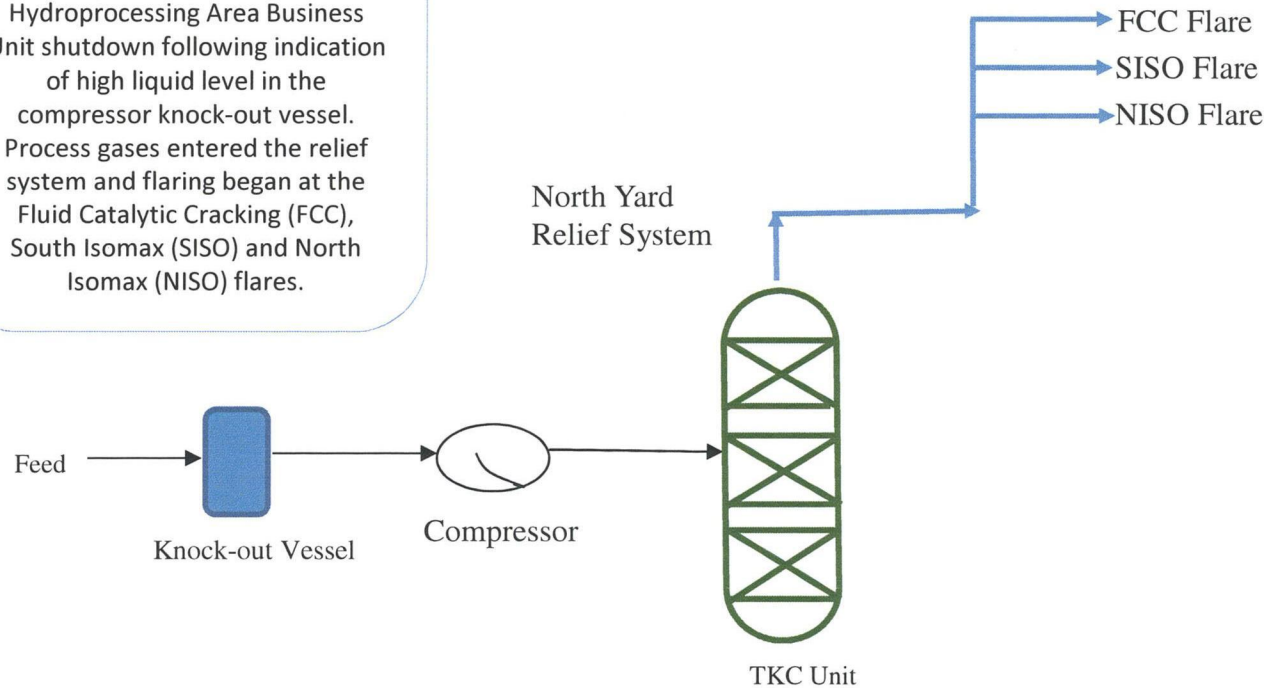
Unplanned Shutdown of TKC Unit Due to Level Indication Malfunction

Initial investigation indicated that plugging in the level bridle caused a false high level. The level bridle was flushed and level indication returned to normal operation. After level indication was restored following this April 13, 2019 flaring incident, inaccurate liquid level indication on the same compressor knock-out vessel caused a second flaring incident on May 3, 2019. Further root cause investigation identified ammonium bisulfide salts can accumulate in the level indication equipment on the compressor knock-out vessel and caused the false level indication in both flaring incidents.

On April 13, 2019 at approximately 12:41AM, a compressor in the Hydroprocessing Area Business Unit shutdown following indication of high liquid level in the compressor knock-out vessel. Process gases entered the relief system and flaring began at the Fluid Catalytic Cracking (FCC), South Isomax (SISO) and North Isomax (NISO) flares.

1. Install permanent heat tracing on all level indication bridles on the compressor knock-out vessel to prevent the formation of ammonium bisulfide salts.
Projected Completion Date: November 31, 2019
