**Chevron Richmond Refinery
May 2019 Flaring Causal Analysis Report**

TKC Flaring Due to Level Indication Malfunction

Refinery Flare Event – Cause Investigation Report

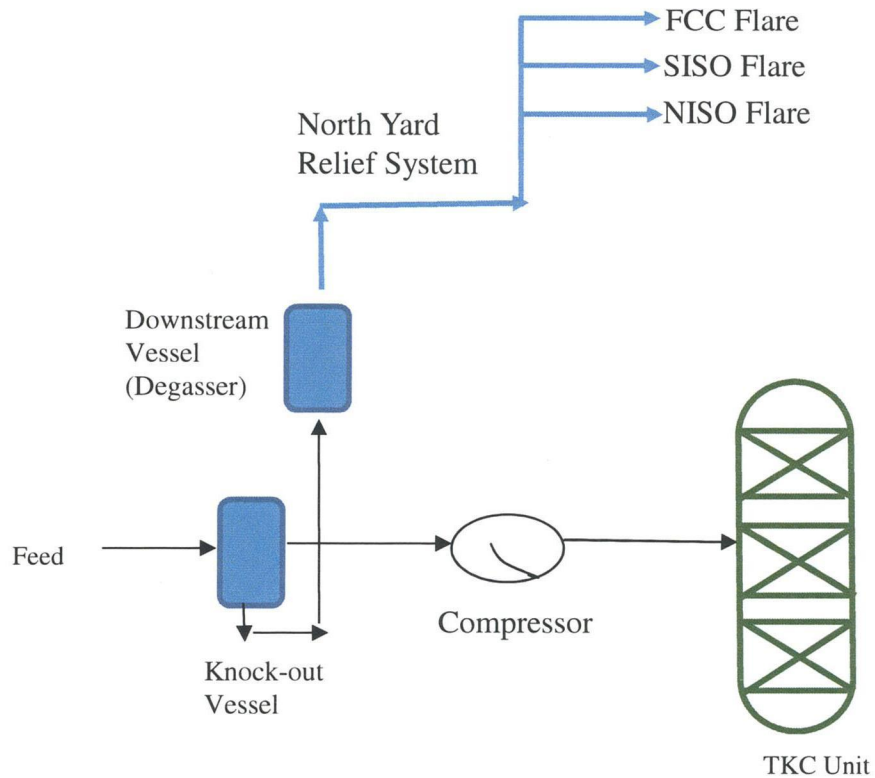
TKC Flaring Due to Level Indication Malfunction

Ammonium bisulfide salts accumulated in the level indication equipment on the compressor knock-out vessel, resulting in false high level indication.

On May 3, 2019 at approximately 7:00AM, a compressor knock-out vessel in the Hydroprocessing Area Business Unit began indicating a false high level. Level control equipment automatically adjusted to reduce the level which resulted in increased downstream pressure, lifting a pressure safety valve. Process gases entered the relief system and flaring began at the Fluid Catalytic Cracking (FCC), South Isomax (SISO) and North Isomax (NISO) flares.

1. Install permanent heat tracing on all level indication bridles on the compressor knock-out vessel to prevent the formation of ammonium bisulfide salts.
Projected Completion Date: November 31, 2019
