Causal Analysis Report

Chevron Richmond Refinery
Reportable Flaring Events

May 10, 2019 – May 11, 2019
Shutdown and Start-up of Hydrogen Plant Train 2
(S-4450)

Refinery Flare Event – Cause Investigation Report

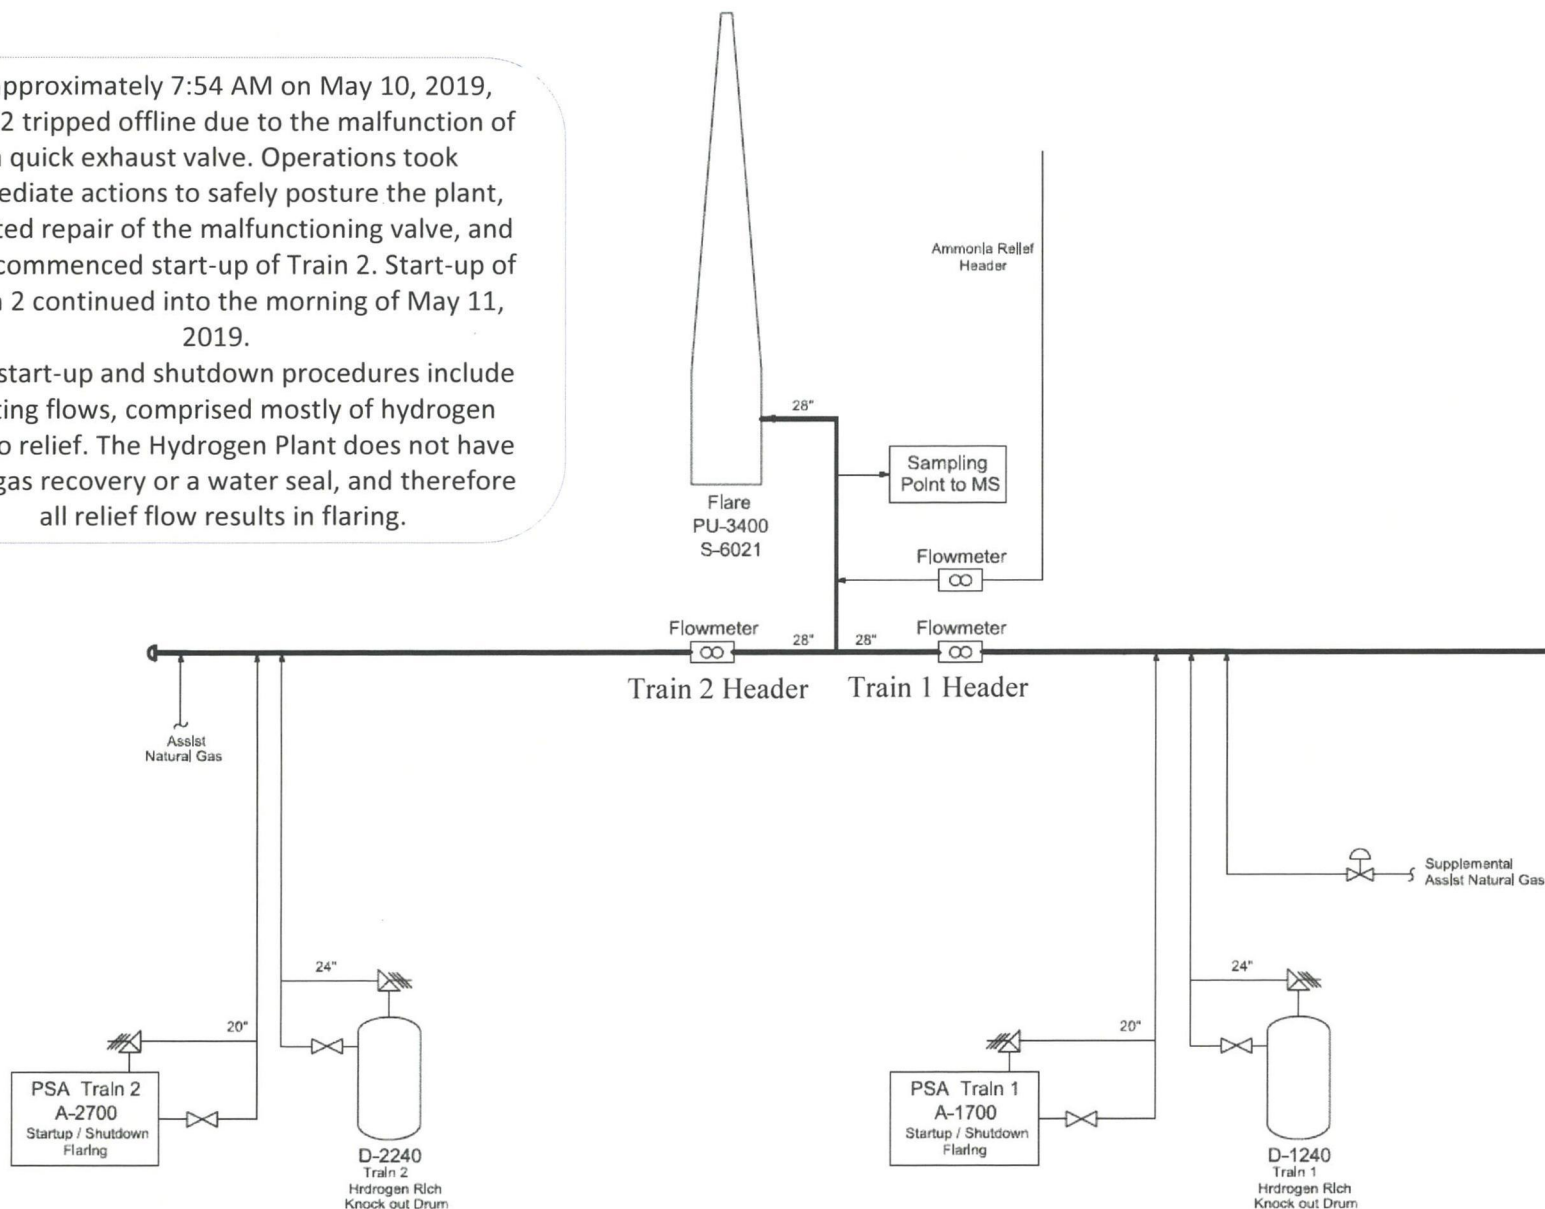
Shutdown and Start-up of Hydrogen Plant Train 2

At approximately 7:54 AM on May 10, 2019, Train 2 tripped offline due to the malfunction of a quick exhaust valve. Operations took immediate actions to safely posture the plant, initiated repair of the malfunctioning valve, and then commenced start-up of Train 2. Start-up of Train 2 continued into the morning of May 11, 2019.

Both start-up and shutdown procedures include routing flows, comprised mostly of hydrogen gas, to relief. The Hydrogen Plant does not have flare gas recovery or a water seal, and therefore all relief flow results in flaring.
