Causal Analysis Report

Chevron Richmond Refinery Reportable Flaring Events

May 28, 2019 – May 29, 2019
Shutdown and Start-up of Hydrogen Plant Train 2
(S-4450)

Refinery Flare Event – Cause Investigation Report

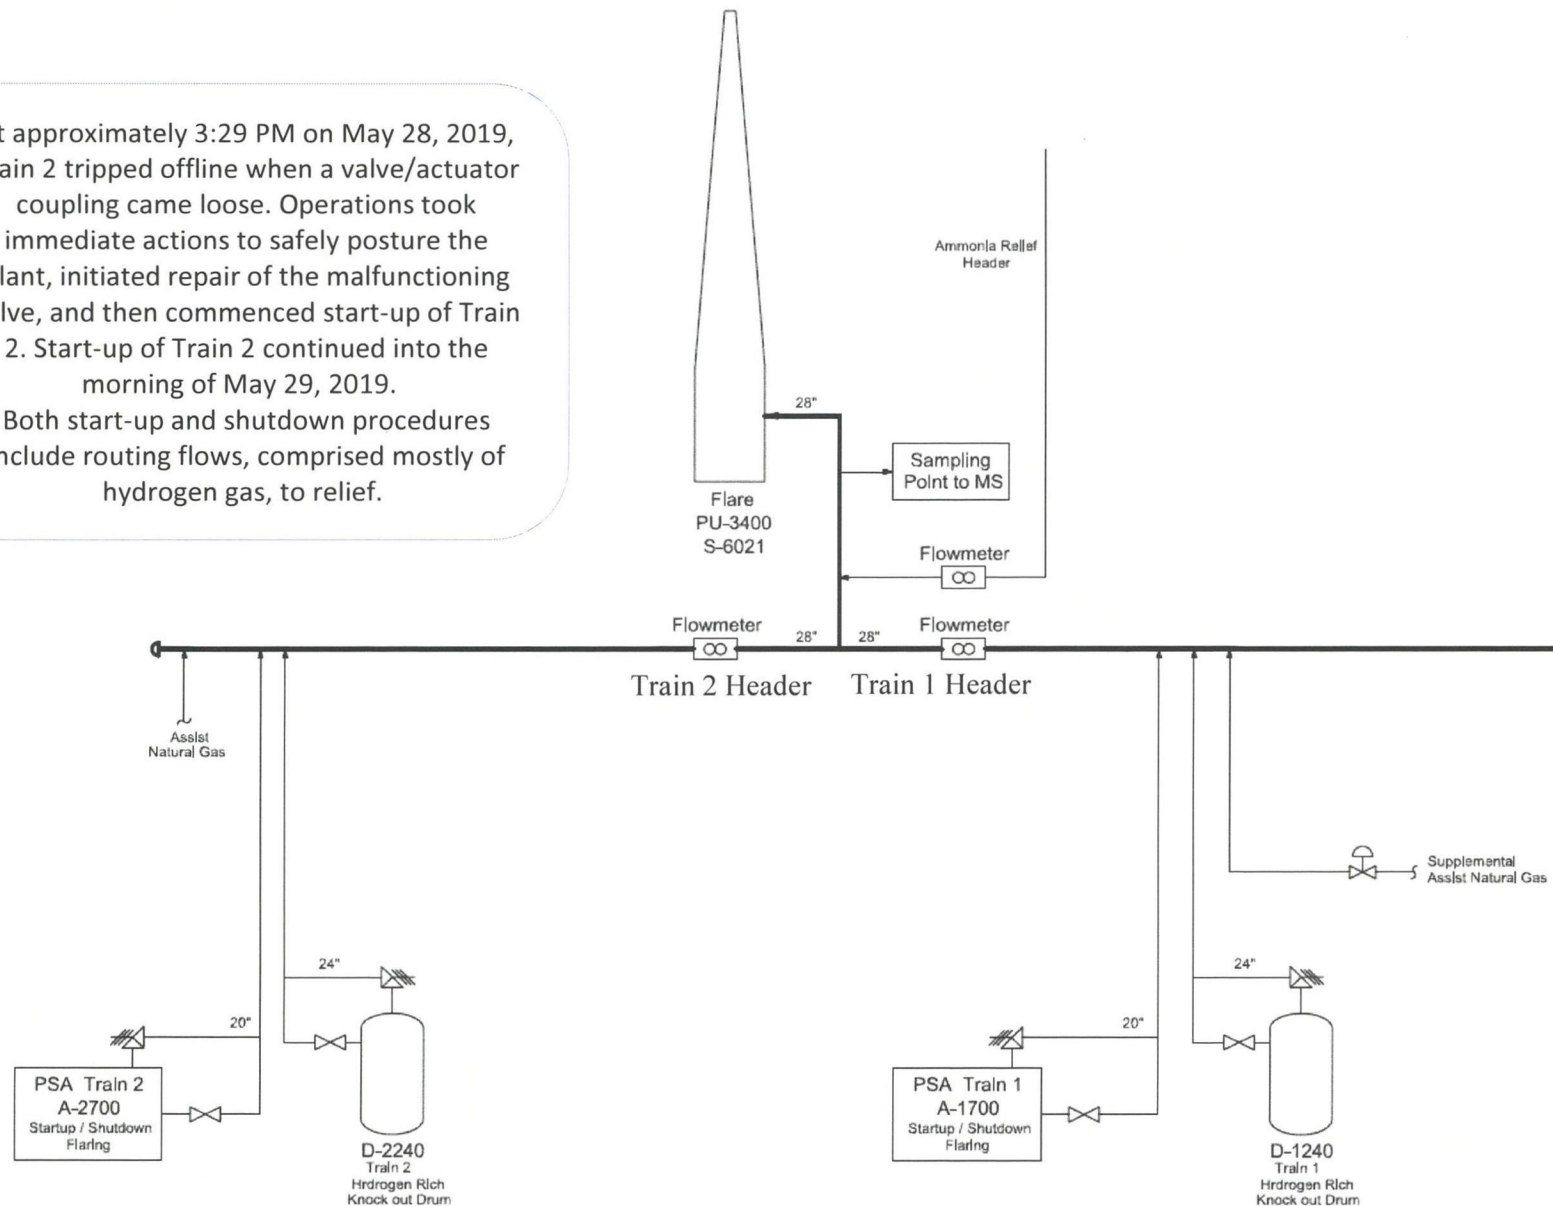
Shutdown and Start-up of Hydrogen Plant Train 2

The Train 2 shutdown and subsequent flaring occurred when a valve/actuator coupling came loose and allowed a PSA tail gas valve to open, resulting in the automatic shutdown of Train 2.

At approximately 3:29 PM on May 28, 2019, Train 2 tripped offline when a valve/actuator coupling came loose. Operations took immediate actions to safely posture the plant, initiated repair of the malfunctioning valve, and then commenced start-up of Train 2. Start-up of Train 2 continued into the morning of May 29, 2019.

Both start-up and shutdown procedures include routing flows, comprised mostly of hydrogen gas, to relief.

1. Inspect valve to actuator couplings on all Pressure Swing Absorber (PSA) valves. If identified, repair any coupling issues.
