Causal Analysis Report

Chevron Richmond Refinery
Reportable Flaring Events

May 29, 2019

Flaring Due to Vessel Depressurization

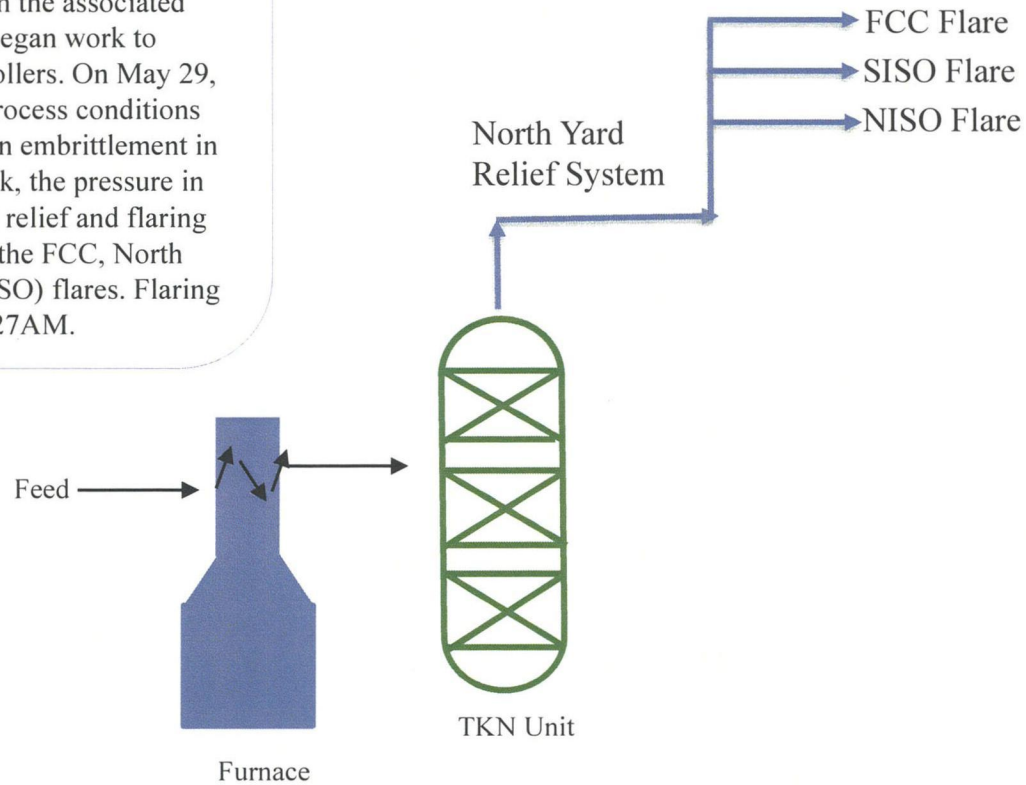
TKN Flaring Due to Vessel Depressurization

1. The stem of the minimum flow regulator of fuel gas to the furnace did not function properly, causing the furnace to automatically shutdown.
2. Reactor vessel depressurization was not initiated quickly enough after feed was removed from the unit, resulting in the need for a rapid depressurization of the vessel which overwhelmed the flare gas recovery system

The main contributor of vent gas flow during this event originated from TKN reactor vessels.

During the evening of May 28, 2019, a furnace in the Taylor Katalytic Denitrifier (TKN) unit of the Hydroprocessing Area Business Unit began to experience flow control issues. The furnace was shutdown, hydrocarbon feed was removed from the associated reactor vessel, and maintenance began work to troubleshoot and repair the flow controllers. On May 29, 2019, an engineering review of the process conditions identified an increased risk of hydrogen embrittlement in the reactor vessel. To mitigate this risk, the pressure in the vessel was quickly depressurized to relief and flaring began at approximately 9:12AM at the FCC, North Isomax (NISO), and South Isomax (SISO) flares. Flaring ended at approximately 9:27AM.

1. Repair the stem of the minimum flow regulator of fuel gas to the furnace
Commencement Date: 5/28/2019
Completion Date: 5/29/2019
2. Revise applicable procedures to provide prescriptive actions to address hydrogen embrittlement risk during loss of feed scenarios, including guidelines for time frame
Commencement Date: 6/20/2019
Projected Completion Date: 9/27/2019
