Causal Analysis Report

Chevron Richmond Refinery  
Reportable Flaring Events

June 12, 2019  
Shutdown of Hydrogen Plant Train 2  
(S-4450)

## Refinery Flare Event – Cause Investigation Report

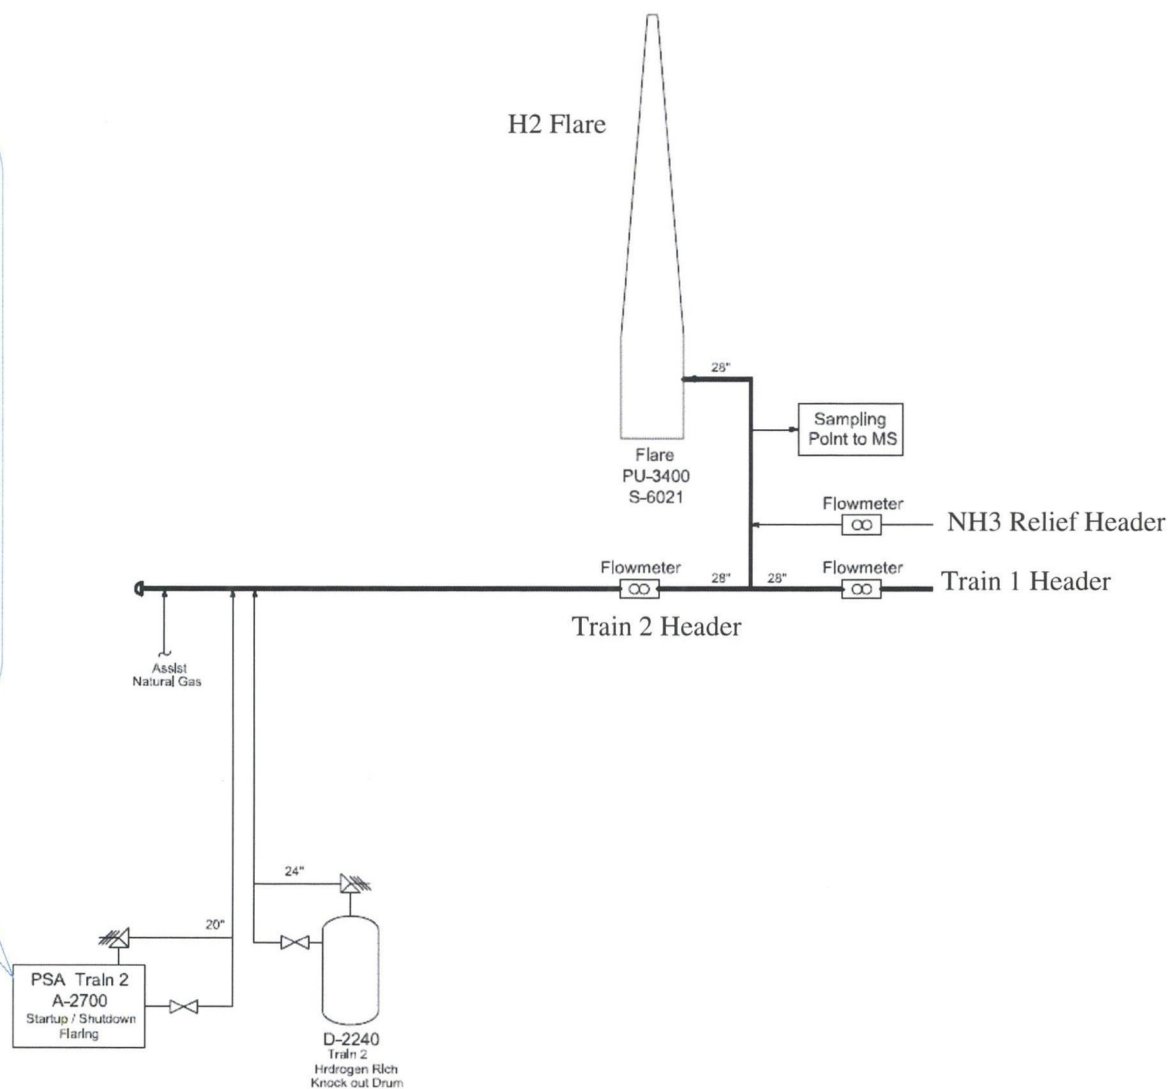
# Hydrogen Plant Train 2 Shutdown

The Train 2 shutdown and subsequent flaring was caused by the malfunction of the induced draft fan. The run indication contact falsely indicated that the motor was not running, triggering computerized safety systems to shutdown the fan and subsequently Hydrogen Plant Train 2.

On June 11, 2019, at approximately 9:18PM, Hydrogen Plant Train 2 tripped offline following the shutdown of the induced draft fan. Operations took immediate actions to safely posture the plant.

Hydrogen plant shutdown procedures include routing flows to relief. The Hydrogen Plant does not have flare gas recovery or a water seal, and therefore all relief flow results in flaring. The vent gas volume exceeded 500,000 scf on June 12, 2019.

1. Modify the Distributed Control System automatic safety shutdown condition to use two-of-two voting logic on induced air fans
