Causal Analysis Report

Chevron Richmond Refinery
Reportable Flaring Events

June 13-14, 2019
Startup of Hydrogen Plant Train 2
(S-4450)

Refinery Flare Event – Cause Investigation Report

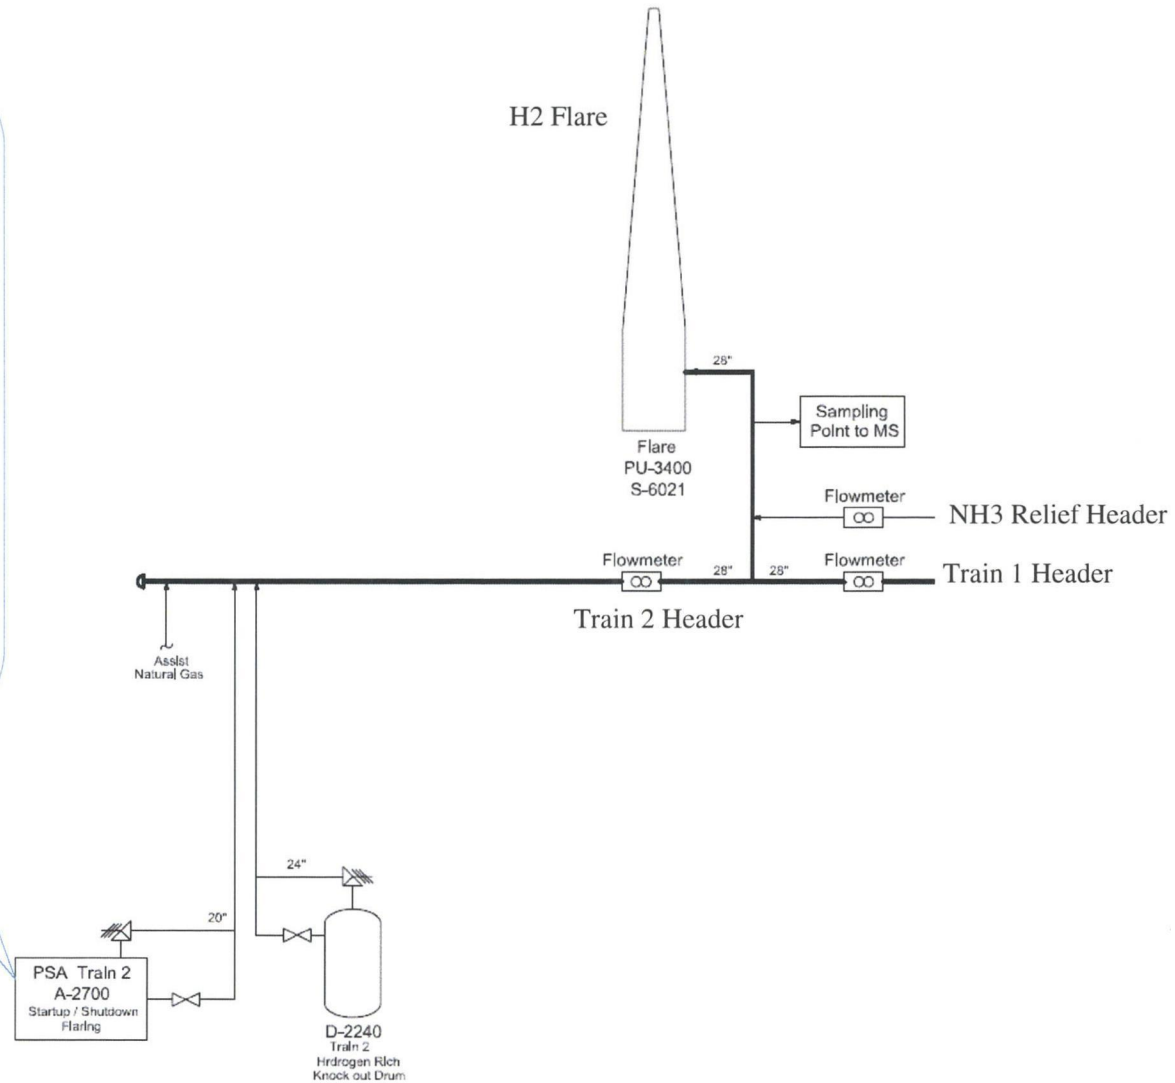
Hydrogen Plant Train 2 Start-up

On June 13, 2019, at approximately 12:24PM, Operations introduced hydrocarbon feed to the Hydrogen Plant Train 2 as part of start-up procedures. Hydrogen plant startup procedures include routing flows to relief. The Hydrogen Plant does not have flare gas recovery or a water seal, and therefore all relief flow results in flaring. The vent gas volume exceeded 500,000 scf on June 13 and June 14, 2019.
