Causal Analysis Report

Chevron Richmond Refinery
Reportable Flaring Events

July 16-17, 2019
Startup of Hydrogen Plant Train 2
(S-4450)

Refinery Flare Event – Cause Investigation Report

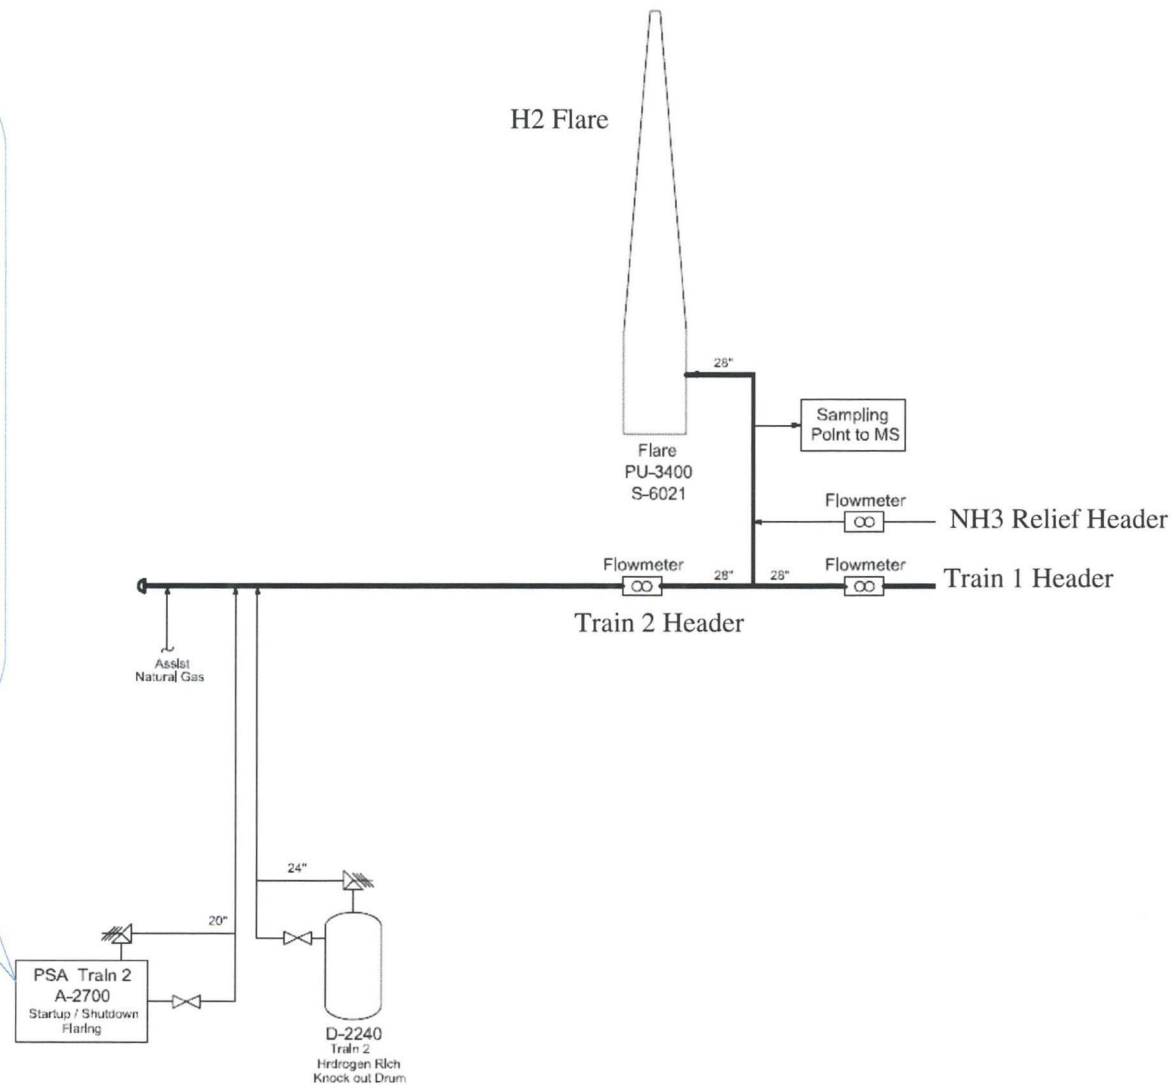
Hydrogen Plant Train 2 Start-up

On July 16, 2019, at approximately 7:24PM, Operations introduced hydrocarbon feed to the Hydrogen Plant Train 2 as part of start-up procedures. Hydrogen plant startup procedures include routing flows to relief. The Hydrogen Plant does not have flare gas recovery or a water seal, and therefore all relief flow results in flaring.
