Causal Analysis Report

Chevron Richmond Refinery
Reportable Flaring Events

August 5, 2019
Start-up of Hydrogen Plant Train 1
(S-4449)

Refinery Flare Event – Cause Investigation Report

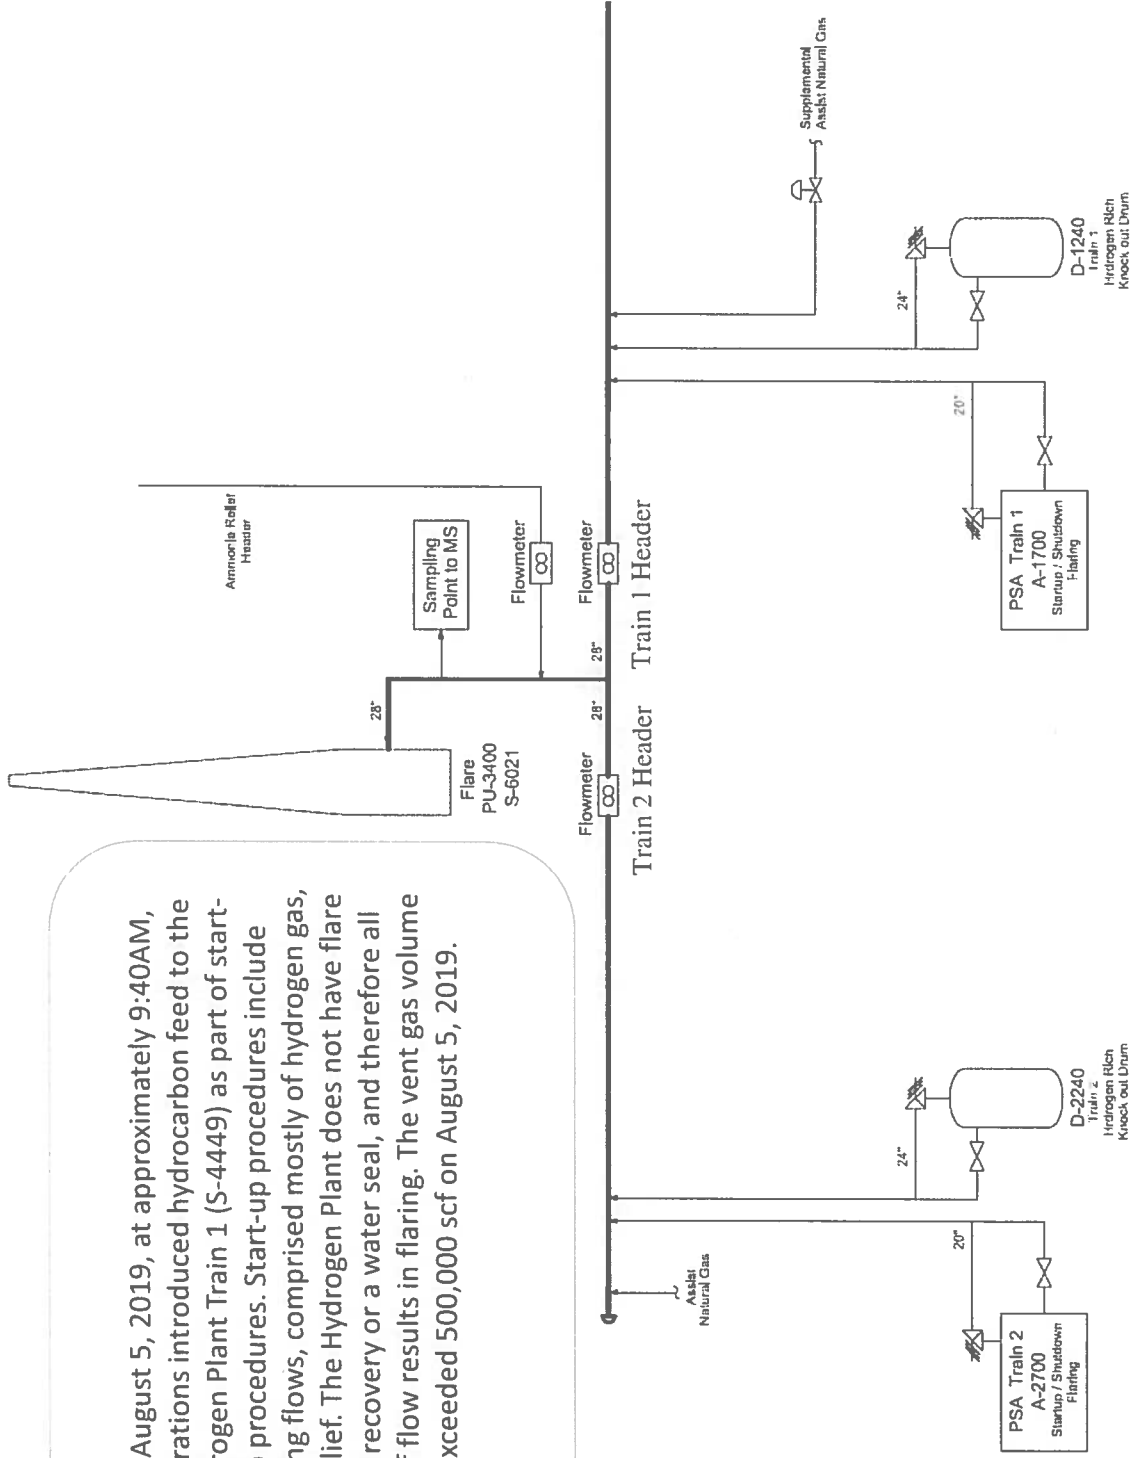
Start-up of Hydrogen Plant Train 1

On August 5, 2019, at approximately 9:40AM, Operations introduced hydrocarbon feed to the Hydrogen Plant Train 1 (S-4449) as part of start-up procedures. Start-up procedures include routing flows, comprised mostly of hydrogen gas, to relief. The Hydrogen Plant does not have flare gas recovery or a water seal, and therefore all relief flow results in flaring. The vent gas volume exceeded 500,000 scf on August 5, 2019.
