**Chevron Richmond Refinery
September 2019 Flaring Causal Analysis Report**

TKC Flaring Due to Seal Oil System Malfunction

Refinery Flare Event – Cause Investigation Report

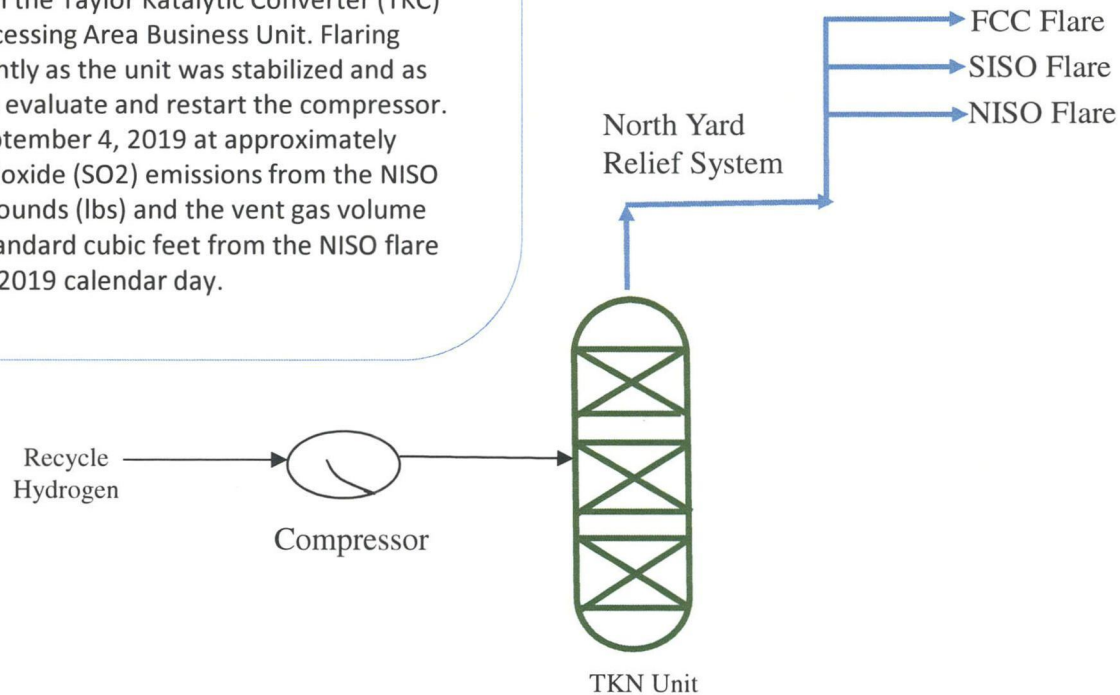
TKC Flaring Due to Seal Oil System Malfunction

Root cause: Malfunction of the positioner on the seal oil tank level control valve, leading to abnormal seal oil system flows and the decision to shut down the compressor

On September 4, 2019, operators in the Hydroprocessing Area Business Unit identified abnormal conditions on the seal oil system of a hydrogen recycle compressor. The compressor was manually shutdown and the unit was depressured to relief per procedure. Flaring began at approximately 9:35AM at the North Isomax (NISO), South Isomax (SISO) and Fluid Catalytic Cracking (FCC) flares. The primary source of vent gas flared during this event was process material from the Taylor Katalytic Converter (TKC) unit of the Hydroprocessing Area Business Unit. Flaring continued intermittently as the unit was stabilized and as efforts were made to evaluate and restart the compressor. Flaring ceased on September 4, 2019 at approximately 7:45PM. The sulfur dioxide (SO₂) emissions from the NISO flare exceeded 500 pounds (lbs) and the vent gas volume exceeded 500,000 standard cubic feet from the NISO flare on the September 4, 2019 calendar day.

1. Replace faulty positioner on seal oil tank level control valve.
