Causal Analysis Report

Chevron Richmond Refinery
Reportable Flaring Events

October 11-12, 2019

Startup of Hydrogen Plant Train 1 (S-4449) and Train 2 (S-4450)

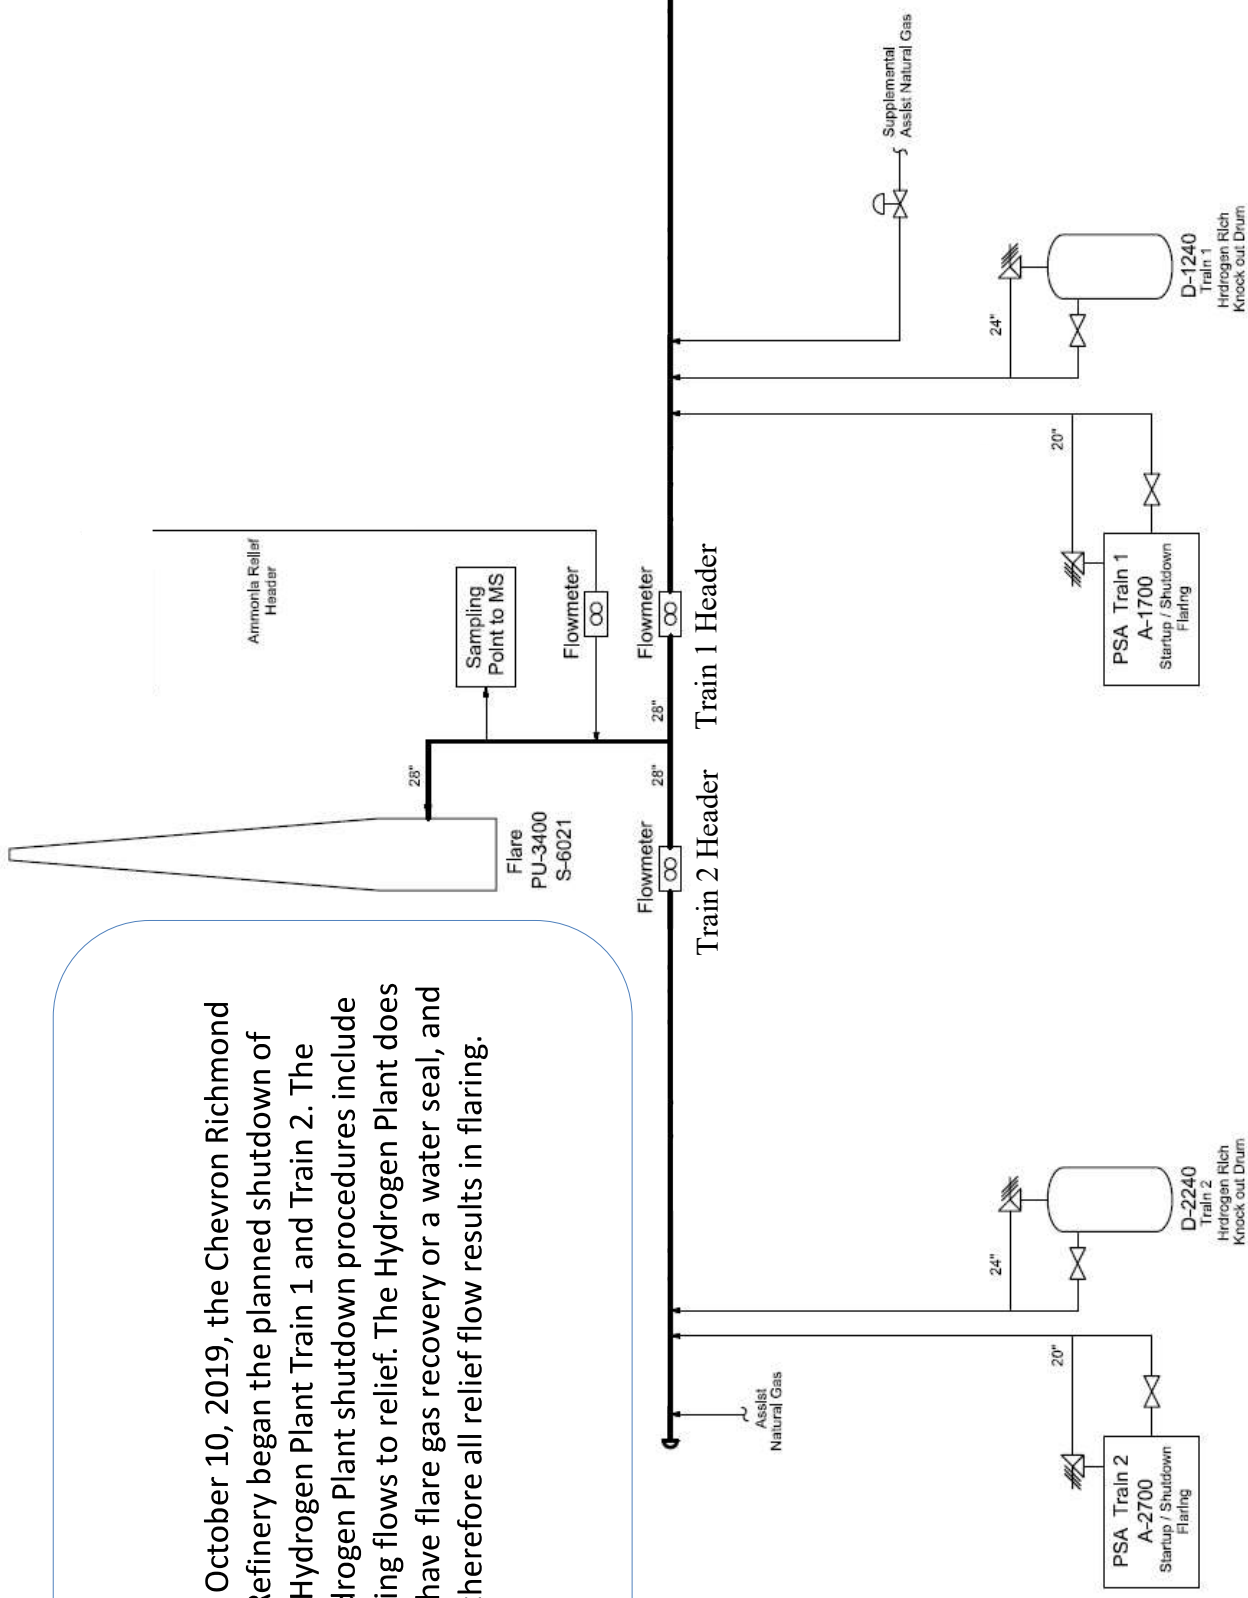
Hydrogen Plant Train 1 and Train 2 Planned Shutdown

On October 10, 2019, the Chevron Richmond Refinery began the planned shutdown of Hydrogen Plant Train 1 and Train 2. The Hydrogen Plant shutdown procedures include routing flows to relief. The Hydrogen Plant does not have flare gas recovery or a water seal, and therefore all relief flow results in flaring.

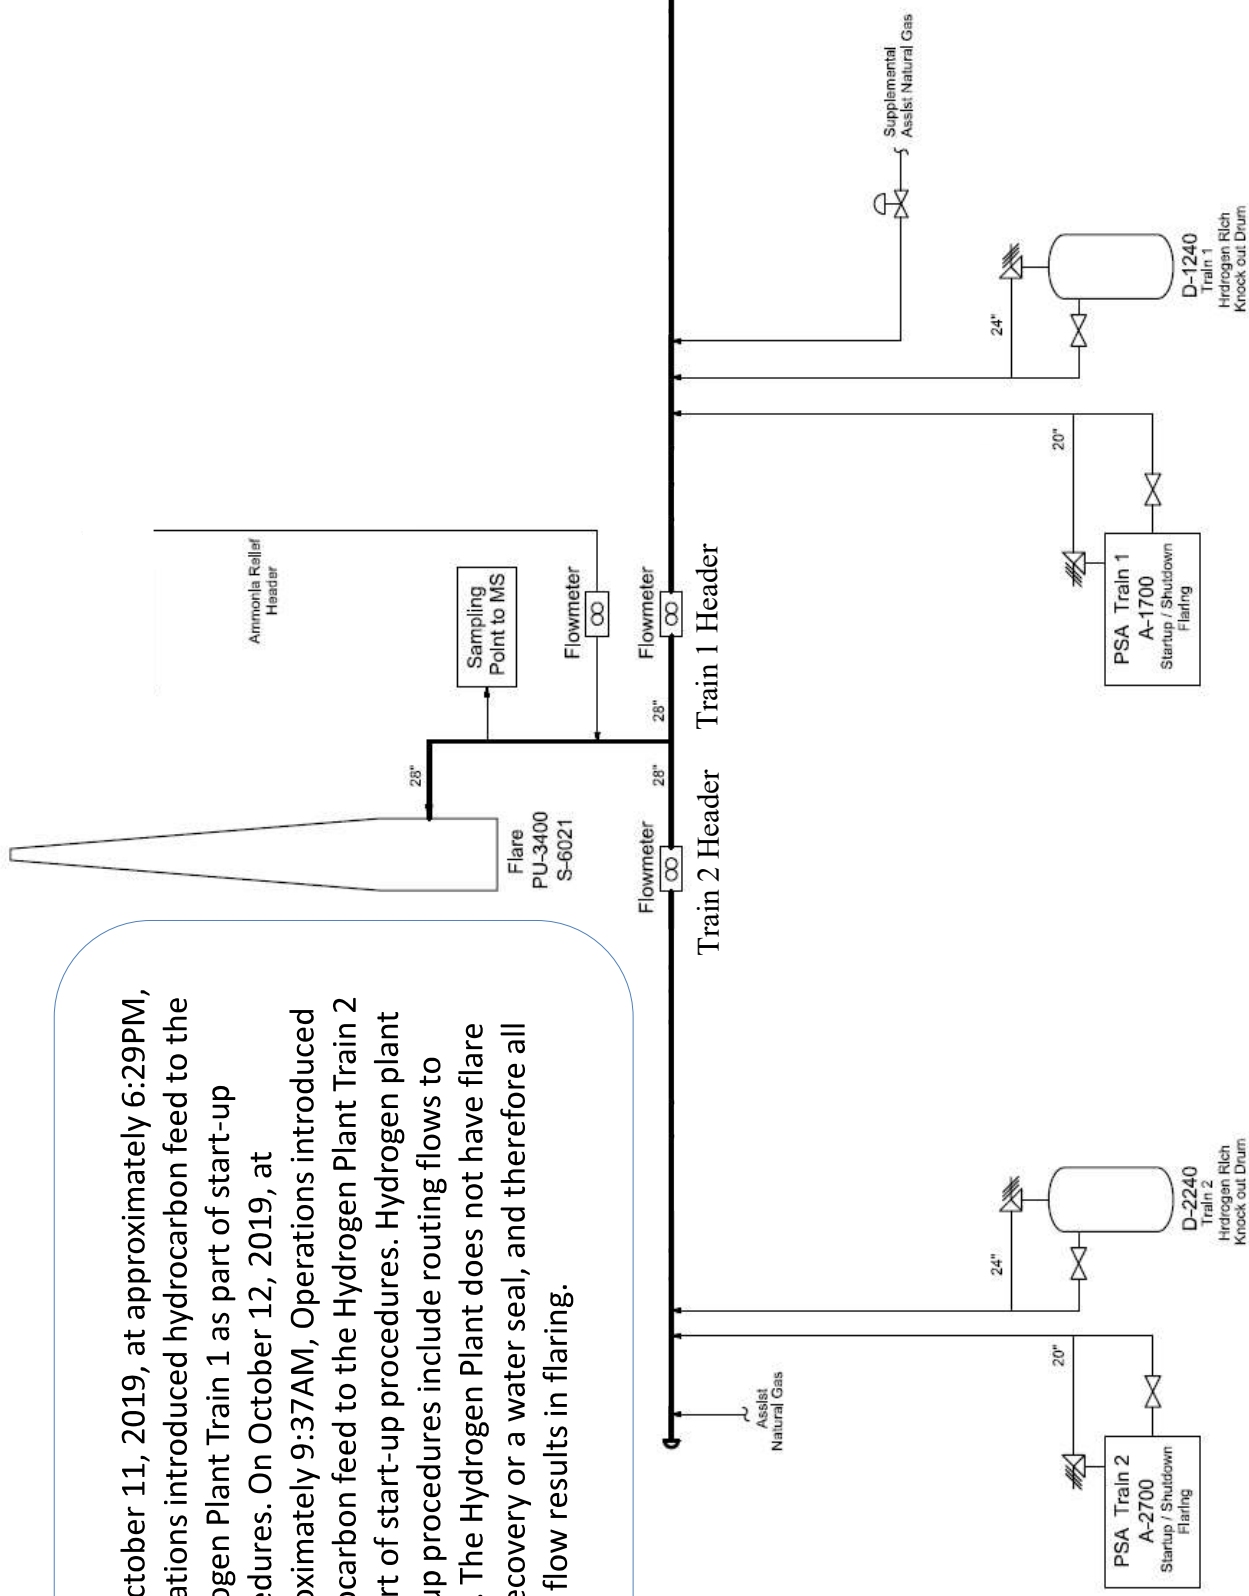
Hydrogen Plant Train 1 and Train 2 Startup

On October 11, 2019, at approximately 6:29PM, Operations introduced hydrocarbon feed to the Hydrogen Plant Train 1 as part of start-up procedures. On October 12, 2019, at approximately 9:37AM, Operations introduced hydrocarbon feed to the Hydrogen Plant Train 2 as part of start-up procedures. Hydrogen plant startup procedures include routing flows to relief. The Hydrogen Plant does not have flare gas recovery or a water seal, and therefore all relief flow results in flaring.
