A subsidiary of Marathon Petroleum Corporation
Martinez Refinery
150 Solano Way
Martinez, CA 94553-1487

FLARE CAUSAL ANALYSIS REPORT

Flaring Associated with #3 HDS Compressor Trip

February 7, 2020

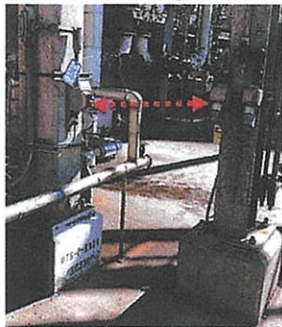
On February 7, 2020, a mechanic accidentally bumped the “off” switch on lube oil pump with his radio harness as he was checking out the location to land a crane. Immediately following the realization that the pump shutdown, he pushed the start button to run the lube oil pump. The swing in lube oil pressure tripped the turbine on the recycle gas compressor. This resulted in the #3 HDS unit shutdown.

The root cause was the On/Off Switch design on the lube oil pump. The design has a “button well” which is designed to prevent the button from being depressed from a large surface area type of object. Pointed items such as fingers, radio antennas, wrenches or pens would not be blocked from depressing the “off” button if an individual is passing close to the switch.

Corrective Actions	Anticipated Date of Completion
1	Immediate taping off of area around on/off switch for remainder of job to prevent reoccurrence.	Complete
2	Write notification to upgrade switch to an enclosed switch	Complete
3	Survey other switches that need to be upgraded or relocated	Complete
