Causal Analysis Report

Chevron Richmond Refinery
Reportable Flaring Events

February 10, 2020
Flaring Due to Hydrogen Feed Compressor Trip

Refinery Flare Event – Cause Investigation Report

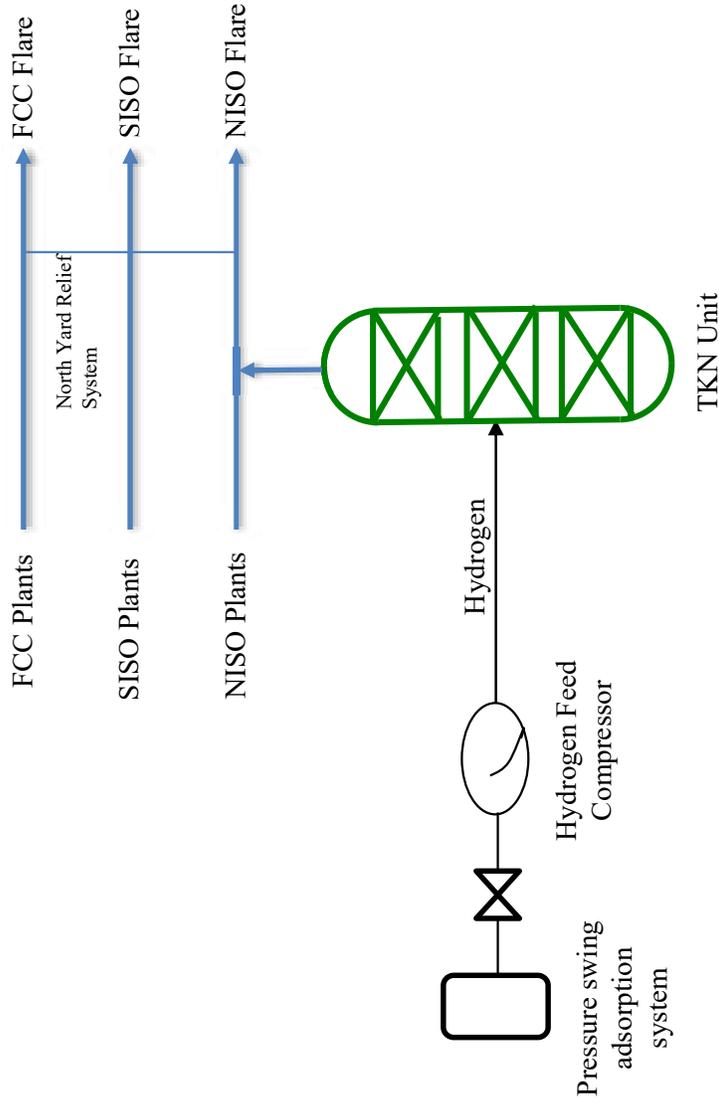
Flaring Due to Hydrogen Feed Compressor Trip

Root cause: The pressure swing adsorption system was isolated with a valve that did not isolate the system from the hydrogen feed compressor.

Contributing factor: The procedure did not include the scenario that the valve would not be able to isolate the pressure swing adsorption system from the compressor.

On February 10, 2020, a pressure swing adsorption system at the Hydrogen Plant had been out of service for maintenance and isolated from a hydrogen feed compressor with a valve. During maintenance of the pressure swing adsorption system, the hydrogen feed compressor tripped due to insufficient isolation by the valve. The hydrogen feed compressor shutdown reduced hydrogen feed to downstream units. This led to an unstable process condition at the Taylor Catalytic Denitrifier (TKN) Unit of the Hydroprocessing Area Business Unit. Due to the unstable condition, process gases were depressured to relief per procedure. Flaring began at approximately 4:01AM at the North Isomax (NISO) Flare. The primary source of vent gas flared during this event was process material from the TKN Unit. Flaring continued intermittently at the NISO Flare as the unit was stabilized. Flaring occurred at the South Isomax (SISO) and Fluid Catalytic Cracking (FCC) flares but did not exceed the reporting threshold in BAAQMD Regulation 12-12-208; however, Chevron is including the emissions from the flaring activities for informational purposes. Once the unit was stable, flaring ceased at approximately 10:36AM. The sulfur dioxide (SO₂) emissions exceeded 500 pounds (lbs) and the vent gas volume exceeded 500,000 standard cubic feet (SCF) at only the NISO Flare on February 10, 2020.

Update the pressure swing adsorption system isolation procedure to take into account that the valve does not isolate the pressure swing adsorption system from the hydrogen feed compressor.
