**Chevron Richmond Refinery
August 2020 Flaring Causal Analysis Report**

Causal Analysis Report

Flaring Due to Fire Suppression System Activation Malfunction

Refinery Flare Event – Cause Investigation Report

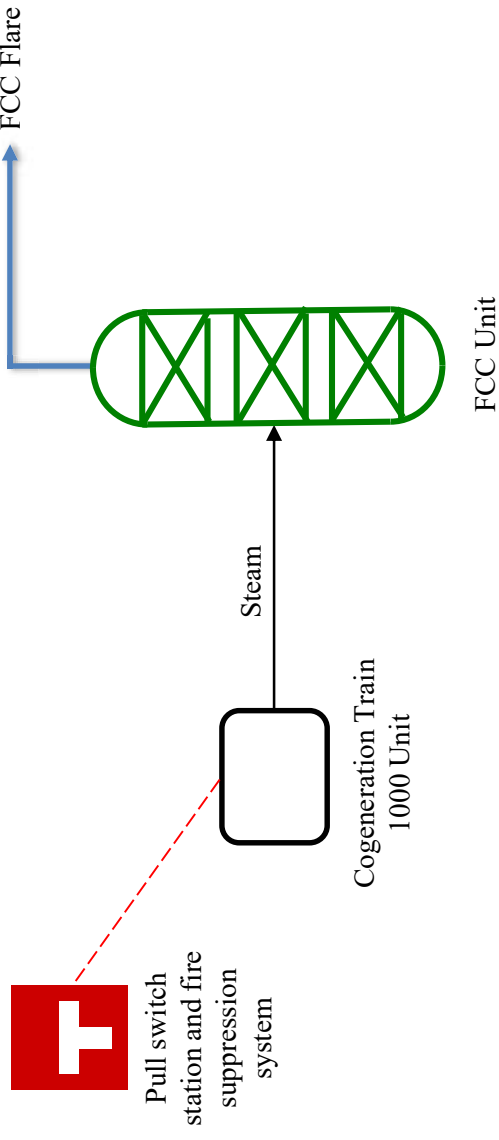
Root cause: Failure occurred in the pull switch sending signal.

Contributing factor: Early life failure of complex electrical system.

Contributing factor: Temperature limit exceeded for pull switch station.

On August 14, 2020, after ambient temperatures reached approximately 90 deg F, the fire suppression system at the Cogeneration Train 1000 Unit (Utilities and Environmental Area Business Unit) activated. This was due to a false interpretation of a pull from a pull switch station handle, causing the steam producing unit to trip. The sudden loss of steam header pressure caused an unstable process condition, and process gases were depressured per process controls. Flaring began at approximately 11:21 AM at the Fluid Catalytic Cracking (FCC) flare. The primary source of vent gas flared during this event was process material from the FCC Unit in the Cracking Area Business Unit. Operations immediately responded, minimizing vent gas to the flare and reducing steam consumption refinery-wide to restore the steam header pressure, and flaring stopped at approximately 12:39 PM. The sulfur dioxide (SO₂) emissions exceeded 500 pounds (lbs) and the vent gas volume exceeded 500,000 standard cubic feet (SCF) at the FCC Flare on August 14, 2020.

Install shade over pull switch station to prevent from overheating.

Evaluation of alternatives for long-term solutions for pull switch system failure and implementation plan development.
