Causal Analysis Report

Chevron Richmond Refinery  
Reportable Flaring Events

November 8-10, 2020  
Flaring Due to Unit Startup Following Power Outage

## Refinery Flare Event – Cause Investigation Report

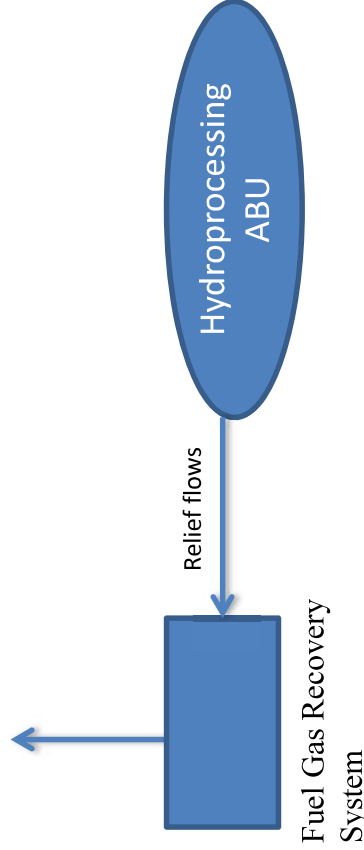
RLOP Flare

On November 8th, 2020, multiple process units in the Hydroprocessing ABU (Area Business Unit) were starting up following unplanned shutdowns. Due to the start-up operating conditions, the Flare Gas Recovery (FGR) system had a high base load. In addition, a FGR compressor startup was delayed and part of the FGR system began to build up differential pressure. Both issues reduced the FGR system's capacity to capture process gases. Subsequently, the FGR system exceeded its capacity and process gases were sent to the relief system. Flaring began at approximately 9:38 PM on November 8th, 2020 at the RLOP Flare. The primary source of vent gas flared during this event was process material from the units starting up in the Hydroprocessing ABU. Operations immediately responded, taking action to clear the high liquid level, drop the FGR system's differential pressure, and worked to bring the compressor online. Intermittent flaring stopped on November 10th, 2020 at approximately 3:30 AM. The sulfur dioxide (SO<sub>2</sub>) emissions from the RLOP flare exceeded 500 pounds (lbs) within a 24-hr period.
