Causal Analysis Report

Chevron Richmond Refinery
Reportable Flaring Events

December 10, 2020
Flaring Due to Faulty Breaker in Pump

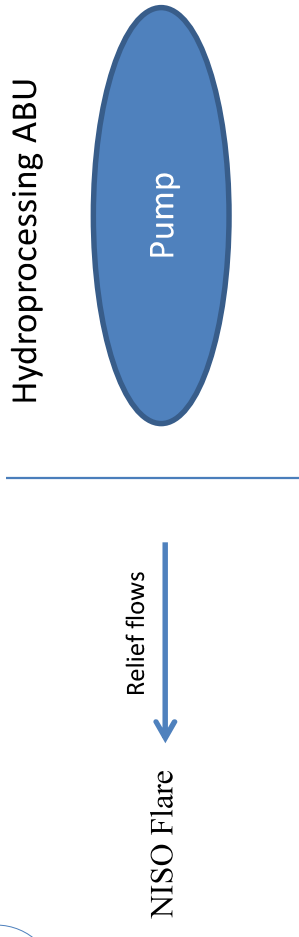
Flaring Due to Faulty Breaker in Pump

On December 10th, 2020, a unit in the Hydroprocessing Area Business Unit (ABU) initiated a shutdown. During this process, Operations attempted to shutdown a pump per procedure, but a faulty breaker prevented the pump from shutting down. The unit was subsequently de-pressured, sending flows to the Flare Gas Recovery (FGR) system exceeding FGR capacity, and process gases were sent to the flare relief system. Operations immediately responded, successfully executing a manual shutdown of the pump, which stopped the flow to relief.
