Causal Analysis Report

Chevron Richmond Refinery
Reportable Flaring Events

November 1-5, 2021

Flaring Due to Faulty Valves at a Compressor

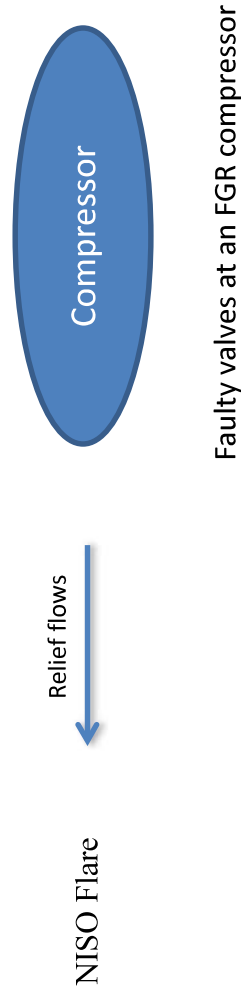
Flaring Due to Faulty Valves at a Compressor

On November 1st, 2021, a Flare Gas Recovery (FGR) compressor malfunctioned due to faulty valves in the compressor. Multiple attempts were made by Operations to troubleshoot the valves but were unsuccessful. To prevent further damage to the machine, the compressor was shut down, causing process gases to be routed to the flare relief system. Repairs were conducted and the compressor was put back in service on November 5, 2021. This stopped flows to the flare relief system, and the flaring ceased.

Primary causal factor: Compressor malfunction due to faulty valves.

Multiple attempts were made to troubleshoot the valves but were unsuccessful. Repairs were conducted and the compressor was put back in service on November 5, 2021. This stopped flows to the flare relief system, and the flaring ceased.

1. Repair the compressor in a timely fashion to put the machine back in service and minimize flaring. Repair was completed 11/5/2021.
