Causal Analysis Report

Chevron Richmond Refinery  
Reportable Flaring Events

May 14, 2021  
Flaring Due to Pump Malfunction

Refinery Flare Event – Cause Investigation Report

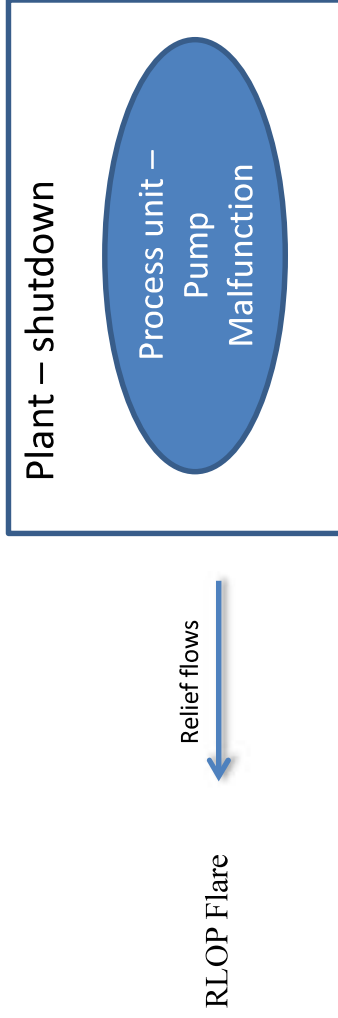
# Flaring Due to Pump Malfunction

Primary causal factor: The primary cause that initiated this event was the lack of sufficient seal flush to the pump. Lack of seal flush led to seal face damage that opened a leak path. After the seal failed, the pump bearings failed.

Contributing causal factor: The pump vibration trip system was disarmed and thereby did not trip the motor. The vibration trip system would not have avoided the release, but it would likely have tripped the pump earlier during the event, thereby reducing the release.

Contributing causal factor: The pump suction air operated valves remained open for part of the event allowing process fluid to reach the failed pump. Operators attempted to close the valves immediately but were unsuccessful.

Contributing causal factor: A nearby flange leaked during the event. The flange leak was a result of multiple causes: (1) high pipe stress,(2) high heat from the fire combined with stress relaxed and plastically deformed two of the studs at that flange, and (3) high vibrations from the pump running on failed bearings likely contributed to weakening the assembly.

1. Upgrading of the seal system design.
2. Improving operator rounds pertaining to monitoring of the seal system of the pump.
3. Assuring appropriate groups are communicating (nuisance alarms, operational concerns, pump monitoring) in the proper forums.
4. Reinforcing the use of shift turnovers to document when the vibration trip systems are disarmed.
5. Management actions to reinforce appropriate management of the vibration trip system.
6. Additional training regarding the suction air operated valves.
7. Redesign the piping system using current design tools. This measure is complete as of July of 2021.
