**Chevron Richmond Refinery
July Flaring Causal Analysis Report**

Causal Analysis Report

July 25-26, 2021
Flaring Due to Power Dip

Refinery Flare Event – Cause Investigation Report

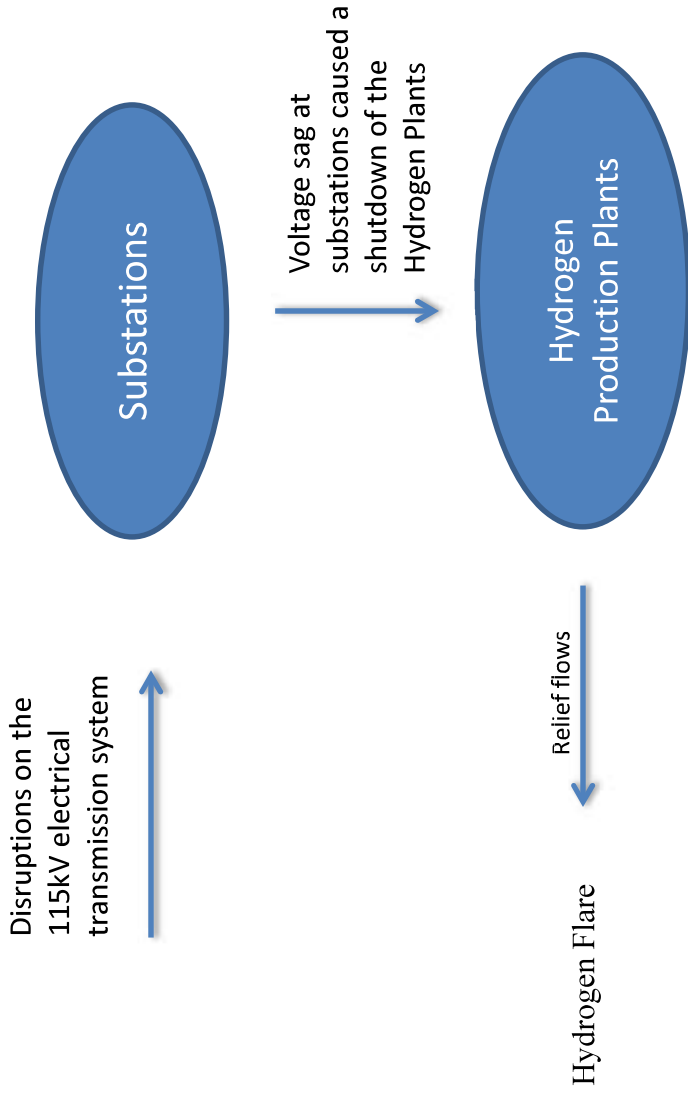
See Attachment Ia.

On July 25th, 2021, the Refinery experienced two momentary disruptions on the 115kV electrical transmission system. The momentary disruptions led to voltage sags at the substations. As a result of the voltage sags, hydrogen production plants shut down in response to pressure issues on Train 1 and loss of air flow on Train 2. Hydrogen plant shutdown procedures include routing flows to relief and subsequent flaring.

Primary causal factor: Contaminant accumulation on a 115kV insulator.

Contributing causal factor: Logic at H2 plant motor control circuits tripped unit equipment.

The primary contributor of the vent gas flow to the flare was the Hydrogen Plant.

1. Review preventative cleaning program for 115 kV electrical system. Evaluate increasing the frequency of insulator cleaning on 115 kV system.
2. Redesign and implement new control relay coordination and logic of the 4kV motor control at the H2 Trains.
