Causal Analysis Report

Chevron Richmond Refinery
Reportable Flaring Events

Flaring Due to Faulty Pressure Transmitter

Refinery Flare Event – Cause Investigation Report

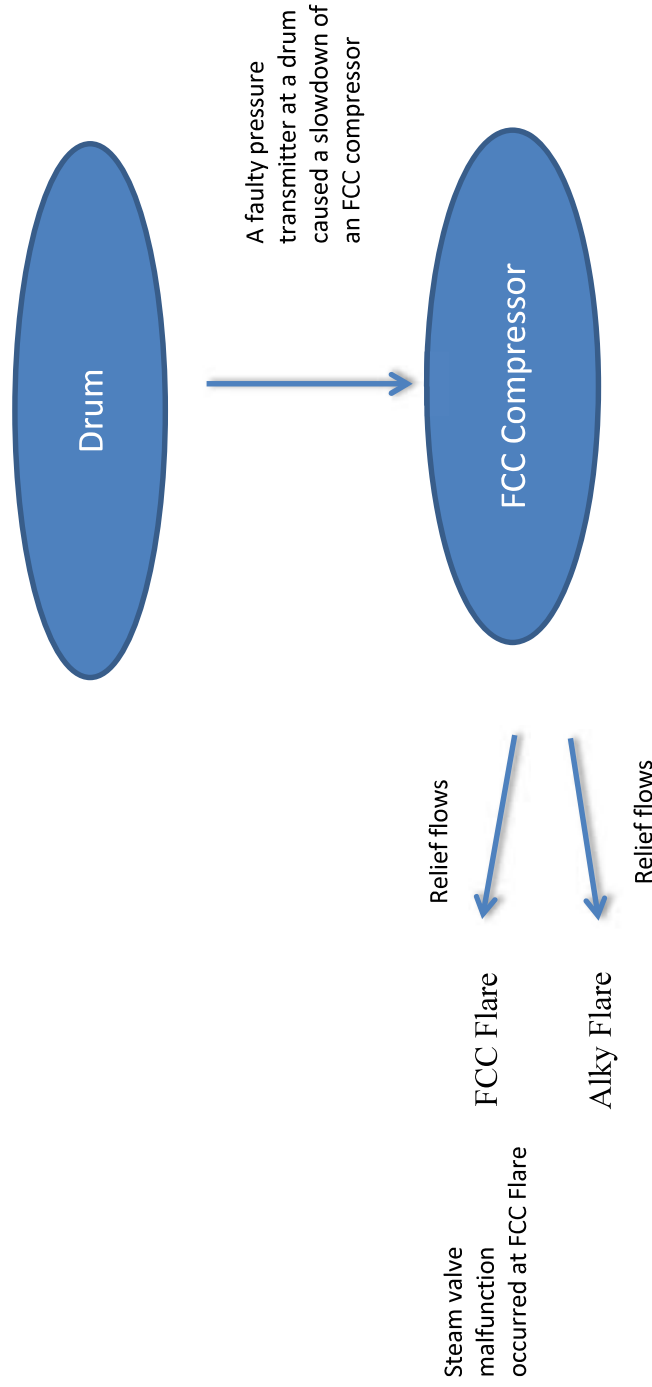
Flaring Due to Faulty Pressure Transmitter

On August 10, 2021, visible flaring occurred at the FCC and Alky flares due to a faulty pressure transmitter on a drum which resulted in an unexpected slowdown of an FCC compressor. Additionally, the steam valve on the FCC Flare malfunctioned which limited the operator's ability to increase steam to reduce smoking at the FCC flare, resulting in visible emissions.

The primary cause of the flaring event is a faulty pressure transmitter.

The main contributor of vent gas flow during this event was the drum in the Cracking Area Business Unit (ABU).

1. A pressure transmitter has been removed from the control logic system to aid in the prevention of an unexpected slowdown of an FCC compressor.
2. Identify any additional prevention measures with input from subject matter experts, including control logic vendor.
