Causal Analysis Report

Chevron Richmond Refinery
Reportable Flaring Events

March 09 - 11, 2023

Flaring Due to Faulty Feedwater Boiler Pump Motor

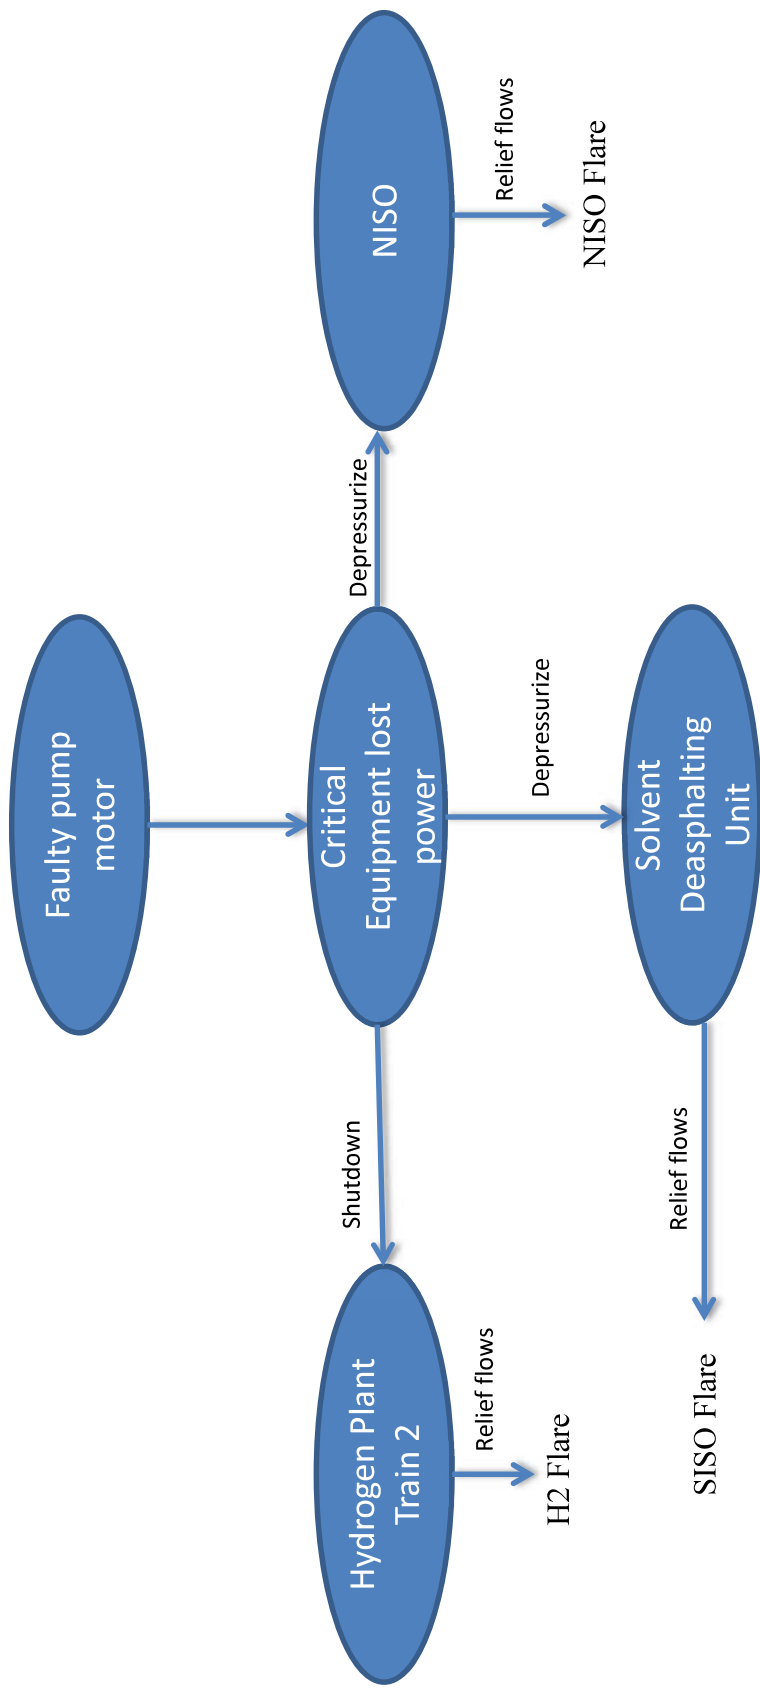
Flaring Due to Faulty Boiler Feedwater Pump Motor

Primary causal factor: Faulty boiler feedwater pump motor. This was due to corrosion from water intrusion, as well as incorrectly ranged pressure gauge on the motor and excessive air filter pressure.

Contributing Factor: Inadequate design of electrical backup systems.

1. Evaluate the potential for undervoltage on hydrogen plant motors.
2. Validate gauges are correctly ranged for all motors.
3. Share lessons learned from event with applicable refinery personnel.
4. Replace boiler feedwater pump motor.
5. Identify potential solutions for backup power from critical equipment fed from common buses.
6. Consider updating electrical protection mechanisms.
