**Chevron Richmond Refinery  
January 2026 Flaring Causal Analysis Report**

Chevron Richmond Refinery  
Reportable Flaring Events

January 9, 2026  
Flaring Due to External Power Outage

## Refinery Flare Event – Cause Investigation Report

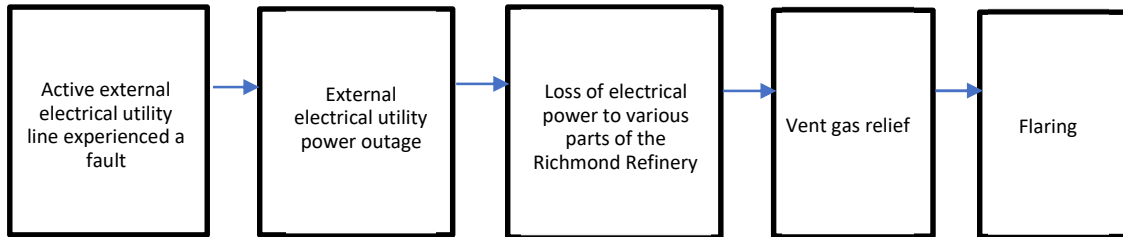
## Attachment Ia: Flaring Due to External Power Outage

Primary causal factor: The fault experienced by an external electrical utility line.

The primary contributor of the vent gas to the flare was multiple operating plants.
