**Supplemental Comment 3 Regarding Regulation 6, Rule 5: Particulate Emissions from Refinery Fluidized Catalytic Cracking (FCC) Units — Catastrophic Explosion Hazard**

**December 2018 Factual Investigative Update; and August 2018 Factual Investigative Update; April 26, 2018 Husky Superior Refinery Explosion and Fire. U.S. Chemical Safety and Hazard Investigation Board: Washington, D.C.**

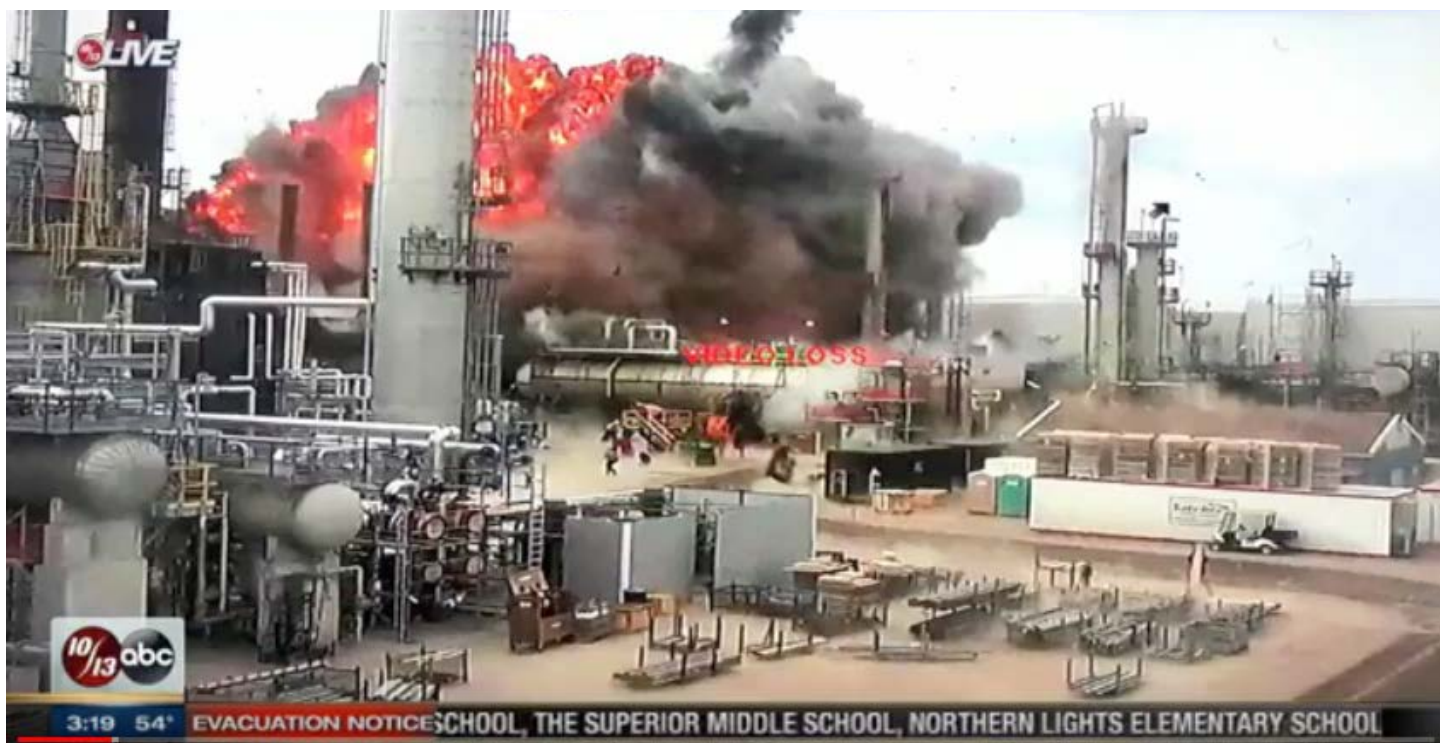
**Figure 1.** Surveillance Camera Image of the Husky Superior Refinery Explosion. Credit: WDIO ABC News.

On April 26, 2018, an explosion (Figure 1) and subsequent fire (Figure 2) occurred at the Superior Refinery Company LLC refinery in Superior, Wisconsin (“Husky Superior Refinery”).<sup>1</sup> The incident occurred in the refinery’s Fluid Catalytic Cracking Unit (FCCU). As a result of the explosion, thirty-six people sought medical attention, including eleven refinery and contract workers who suffered OSHA recordable injuries. In addition, a portion of Superior,<sup>2</sup> Wisconsin was evacuated. Evidence collected to date suggests similarities with a previous investigation of the February 18, 2015 explosion at a refinery in Torrance, CA.

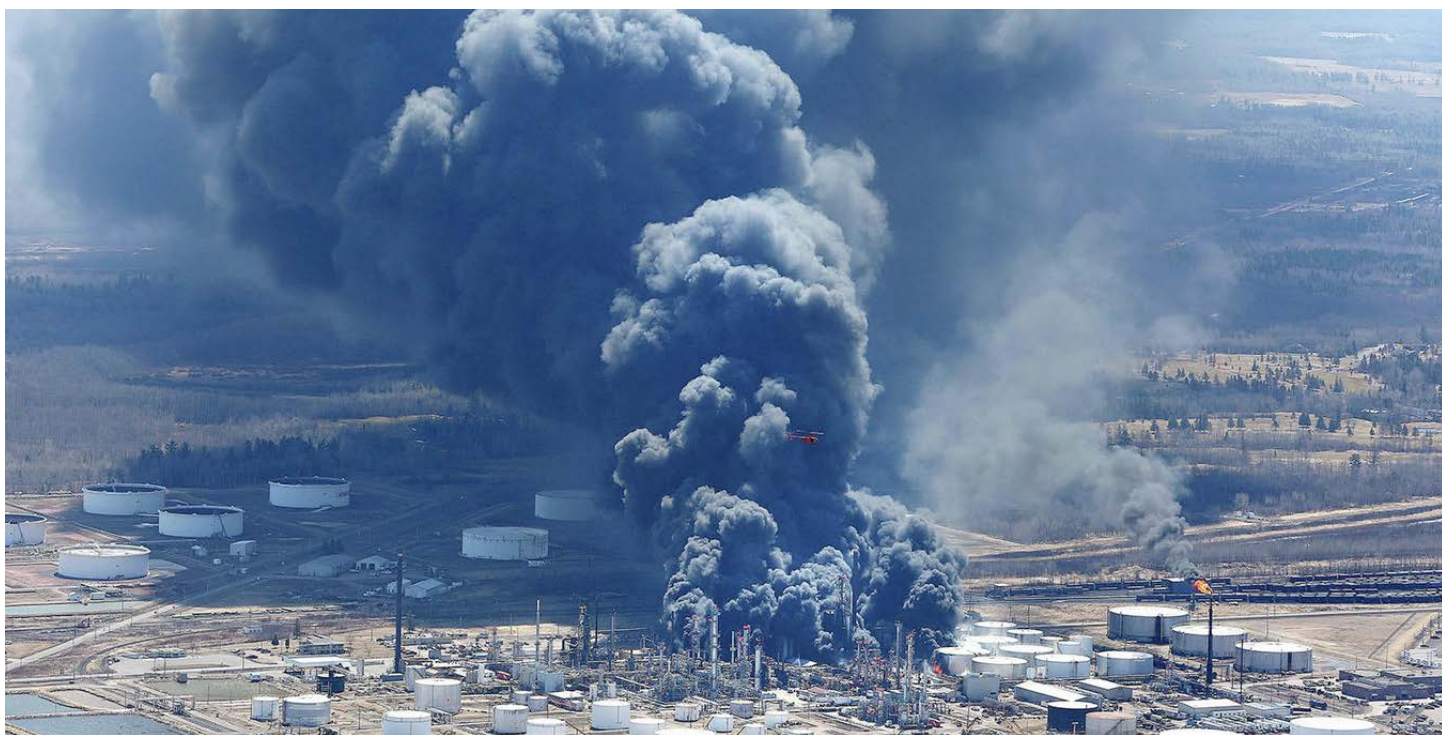
**Figure 2.** Smoke from the Fire at the Husky Superior Refinery. Credit: WDIO ABC News.

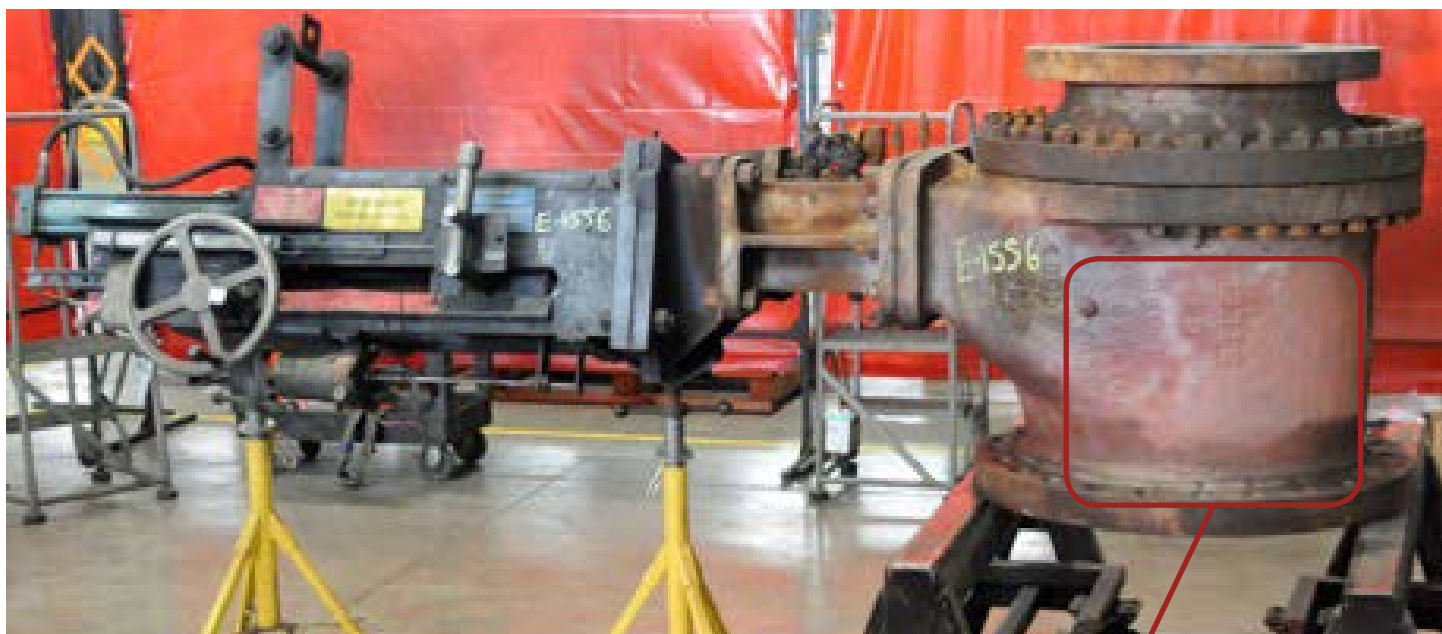
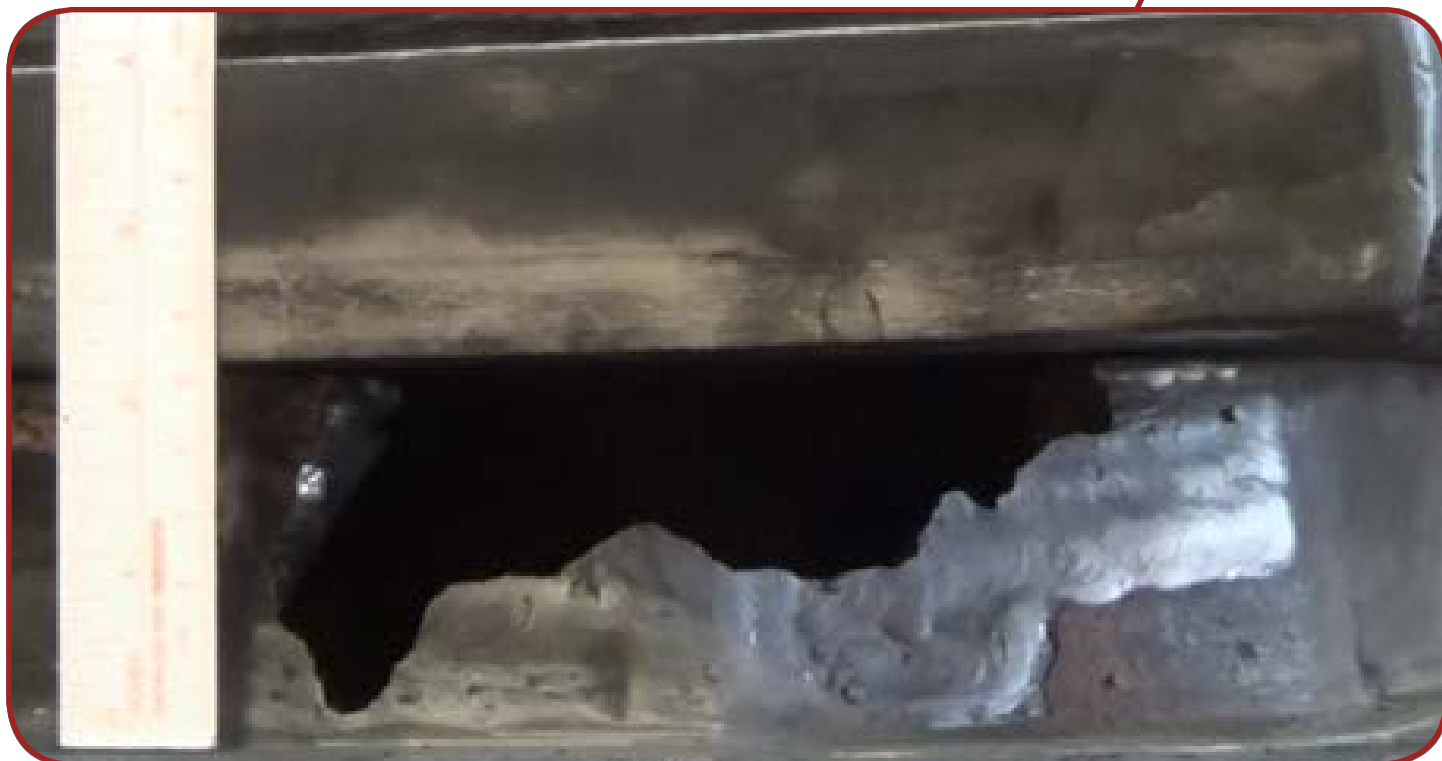
Both incidents involved the company relying on a SCSV to maintain a barrier between the hydrocarbon and air sides of the FCCU during non-routine operation. The CSB has determined that the FCCU SCSV used at the Superior refinery was "designed for complete shut-off of flow" and that even though it was subject to erosion from the FCCU catalyst, it was intended to be "provided with erosion protection suitable for the design life at the design conditions." Despite this, the FCCU SCSV was unable to maintain a catalyst level to prevent air from mixing with hydrocarbons in the FCCU during the shut-down (**Figure 3**).

**Figure 3.** The Husky Superior FCCU SCSV post-incident. The top picture shows the entire valve assembly and the bottom picture shows the eroded orifice port.

erosion prevented the closed SCSV from developing the necessary catalyst barrier on the day of the incident.

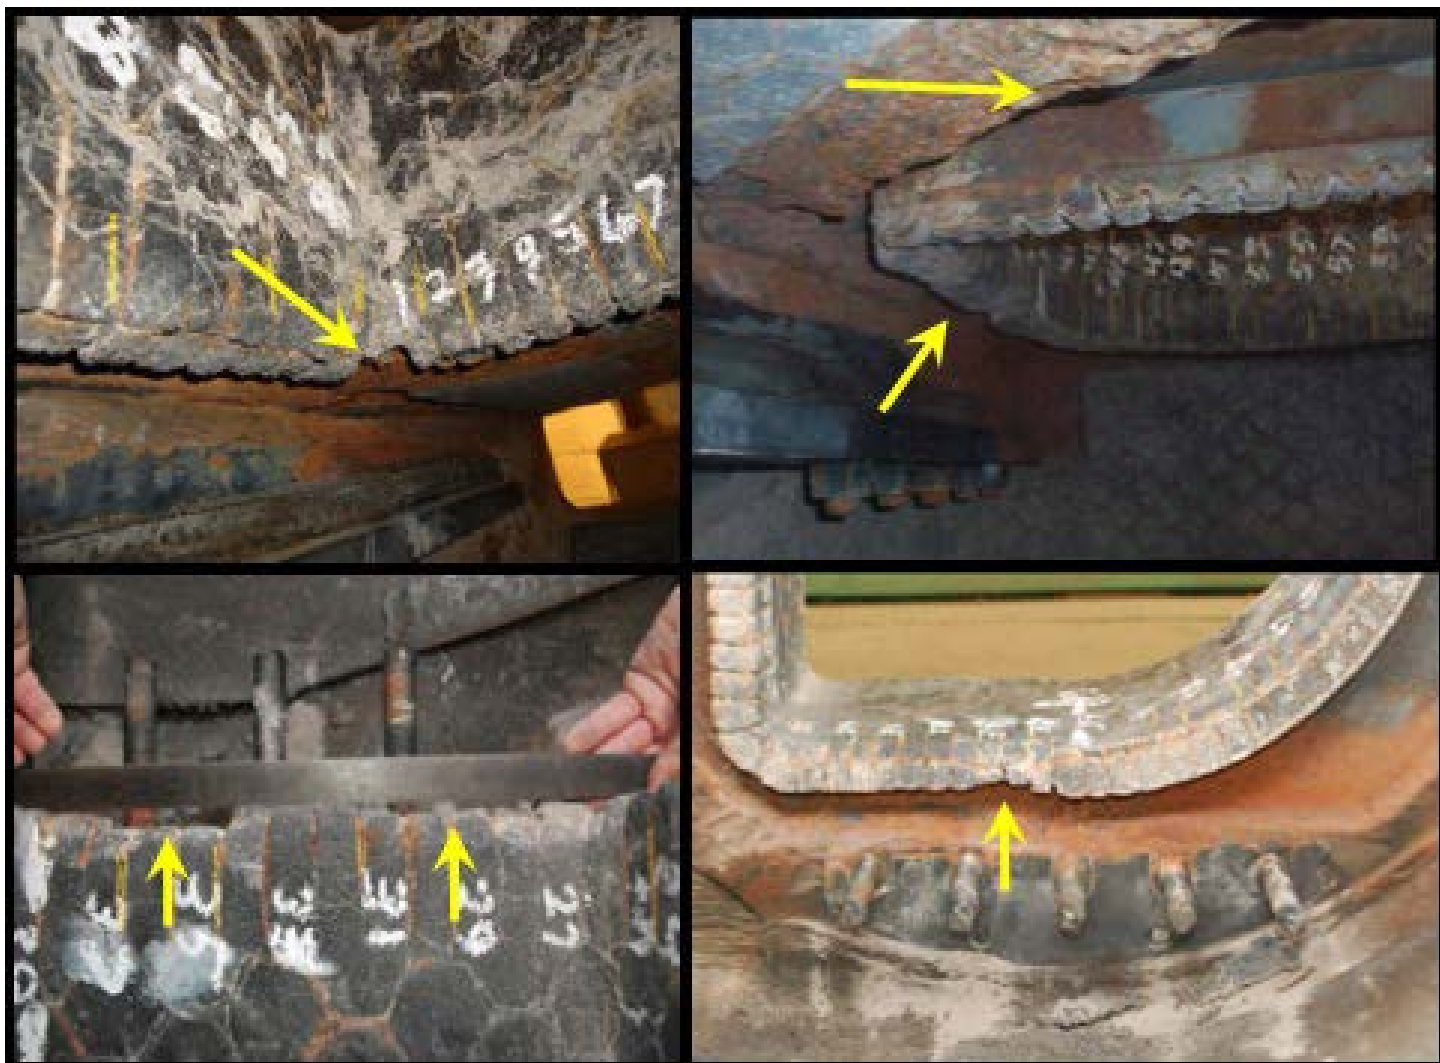
In its investigation of the Torrance incident, the CSB inspected the internal components of the SCSV. The inspection found the valve internals eroded to the point that the valve could not seal (**Figure 4**). An area of approximately 16 square inches eroded away during six years of operation, providing an open path for catalyst to flow through the valve even when in the fully closed position. The

**Figure 4.** Torrance Refinery SCSV post-incident. The yellow arrows show the erosion in the valve.

The CSB's Torrance investigation also recommended that the Torrance refinery make changes to the way safety critical equipment, such as the SCSV, was maintained and to ensure that there were operating procedures for each mode of operation. After the incident, the Torrance refinery stated that the refinery conducted a review of the FCCU safety critical devices and implemented the following:

- Identification of all safety critical equipment;
- Consequences of failure for each mode of operation;
- Evaluated and established parameters, limits, and associated equipment to ensure an appropriate steam-induced

pressure barrier for FCC Emergency Shutdown and Safe Park procedures;

- Updated Emergency Shutdown and Safe Park procedures to address the loss of catalyst seal, loss of steam barrier, and failure of the ESP to de-energize; and
- Evaluated additional isolation facilities between the main column and the flue gas system.
- The Torrance refinery also formed a cross-functional team of experts and developed an FCCU Safe Park procedure and updated the FCCU Normal Shutdown, Emergency Shutdown, and Start-up procedures for the Torrance Refinery. The Torrance refinery reviewed areas of higher risk or with a higher vulnerability through an independent risk assessment to ensure that adequate layers of protection were in place during stand-by mode and other operation modes.

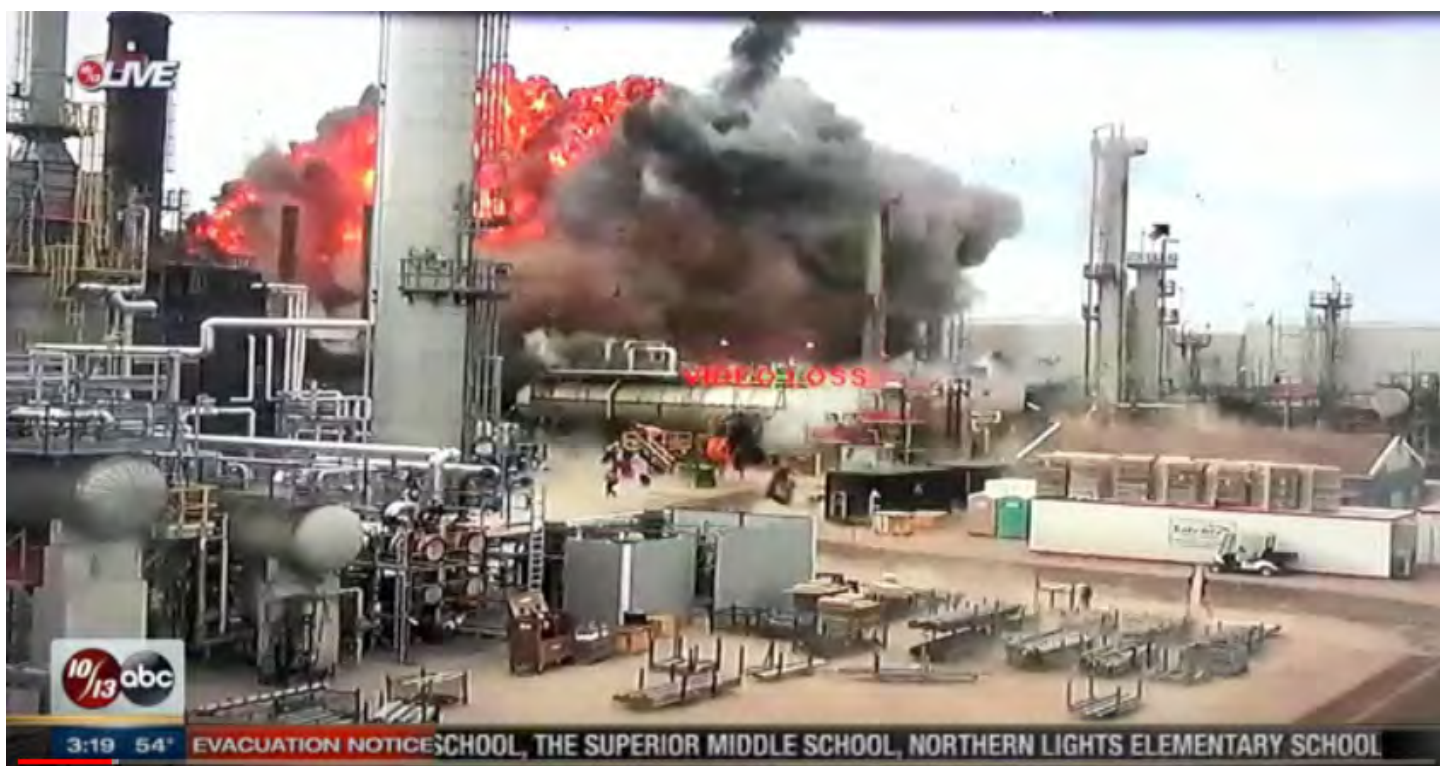
**Figure 1.** Surveillance Camera Image of the Husky Superior Refinery Explosion. Credit: WDIO ABC News.

**O**n April 26, 2018, an explosion (Figure 1) and subsequent fire (Figure 2) occurred at the Superior Refinery Company LLC refinery in Superior, Wisconsin (“Husky Superior Refinery”).<sup>1</sup> The incident occurred in the refinery’s Fluid Catalytic Cracking Unit (FCCU). In preparation for the shutdown, the refinery brought in hundreds of contractors and increased operations staffing. The contractors were performing many tasks such as electrical work, preparing for chemical cleaning, building scaffolding, and welding. As a result of the explosion, thirty-six people sought medical attention, including eleven refinery and contract workers who suffered OSHA recordable injuries. In addition, a large portion of Superior,<sup>2</sup> Wisconsin was evacuated.

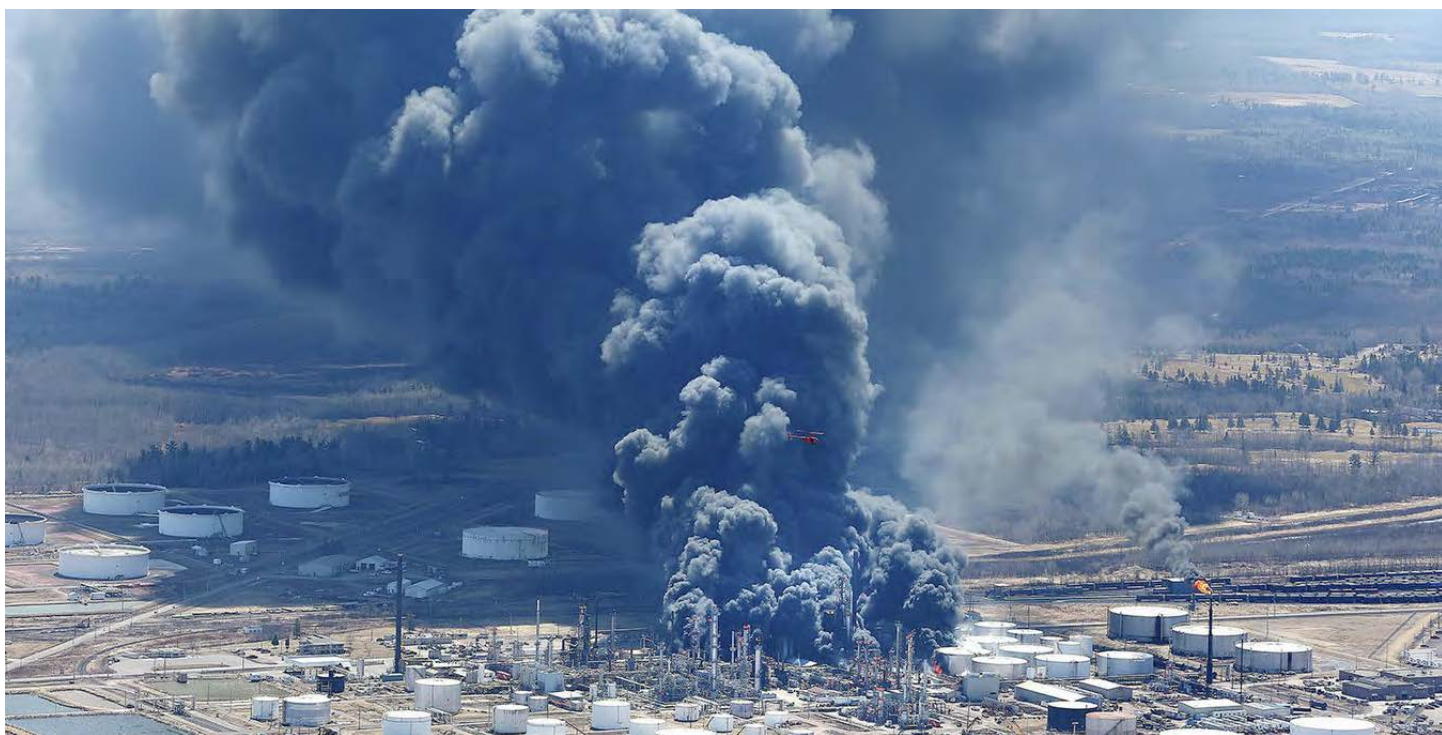
**Figure 2.** Smoke from the Fire at the Husky Superior Refinery. Credit: WDIO ABC News.

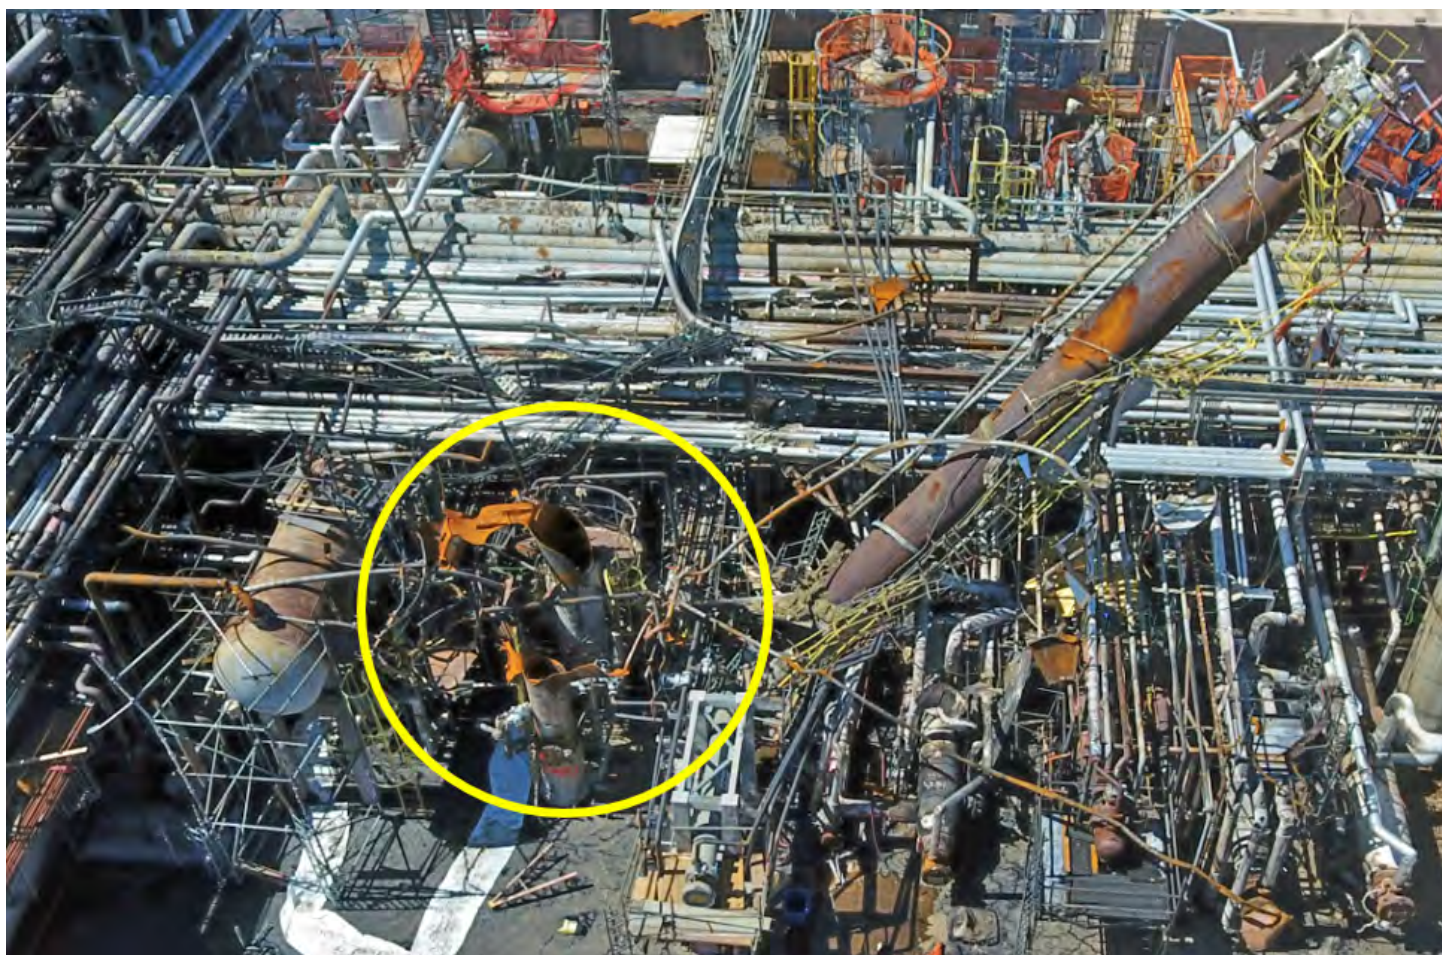
**Figure 3.** Two of the Vessels Destroyed in the Explosion at the Husky Superior Refinery (yellow circle). The photo shows that only the bottom portion of the two process vessels remained after the explosion. The remaining portions of the vessels were blown into surrounding units of the refinery. Credit: Husky Superior Refinery.

Two FCCU vessels,<sup>6</sup> the primary absorber<sup>7</sup> and sponge absorber<sup>8</sup>

(Figure 3), were destroyed in the explosion. The primary and sponge absorbers serve to recover heavy hydrocarbons<sup>9</sup> from a gas stream by mixing the gas stream with a liquid stream that absorbs the heavy hydrocarbons.

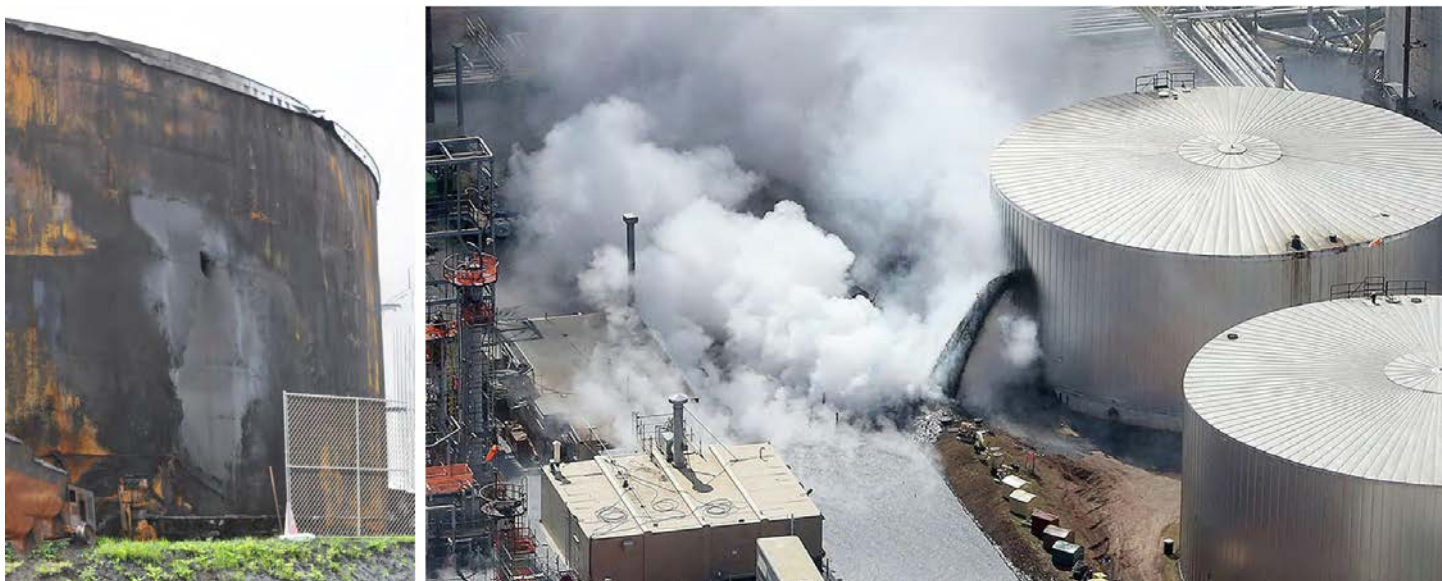
Debris from the explosion flew about 200 feet, and impacted a large, nearby, aboveground storage tank containing about 50,000 barrels of asphalt, puncturing the side of the steel tank and spilling over 15,000 barrels of hot asphalt into the refinery (Figure 4). This released asphalt ignited about two hours after the explosion, creating a large fire.

**Figure 4.** Post-incident photographs of the leaking Asphalt Storage Tank. Debris from the explosion punctured the side wall of the tank creating a large asphalt leak outside of the secondary containment area. Credit: CSB (left) Duluth News Tribune (right).

Around 12:15 pm the spilled asphalt ignited, creating a large fire spanning multiple units at the refinery. Because this fire risked compromising other process equipment containing hazardous chemicals, the Unified Command issued its first community evacuation notice at 1:00 pm. By 2:41 pm, the evacuation zone consisted of a 3-mile radius around the refinery, and a 10-mile rectangle extending south from the refinery (Figure 5). The evacuation zone size was established to protect the public from the smoke plume and as a precaution in case the refinery's highly toxic hydrofluoric acid equipment was compromised.<sup>10</sup>
