**Supplemental Comment 3 Regarding Regulation 6, Rule 5: Particulate Emissions from Refinery Fluidized Catalytic Cracking (FCC) Units — Catastrophic Explosion Hazard**

**December 2018 Factual Investigative Update; and August 2018 Factual Investigative Update; April 26, 2018 Husky Superior Refinery Explosion and Fire. U.S. Chemical Safety and Hazard Investigation Board: Washington, D.C.**

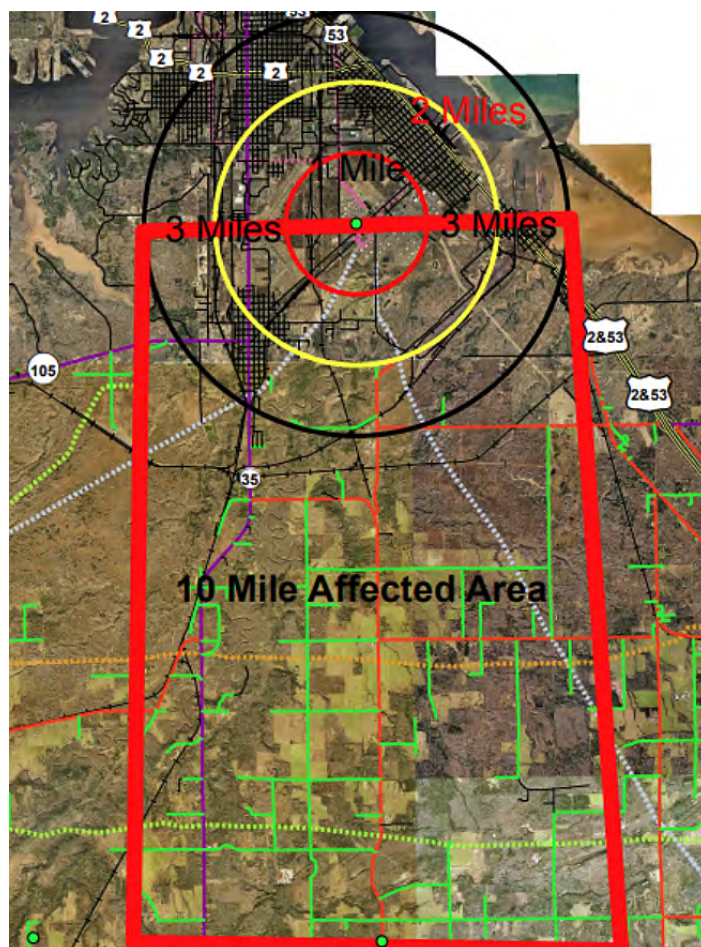
Around 12:15 pm the spilled asphalt ignited, creating a large fire spanning multiple units at the refinery. Because this fire risked compromising other process equipment containing hazardous chemicals, the Unified Command issued its first community evacuation notice at 1:00 pm. By 2:41 pm, the evacuation zone consisted of a 3-mile radius around the refinery, and a 10-mile rectangle extending south from the refinery (Figure 5). The evacuation zone size was established to protect the public from the smoke plume and as a precaution in case the refinery's highly toxic hydrofluoric acid equipment was compromised.<sup>10</sup>

**Figure 5.** Evacuation Zone on April 26, 2018. Credit: Douglas County, Wisconsin.
