BEFORE THE HEARING BOARD
OF THE
BAY AREA AIR QUALITY MANAGEMENT DISTRICT
STATE OF CALIFORNIA

APPLICATION FOR VARIANCE

The use of a long reach specialized excavator to demolish a 200' tall blimp hangar where the roof, with non-friable asbestos felt paper, is in need of demolition to eliminate the risk of building collapse.

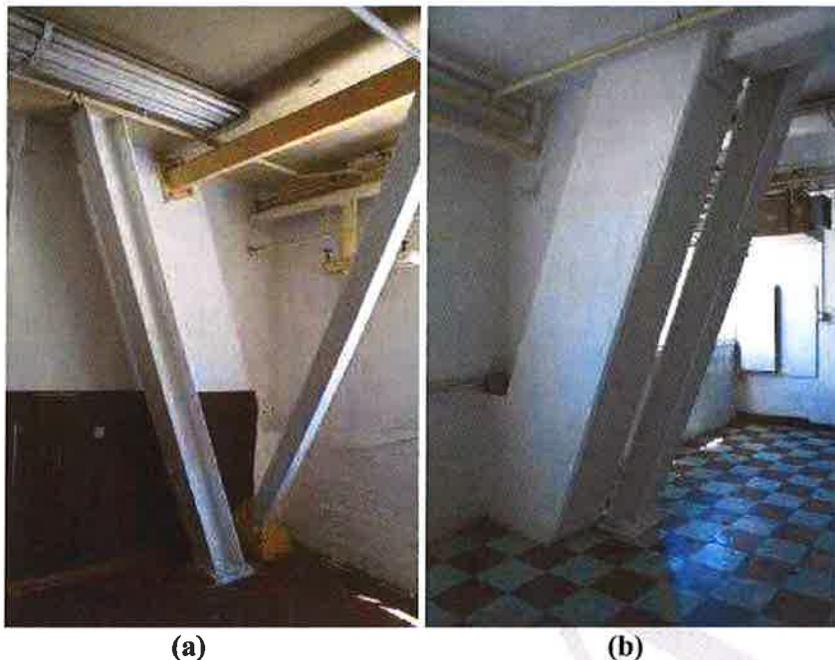
Figure 9. Hangar 2 office space retrofits (a) Longitudinal HSS and Lateral I-Shape bracing (b) Lateral I-Shape and HSS bracing.

It was also observed while walking through the office spaces that various concrete bents in Hangar 2 are braced in the weak axis with steel HSS horizontal and cross braces. This was documented by Page &

Turnbull (2006). However, wide flange steel shapes were also observed for additional reinforcement of the concrete bents in the strong axis, as shown in Figure 9.

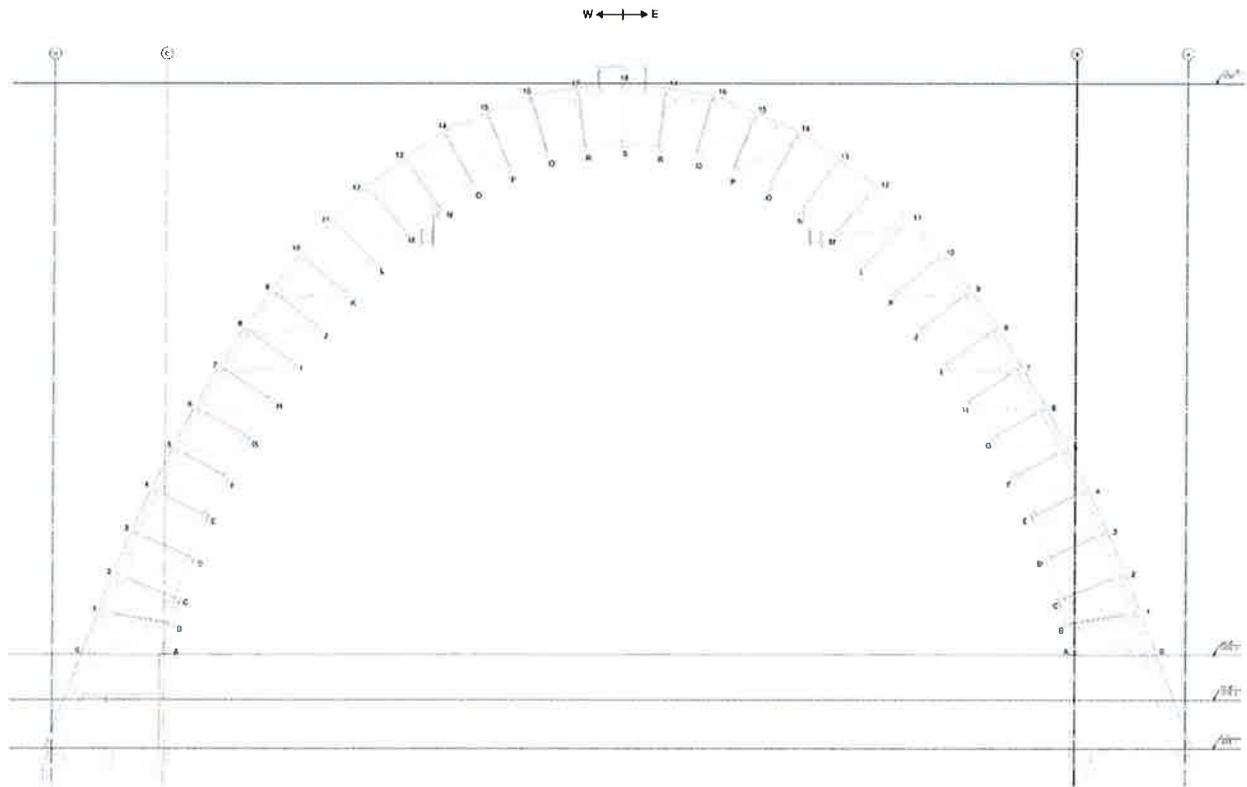
Figure 4. Typical truss elevation with labeled panel points.

On June 24, 2015, KPFF performed a routine site visit to observe field conditions of the shed framing in Hangar 2. During that site visit, KPFF also observed Hangar 3 trusses from the deck slab and upon observation, suspected damage progression in the Hangar 3 arched trusses. On June 30, 2015, KPFF performed a follow-up site visit to Hangar 3 with aerial boom lift access and observed severe damage progression and increased excessive truss deflections. Turner Construction provided photographs of the ridge line indicating substantial increased deflection at the roof monitor. KPFF issued findings in engineer's field report EFR-03 along with recommendations for a zone of immediate emergency shoring due to damage progression. Selected photos from EFR-03 are provided below in Figure 1, Figure 2, and Figure 3. A reference truss elevation with panel points labeled is provided in Figure 4.

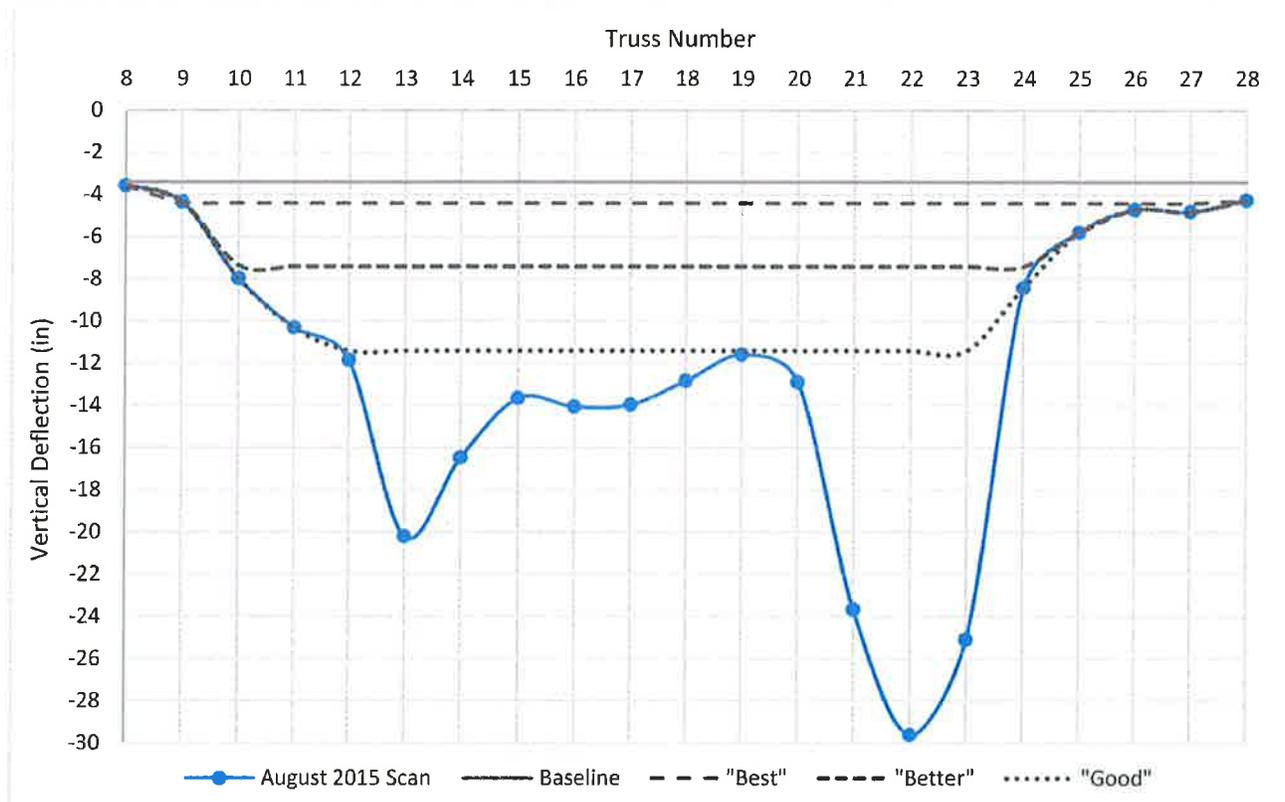
Figure 9. Hangar 3 Panel Point 18 Deflection with Deflection Criteria Options

Figure 9 was generated to illustrate the roof deflections (in blue) relative to a baseline that represents the average roof deflection at the trusses in the hangar that do not exhibit severe damage. The figure was used to compare the different deflection criteria options.

In addition to selecting a method of installation, the project team also selected a target criteria for roof deflections. The number of exoskeletons and the number of jacks required depends on the amount of deflection to be reversed during the Emergency Repair process. However, full restoration back to the previous undamaged roof geometry may prove to be physically infeasible due to the complexity, risk, and timing involved in these operations due to existing field conditions. KPFF established the target deflection criteria shown in Table 1 and Figure 9 based on “Good”, “Better”, and “Best” scenarios.

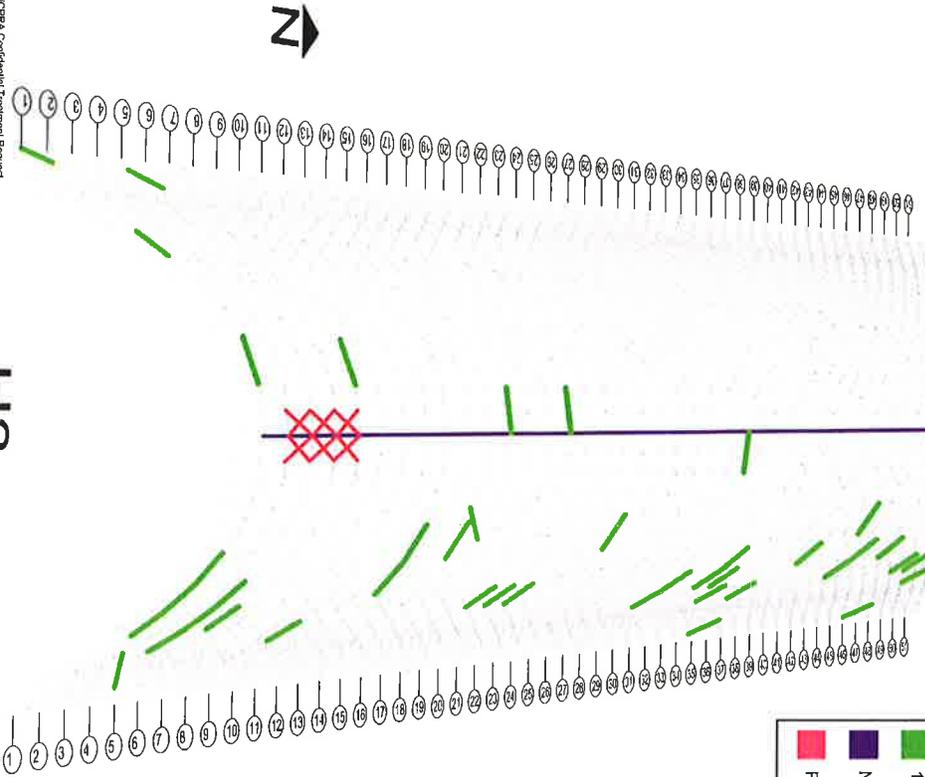
1981 REPAIRS

- Major glulam repairs were made in 1981 to correct buckling observed in truss chords
- Glulam strongback members were installed to re-align chords, but load path remained in the original members
- Major repairs made to **49** members
- Struts added at each arch at node 18 to brace top of truss, with rod cross-bracing added at the north and south ends of the hangar
- Minor repairs were also made with clamps and stitch bolts. Many 1x6 purlin ties were replaced with steel rod ties

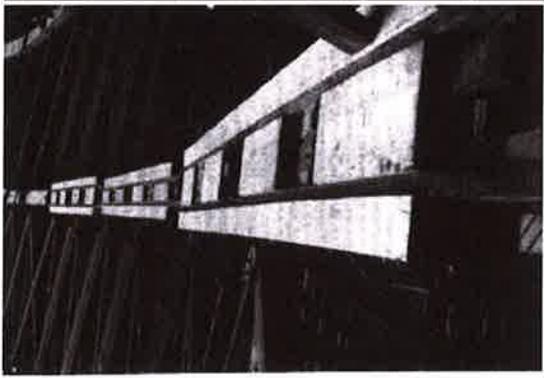
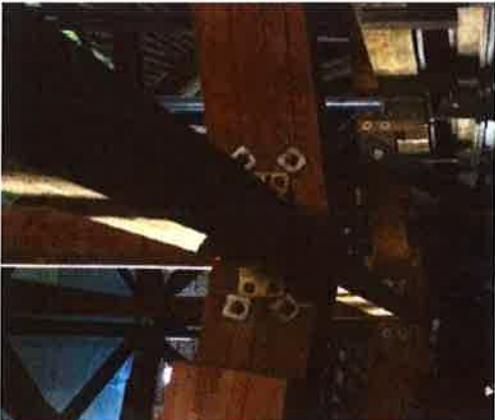
Buckled chords (left) and glulam strongback repairs (right)
-“Restoration of Navy LTA (Lighter than air) Hangars”, Donal Neal, 1996

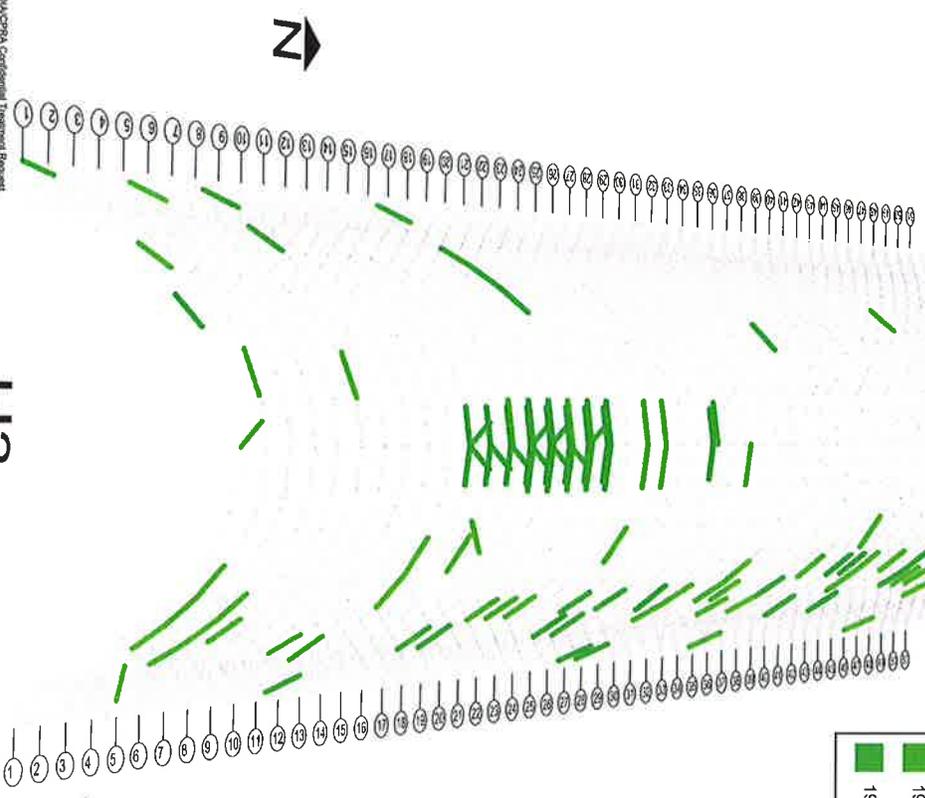
1993 GLULAM REPAIRS

- Continued deterioration of Hangar 3 necessitated further glulam repairs in 1993
- Repairs consisted of glulam strongbacks for buckling, and multi-chord glulam sistered members
- Many of these repairs were made in the critical zone where the most severe deflections and damage were later found
- Major repairs made to **75** members
- Sistering repairs also made to roof support purlins and minor clamp repairs were again performed on arch trusses

1993 glulam sister repairs to chord members in critical zone

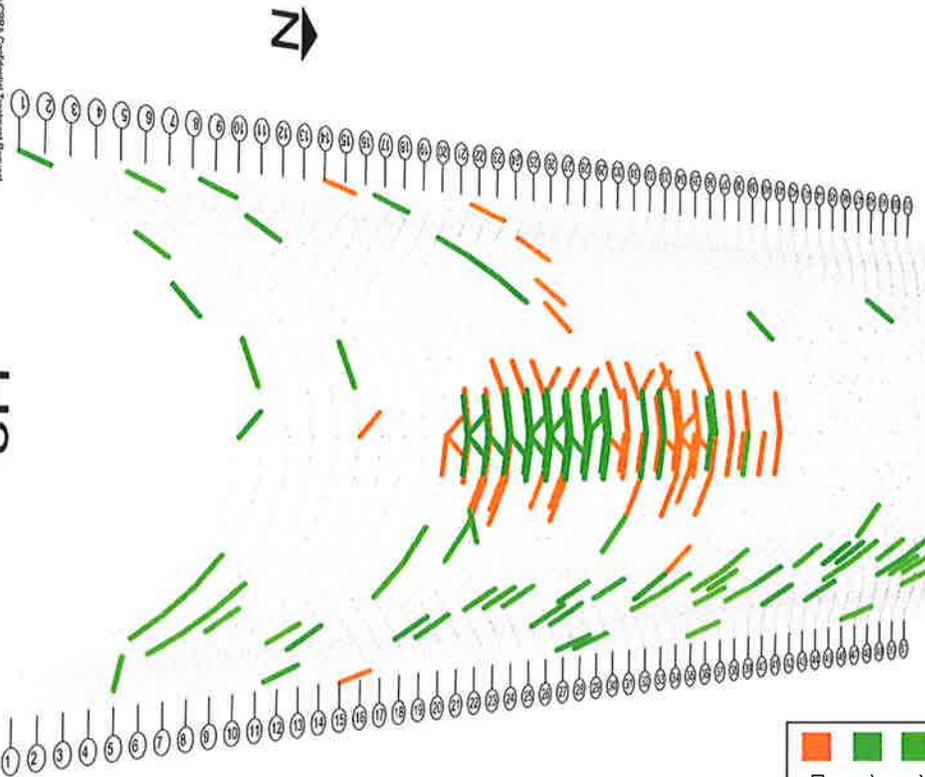
DDIF REPAIR SCOPE

- TPAS® data was reviewed and damaged members were identified for repair
- **68** members were found to be damaged and in need of major repairs

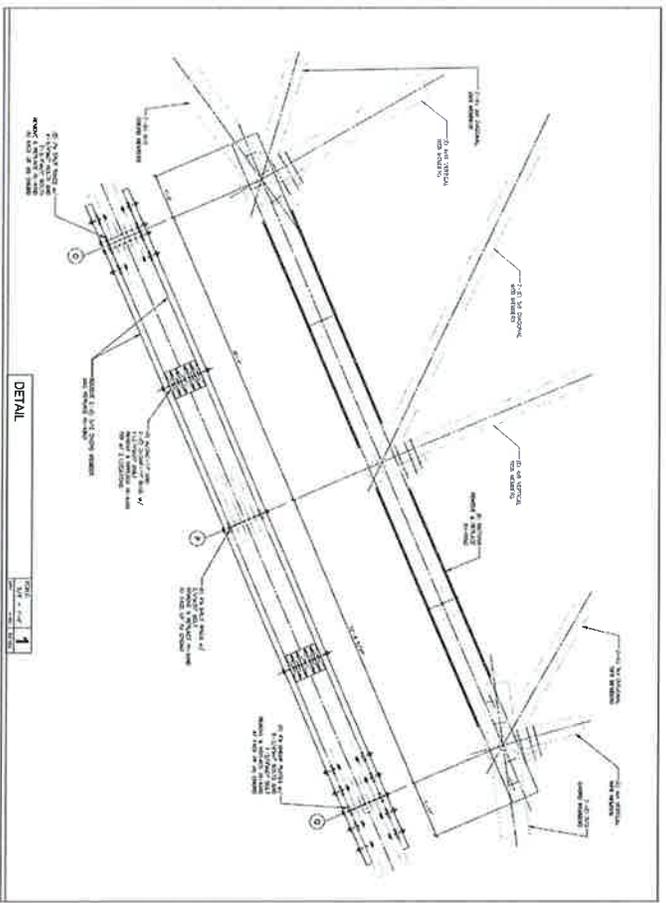
Example detail for removal and replacement of damaged chords found in TPAS®

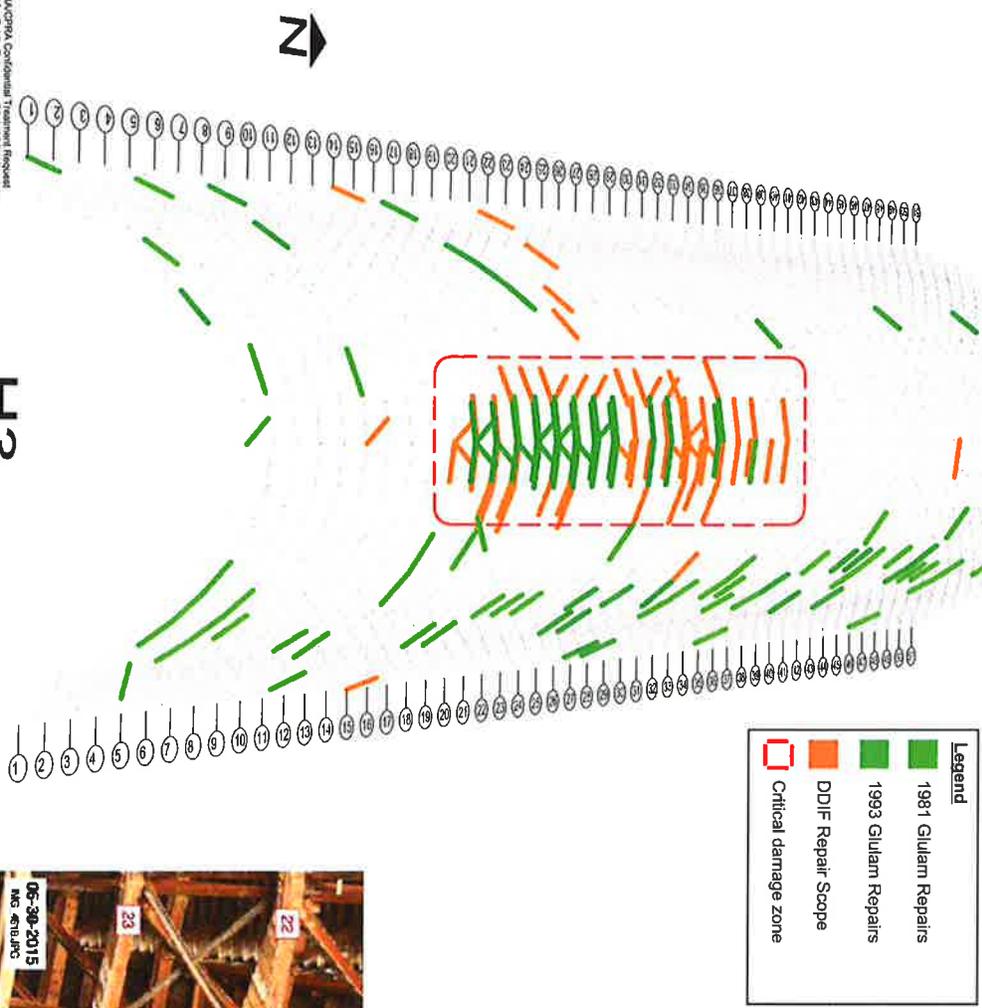
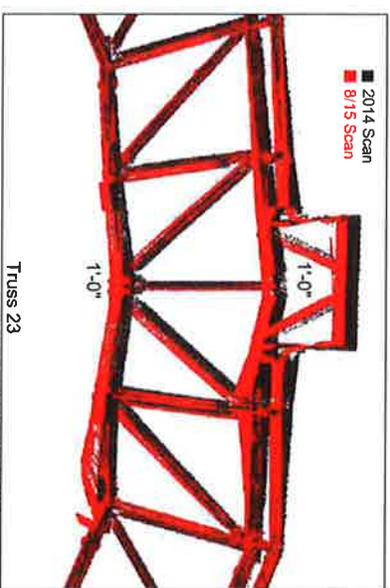
- During a site visit on June 24, 2015 KPFF observed damage progression in arch trusses
- On July 2, 2015 KPFF issued an Emergency Truss Repairs permit drawing set
- KPFF, Power Engineering Construction, Turner, and Page & Turnbull coordinated work to implement shoring and emergency truss repairs
- Permit for emergency repairs was received from NASA on August 19, 2015.

Point cloud visualization of damage progression

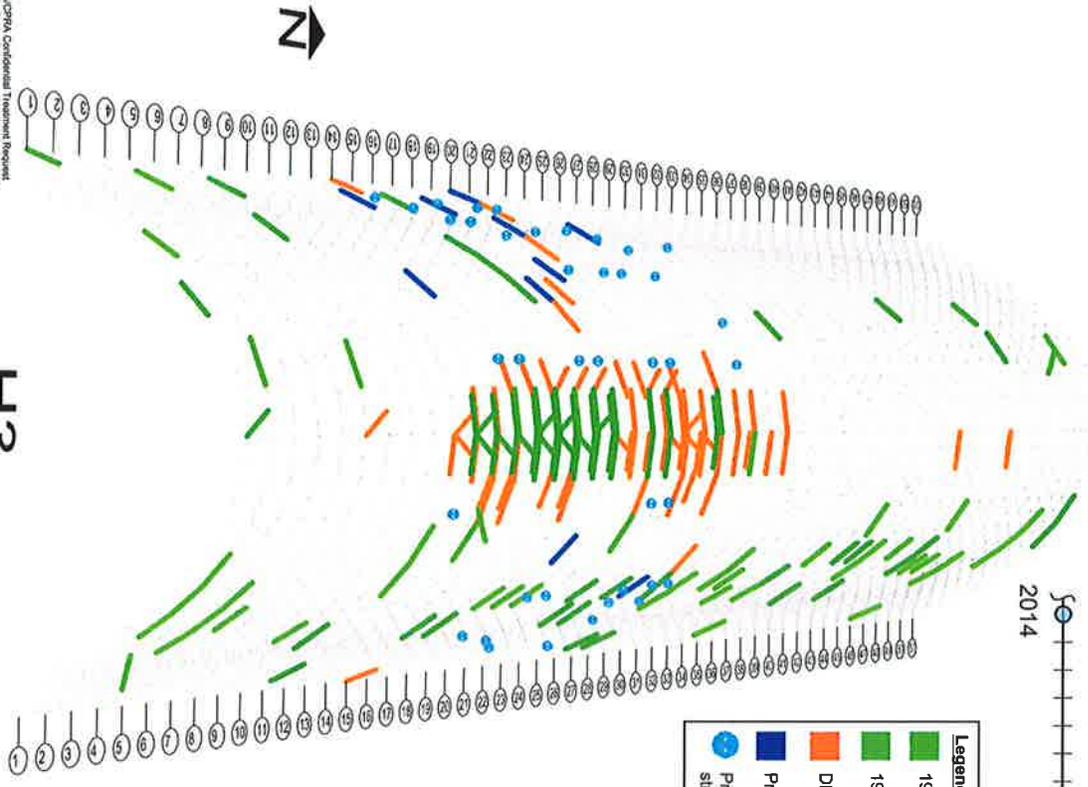
PRE-JACKING REPAIR SCOPE

- The KPF survey discovered chord damage which was either not observed or not present during the due diligence investigations
- The survey uncovered extensive deficiencies within the web member connections, including many plug pullout failures
- **10** additional arch members received glulam sistering repairs
- **39** chord connections received connection strengthening brackets

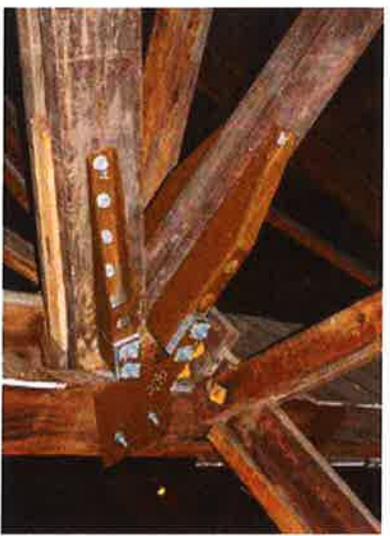
Typical connection strengthening bracket

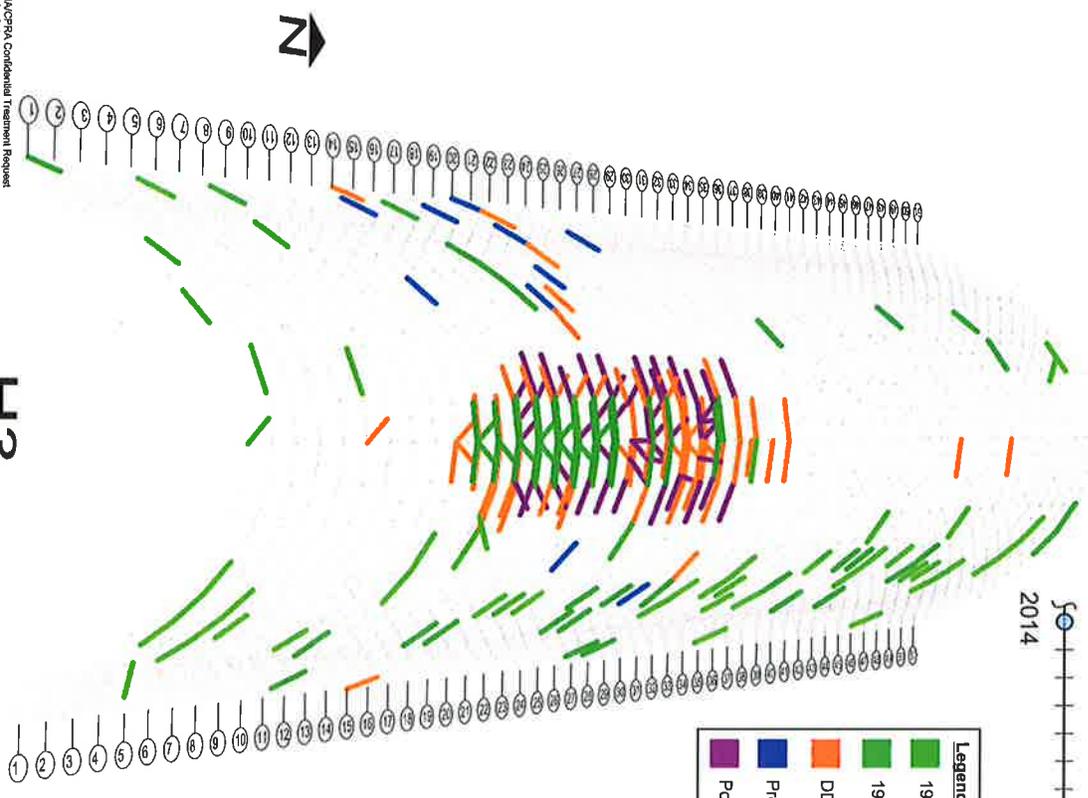
POST-JACKING REPAIR SCOPE

- 50 additional members were identified as severely damaged and scheduled to be removed and replaced after roof jacking
- Before jacking and repairs were made, decision was made to defer further construction activities

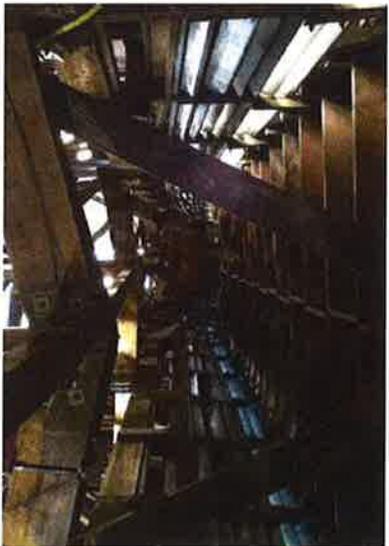
Roof monitor deflection in critical zone

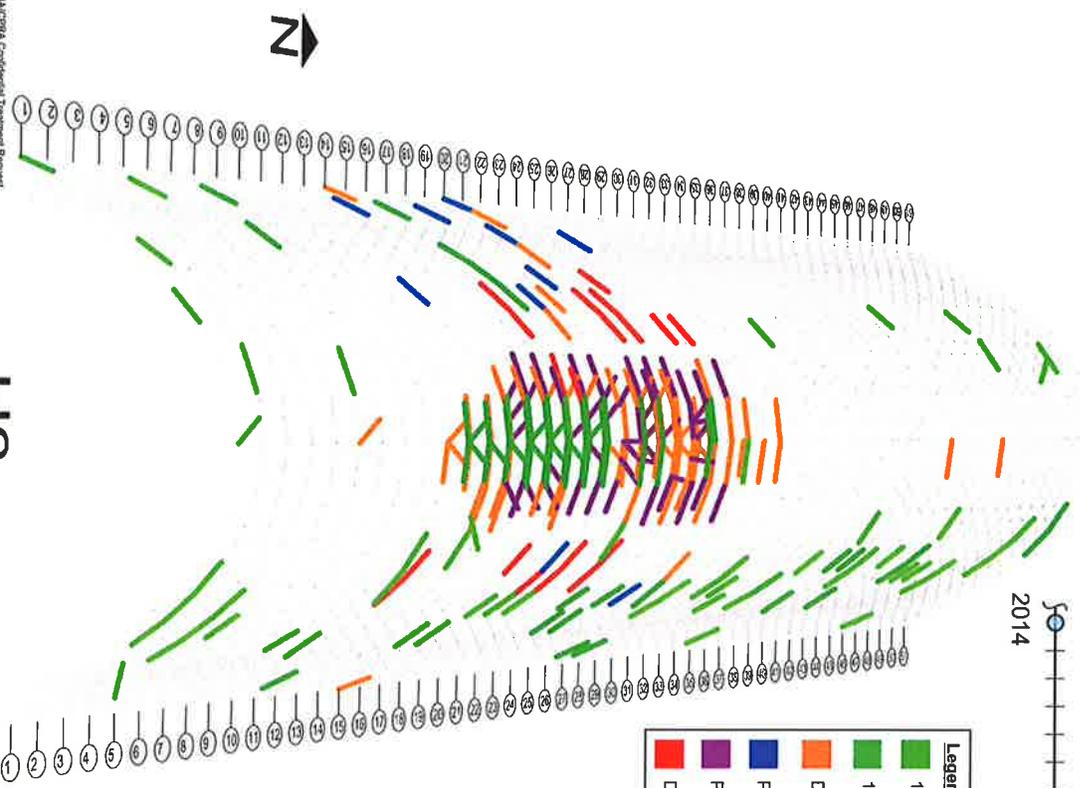
DAMAGE PROGRESSION

- Months after installation of exoskeletons, major splits were observed in chord members which had previously been observed and cleared.
- Major damage was observed on **19** chords, most between panel points I to M.
- Sistering repairs installed on most severe cases
- Due to the concentration of new damage at the lower chord members at panel points I to M, preemptive measures were taken to help reduce the progression of damage.
- Preemptive measures included fully-threaded screws at connections, and steel clamps.
