Shell Martinez Refinery

FLARE MINIMIZATION PLAN

Updated October 1, 2013

Shell Oil Products US
Martinez Refinery
Martinez, California 94553
BAAQMD Plant No. A0011

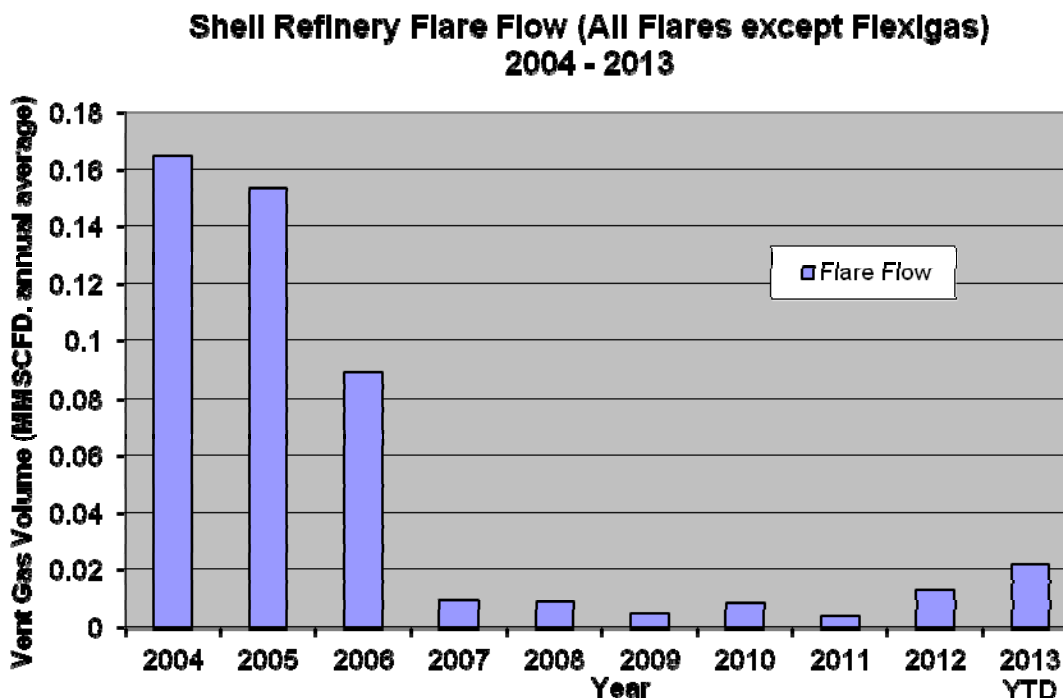
FIGURE ES-1

Figure ES -1 presents the annualized total flare flow from the LOP, OPCEN Hydrocarbon and Delayed Coking (Clean Fuels) Flares at the refinery from 2004 through June 30, 2013. A slight increase in flare volume over previous years occurred in 2012 and 2013 predominantly as a result of flaring on the LOP flare. A significant portion of the LOP flaring occurred in order to conduct required 10-year flare pressure vessel inspections in September 2012 and January 2013. Because the LOP flare header was originally designed without isolation valves, the flare recovery compressors had to be bypassed to install blinds to isolate the flare vessels for inspection. As required by this FMP, Shell reviewed the planned work for ways to minimize or eliminate the flaring. Through the review process, Shell engineers determined that the inspections could be conducted with only 2 flaring events rather than 3 as initially scheduled. In addition, as a result of this review, new piping and isolation valves were installed on the flare system during the inspection work so that in the future the vessels can be taken out of service without flaring.

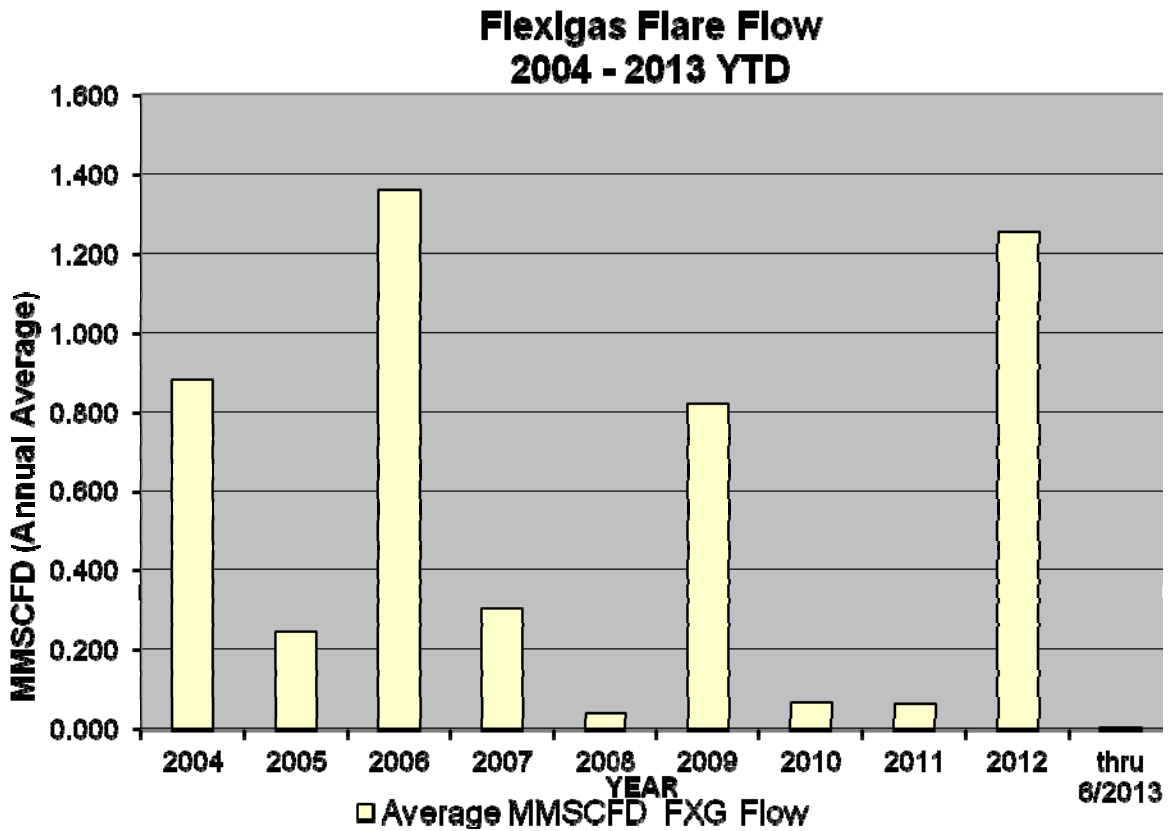
FIGURE ES-2

The Flexigas Flare flow volume is displayed separately in ES-2. The Flexicoker produces a relatively large volume of Flexigas (FXG) compared to regular refinery fuel gas. When FXG is flared, the volume of gas is typically large compared to the volume flared in the other refinery process flares, but emissions are significantly less because Flexigas contains very low concentrations of non-methane hydrocarbon and sulfur. Flexigas is treated for sulfur removal in the Flexisorb Unit before being combusted either in the process heaters or if necessary, in the flare. Flexigas is used as a supplemental refinery fuel gas in refinery process heaters.

Figure ES-2 shows the annualized vent gas flow from the Flexigas flare. This figure shows a significant increase in Flexigas flaring in 2012 as a result of a planned turnaround on the Flexicoker. This flaring is specifically allowed in Shell's Title V permit and is required during startup and shutdowns due to the nature of the Flexicoking process.

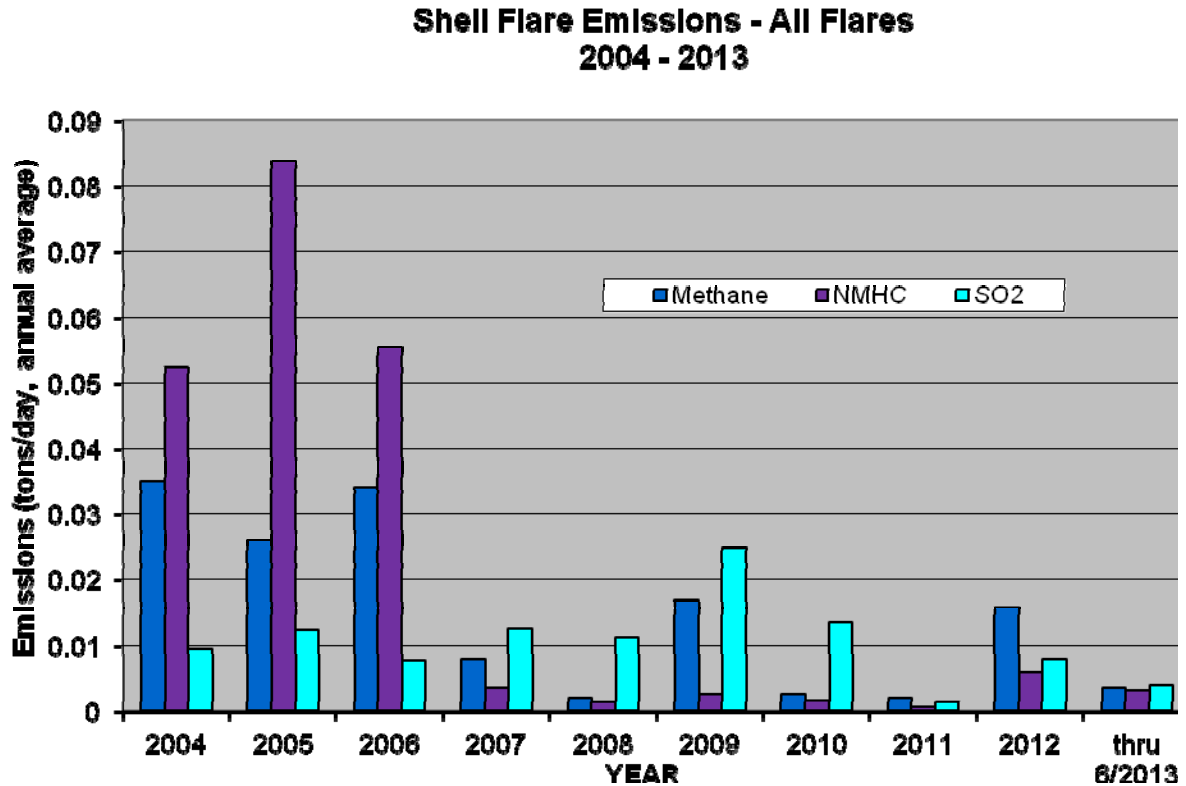
FIGURE ES-3

Figure ES-3 presents the flare emissions from all four refinery process flares from 2004 through year-to-date.

Figure ES-3 shows the significant reduction in emissions that has occurred since the implementation of the Flare Minimization Plan in 2006. During the time period covered by this update, there were eight flaring events triggering Causal Analysis investigation for flaring > 0.5 MMSCF or 500 lbs of SO2. All flaring was managed per our flare procedures to minimize the amount of flaring and was in compliance with the requirements of BAAQMD Regulation 12 Rules 11 and 12 and Shell's Flare Minimization Plan.

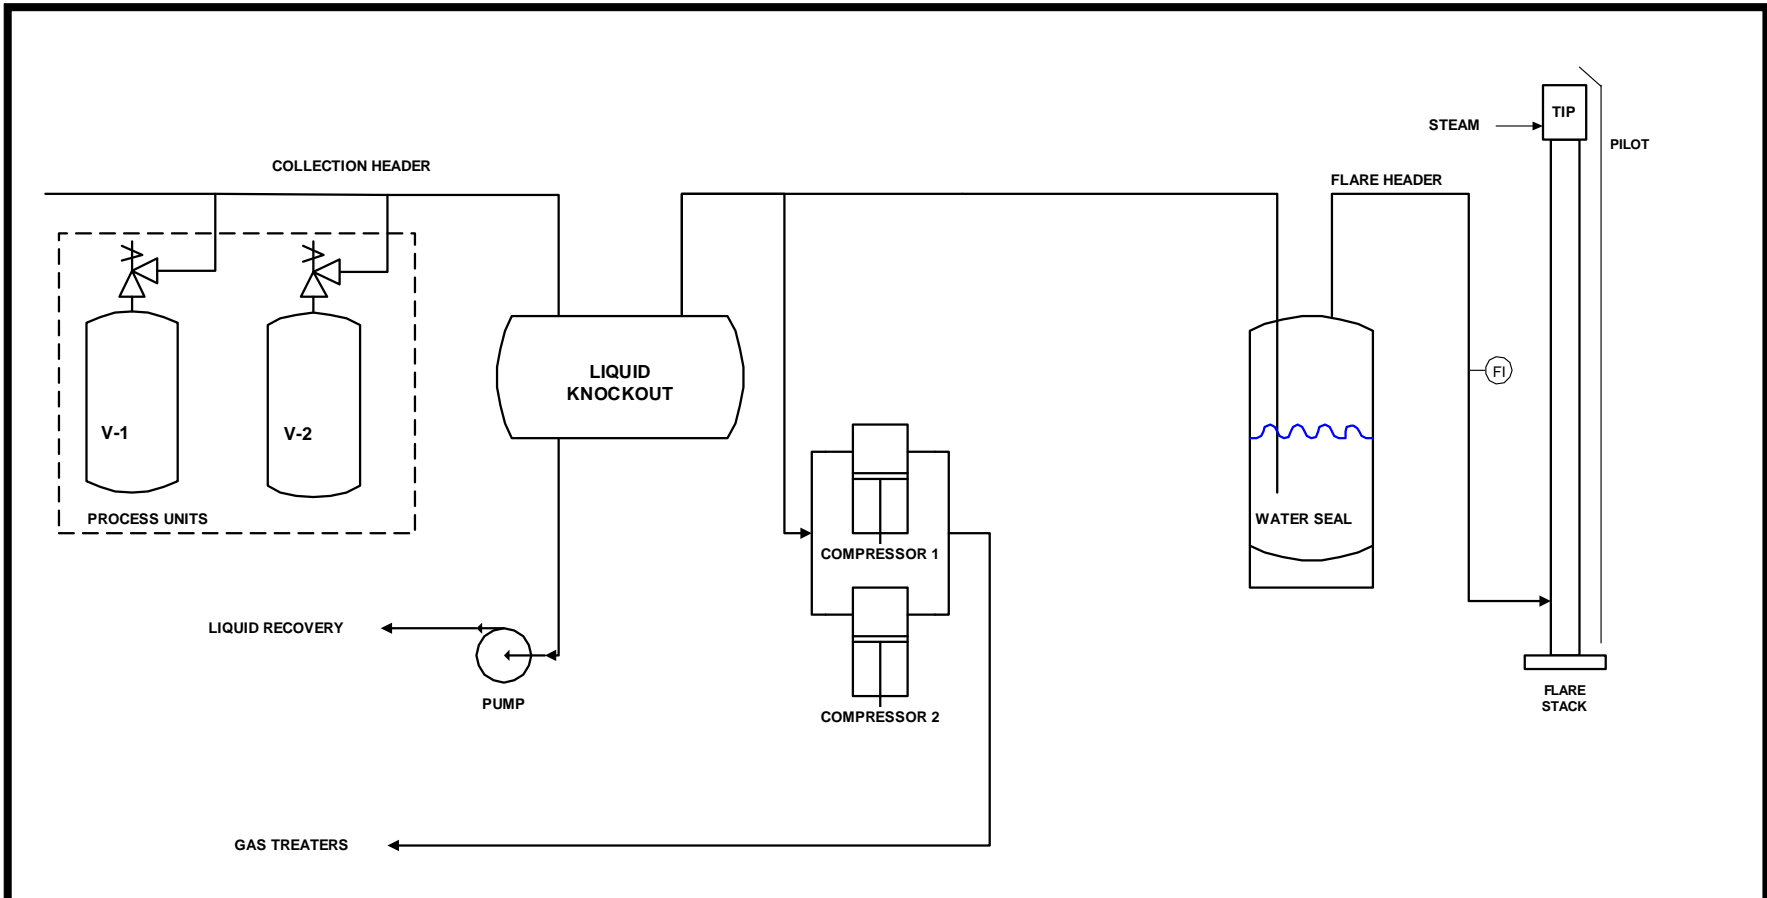
FIGURE 1. LOP AREA FLARE PROCESS SKETCH

Recovered flare gas is treated to remove hydrogen sulfide and condensable liquids. Treated gas is routed to the fuel gas system. The fuel gas treaters typically used for LOP recovered flare gas are located in the Catalytic Cracker Gas Plant (CGP). When this unit is unavailable for any reason, recovered gas may be routed to the Saturates Gas Plant (SGP). Sufficient capacity can be made available in both sets of treaters for the incremental flow up to the total capacity of both compressors of about 6.4 MMSCFD.

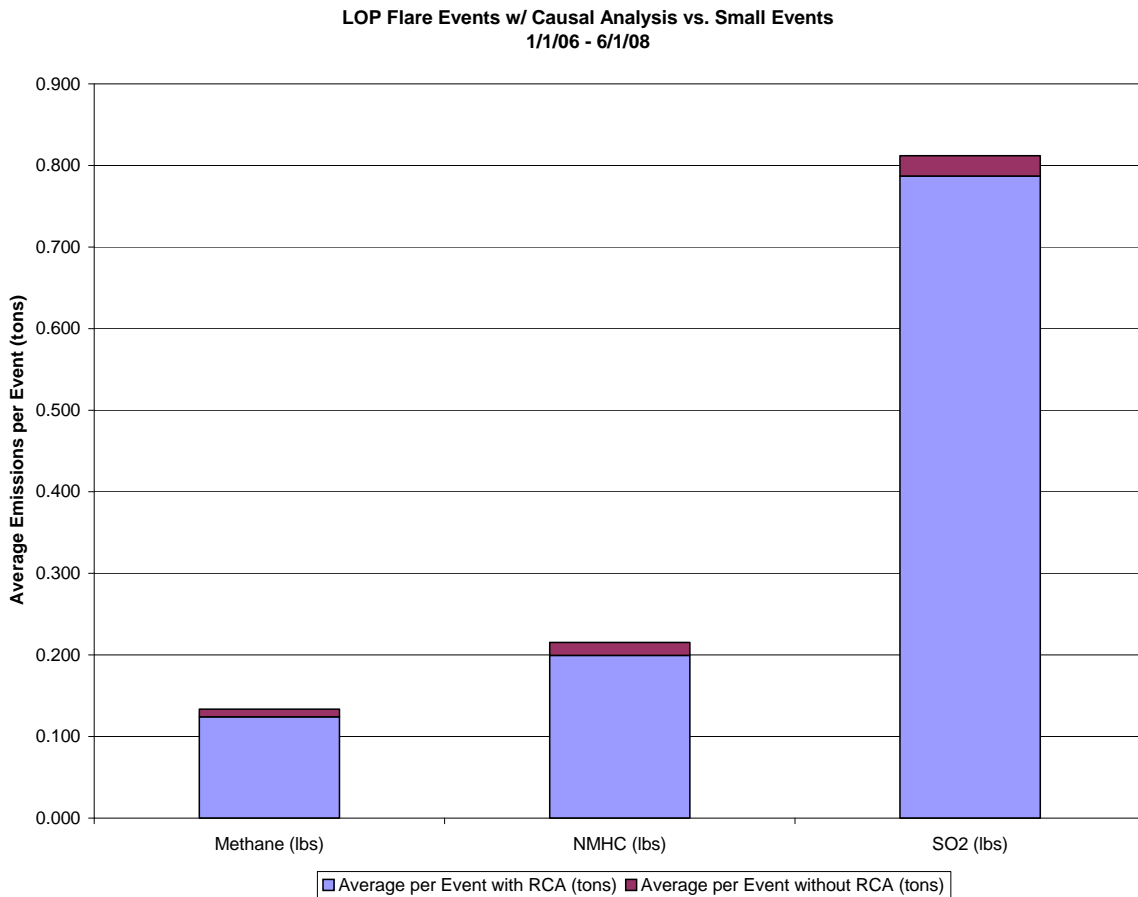
FIGURE 2008 –1

Beginning in November 2006 with the adoption of the Flare Procedures described in the Common Measures Section, pertinent information, when available, was captured immediately after a flaring event to determine the cause of any flaring and what could be done to prevent it from happening again. Total emissions from all flaring during the period from 12/1/06 through 6/1/08 were: 0.6 tons of methane, 0.99 tons of non-methane hydrocarbon and 2.5 tons of SO₂. Figure 2008-1 presents a comparison of the average emissions per large reportable events over this time period vs. the average emissions per small event. This figure shows that small events contributed on average < 10% of the emissions of a large event. Figure 2008-1 reinforces the appropriateness of the causal analysis trigger of 0.5 MMSCF/ 500 lbs SO₂ to ensure the resources to conduct a Causal Analysis are most effectively applied to address high emission events.

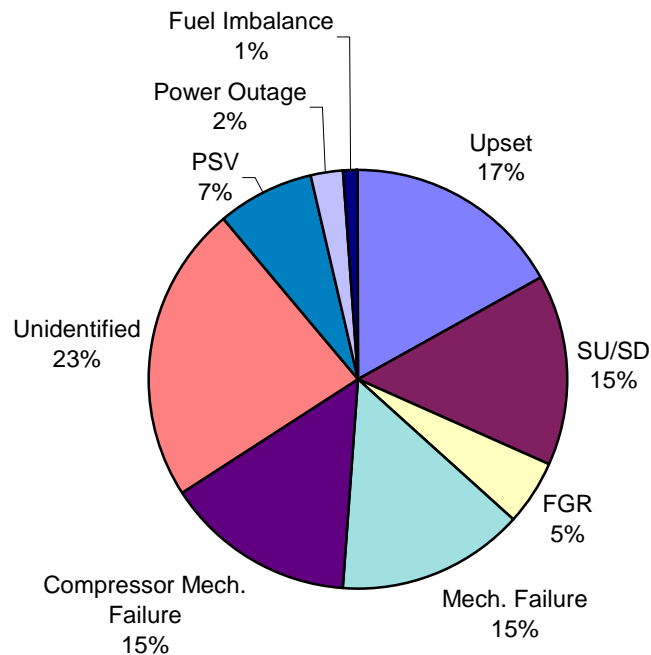
**Figure 2. LOP Area Flare Events
(2000-2005)**

Based on these data, about 65% of the flare events occurring from 2000 - 2005 are essentially evenly divided among the following categories: process upsets, process startup and shutdowns, mechanical failures of compressors and other equipment. Almost one quarter of the time the occurrences where the water seal was broken indicating that flaring occurred were so small, and of such brief duration, no cause could be reliably determined.

Flaring prior to January 2004. Review of flare events prior to January 2004 provided little usable information. Without flow meters, neither durations nor volumes could be accurately determined. In many cases, even the proximate cause of flaring could not be reliably determined due to the limited documentation and time elapsed since the event. With these qualifications, a breakdown of the general cause of LOP flare events for the previous five years is depicted in Figure 2. A description of the various categories listed is provided below:

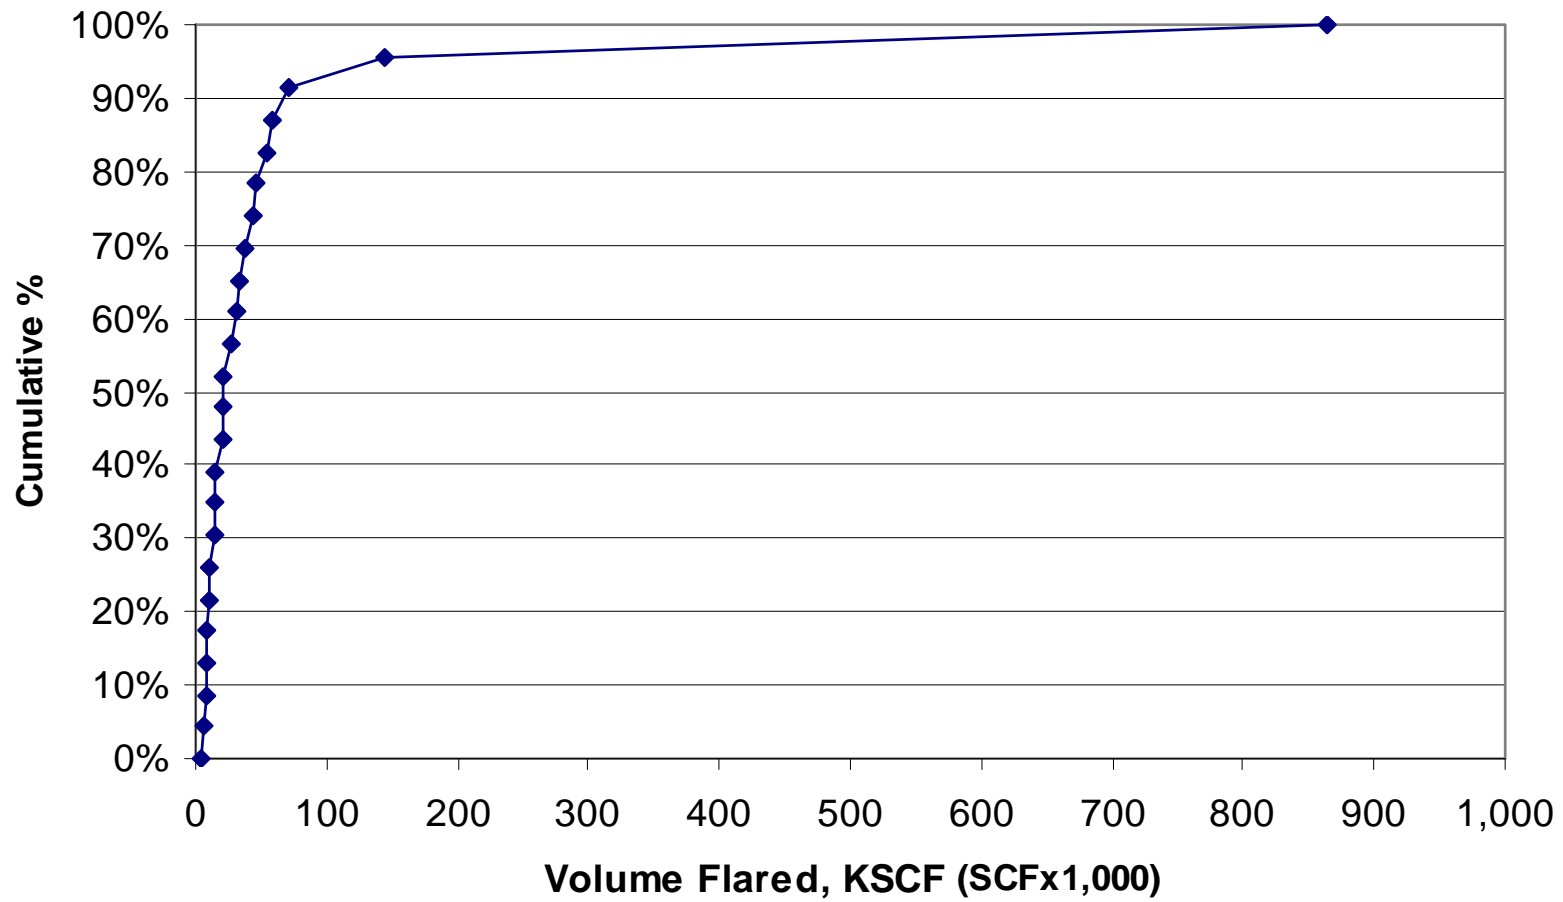
**Figure 3. LOP Flare Gas Volumes
(2005)**

Volumes flared: Figure 3 depicts the amount of material flared during the 25 events occurring in 2005. Each point on this plot represents the total flare volume of gas during that event. The

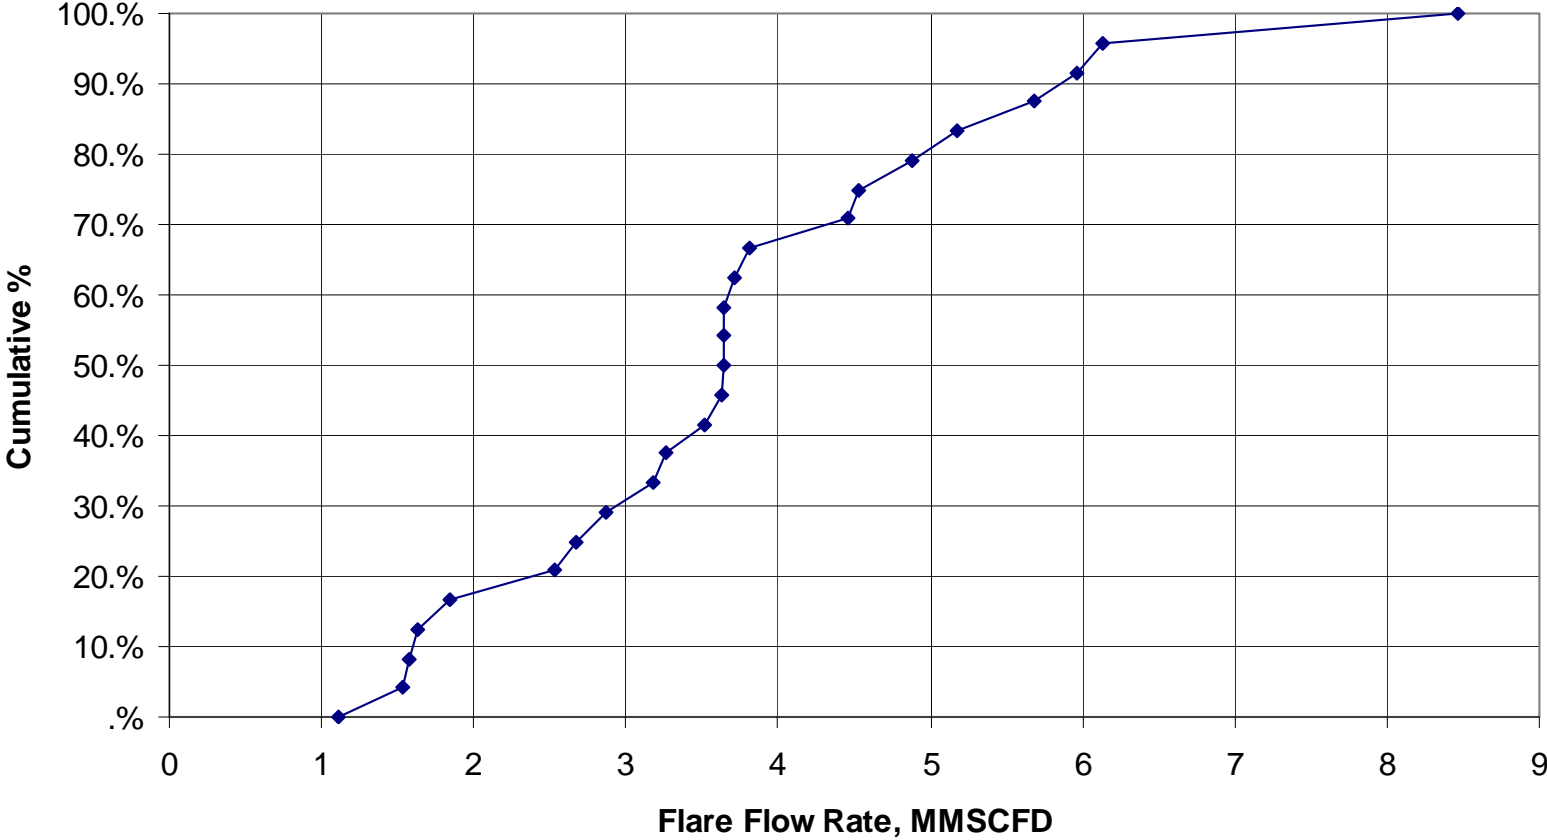
**Figure 4. LOP Flare Gas Flow Rates
(2005)**

Figure 4 depicts the average rates of flow to the flare for events occurring in 2005. These data indicate that approximately 30% of the flare events had event-average flow rates of less than 3 million standard cubic feet per day. Actual instantaneous rates are generally higher – often significantly – than these average rates. This difference between the average rate for an event and instantaneous flare gas rate during an event is important because once the instantaneous rate exceeds the available compressor capacity the water seal is typically broken and flaring occurs. Once flaring begins, backpressure in the flare header provided by the water seal is significantly reduced. Due to the lower header pressure, flare gas recovery rates are typically significantly reduced from their rated capacity.

Data from Figure 4 were used to evaluate the leverage provided by additional flare gas recovery in LOP. As each increment of compressor capacity was added, the corresponding events with average flows within the newly revised total capacity were considered to be recovered rather than flared. Similarly, the reported emissions for these events were presumed not to occur. This provided the basis for emissions reductions as a function of compressor capacity.

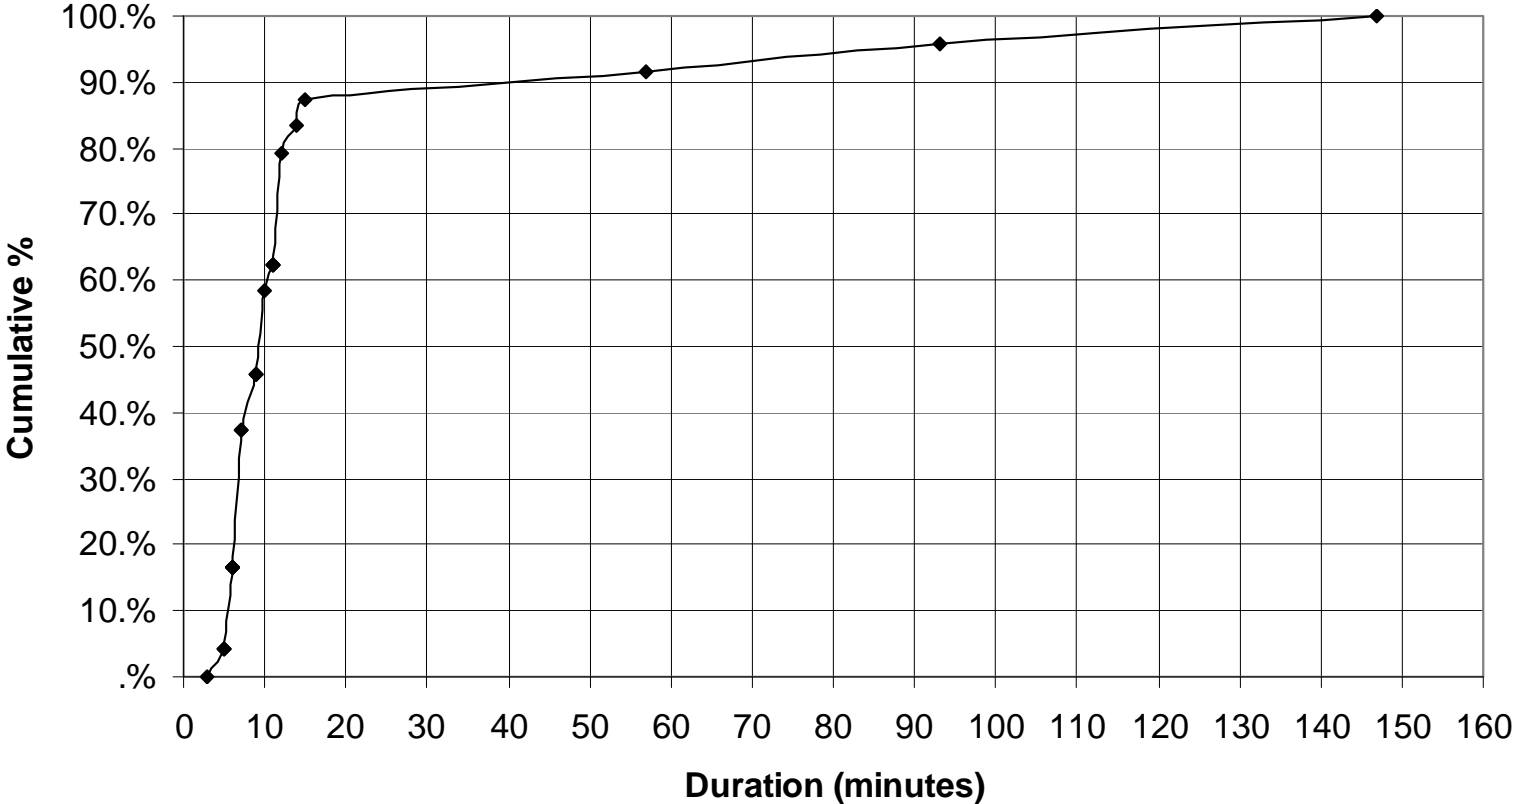
Figure 5. LOP Flare Durations
(2005 - 25 Events)

Figure 5 depicts the distribution of flare event durations for 2005, the year for which these data are available. Most flare events have very short durations with small volumes of gas flared. From Figure 5 it can be seen that half of the flare events had durations of less than 10 minutes. By combining event durations with additional data on the volume flared during each event, it can be shown that the 50% of events with durations less than 10 minutes contributed less than 10% to the total volume of gas flared. The 85% of events which lasted 15 minutes or less contributed less

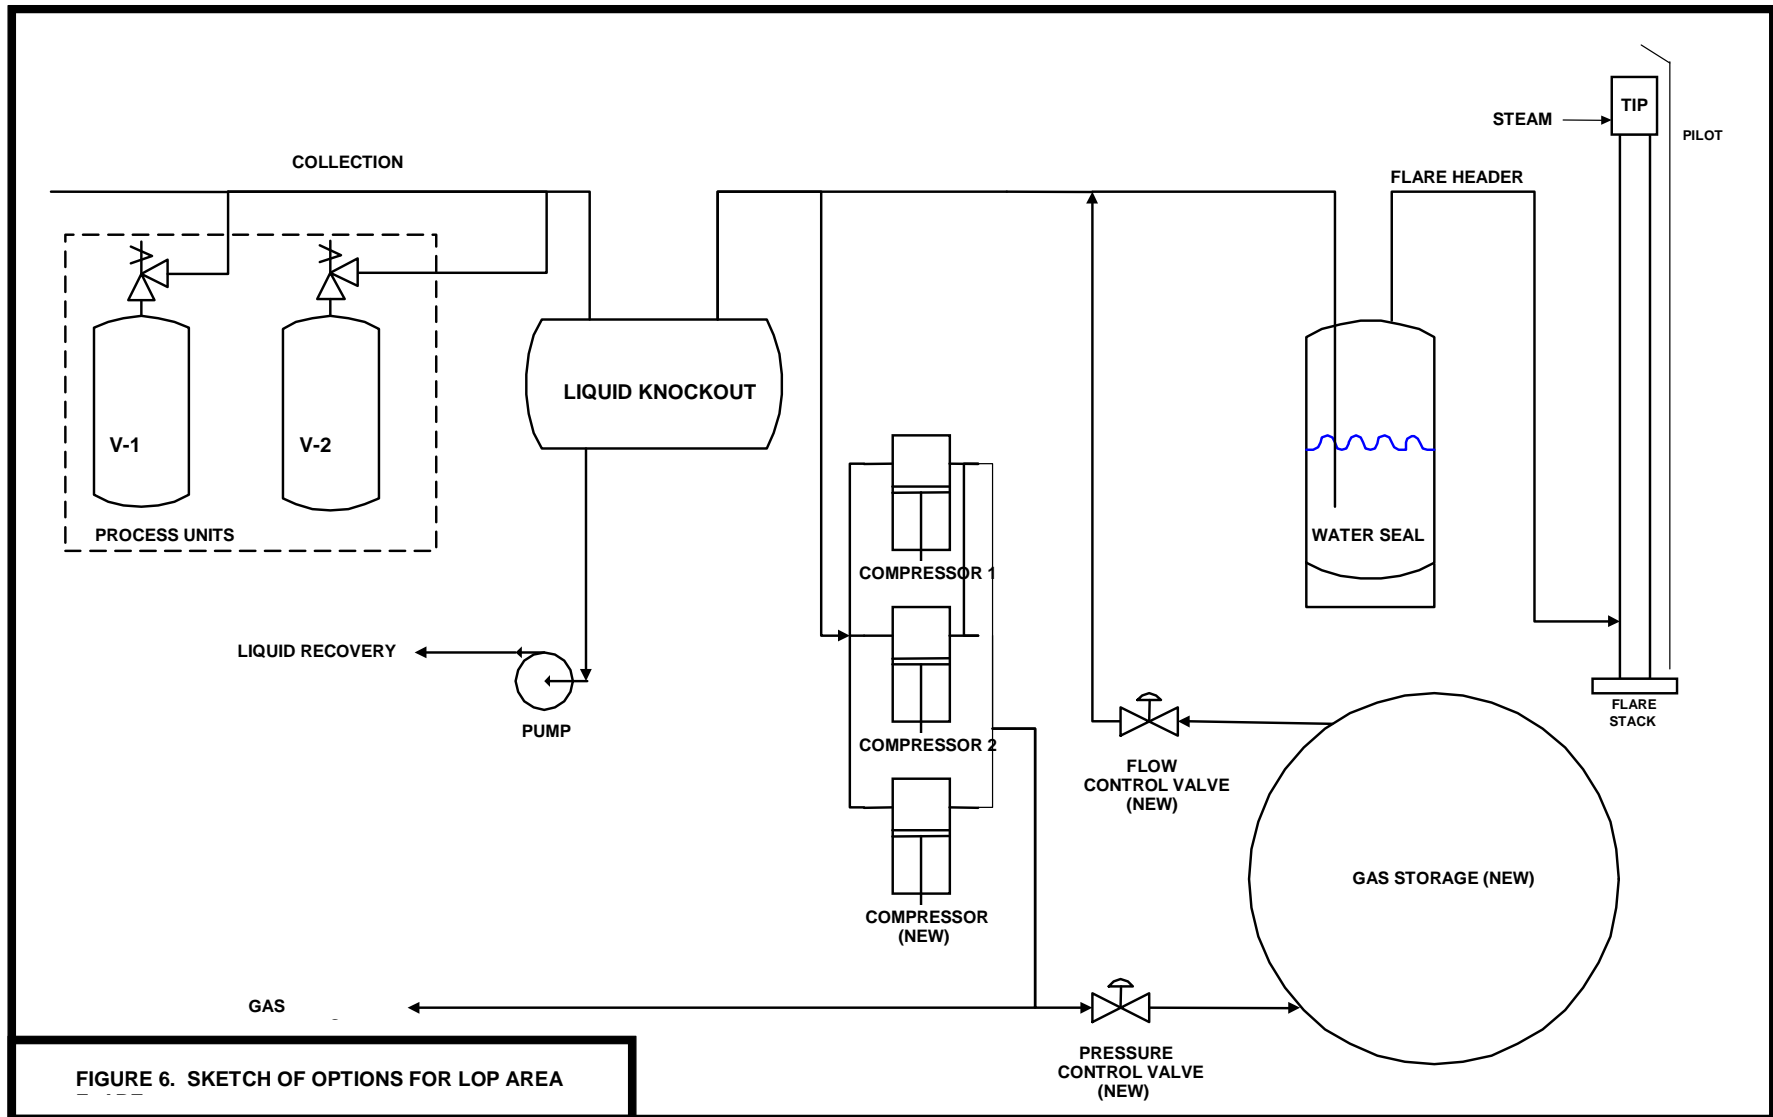
FIGURE 6. SKETCH OF OPTIONS FOR LOP AREA

Prevention Measure Options Considered for Recovery, Storage and Treatment: Costs and potential benefits of improving gas recovery and reducing flare emissions from the current 99.7% recovery efficiency are addressed by considering the addition of flare gas recovery compression and flare gas storage. Gas treating capacity is expected to be adequate for all options evaluated. A sketch of the potential options is provided in Figure 6.

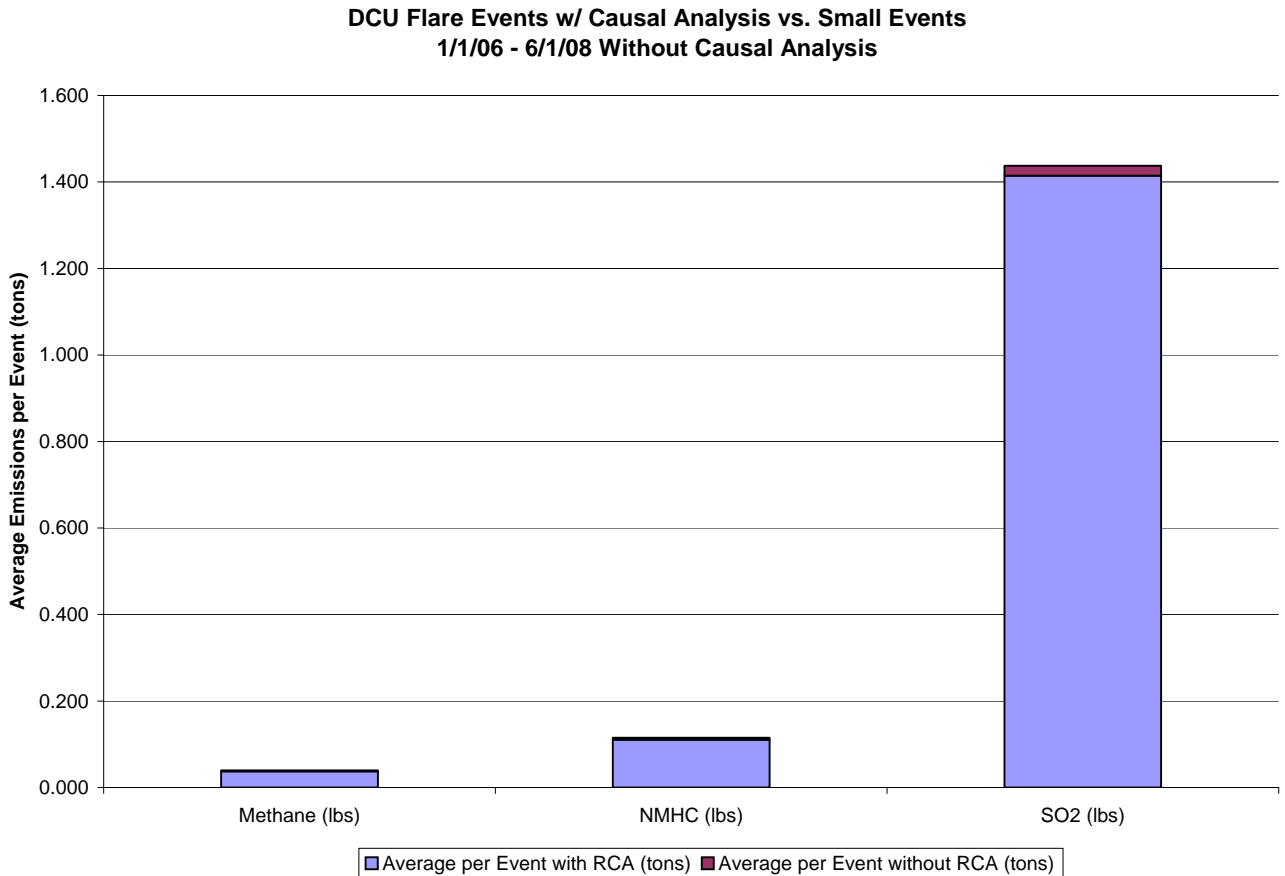
FIGURE 2008-2

Beginning in November 2006 with the adoption of the Flare Procedures described in the Common Measures Section, pertinent information, when available, was captured immediately after a flaring event to determine the cause of any flaring and what could be done to prevent it from happening again. Total emissions from all flaring during this 30-month period were: 0.17 tons of methane, 0.45 tons of non-methane hydrocarbon and 4.19 tons of SO₂. Figure 2008-2 presents a comparison of the average emissions per large reportable events over this time period vs. the average emissions per small event for the DCU Flare. This figure shows that small events contributed < 6% of the emissions of a large event. Figure 2008-2 reinforces the appropriateness of the causal analysis trigger of 0.5 MMSCF/ 500 lbs SO₂ to ensure the resources to conduct a Causal Analysis are most effectively applied to address high emission events.

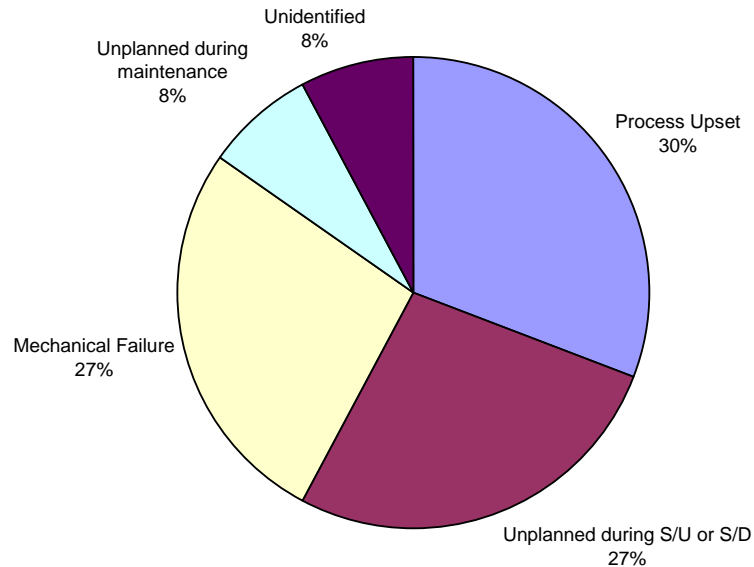
FIGURE 2008 - 3

The DCU flare events that occurred from 1/1/06 – 6/1/08 were categorized by probable cause in Figure 2008-3. None of the flaring was planned. Most of the events were < 10 minutes long. The

majority of the events were caused by process upset, mechanical failure or were unplanned during startup and shutdowns.

**Probable Cause of Flaring on DCU Flare 1/1/06-6/1/08
26 Events**

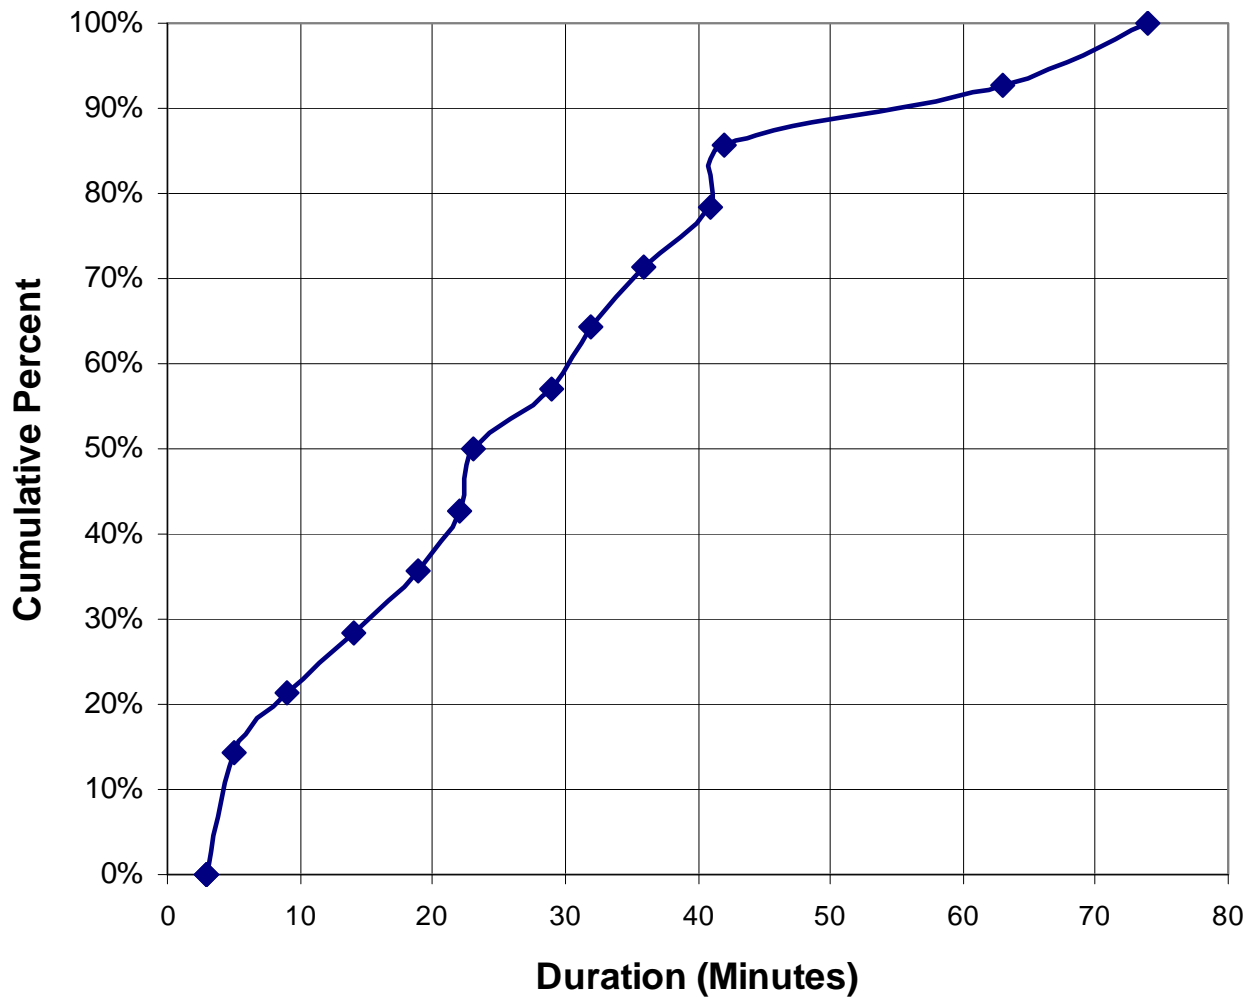
**Figure 11. Delayed Coking Area Flare Event Durations
(2005)**

Figure 11 depicts the distribution of flare event durations for 2005 where these data are available. 50% of the events lasted less than 30 minutes. This is consistent with other data characterizing the bulk of flare events being very brief.

Flaring due to gas quantity: Non-emergency flaring from the Delayed Coking Area flare during 2004 and 2005 amounted to less than 0.04% of permitted emissions of non-methane hydrocarbon. Efficiency of the existing flare gas recovery system is > 99.9%. Actual data for this flare is provided in figures 9 through 11. These data, together with knowledge of the various process units and hardware served by the flare, provide no new alternative mitigations beyond those already presented for the LOP Area flare.¹⁴

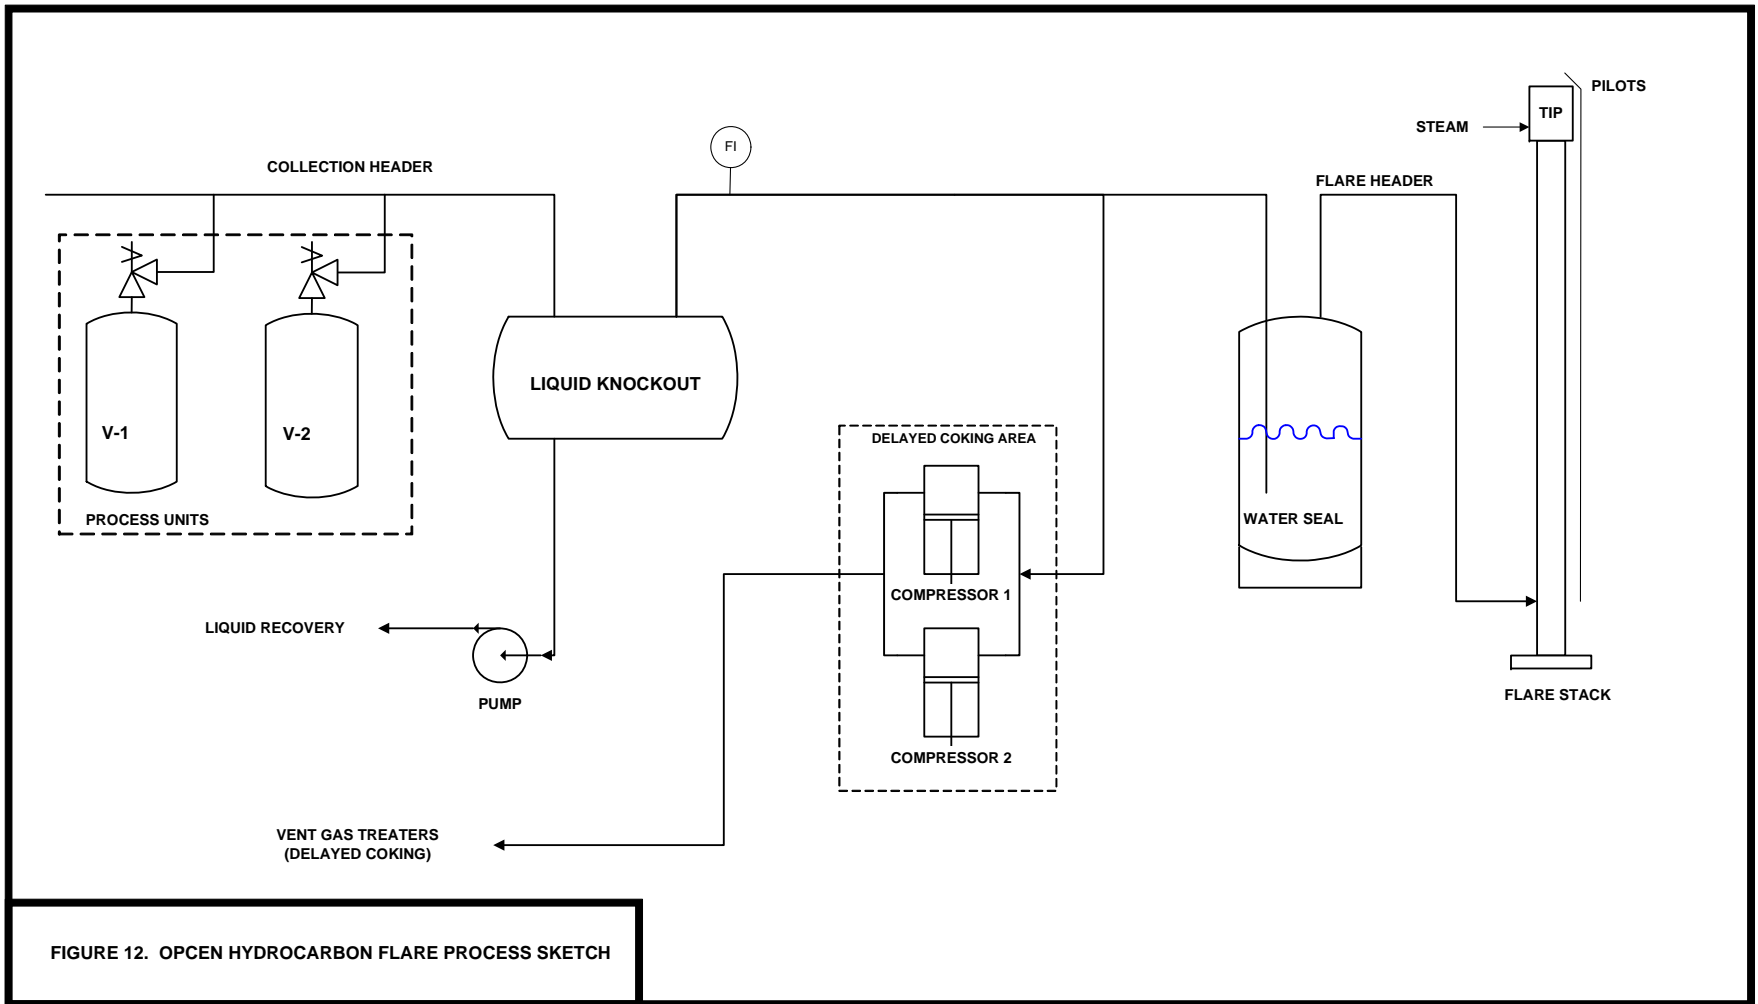
FIGURE 12. OPCEN HYDROCARBON FLARE PROCESS SKETCH

Process units in the OPCEN area are served by a dedicated flare system. This flare was modified by a project to provide flare vapor recovery. The vapor recovery project was operational in November 2006. A sketch of the flare system is provided in Figure 12. The OPCEN HC flare system is comprised of collection headers, a liquid knockout vessel, a water seal vessel, piping to flare gas recovery compressors and gas treating, the flare header proper, and the flare¹⁶. Additional details of the flare are provided in Appendix C.

Recovered gas from OPCEN is treated to remove H₂S and routed to fuel and hydrogen plant feed along with the recovered gas from Delayed Coking. The normal routing for Delayed Coker Area recovered flare gas is the Vent Gas Treater. Sufficient capacity is available for the incremental flow (up to the total recovery compressor capacity of about 8 MMSCFD).

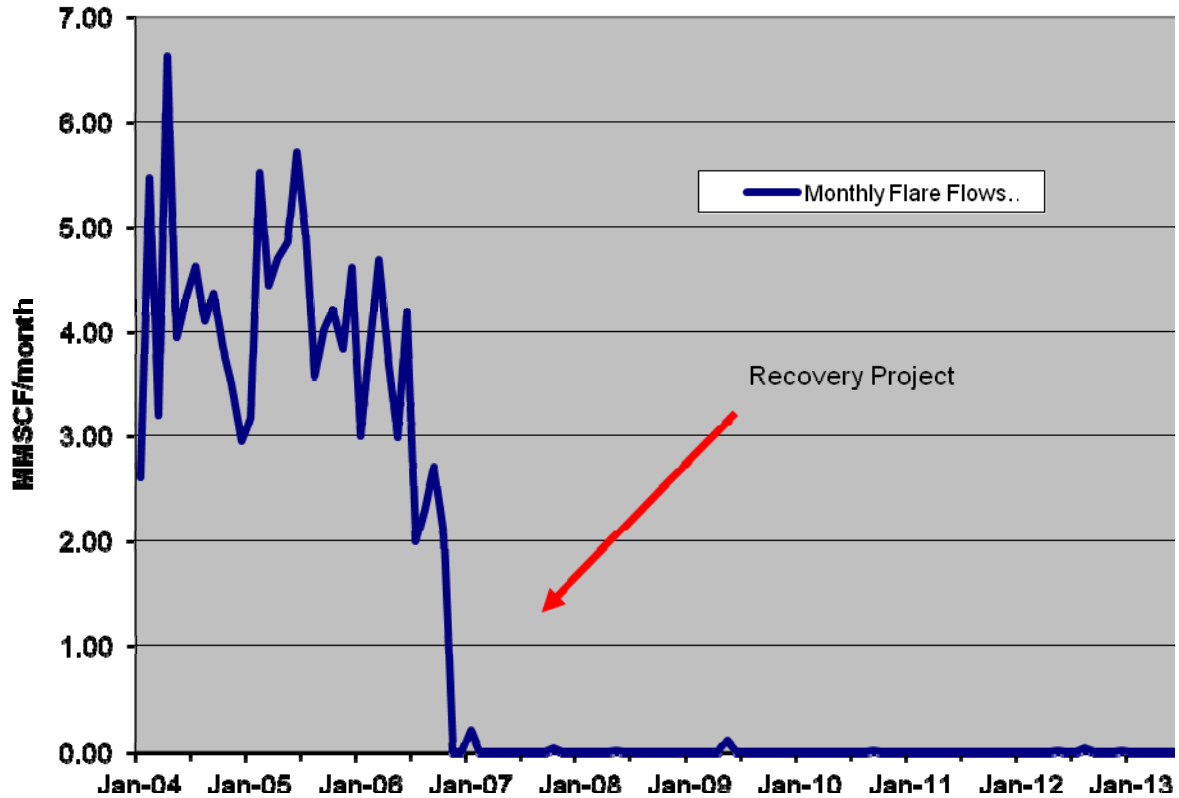
FIGURE 1

Figure 1 below has been updated through 7/1/13 and shows the continued success of the implementation of the flare recovery project that occurred in 2006 on this flare.

OPCEN HC FLare Monthly Flare Flows 1/1/04 - 7/1/13

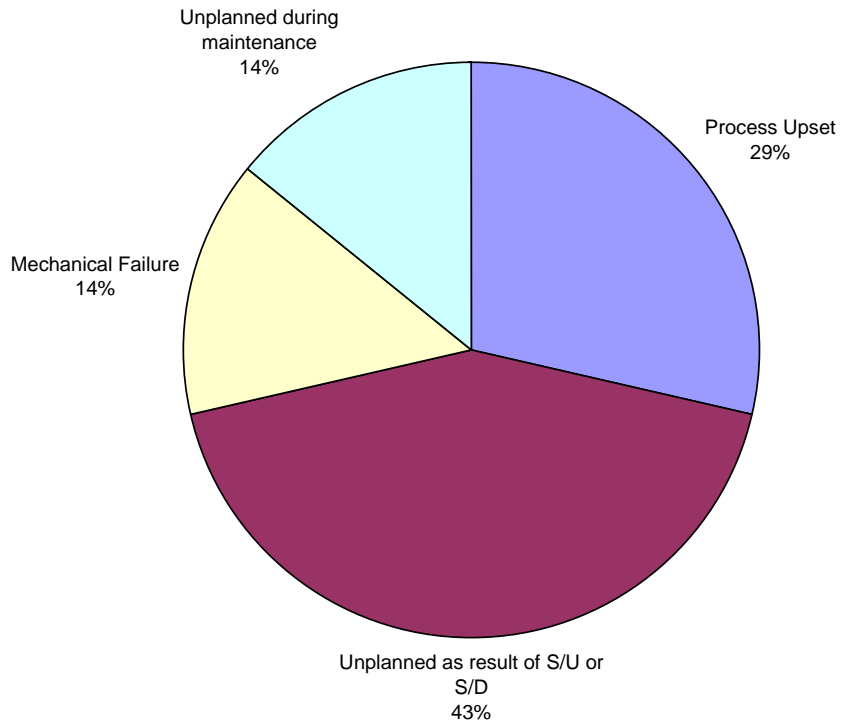
FIGURE 2008-4

OPCEN HC Flare- Cause of Flaring 11/1/06 - 6/1/08
7 Events

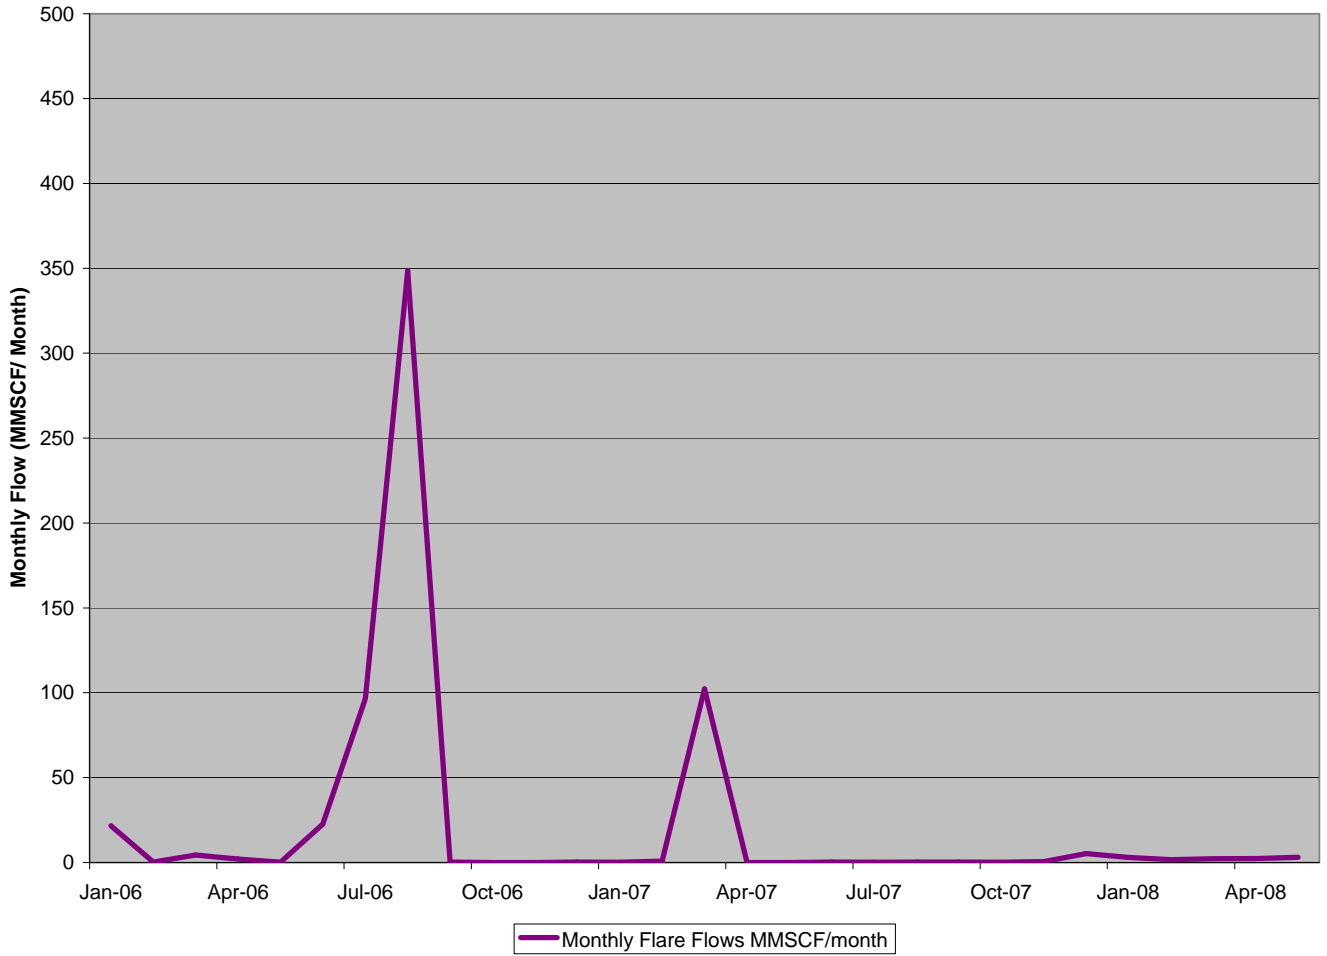
FIGURE 2008-5

FXG Flare Flows 1/1/06 - 6/1/08

Flexigas flare activity since 1/1/06 was reviewed for potential reduction opportunities. Figure 2008-5 shows the FXG flare flows over this time period. There were 11 events that required Causal Analysis. All of these flaring events were investigated and prevention measures identified and implemented (see Part 3 of this Section – Reductions Previously Realized). The results of the investigations into these events were reported to the District in Causal Analysis reports.
