Shell Martinez Refinery

FLARE MINIMIZATION PLAN

Updated October 1, 2013

Shell Oil Products US
Martinez Refinery
Martinez, California 94553
BAAQMD Plant No. A0011

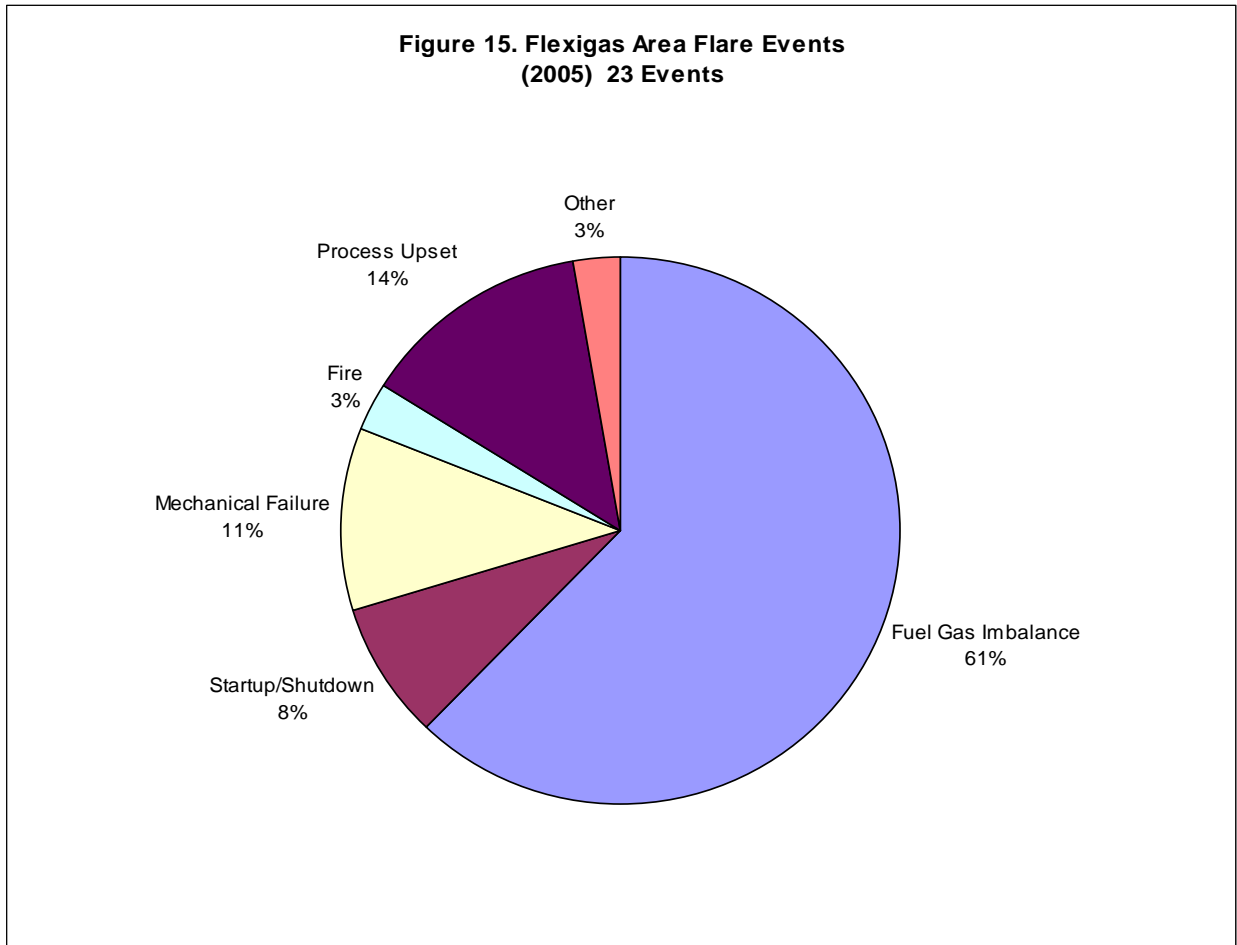
Historical flaring at the OPCEN Flexigas flare was reviewed to identify opportunities for potential mitigation. The highest quality data are available for the period from December 2003, to January 2006. This coincides with installation of the flare flow meter and BAAQMD flare reporting. Data for 2005 are plotted in Figure 15 and Figure 16.

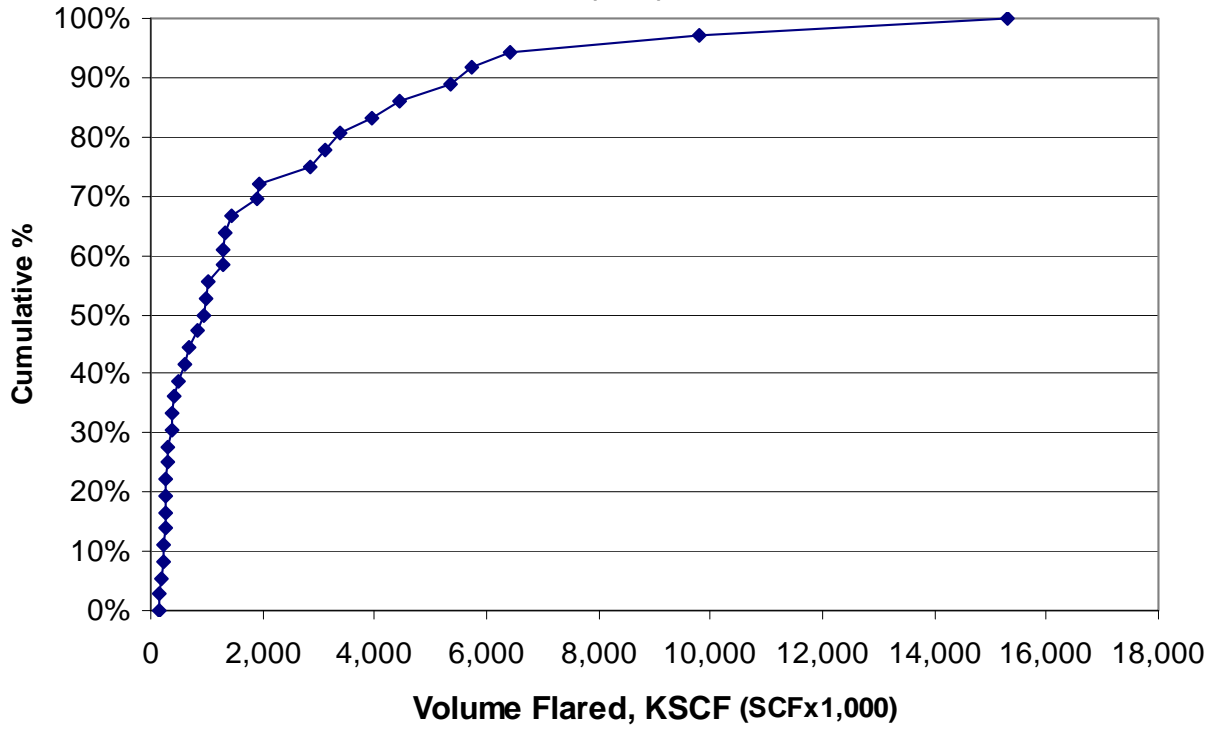
**Figure 16. Flexigas Flare Gas Volumes
(2005)**

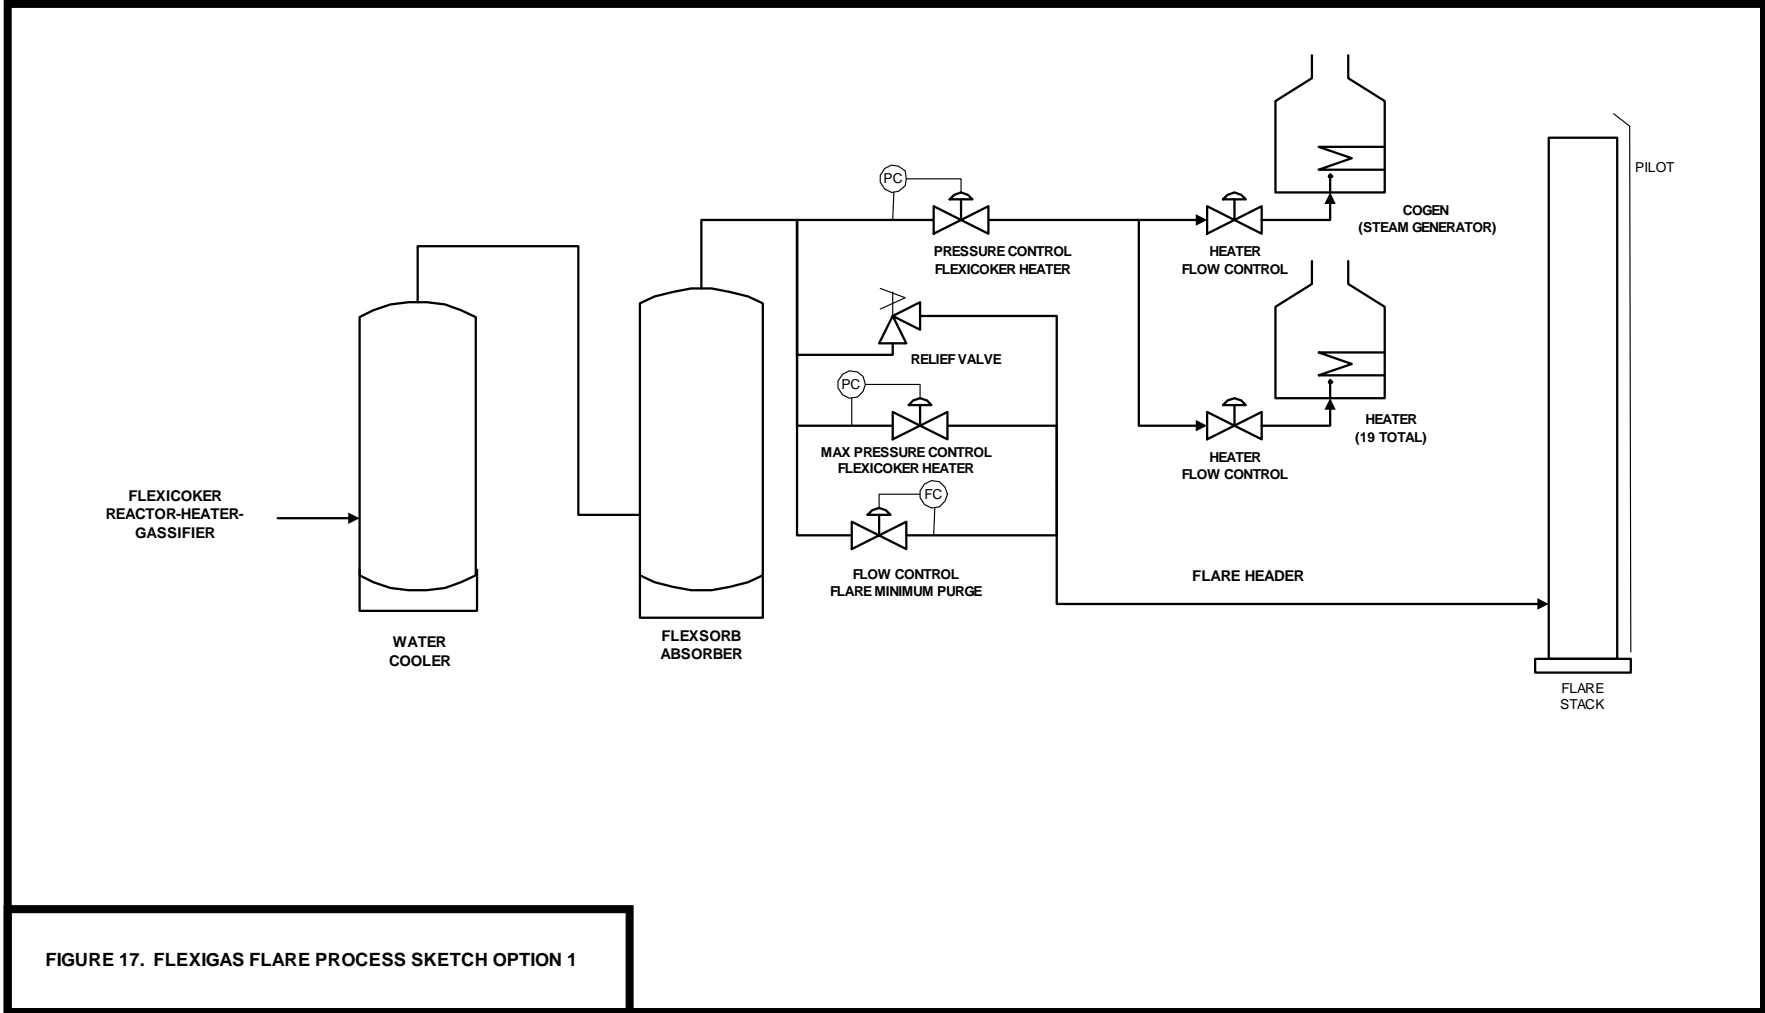
FIGURE 17. FLEXIGAS FLARE PROCESS SKETCH OPTION 1

OPTION 1: PROVIDE ADDITIONAL FLEXIGAS CONSUMERS (see Figure 17).

The objective of this project would be to provide an additional consumer that can rapidly pick up the Flexigas volumes made available by loss of another consumer (e.g., process heater) for any reason. Because excess Flexigas is available less than 10% of the time (based on the percent of days on which flaring occurred from Figure 16), and the current fuel system is roughly in balance, this consumer must essentially remain in hot standby until needed. This means it must be waiting to burn between 1 MMSCFD and 40 MMSCFD Flexigas when an existing consumer unexpectedly comes off line.

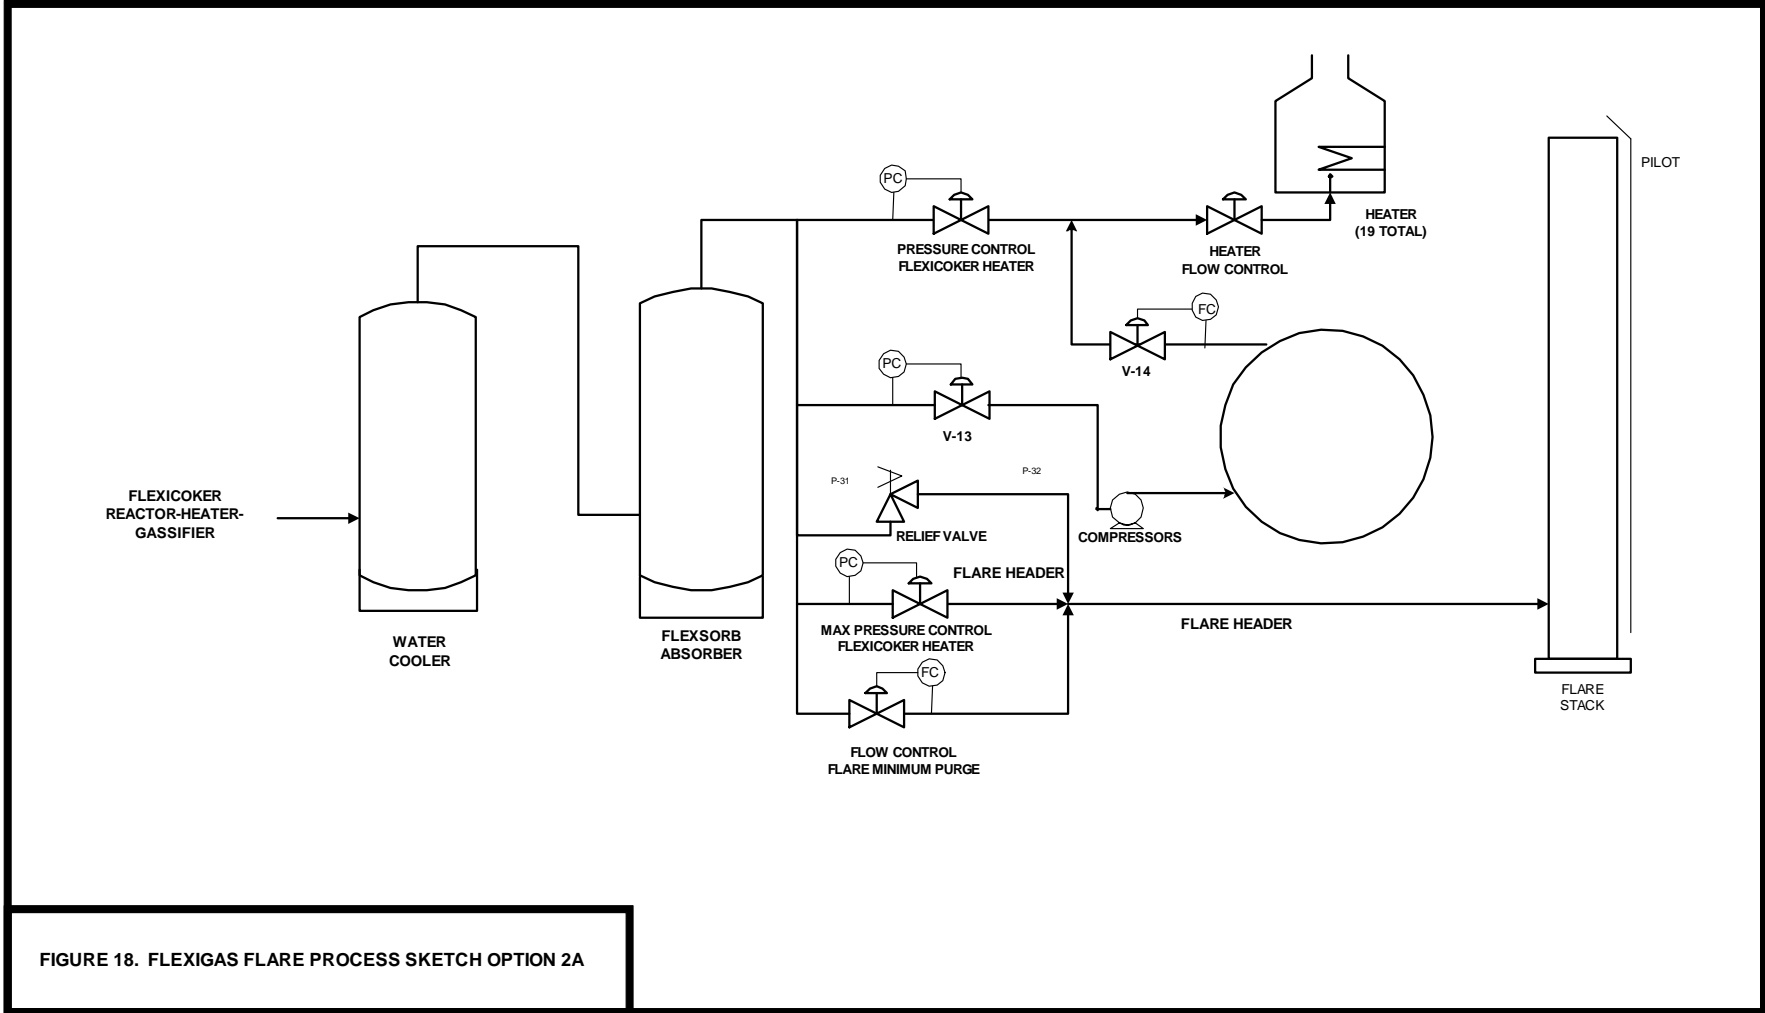
FIGURE 18. FLEXIGAS FLARE PROCESS SKETCH OPTION 2A

Option 2A consists of a pressurized vessel that would require a compressor with capacity ranging between 1 MMSCFD and 10 MMSCFD. This option is depicted in Figure 18. Flexigas in excess of consumer demand is routed to storage via compressor(s). A controlled flow is returned to the distribution system when enough consumers are available to avoid flaring. Due to the limited capacity of this storage, it has no real capability to accommodate prolonged fuel system imbalances. As a result, the expected best-case emission reductions are about the same as those available in 2005. A rough capital cost for the storage and large compressors is about \$27,000,000²². Annual electrical costs for the required compressors add another \$600,000. The annualized capital plus electrical costs to eliminate a ton of non-methane hydrocarbon result in a cost-effectiveness of approximately \$190 Million dollars per ton. Therefore, Option 2A is even less cost-effective for reducing flaring than Option 1.

²² Based on a nominal 1 MMSCF sphere (60' diameter) at 120 psig, and two 4 MMSCFD compressors. This system would handle only minor imbalances while the Flexicoker cuts rate.

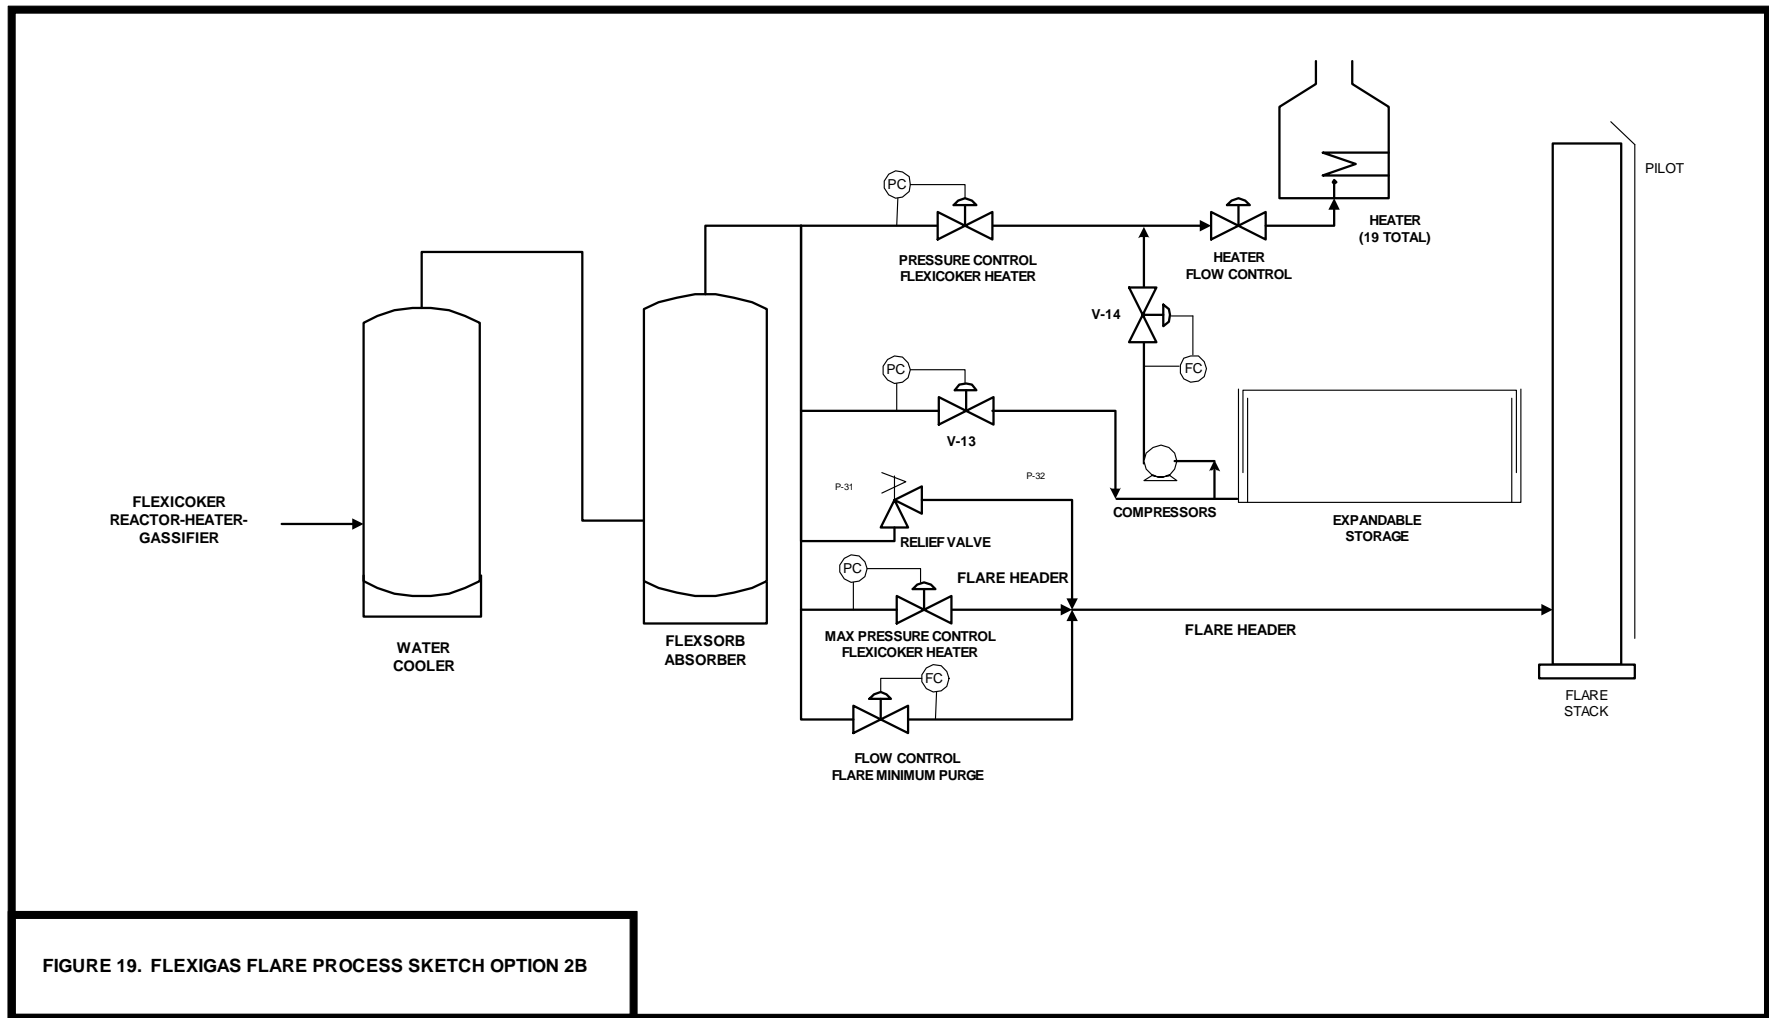
FIGURE 19. FLEXIGAS FLARE PROCESS SKETCH OPTION 2B

Option 2B uses low-pressure expandable gas storage. This option is depicted in Figure 19. This type of storage can be built significantly larger than the pressurized storage used in option 2A, and has the advantage of not requiring compressors in some cases. However, the concentration of carbon monoxide in the gas will likely require use of a water seal to limit leakage, restricting vessel height to a single lift. The requirement for a single lift, combined with low-pressure operation, significantly limits available storage volume²³. In any event, the installed cost is approximately \$21,000,000, providing cost-effectiveness of approximately \$276 Million dollars per ton of NMHC. As was the case for Option 2A, this option is even less cost-effective for reducing flaring than Option 1.
