**Shell Martinez Refinery**

**FLARE MINIMIZATION PLAN**

**Updated October 1, 2014**

**FLARE MINIMIZATION PLAN**  
**SHELL MARTINEZ REFINERY**  
**CONTENTS**

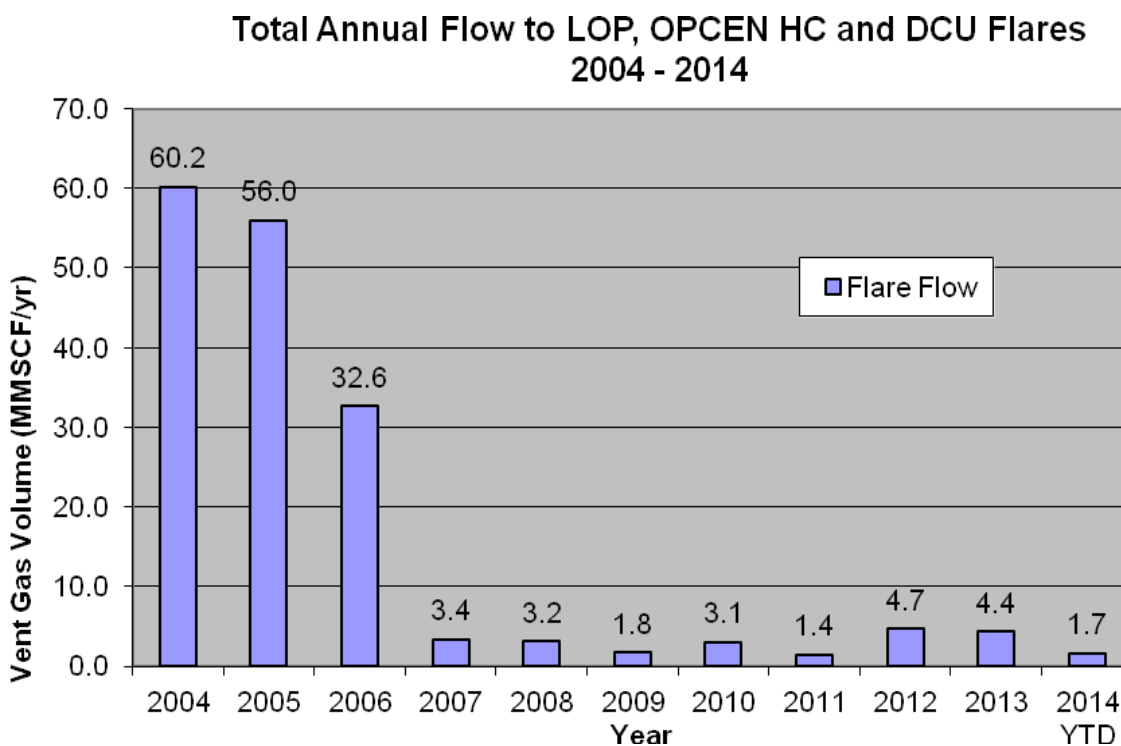
**FIGURE ES-1**

Figure ES -1 presents the total annual vent gas flow to the LOP, OPCEN Hydrocarbon and Delayed Coking (Clean Fuels) Flares at the refinery from 2004 through June 30, 2014. Total flare flow decreased from the previous two years and 2014 is on track to be one of the best years for minimizing flaring at the refinery.

Figure ES-3 shows the significant reduction in emissions that has occurred since the implementation of the Flare Minimization Plan in 2006. During the time period covered by this update, there were four flaring events triggering Causal Analysis investigation for flaring > 0.5 MMSCF or 500 lbs of SO<sub>2</sub> (compared to eight events in the previous period). All flaring was managed per our flare procedures to minimize the amount of flaring and was in compliance with the requirements of BAAQMD Regulation 12 Rules 11 and 12 and Shell's Flare Minimization Plan.

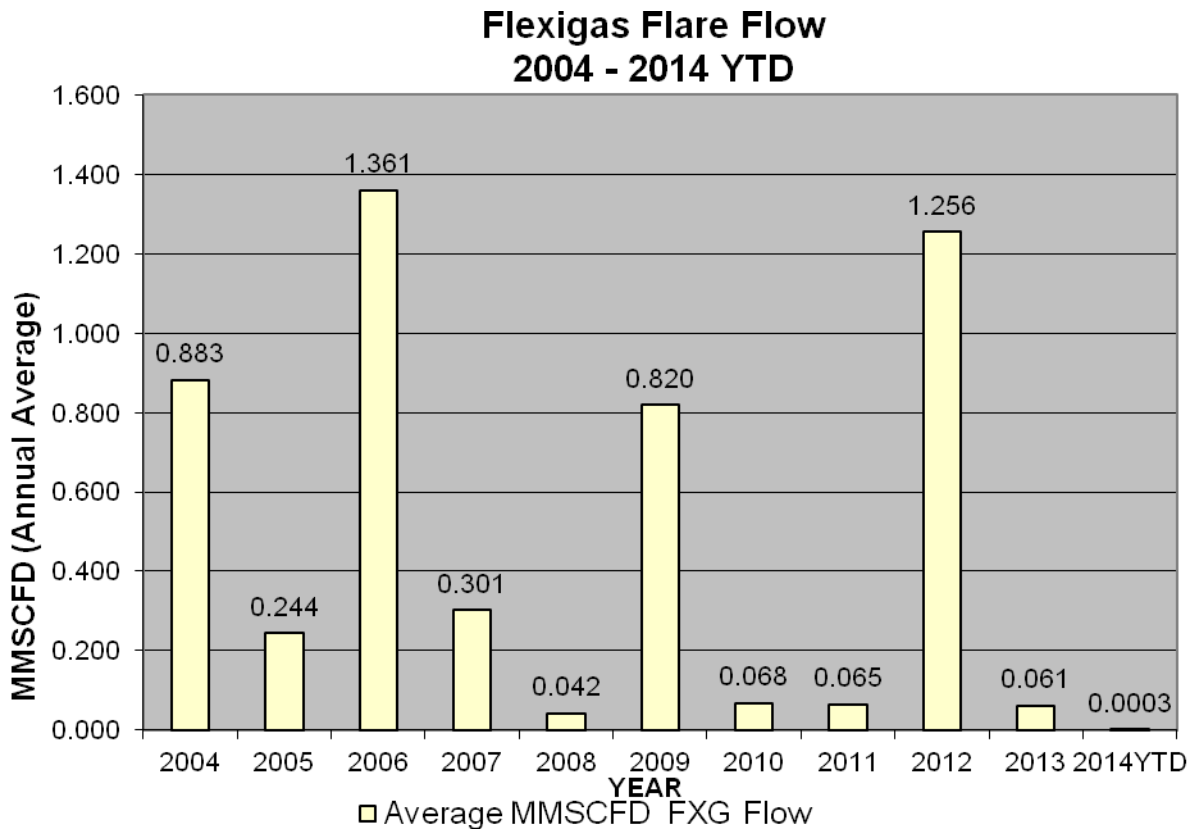
**FIGURE ES-2**

Figure ES-2 shows the annualized vent gas flow from the Flexigas flare. This figure shows an increase in Flexigas flaring during years with startup and shutdown of the Flexicoker due to the nature of the Flexicoking and Flexsorb processes. This flaring is of treated flexigas during startups and shutdowns of the Flexicoker is specifically allowed up to certain limits in Shell's Title V permit.

Other than startup and shutdown flaring, flexigas flaring can occur due to refinery fuel gas imbalance. Shell continues to fine-tune the Flexigas pressure control scheme to minimize flexigas flaring due to small imbalances in fuel gas. Recent improvements in this system, including addition of COGEN to the pressure control scheme, contribute to the very low flexigas flare rate experienced in 2013 and 2014.

The Flexigas Flare flow volume is displayed separately in ES-2. Flexigas is used as a supplemental refinery fuel gas in refinery process heaters. Flexigas is treated for sulfur removal in the Flexsorb Unit before being combusted either in the refinery process heaters or if necessary, in the flare. When FXG is flared, the volume of gas is typically large compared to the volume flared in the other refinery process flares, but emissions are significantly less because Flexigas contains very low concentrations of non-methane hydrocarbon and sulfur.

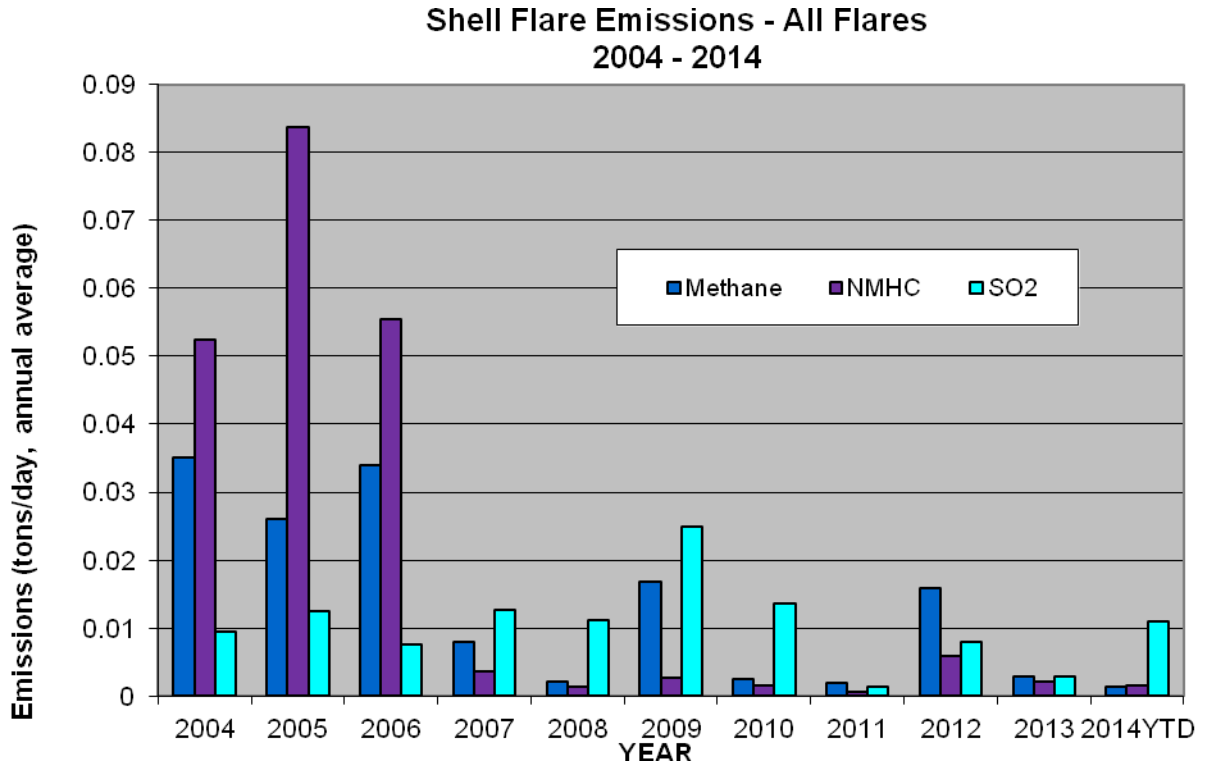
**FIGURE ES-3**

Figure ES-3 displays the methane, non-methane hydrocarbon and sulfur dioxide emissions from all four refinery process flares from 2004 through year-to-date.

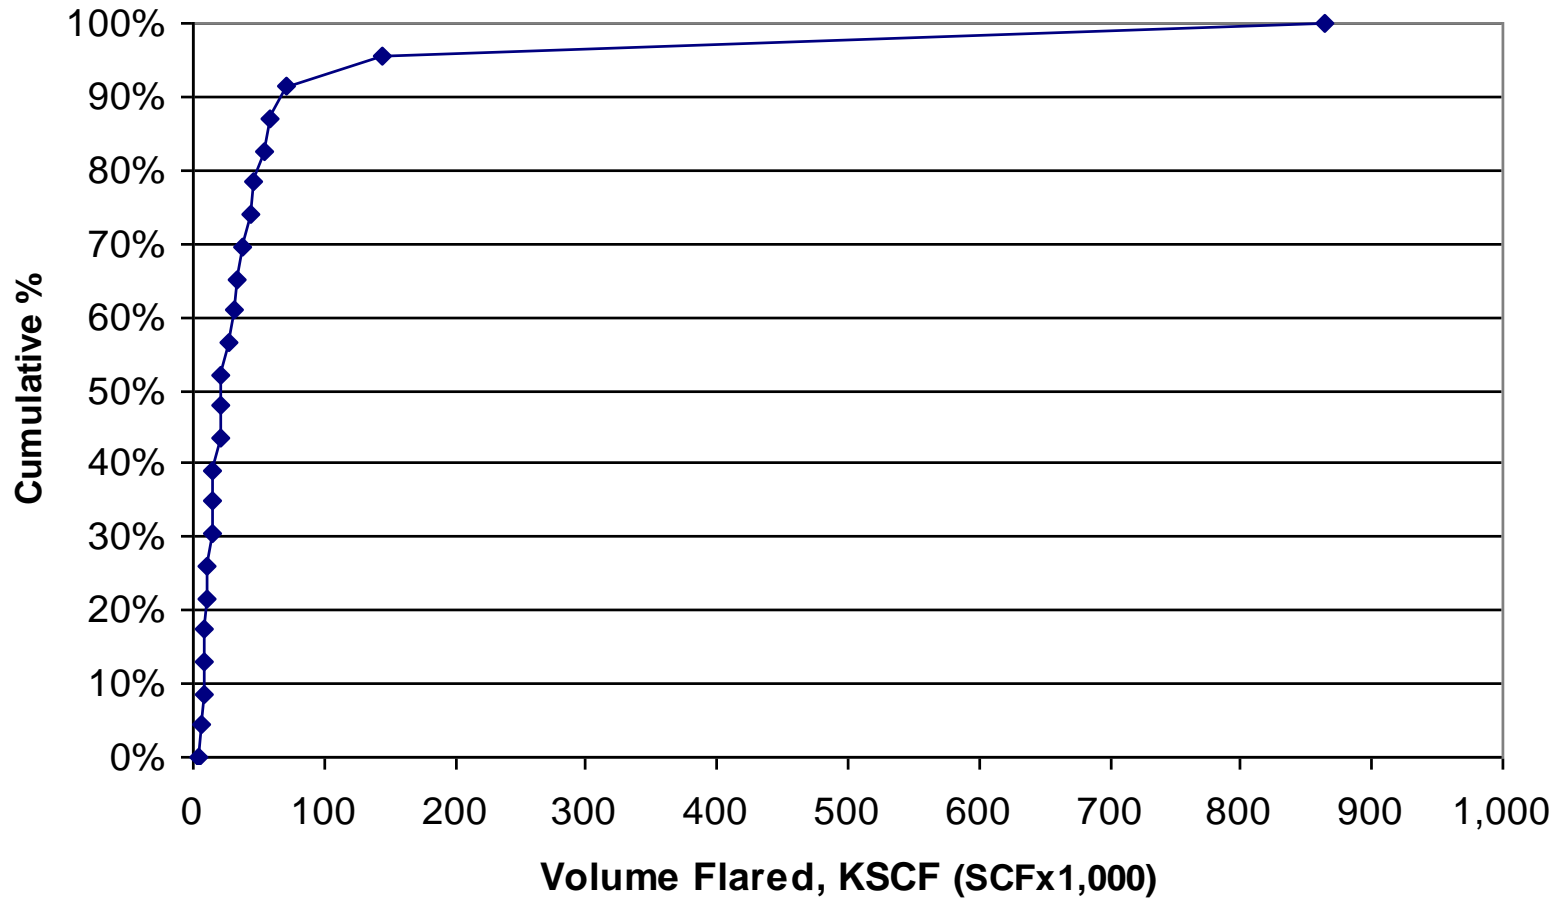
**Figure 3. LOP Flare Gas Volumes**  
(2005)

**Volumes flared:** Figure 3 depicts the amount of material flared during the 25 events occurring in 2005. Each point on this plot represents the total flare volume of gas during that event. The vertical axis is relative magnitude of that event compared with all events in the period. Based on this figure, ninety percent of the events had volumes less than 100 thousand standard cubic feet (MSCF) per event. Approximately five percent had volumes between 100 and 200 MSCF per event. A single emergency event resulted in flaring more than 500 MSCF.

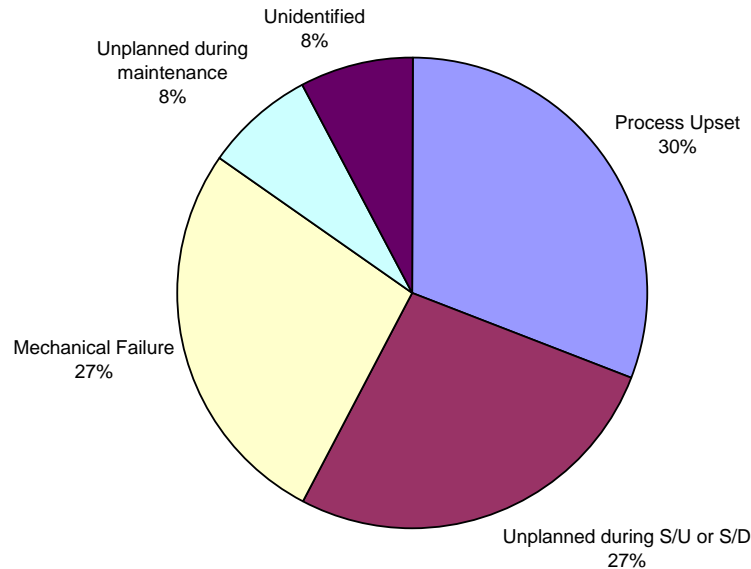
**FIGURE 2008 - 3**

The DCU flare events that occurred from 1/1/06 – 6/1/08 were categorized by probable cause in Figure 2008-3. None of the flaring was planned. Most of the events were < 10 minutes long. The majority of the events were caused by process upset, mechanical failure or were unplanned during startup and shutdowns.

**Probable Cause of Flaring on DCU Flare 1/1/06-6/1/08  
26 Events**
