Shell Martinez Refinery

Regulation 12 Rule 12

FLARE MINIMIZATION PLAN

Updated October 1, 2011

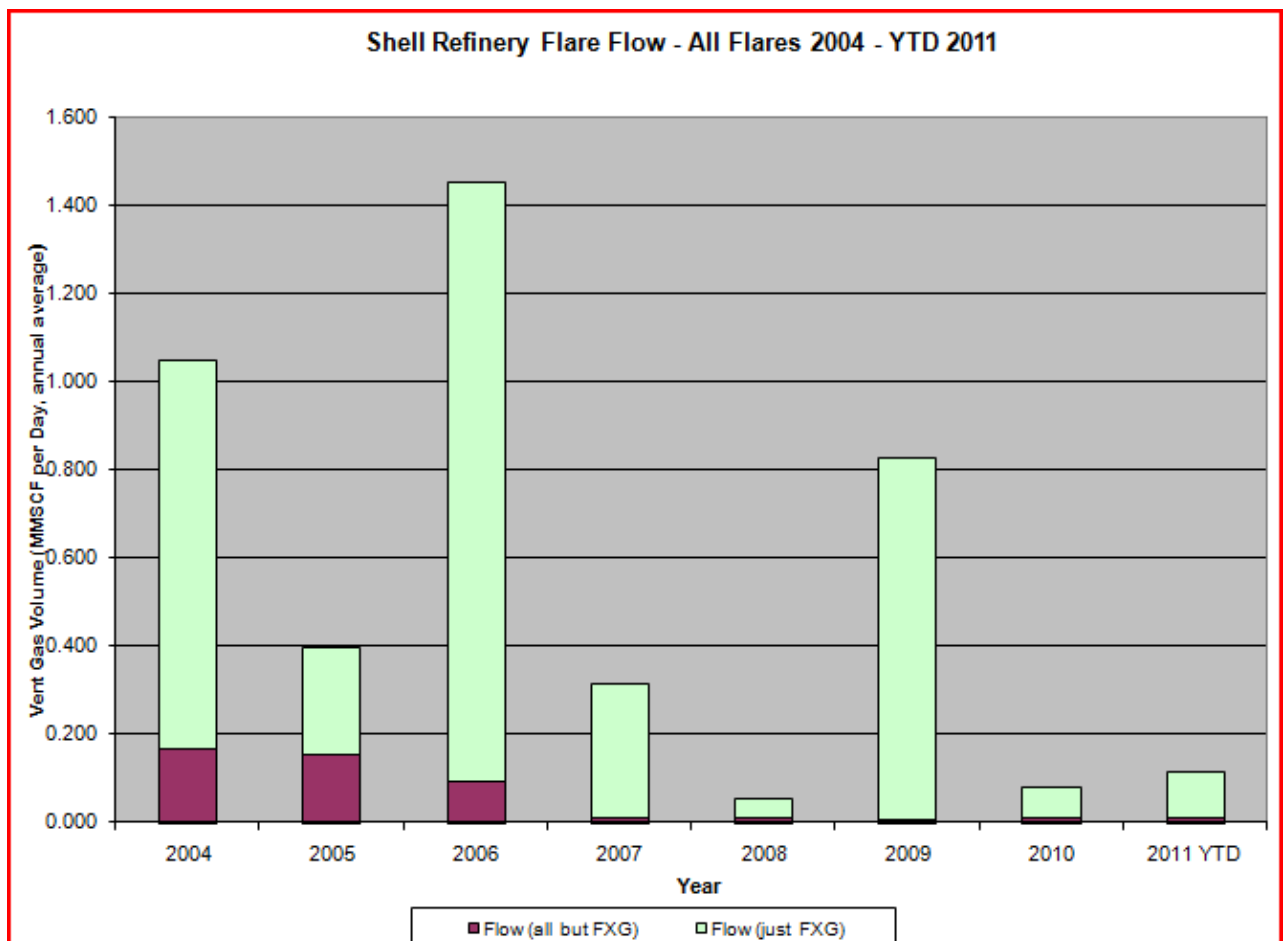
FIGURE ES-1

Figure ES -1 presents the annualized total flare flow from all of the process flares at the refinery from 2004 through June 30, 2011.

The Flexigas Flare volume is displayed separately from the rest of the combined refinery flares and is shown as the green portion of each bar. The Flexicoker produces a relatively large volume of FXG compared to regular refinery fuel gas. When FXG is flared, the volume of gas is typically

large compared to the volume flared in the other refinery process flares, but emissions are less because flexigas contains very low concentrations of non-methane hydrocarbon, methane and sulfur.

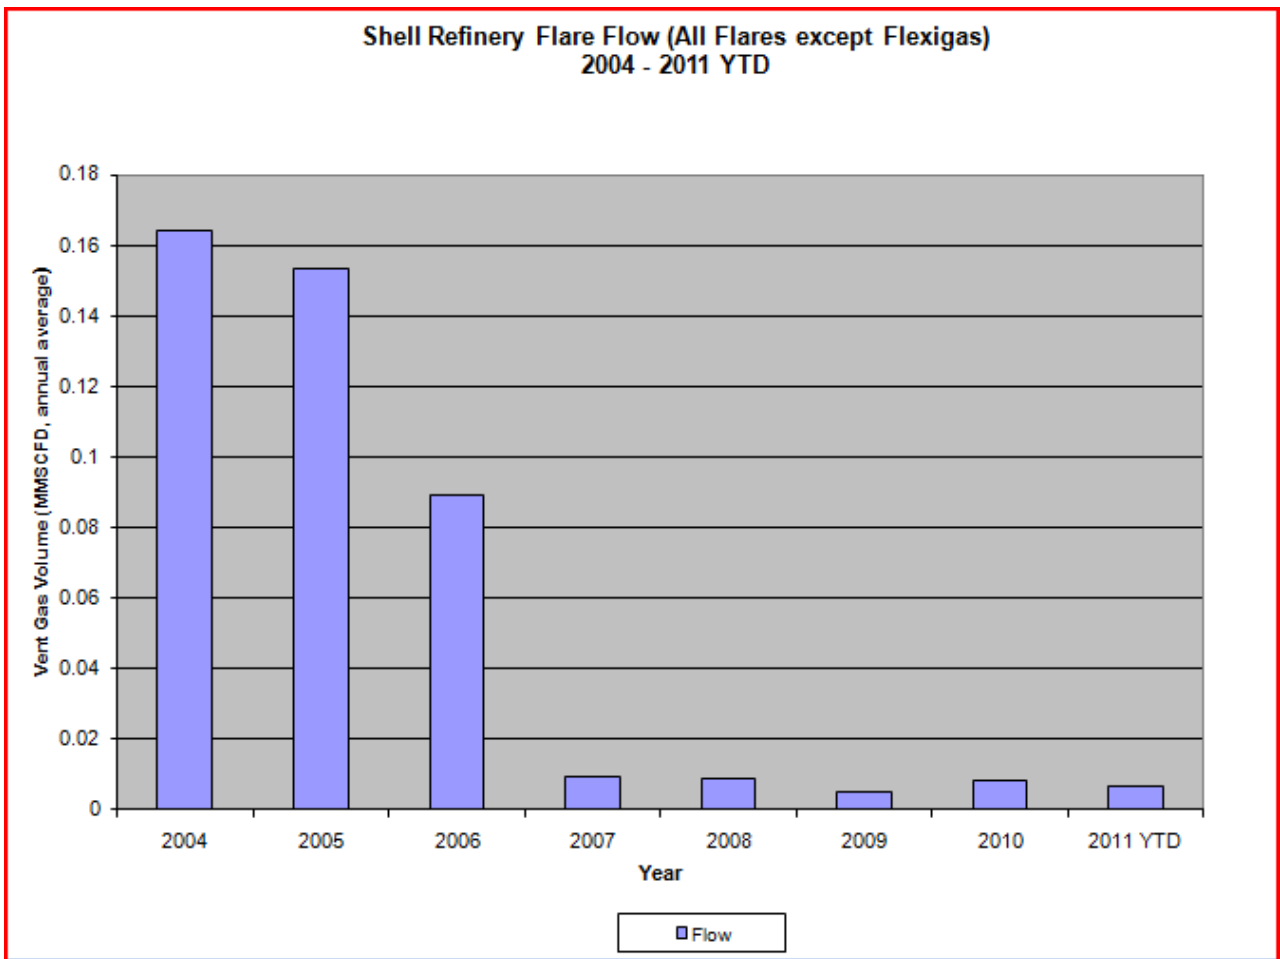
FIGURE ES-2

Figure ES-2 shows the annualized vent gas flow from all refinery process flares except for Flexigas. This figure shows continued improvement in flare reduction. In addition to the flaring reductions achieved in the past, a significant reduction in vent gas flaring occurred in late 2006 when the OPCEN hydrocarbon flare gas recovery system was started up.

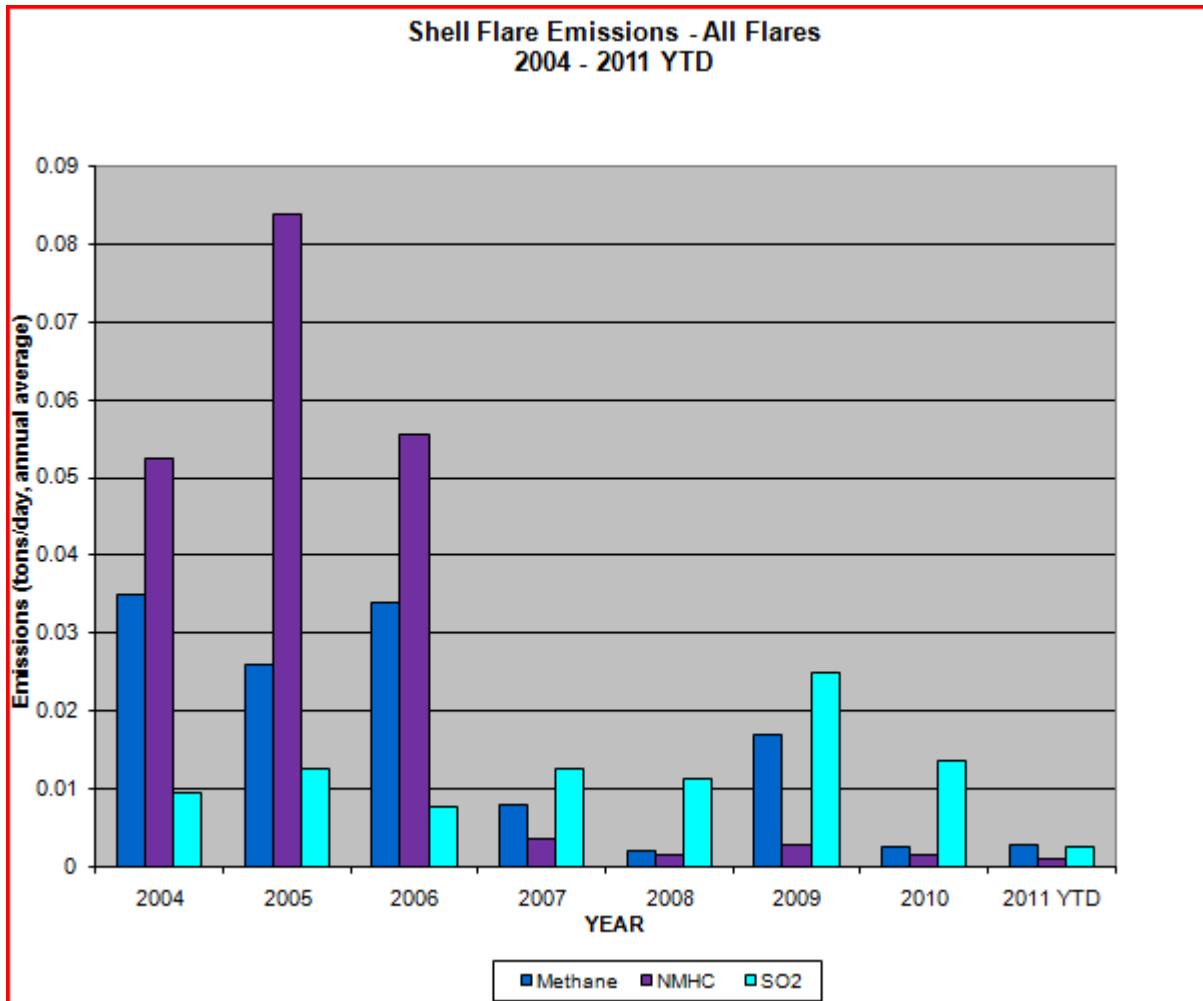
FIGURE ES-3

Figure ES-3 presents the flare emissions from all refinery flares combined from 2004 through year-to-date.

Figure ES-3 shows the significant reduction in emissions that has occurred since the implementation of the Flare Minimization Plan and in particular over the last few years. During the time period covered by this update, there were seven flaring events triggering causal analysis investigation (flaring > 0.5 MMSCF or 500 lbs of SO₂) on three of the four refinery process flares. All of the flaring events were managed per our flare procedures to minimize the amount of flaring and were in compliance with the requirements of BAAQMD Regulation 12 Rules 11 and 12 and Shell's Flare Minimization Plan.

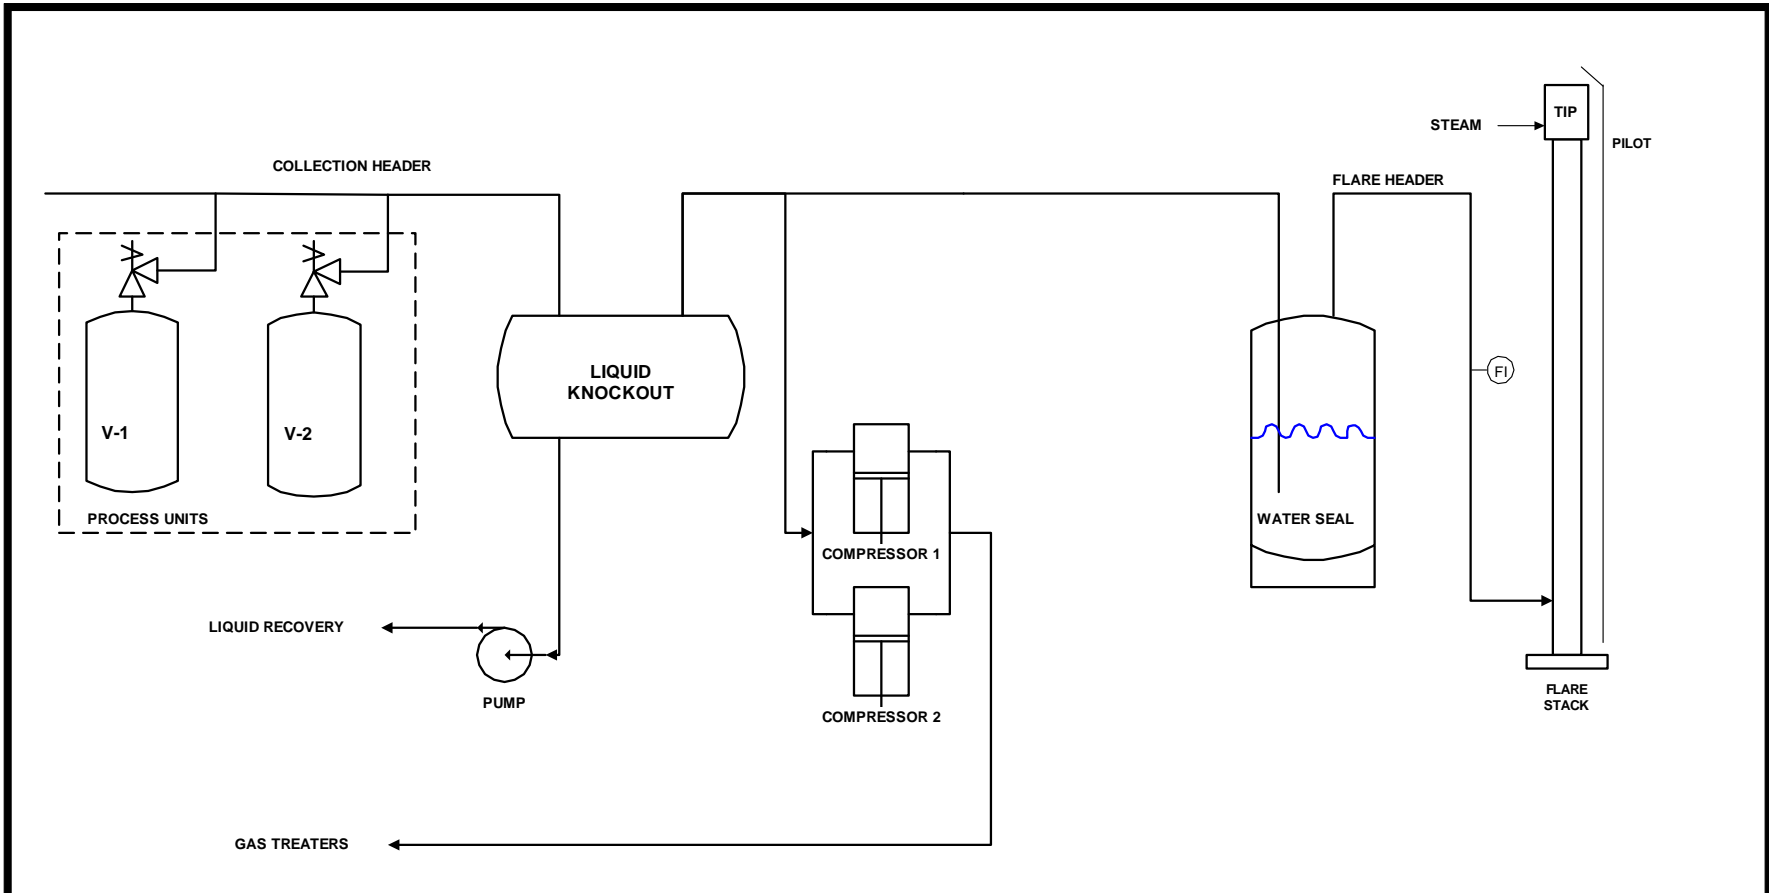
FIGURE 1. LOP AREA FLARE PROCESS SKETCH

The LOP Flare system is comprised of collection headers, liquid knockout vessels, two flare vapor recovery compressors, piping to route recovered gas to fuel gas treaters, a water seal vessel, the flare header proper, and the flare stack. The flare is an elevated, steam-assisted flare with nitrogen purge to prevent air intrusion. Piping provides sufficient flexibility to operate in various configurations, allowing continuous and reliable operation during turnarounds, inspection and maintenance activities. A sketch of the LOP Flare system is provided in Figure 1. Technical details of the system are provided in Appendix A².

Recovered flare gas is treated to remove hydrogen sulfide and condensable liquids. Treated gas is routed to the fuel gas system. The fuel gas treaters typically used for LOP recovered flare gas are located in the Catalytic Cracker Gas Plant (CGP). When this unit is unavailable for any reason, recovered gas may be routed to the Saturates Gas Plant (SGP). Sufficient capacity can be made available in both sets of treaters for the incremental flow up to the total capacity of both compressors of about 6.4 MMSCFD.

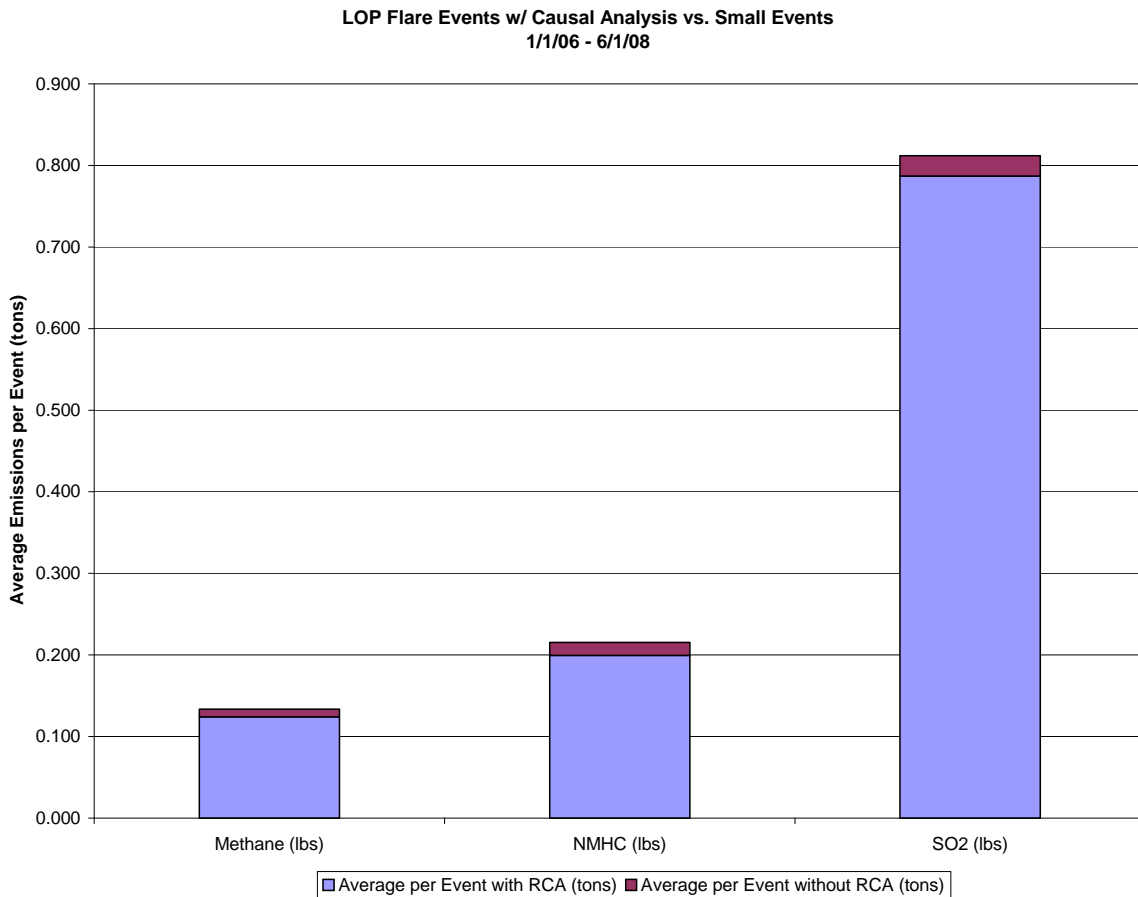
FIGURE 2008 –1

Beginning in November 2006 with the adoption of the Flare Procedures described in the Common Measures Section, pertinent information, when available, was captured immediately after a flaring event to determine the cause of any flaring and what could be done to prevent it from happening again. Total emissions from all flaring during the period from 12/1/06 through 6/1/08 were: 0.6 tons of methane, 0.99 tons of non-methane hydrocarbon and 2.5 tons of SO₂. Figure 2008-1 presents a comparison of the average emissions per large reportable events over this time period vs. the average emissions per small event. This figure shows that small events contributed on average < 10% of the emissions of a large event. Figure 2008-1 reinforces the appropriateness of the causal analysis trigger of 0.5 MMSCF/ 500 lbs SO₂ to ensure the resources to conduct a Causal Analysis are most effectively applied to address high emission events.

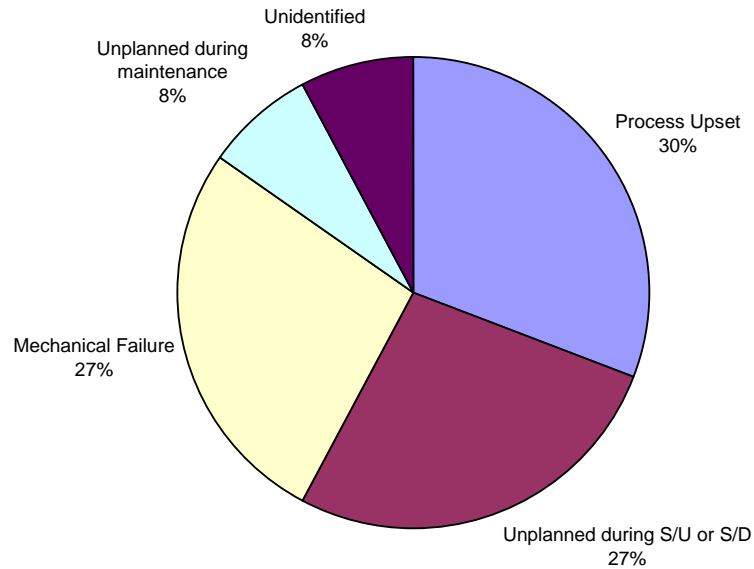
FIGURE 2008 - 3

The DCU flare events that occurred from 1/1/06 – 6/1/08 were categorized by probable cause in Figure 2008-3. None of the flaring was planned. Most of the events were < 10 minutes long. The majority of the events were caused by process upset, mechanical failure or were unplanned during startup and shutdowns.

**Probable Cause of Flaring on DCU Flare 1/1/06-6/1/08
26 Events**

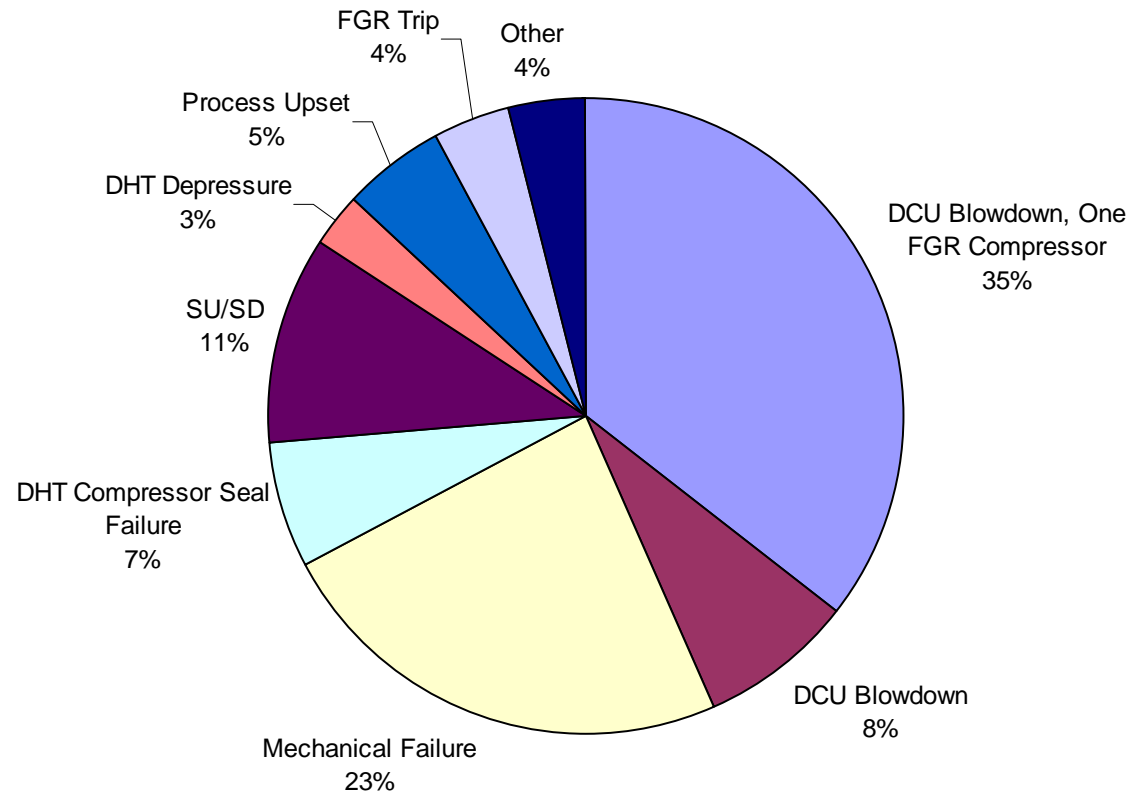
**Figure 8. Delayed Coking Area Flare Events
(2000 - 2005) 76 Events**

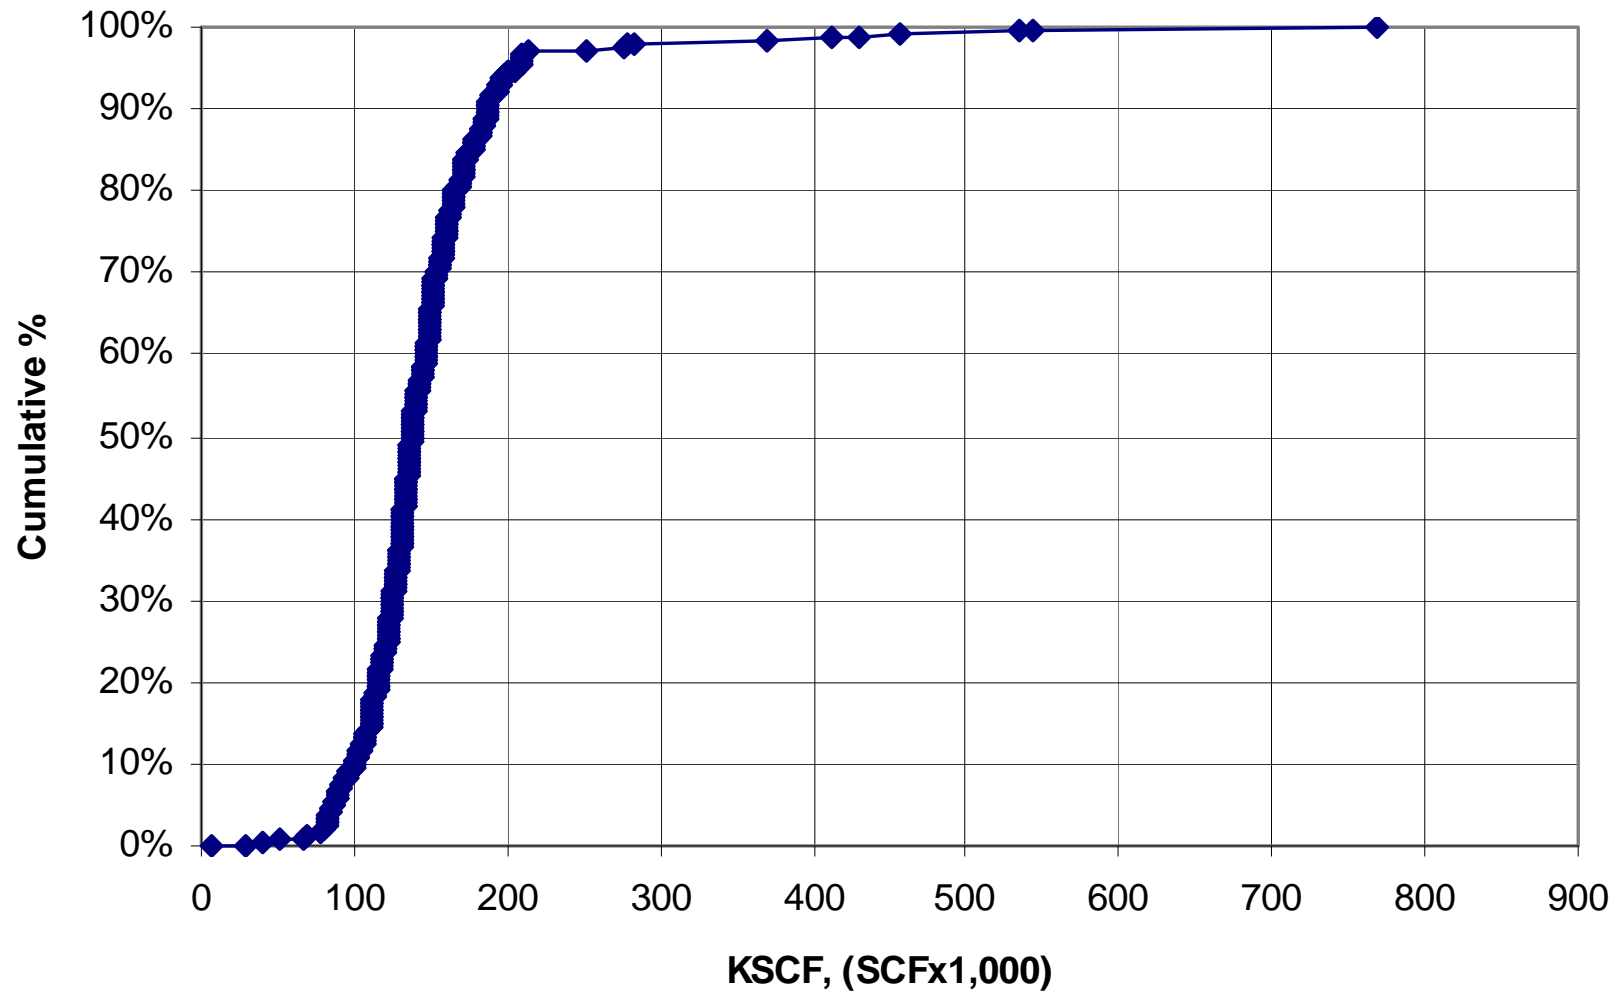
With historical performance profoundly biased by absence of flare gas recovery, this review concentrated on calendar year 2005. Flare data are depicted in Figure 13. Total emissions of non-methane hydrocarbon during 2005 were approximately 30 tons. Emissions of SO₂ in 2005 were 0.3 tons.

**Figure 13. OPCEN Hydrocarbon Flare Gas Volumes
(2005)**
