**Shell Martinez Refinery**

**Regulation 12 Rule 12**

**FLARE MINIMIZATION PLAN**

**Updated October 1, 2014**

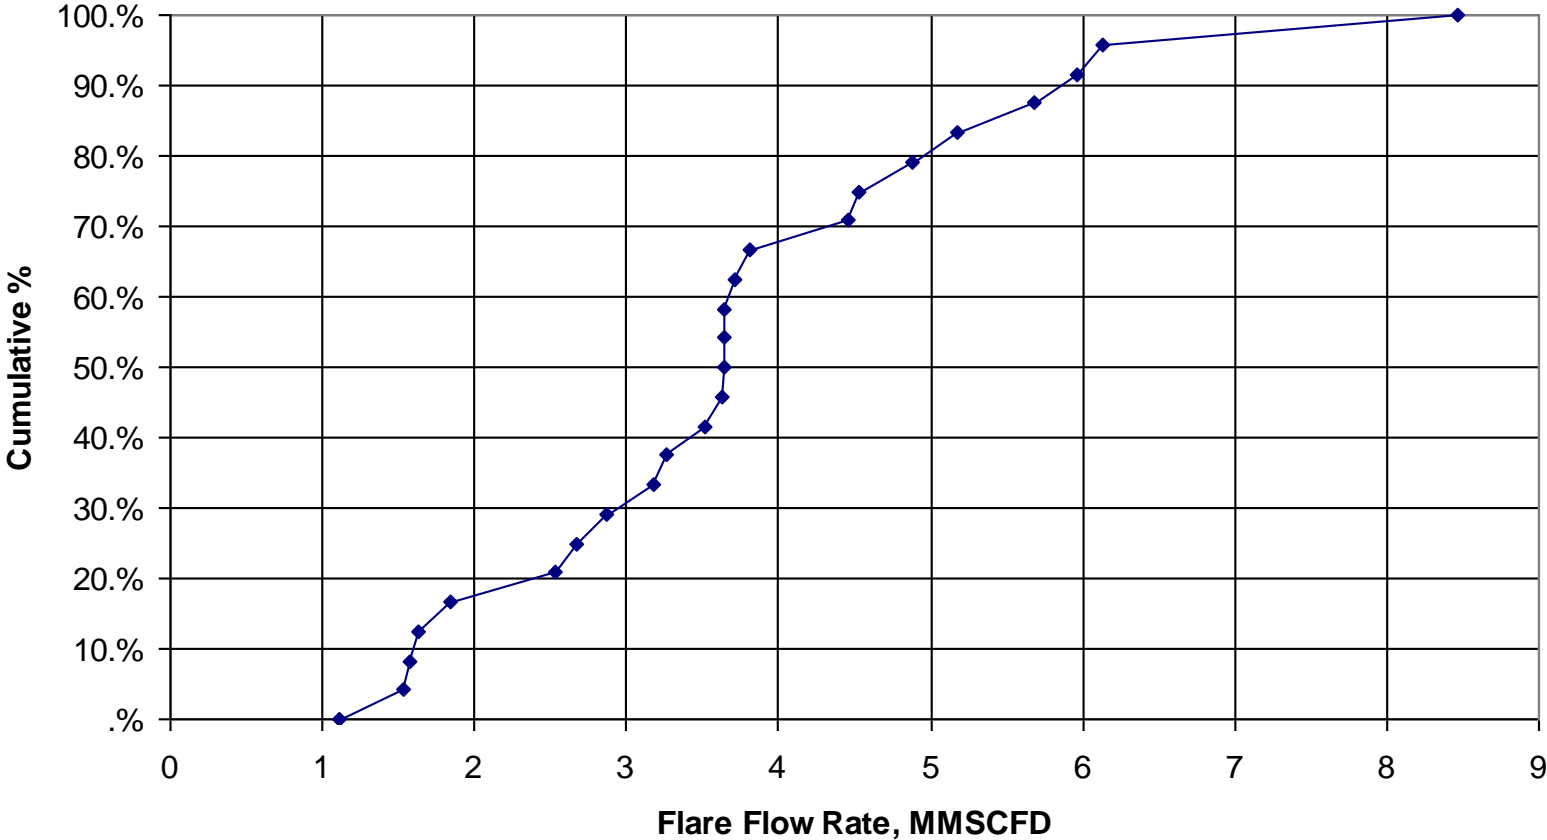
**Figure 4. LOP Flare Gas Flow Rates  
(2005)**

Figure 4 depicts the average rates of flow to the flare for events occurring in 2005. These data indicate that approximately 30% of the flare events had event-average flow rates of less than 3 million standard cubic feet per day. Actual instantaneous rates are generally higher – often significantly – than these average rates. This difference between the average rate for an event and instantaneous flare gas rate during an event is important because once the instantaneous rate exceeds the available compressor capacity the water seal is typically broken and flaring occurs. Once flaring begins, backpressure in the flare header provided by the water seal is significantly reduced. Due to the lower header pressure, flare gas recovery rates are typically significantly reduced from their rated capacity.

Data from Figure 4 were used to evaluate the leverage provided by additional flare gas recovery in LOP. As each increment of compressor capacity was added, the corresponding events with average flows within the newly revised total capacity were considered to be recovered rather than flared. Similarly, the reported emissions for these events were presumed not to occur. This provided the basis for emissions reductions as a function of compressor capacity.

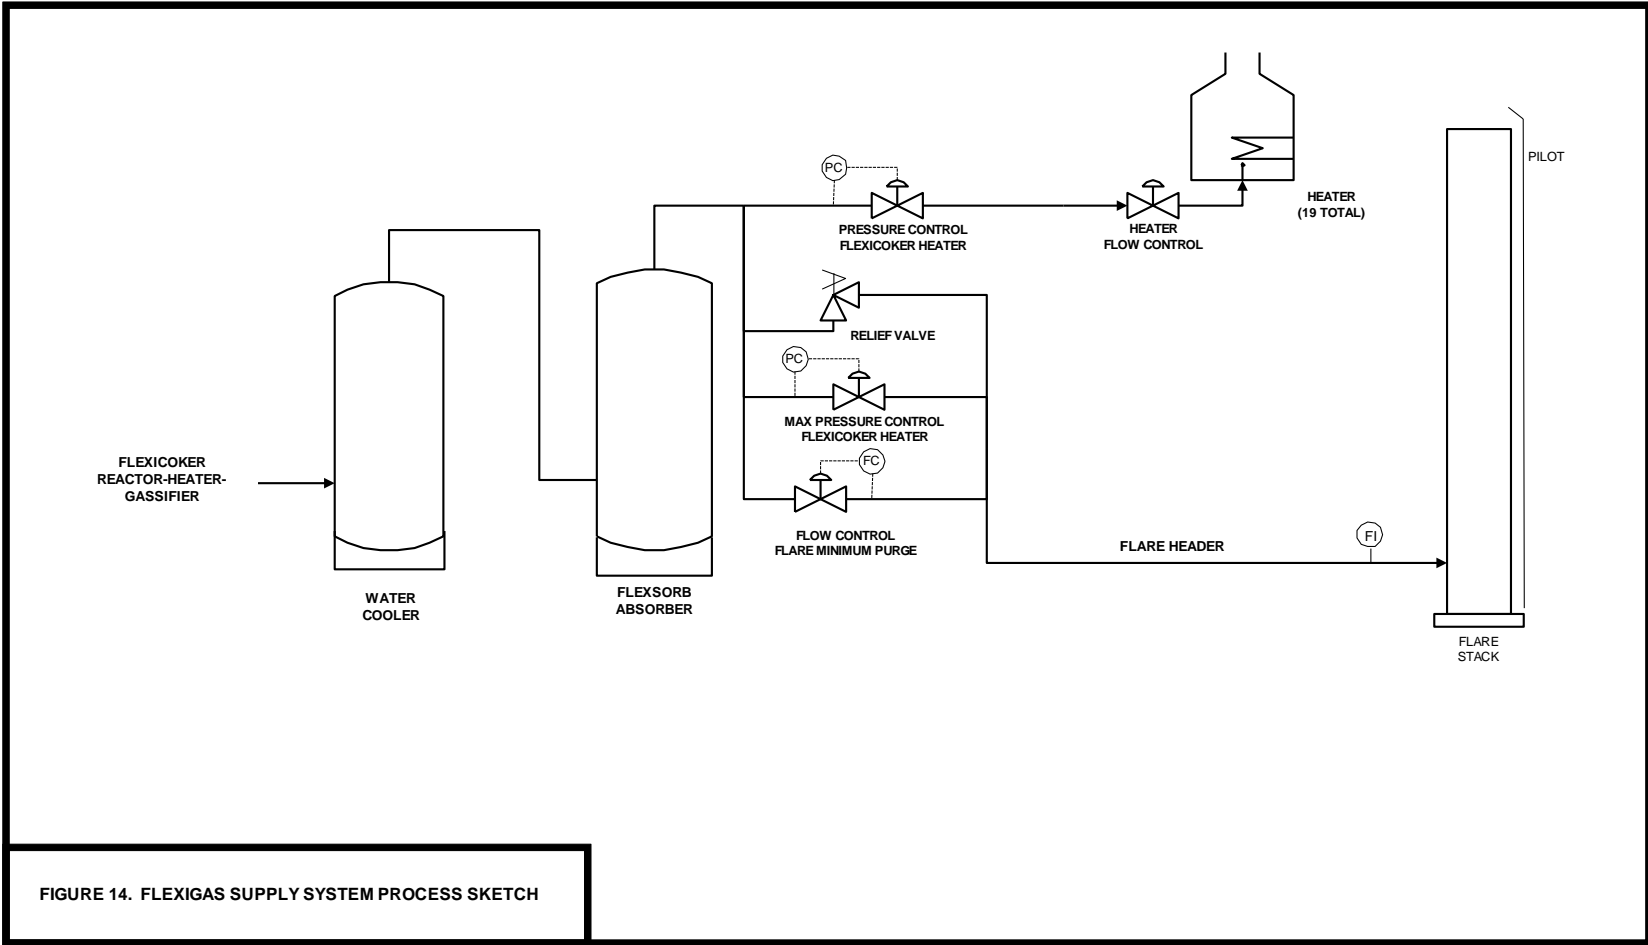
FIGURE 14. FLEXIGAS SUPPLY SYSTEM PROCESS SKETCH

The OPCEN Flexigas flare is a dedicated flare serving the Flexicoker Reactor/Heater/Gasifier. The Flexigas flare only combusts flexigas (FXG). This flare differs significantly from all other process flares serving Bay Area refineries for reasons described below. A simplified process sketch is provided in Figure 14. Details of the system are provided in Appendix D.
