Shell Martinez Refinery

FLARE MINIMIZATION PLAN

Updated October 1, 2017

Shell Oil Products US
Martinez Refinery
Martinez, California 94553
BAAQMD Plant No. A0011

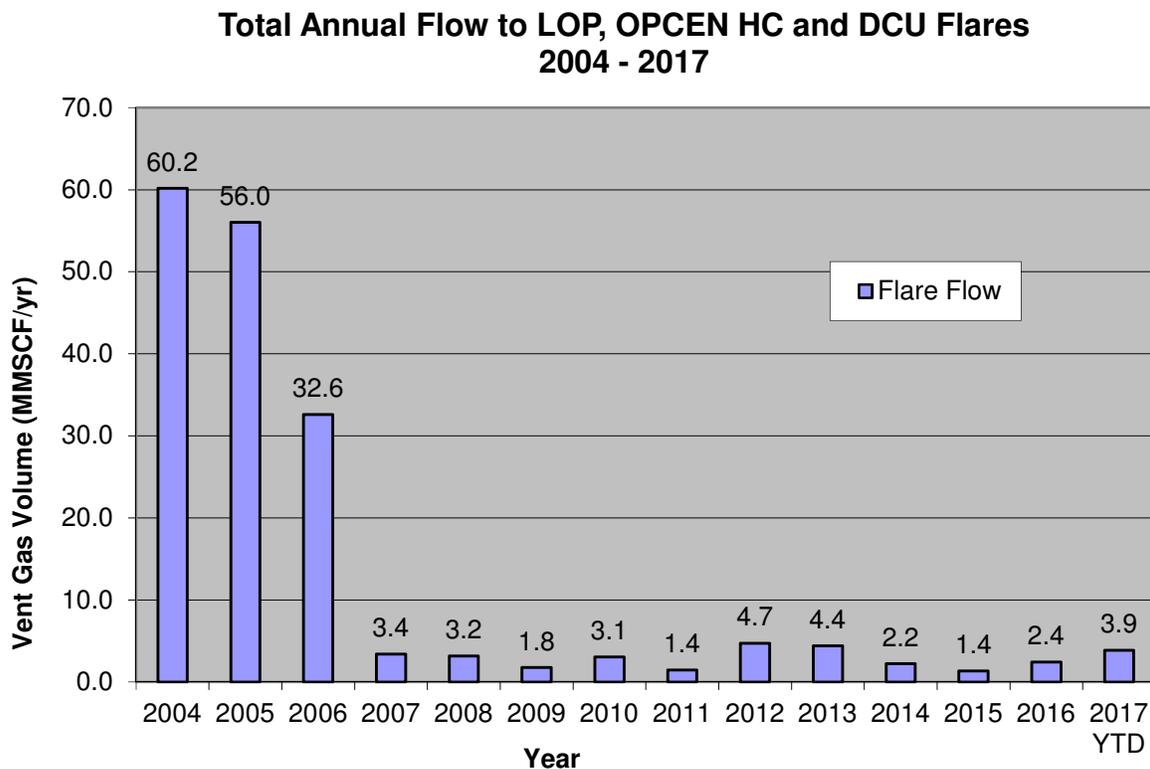
FIGURE ES-1

Figure ES-1 presents the total annual vent gas flow to the LOP, OPCEN Hydrocarbon and Delayed Coking (Clean Fuels) Flares at the refinery from 2004 through June 30, 2017. Flare flow continues to be very low.

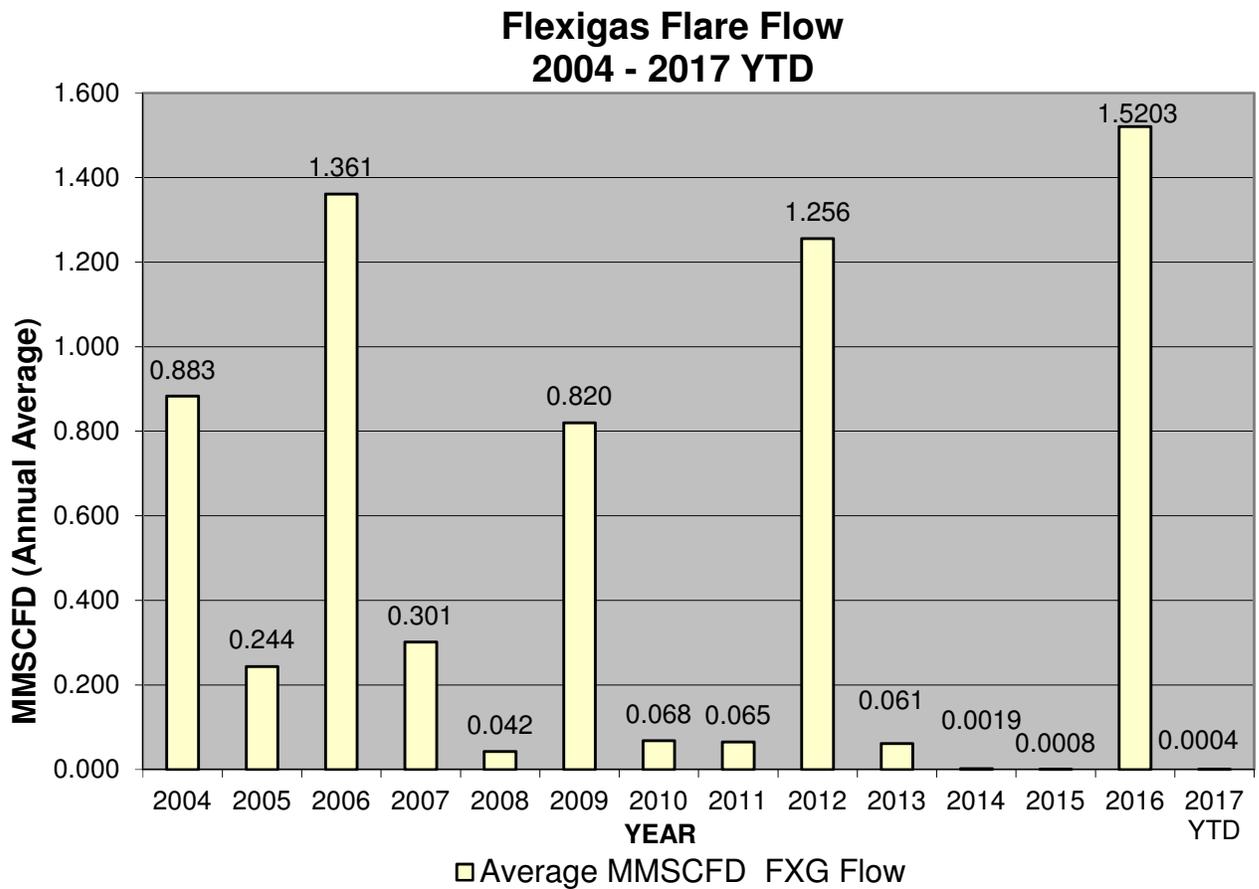
FIGURE ES-2

Figure ES-2 shows the annualized vent gas flow from the Flexigas flare. This figure shows a cyclic increase in Flexigas flaring which occurs during years with startup and shutdown of the Flexicoker due to the nature of the Flexicoking and Flexsorb processes. The flaring of treated flexigas during startups and shutdowns of the Flexicoker is allowed up to specified limits in Shell's Title V permit. Flexigas is a very low BTU gas used as a supplemental refinery fuel gas in refinery process heaters. Flexigas is treated for sulfur removal in the Flexsorb Unit before being combusted either in refinery

process heaters or if necessary, in the Flexigas flare. When FXG is flared, the volume of gas is typically large compared to the volume flared in the other refinery process flares, but emissions are significantly less because Flexigas contains very low concentrations of non-methane hydrocarbon and sulfur.

Flexigas flaring can also occur due to refinery fuel gas imbalance. Shell continues to fine-tune the Flexigas pressure control scheme to minimize flexigas flaring due to small imbalances in fuel gas. Improvements in this system, most notably addition of COGEN to the pressure control scheme, contribute to the very low flexigas flare flow rate seen in non-turnaround years including 2013, 2014, 2015 and 2017.

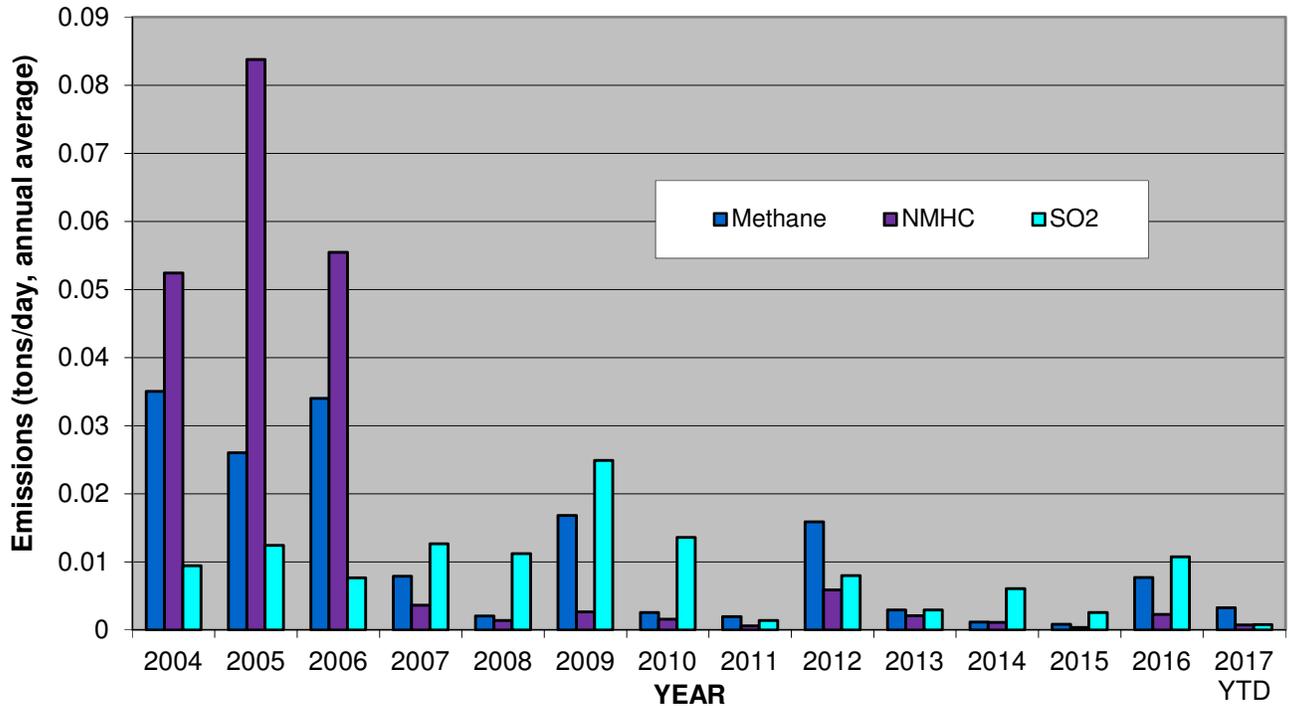
FIGURE ES-3

Figure ES-3 shows the methane, non-methane hydrocarbon and sulfur dioxide emissions from all four refinery process flares from 2004 through June 30 of this year.

**Shell Flare Emissions - All Flares
2004 - 2017 YTD**

Figure ES-3 shows the significant reduction in emissions that has occurred since the implementation of the Flare Minimization Plan in 2006 and highlights that even with large volumes of flexigas flaring during turnaround years, overall emissions from flaring are very low.

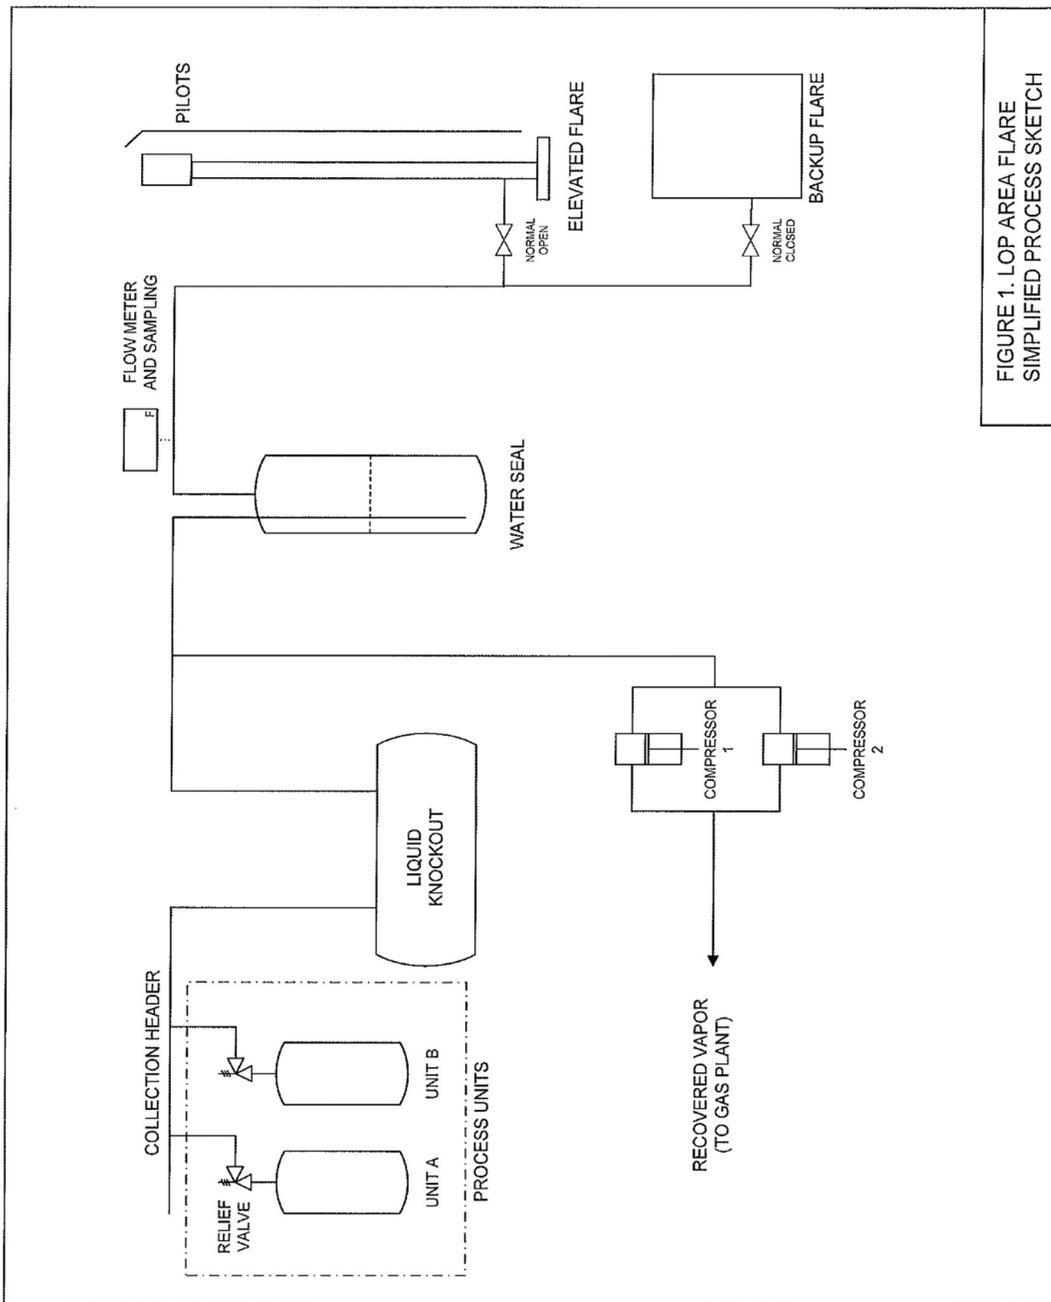
FIGURE 1. LOP AREA FLARE SIMPLIFIED PROCESS SKETCH

Recovered flare gas is treated to remove hydrogen sulfide and condensable liquids. Treated gas is routed to the fuel gas system. The fuel gas treaters typically used for LOP recovered flare gas are located in the Catalytic Cracker Gas Plant (CGP). When this unit is unavailable for any reason, recovered gas may be routed to the Saturates Gas Plant (SGP). Sufficient capacity can be made available in both sets of treaters for the incremental flow up to the total capacity of both compressors of about 6.4 MMSCFD.

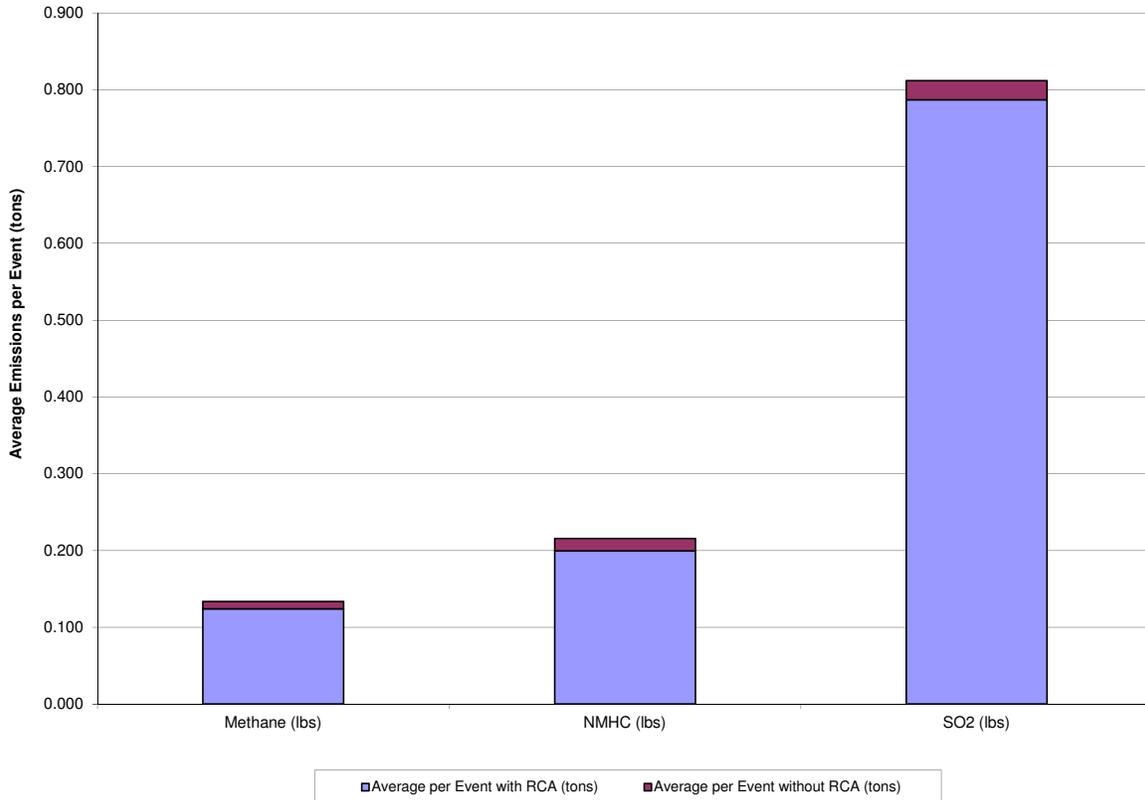
FIGURE 2008 –1

Beginning in November 2006 with the adoption of the Flare Procedures described in the Common Measures Section, pertinent information, when available, was captured immediately after a flaring event to determine the cause of any flaring and what could be done to prevent it from happening again. Total emissions from all flaring during the period from 12/1/06 through 6/1/08 were: 0.6 tons of methane, 0.99 tons of non-methane hydrocarbon and 2.5 tons of SO₂. Figure 2008-1 presents a comparison of the average emissions per large reportable events over this time period vs. the average emissions per small event. This figure shows that small events contributed on average < 10% of the emissions of a large event. Figure 2008-1 reinforces the appropriateness of the causal analysis trigger of 0.5 MMSCF/ 500 lbs SO₂ to ensure the resources to conduct a Causal Analysis are most effectively applied to address high emission events.

LOP Flare Events w/ Causal Analysis vs. Small Events
1/1/06 - 6/1/08

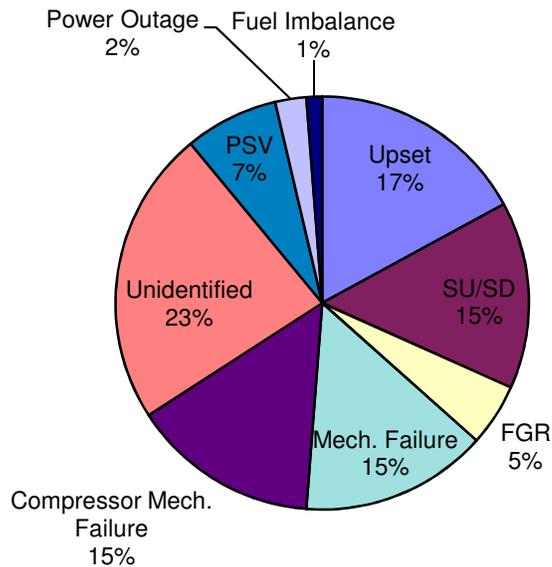
**Figure 2. LOP Area Flare Events
(2000-2005)**

Flaring prior to January 2004. Review of flare events prior to January 2004 provided little usable information. Without flow meters, neither durations nor volumes could be accurately determined. In many cases, even the proximate cause of flaring could not be reliably determined due to the limited documentation and time elapsed since the event. With these qualifications, a breakdown of the general cause of LOP flare events for the previous five years is depicted in Figure 2. A description of the various categories listed is provided below:

Based on these data, about 65% of the flare events occurring from 2000 - 2005 are essentially evenly divided among the following categories: process upsets, process startup and shutdowns, mechanical failures of compressors and other equipment. Almost one quarter of the time the occurrences where the water seal was broken indicating that flaring occurred were so small, and of such brief duration, no cause could be reliably determined.

Figure 2 illustrates that there are a wide range of events that can cause flaring at LOP. The annual volume of gas flared could be reduced in two basic ways. One alternative is an increase in the capacity of the flare gas recovery system. The second is improved measures to limit the rate and volume of gas discharged to the flare gas header so that it does not exceed the capacity of the existing recovery system. These two alternative approaches are discussed below.

Figure 2 shows that activities that have occurred during startups and shutdowns have contributed to less than 15% of the flare events that occurred historically at the LOP flare. Analysis of the flaring back to 2005 indicate that flaring may have been prevented by changing operating practices, improved planning, or minor hardware revisions. The trend over the past years indicates that startup, shutdowns and maintenance-related flaring can be significantly reduced and largely eliminated with careful planning. Major turnarounds on units served by the LOP flare continue to be performed without planned flaring. That this work was performed without flaring is evidence of careful review and planning. We commit to continue this careful review and planning prior to planned major maintenance and expect to perform turnarounds with little or no planned flaring. If during the maintenance planning and review process we find that planned flaring is required, as was the case when preparing for the LOP flare pressure vessel inspections, then all appropriate prevention measures will be considered and feasible measures will be implemented to reduce or eliminate the planned flaring.

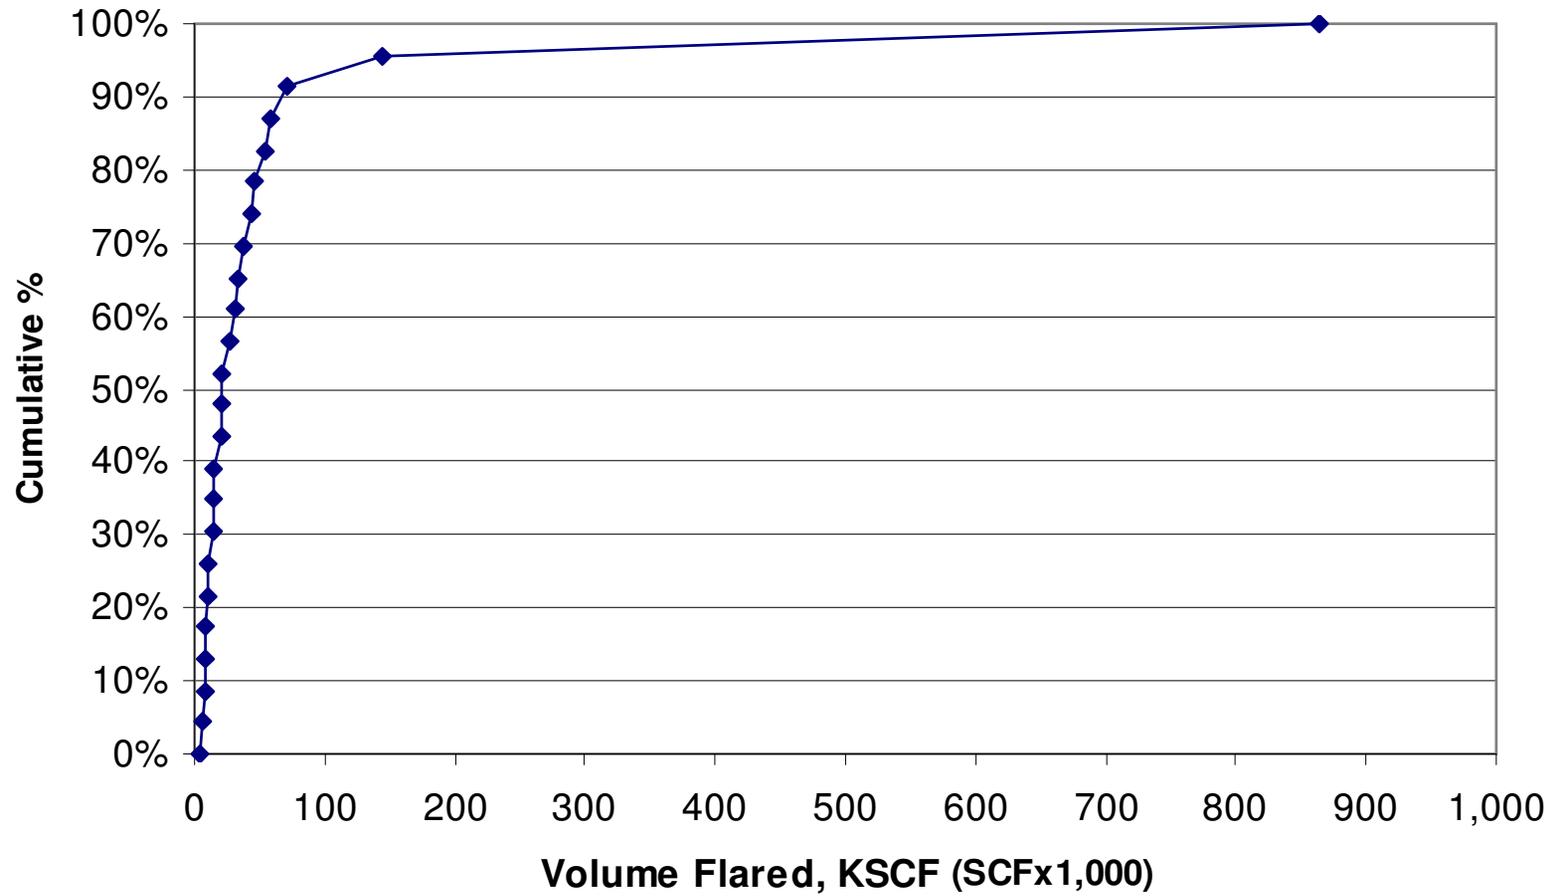
Figure 3. LOP Flare Gas Volumes
(2005)

Volumes flared: Figure 3 depicts the amount of material flared during the 25 events occurring in 2005. Each point on this plot represents the total flare volume of gas during that event. The

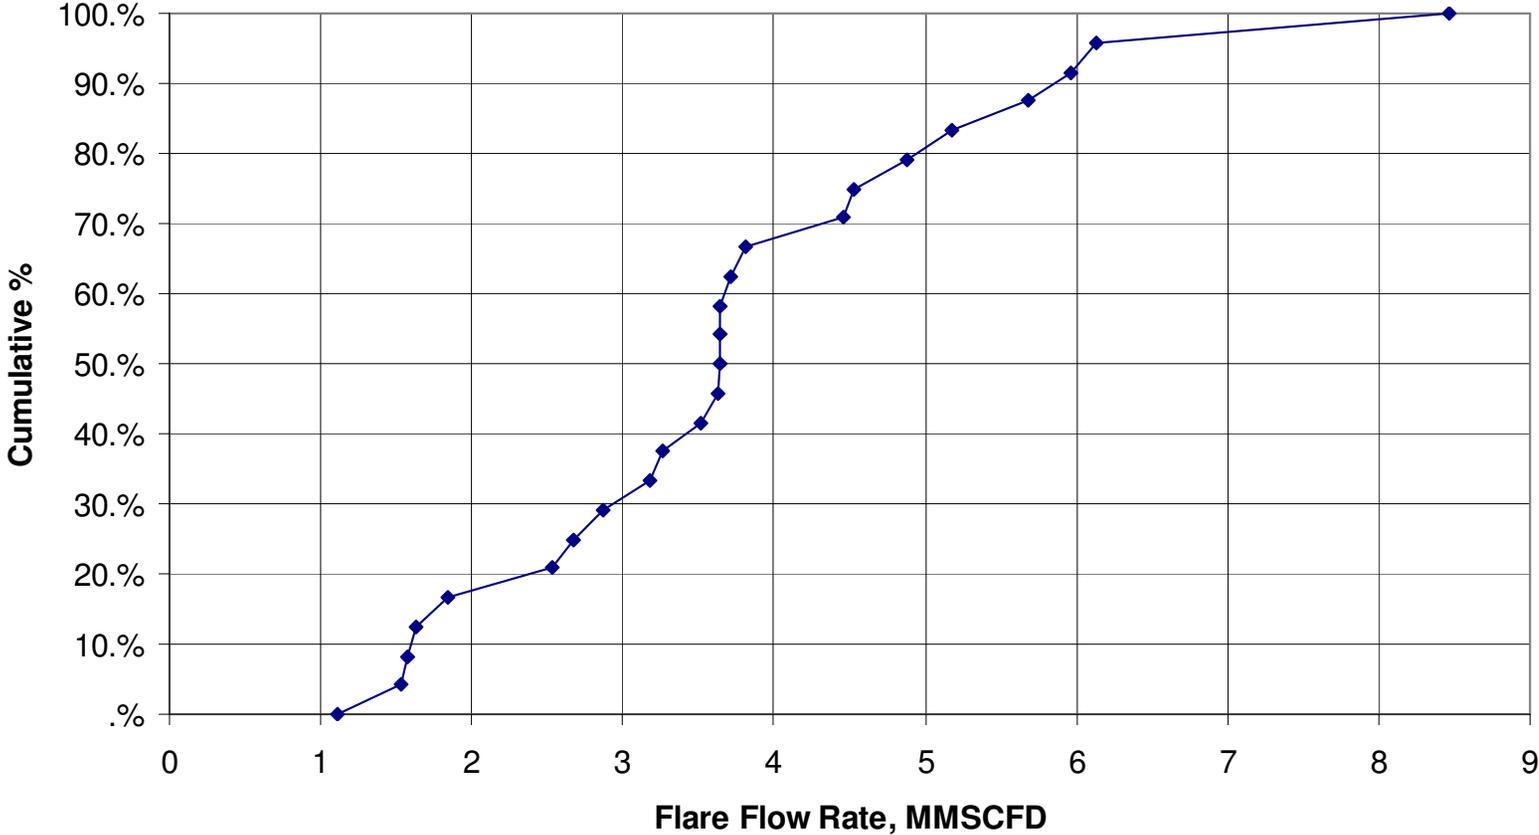
**Figure 4. LOP Flare Gas Flow Rates
(2005)**

Figure 4 depicts the average rates of flow to the flare for events occurring in 2005. These data indicate that approximately 30% of the flare events had event-average flow rates of less than 3 million standard cubic feet per day. Actual instantaneous rates are generally higher – often significantly – than these average rates. This difference between the average rate for an event and instantaneous flare gas rate during an event is important because once the instantaneous rate exceeds the available compressor capacity the water seal is typically broken and flaring occurs. Once flaring begins, backpressure in the flare header provided by the water seal is significantly reduced. Due to the lower header pressure, flare gas recovery rates are typically significantly reduced from their rated capacity.

Data from Figure 4 were used to evaluate the leverage provided by additional flare gas recovery in LOP. As each increment of compressor capacity was added, the corresponding events with average flows within the newly revised total capacity were considered to be recovered rather than flared. Similarly, the reported emissions for these events were presumed not to occur. This provided the basis for emissions reductions as a function of compressor capacity.

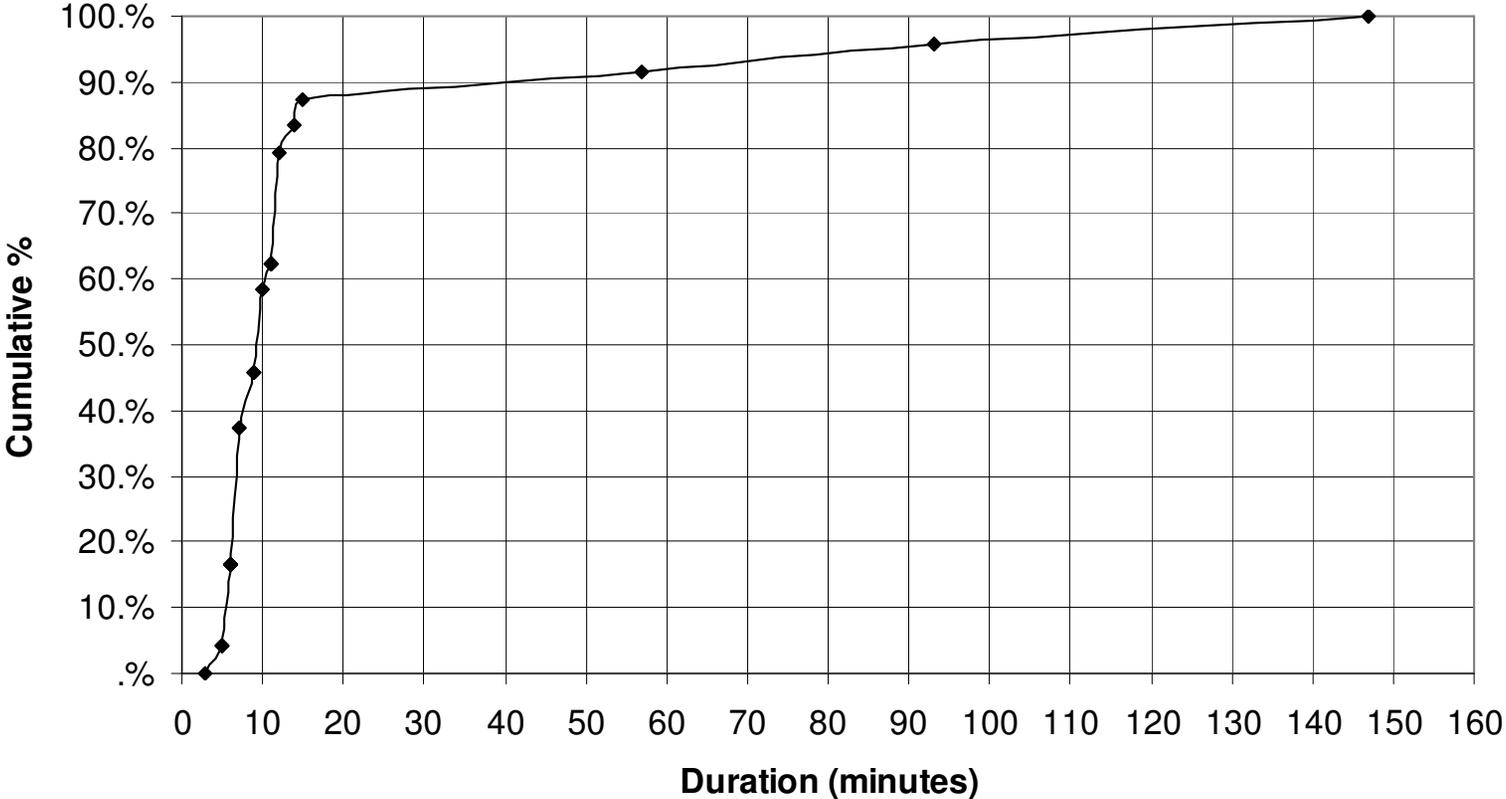
Figure 5. LOP Flare Durations
(2005 - 25 Events)

An additional consideration is that the brief duration of many flare events makes it more difficult to determine their cause. Often excess flow to the flare gas header has stopped before significant troubleshooting activity can be undertaken to determine its source.

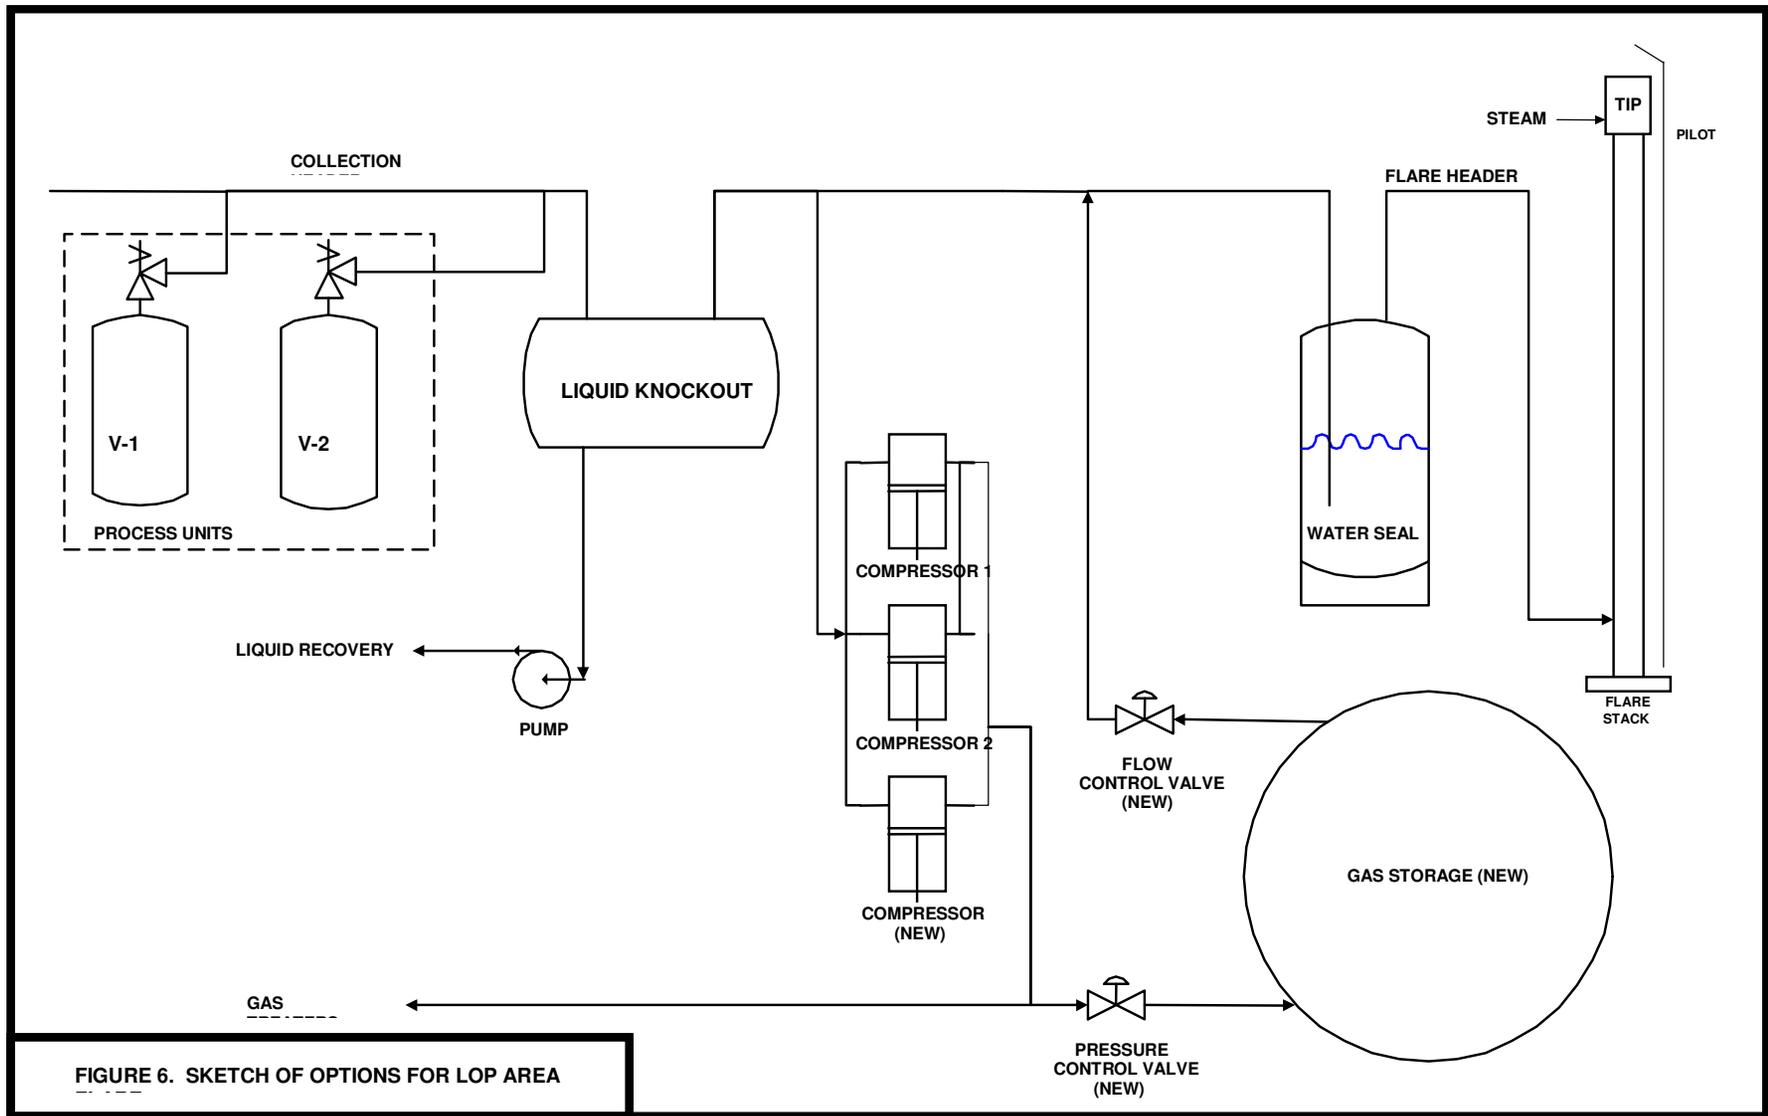
FIGURE 6. SKETCH OF OPTIONS FOR LOP AREA

Prevention Measure Options Considered for Recovery, Storage and Treatment: Costs and potential benefits of improving gas recovery and reducing flare emissions from the current 99.7% recovery efficiency are addressed by considering the addition of flare gas recovery compression and flare gas storage. Gas treating capacity is expected to be adequate for all options evaluated. A sketch of the potential options is provided in Figure 6.

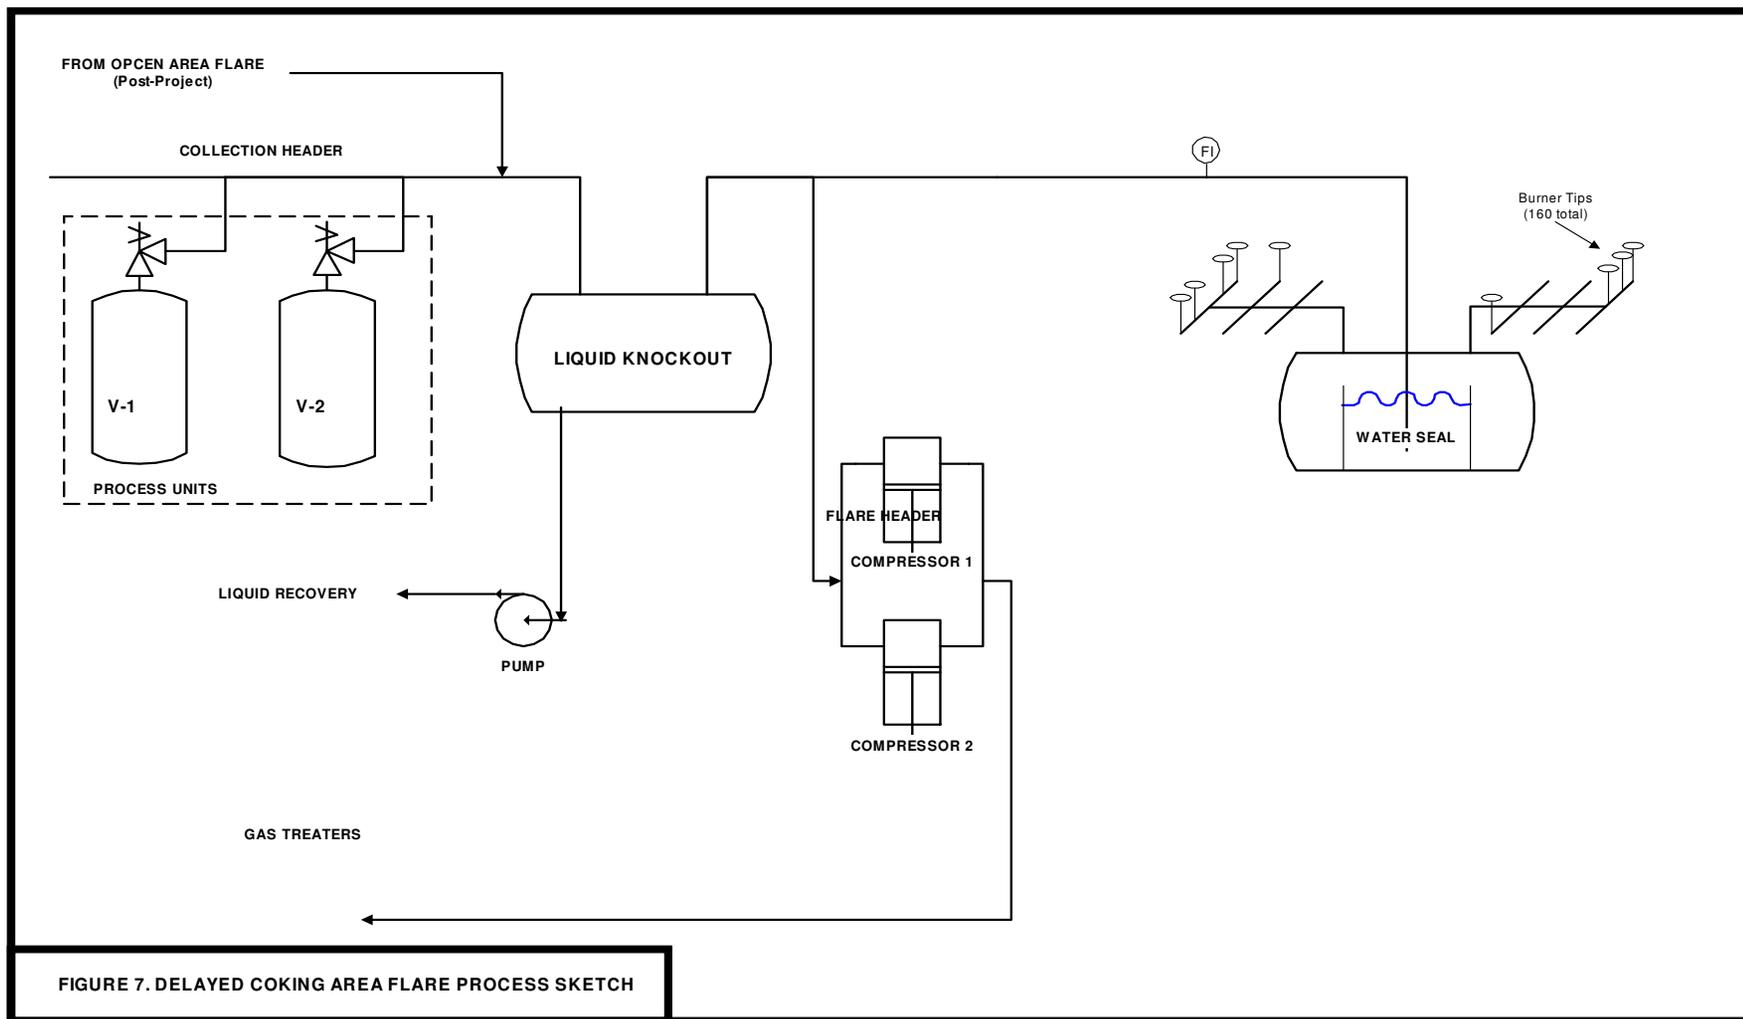
Recovered gas from the Delayed Coking and OPCEN HC flare headers is treated to remove sulfur in the Vent Gas Treater in Delayed Coking. Sufficient capacity is available in this gas treater for the incremental flow (up to the total capacity of about 8 MMSCFD). From the Vent Gas Treater, the treated gases may be routed to the refinery fuel gas blend drum for use as fuel in combustion devices throughout the refinery. In addition, the treated gas from the Vent Gas Treater may be used as feed to Hydrogen Plants 2 and 3. Having the option of using the treated fuel gas as feed to the hydrogen plants or fuel for heaters throughout the refinery increases the flexibility of the fuel gas system, reducing the potential for fuel gas imbalance that may cause flaring.

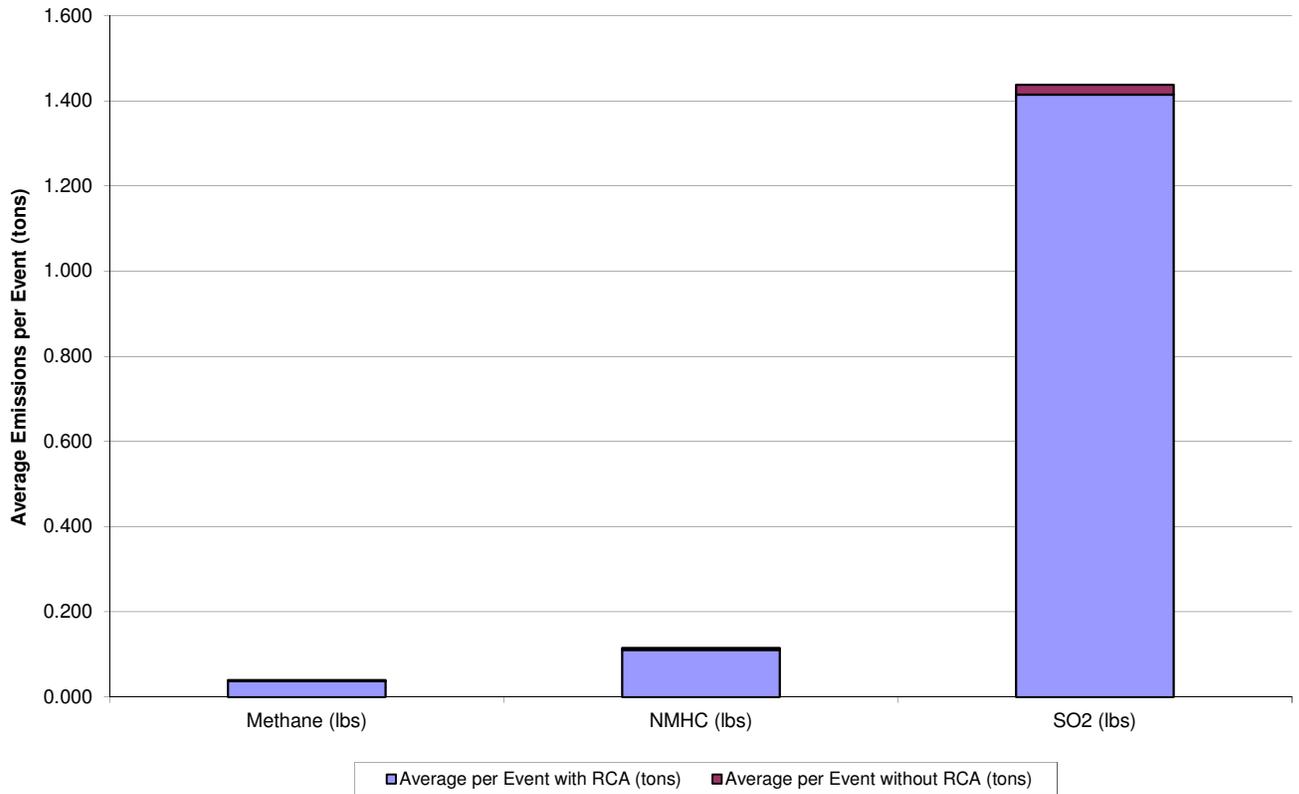
FIGURE 2008-2

**DCU Flare Events w/ Causal Analysis vs. Small Events
1/1/06 - 6/1/08 Without Causal Analysis**

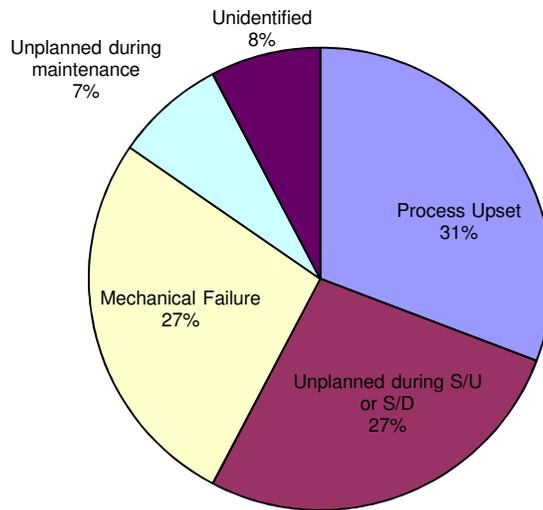
FIGURE 2008 - 3

The DCU flare events that occurred from 1/1/06 – 6/1/08 were categorized by probable cause in Figure 2008-3. None of the flaring was planned. Most of the events were < 10 minutes long. The majority of the events were caused by process upset, mechanical failure or were unplanned during startup and shutdowns.

**Probable Cause of Flaring on DCU Flare 1/1/06-6/1/08
26 Events**

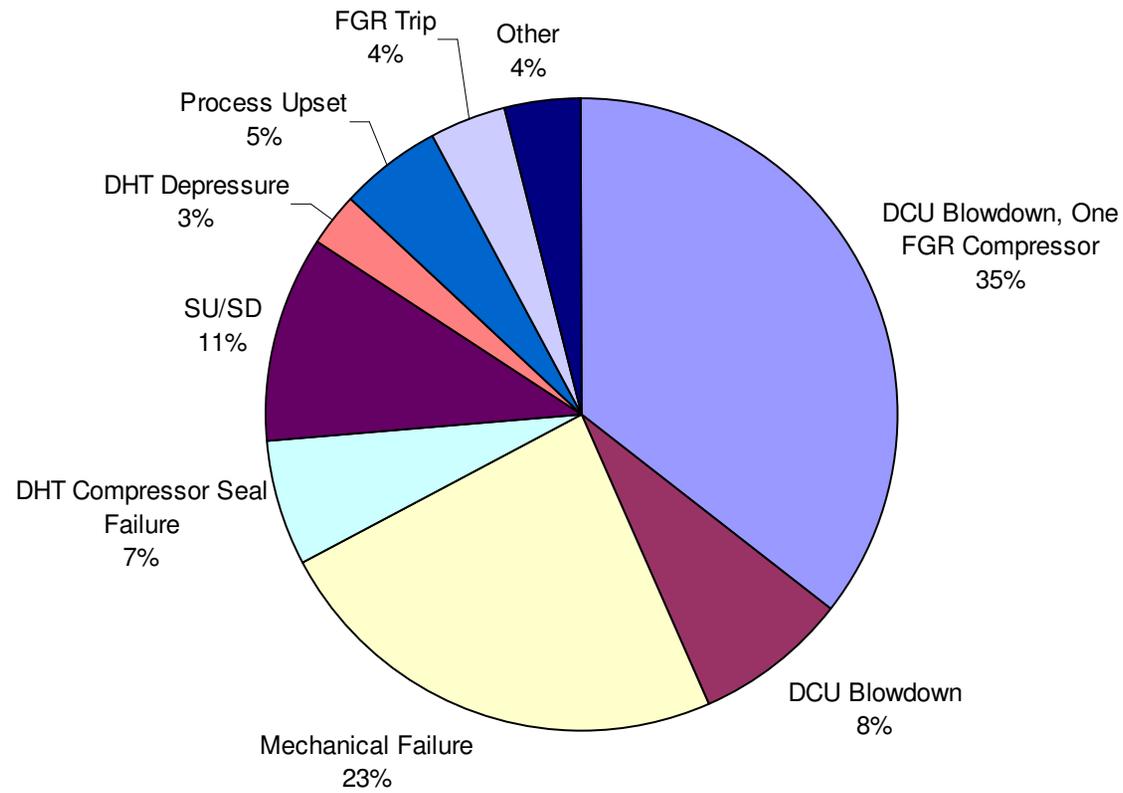
**Figure 8. Delayed Coking Area Flare Events
(2000 - 2005) 76 Events**

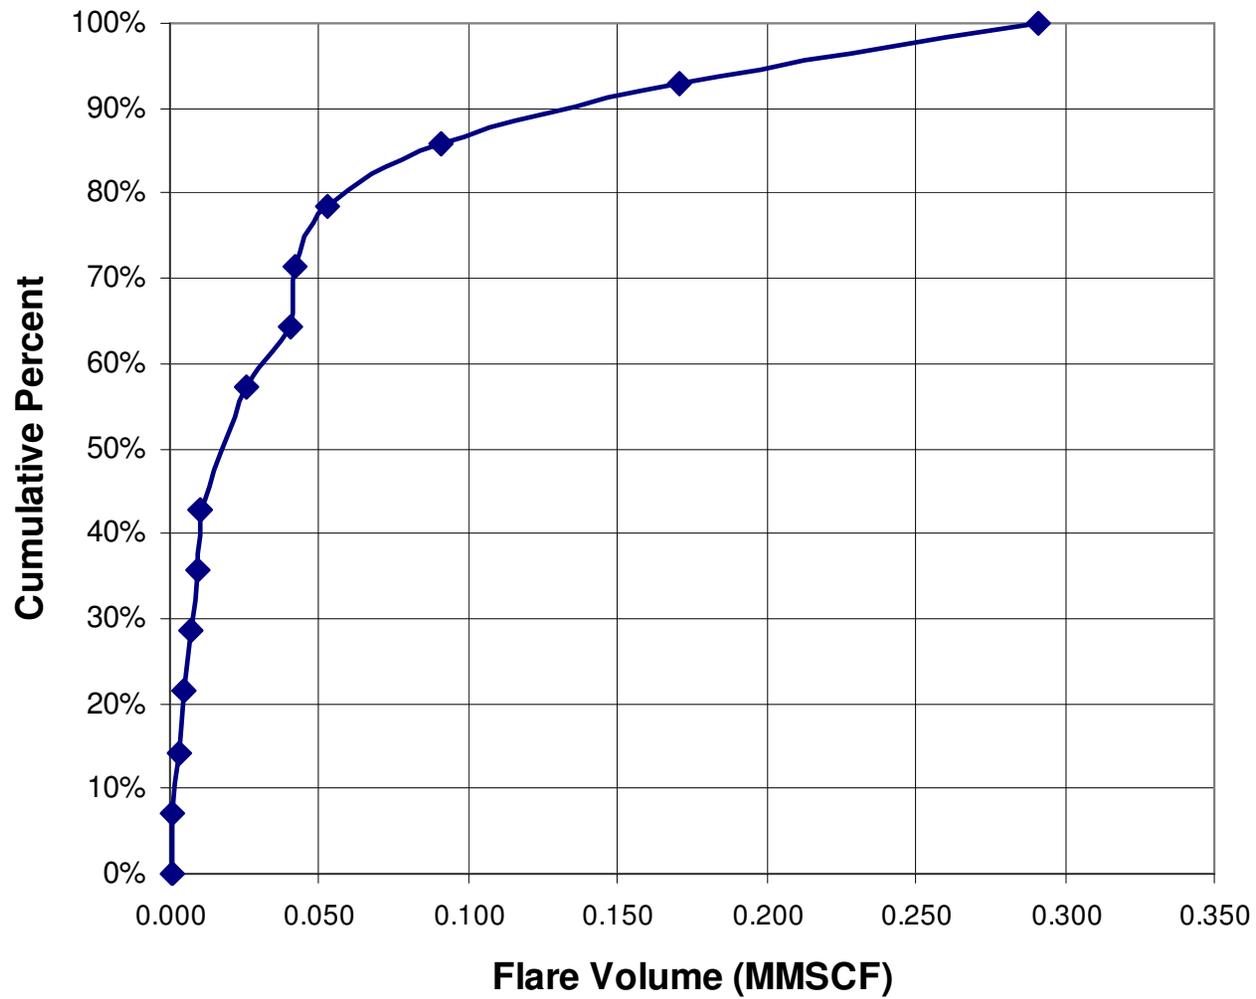
**Figure 9. Delayed Coking Area Flare Gas Volumes
(2005)**

Flaring due to gas quantity: Non-emergency flaring from the Delayed Coking Area flare during 2004 and 2005 amounted to less than 0.04% of permitted emissions of non-methane hydrocarbon. Efficiency of the existing flare gas recovery system is > 99.9%. Actual data for this flare is provided in figures 9 through 11. These data, together with knowledge of the various process units and hardware served by the flare, provide no new alternative mitigations beyond those already presented for the LOP Area flare.¹⁴

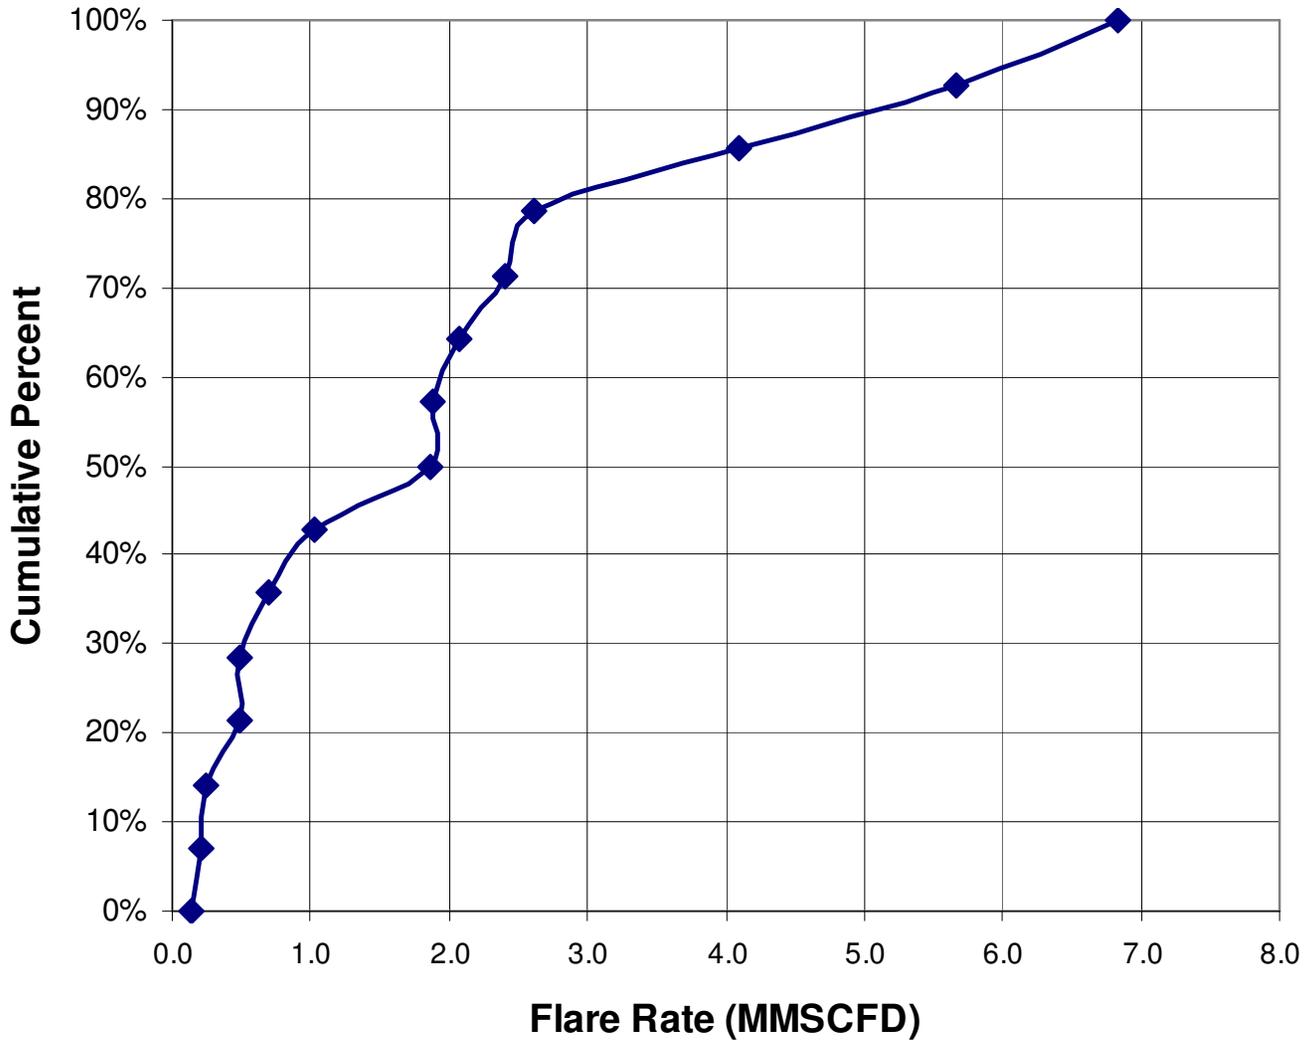
**Figure 10. Delayed Coking Area Flare Gas Flow Rates
(2005)**

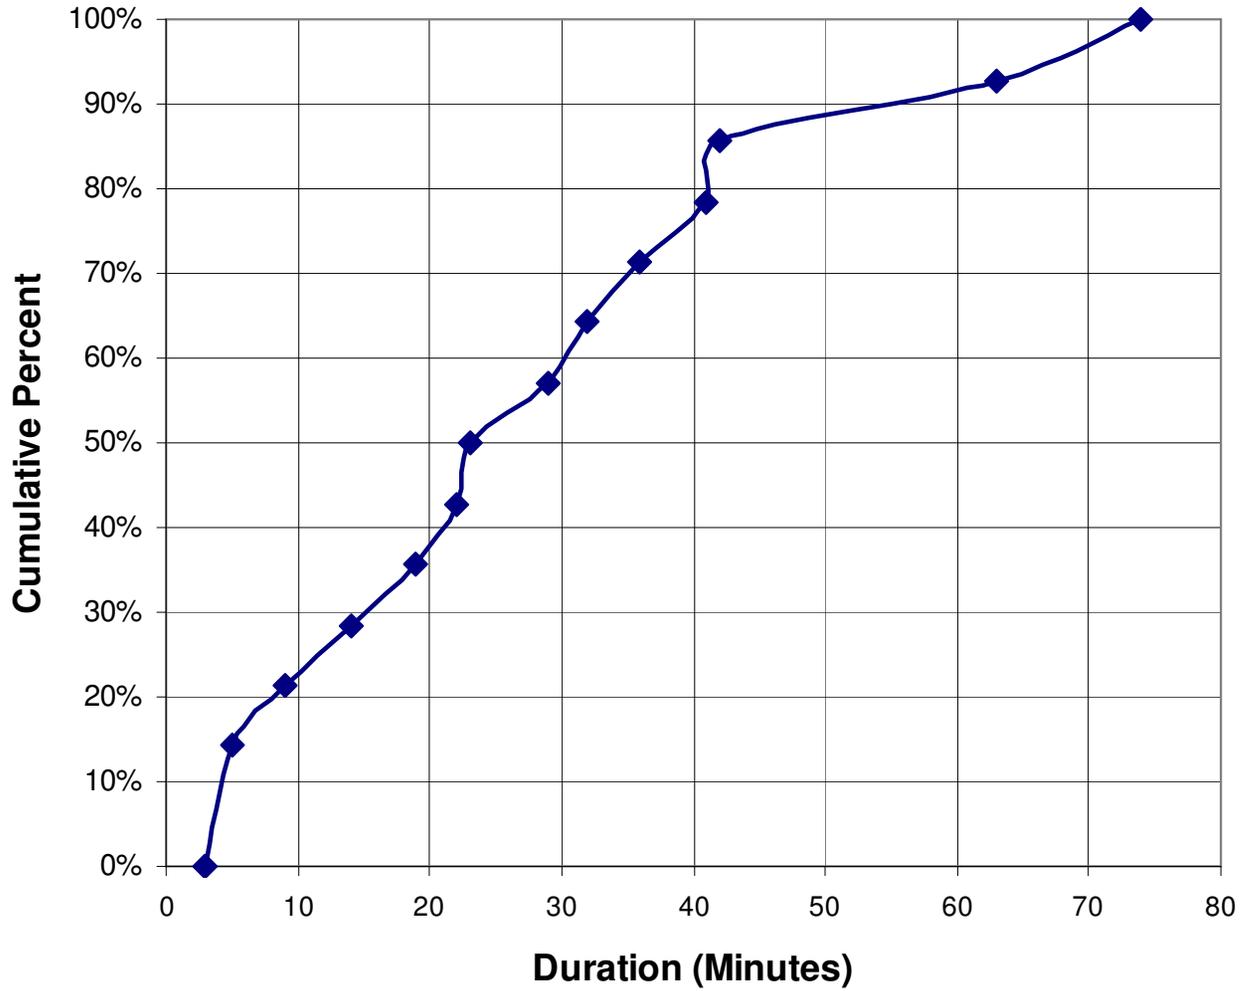
Figure 11 depicts the distribution of flare event durations for 2005 where these data are available. 50% of the events lasted less than 30 minutes. This is consistent with other data characterizing the bulk of flare events being very brief.

**Figure 11. Delayed Coking Area Flare Event Durations
(2005)**
