Shell Martinez Refinery

FLARE MINIMIZATION PLAN

Updated October 1, 2017

Shell Oil Products US
Martinez Refinery
Martinez, California 94553
BAAQMD Plant No. A0011

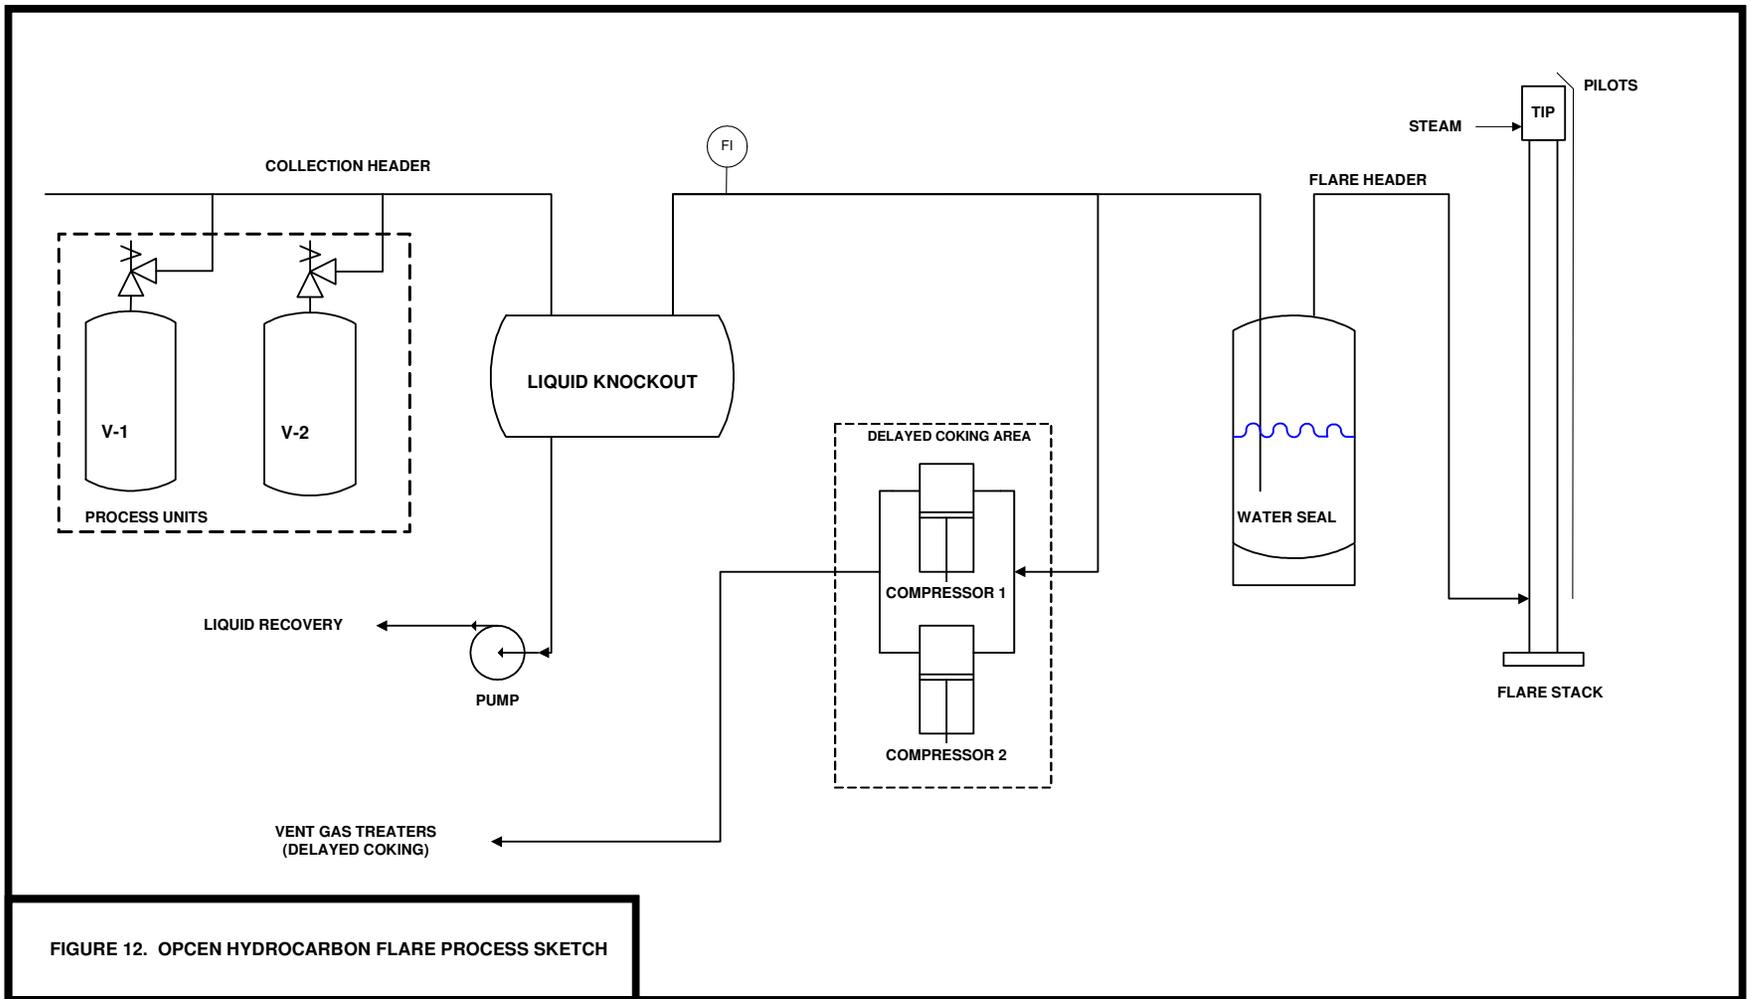
FIGURE 12. OPCEN HYDROCARBON FLARE PROCESS SKETCH

Recovered gas from OPCEN is treated to remove H₂S and routed to fuel and hydrogen plant feed along with the recovered gas from Delayed Coking. The normal routing for Delayed Coker Area recovered flare gas is the Vent Gas Treater. Sufficient capacity is available for the incremental flow (up to the total recovery compressor capacity of about 8 MMSCFD).

¹⁶ This figure includes the flare gas recovery system with the modification. Due to the need for a general shutdown of process units in the OPCEN area, the system was not operable in time for the August 1, 2006 original submittal of this plan. Post-project facilities are used as the basis for system description. However, the historical performance of this flare obviously provides little basis for evaluating mitigation options beyond the implemented flare gas recovery.

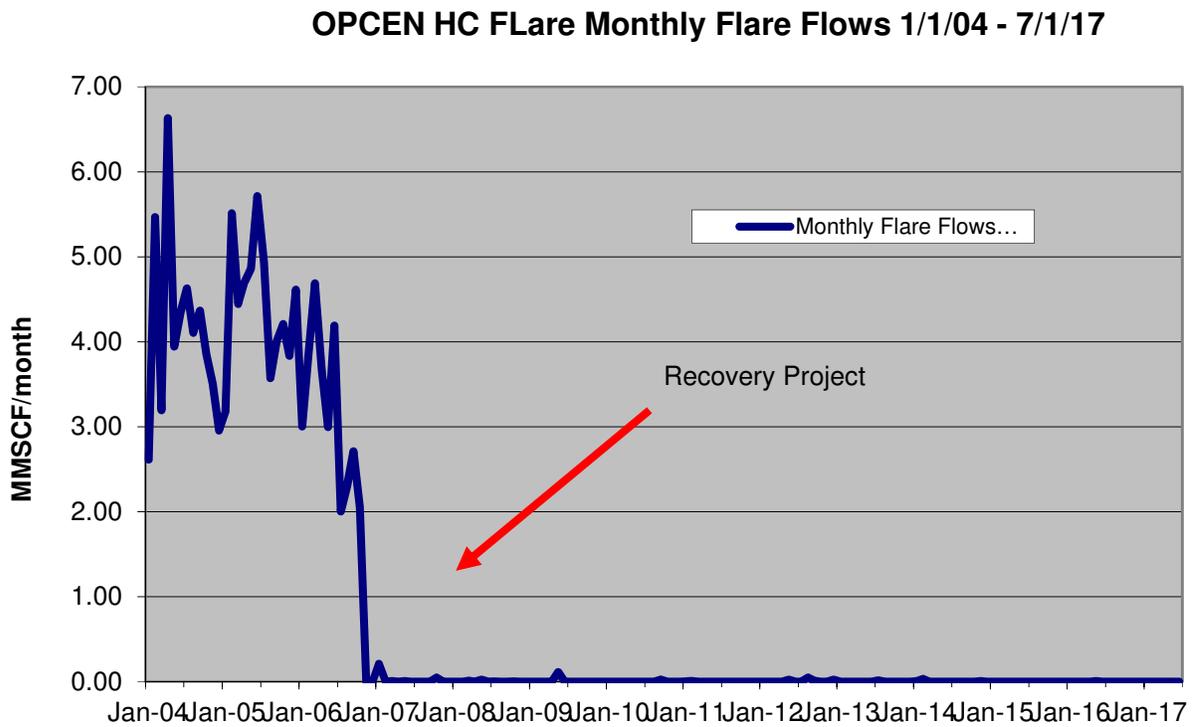
FIGURE 1

Figure 1 below has been updated through 7/1/17 and shows the continued success of the implementation of the flare recovery project that occurred in 2006 on this flare.

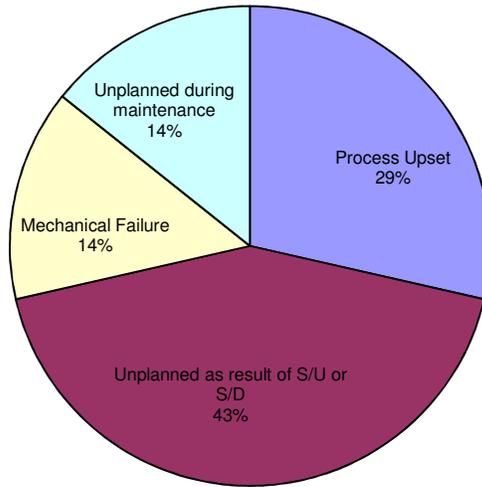
FIGURE 2008-4

OPCEN HC Flare- Cause of Flaring 11/1/06 - 6/1/08
7 Events

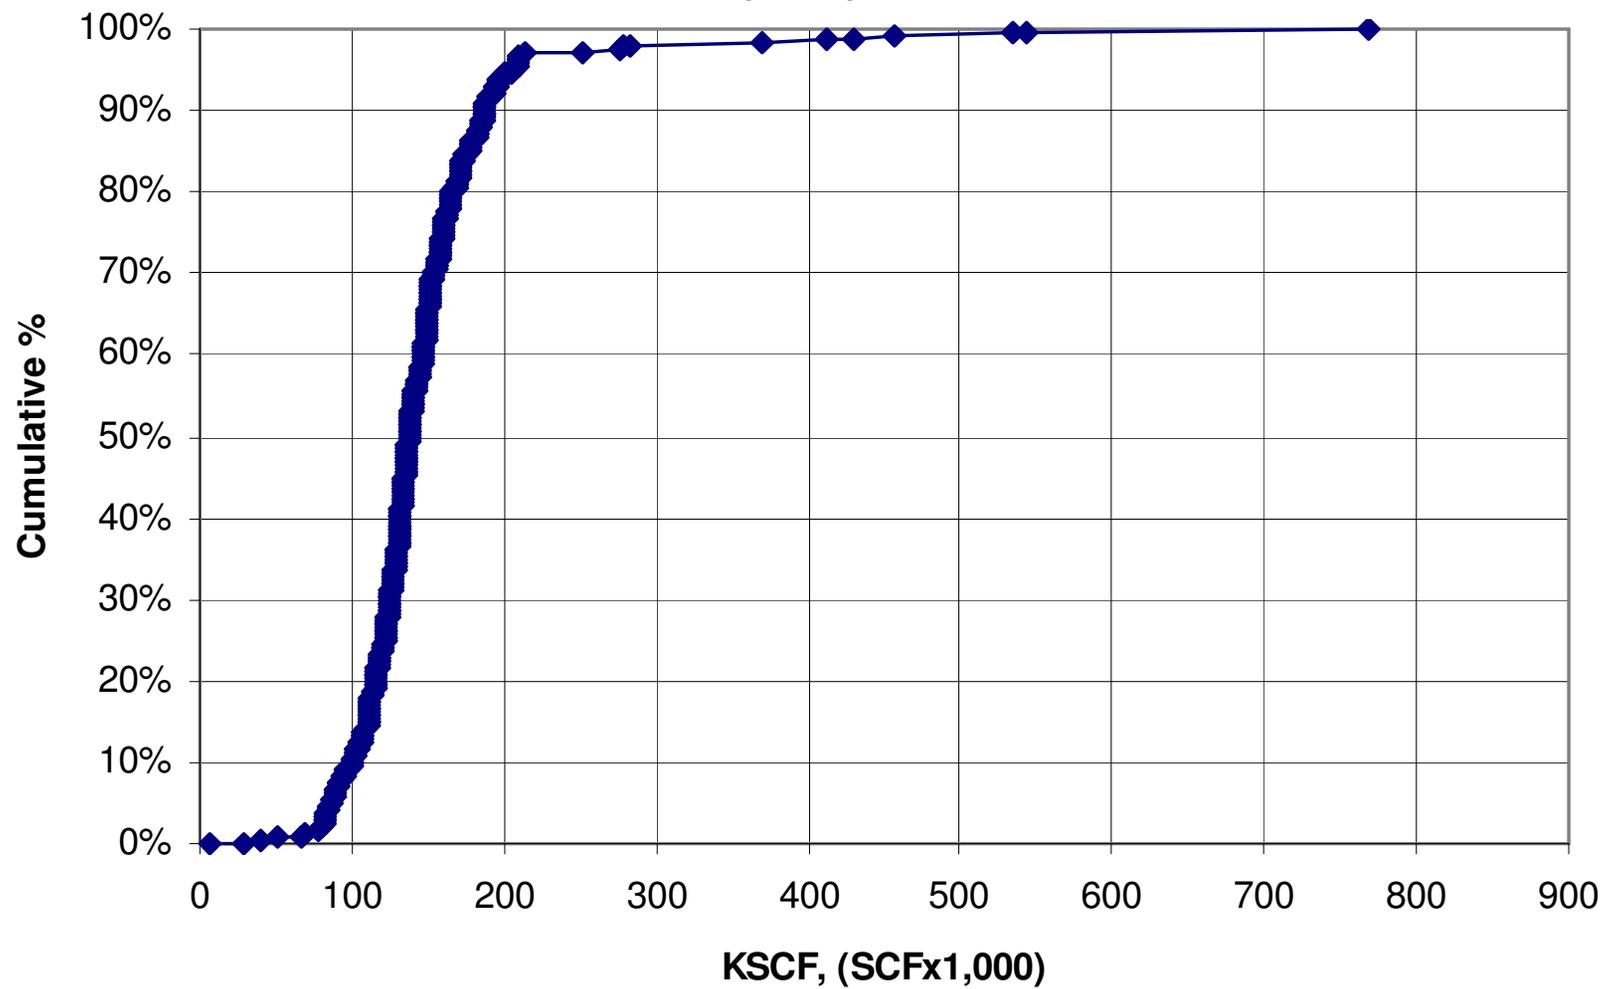
**Figure 13. OPCEN Hydrocarbon Flare Gas Volumes
(2005)**

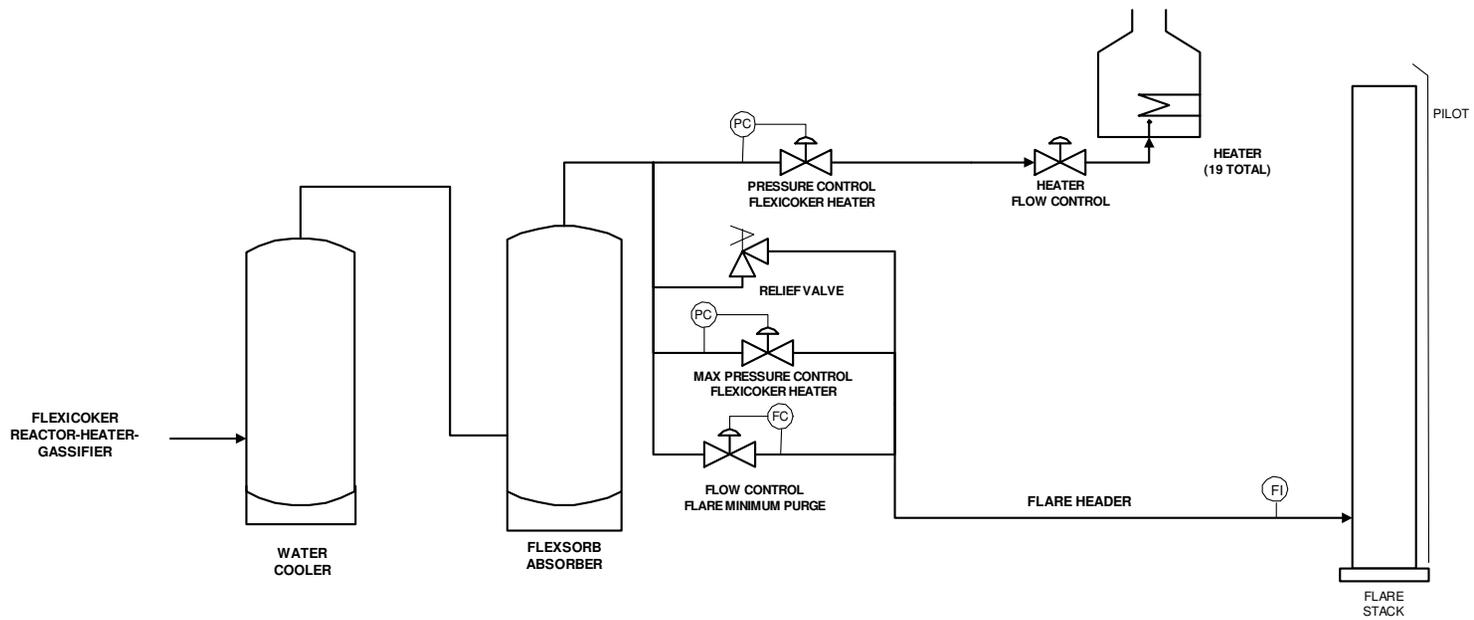
FIGURE 14. FLEXIGAS SUPPLY SYSTEM PROCESS SKETCH

The OPCEN Flexigas flare is a dedicated flare serving the Flexicoker Reactor/Heater/Gasifier. The Flexigas flare only combusts flexigas (FXG). This flare differs significantly from all other process flares serving Bay Area refineries for reasons described below. A simplified process sketch is provided in Figure 14. Details of the system are provided in Appendix D.

¹⁸ Because of its low emissions of SO_x, NO_x and particulates, Flexigas is the fuel flared during those brief periods where a fuel system imbalance occurs as a result of process upset. This may increase the flaring at the Flexigas flare, but results in lower emissions than flaring any other fuel.

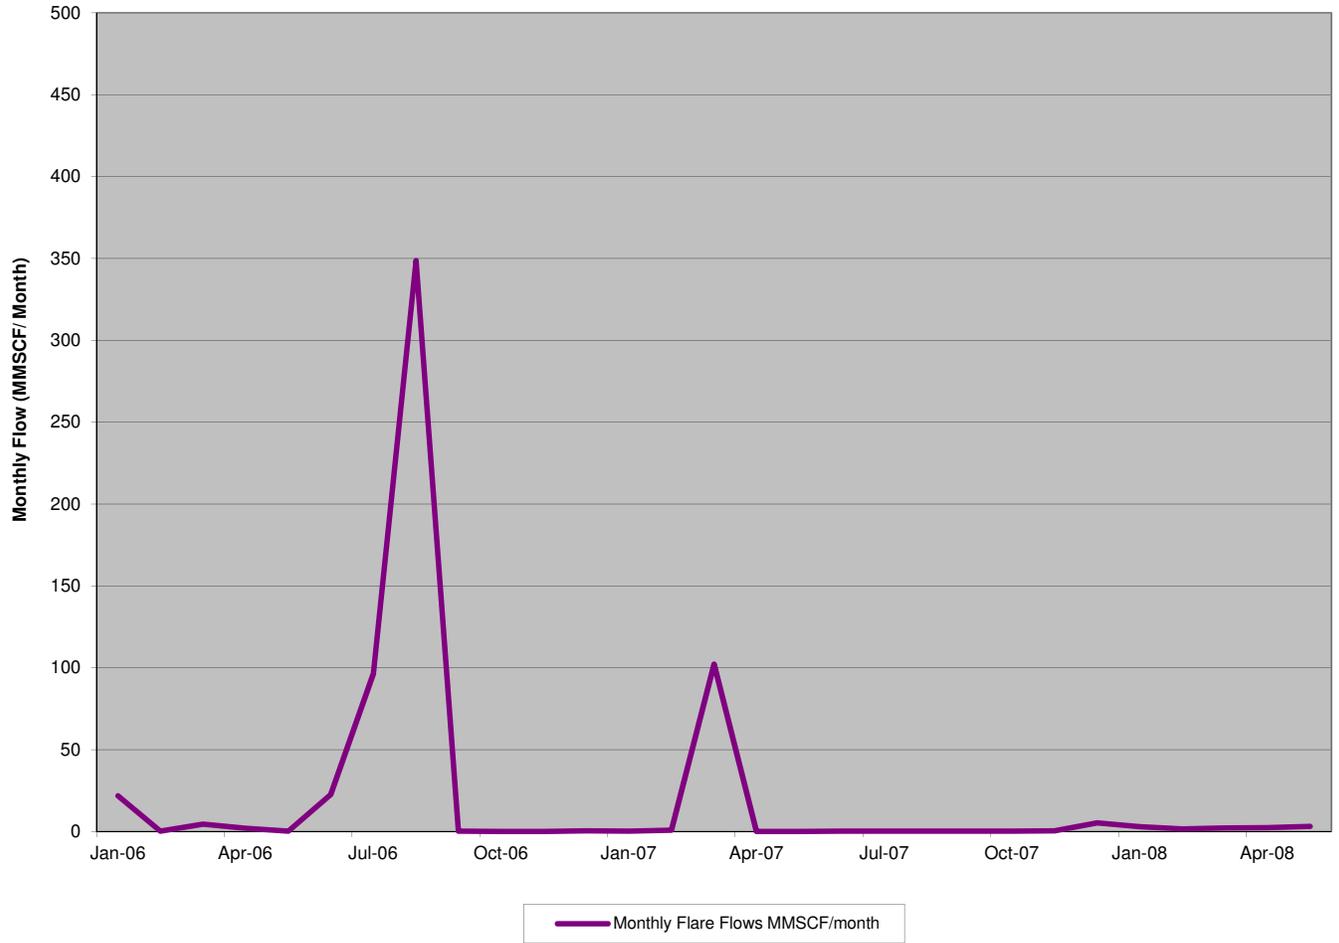
FIGURE 2008-5

FXG Flare Flows 1/1/06 - 6/1/08
