Shell Martinez Refinery

FLARE MINIMIZATION PLAN

Updated October 1, 2018

Shell Oil Products US
Martinez Refinery
Martinez, California 94553
BAAQMD Plant No. A0011

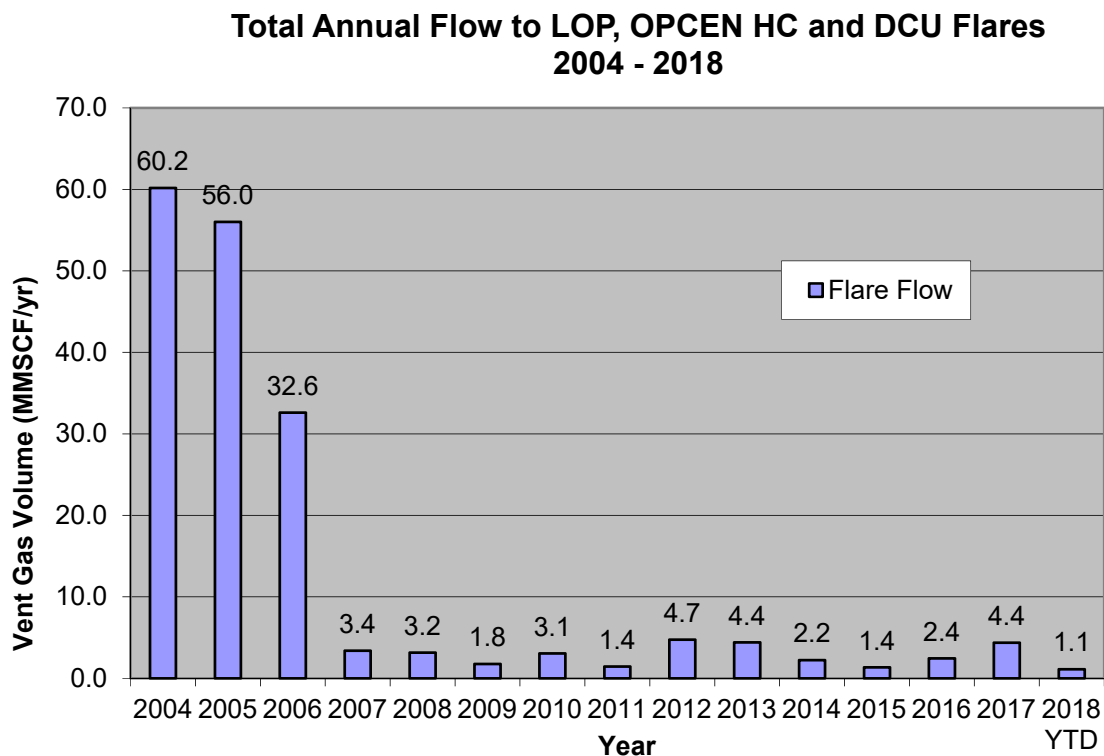
FIGURE ES-1

Figure ES-1 presents the total annual vent gas flow to the Light Oil Processing (LOP), Operations Central Hydrocarbon (OPCEN HC) and Delayed Coking (Clean Fuels) Flares at the refinery from 2004 through June 30, 2018. Flare flow continues to be very low.

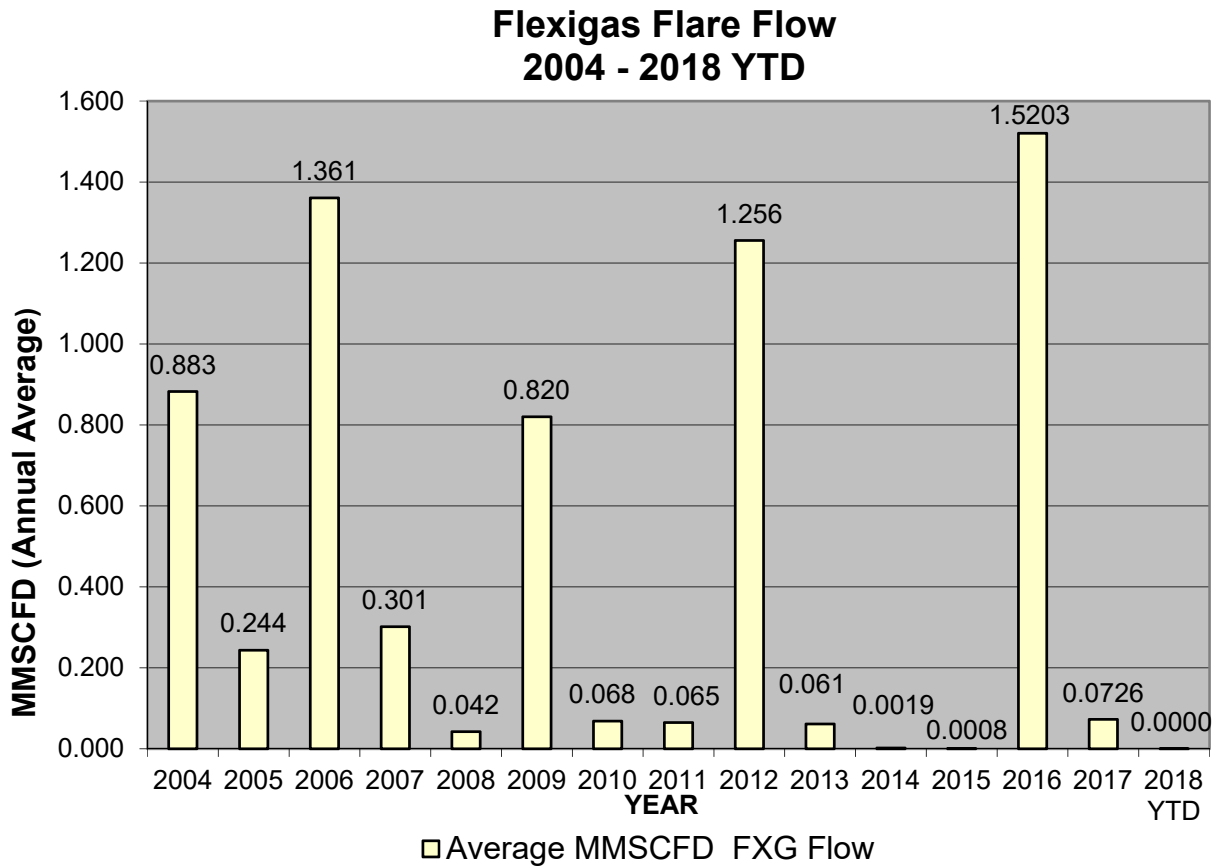
FIGURE ES-2

Figure ES-2 shows the annualized vent gas flow from the Flexigas Flare. This figure shows a cyclic increase in Flexigas flaring which occurs during years with startup and shutdown of the Flexicoker due to the nature of the Flexicoking and Flexsorb processes. The flaring of treated flexigas during startups and shutdowns of the Flexicoker is allowed up to specified limits in Shell's Title V permit. Flexigas is a very low BTU gas used as a supplemental refinery fuel gas in refinery process heaters.

Flexigas is treated for sulfur removal in the Flexsorb Unit before being combusted either in refinery process heaters or if necessary, in the Flexigas Flare. When FXG is flared, the volume of gas is typically large compared to the volume flared in the other refinery process flares, but emissions are significantly less because Flexigas contains very low concentrations of non-methane hydrocarbon and sulfur.

Flexigas flaring can also occur due to refinery fuel gas imbalance. Shell continues to fine-tune the Flexigas pressure control scheme to minimize flexigas flaring due to small imbalances in fuel gas. Improvements in this system, most notably addition of COGEN to the pressure control scheme, contribute to the very low flexigas flare flow rate seen in non-turnaround years including 2013, 2014, 2015, 2017, and 2018.

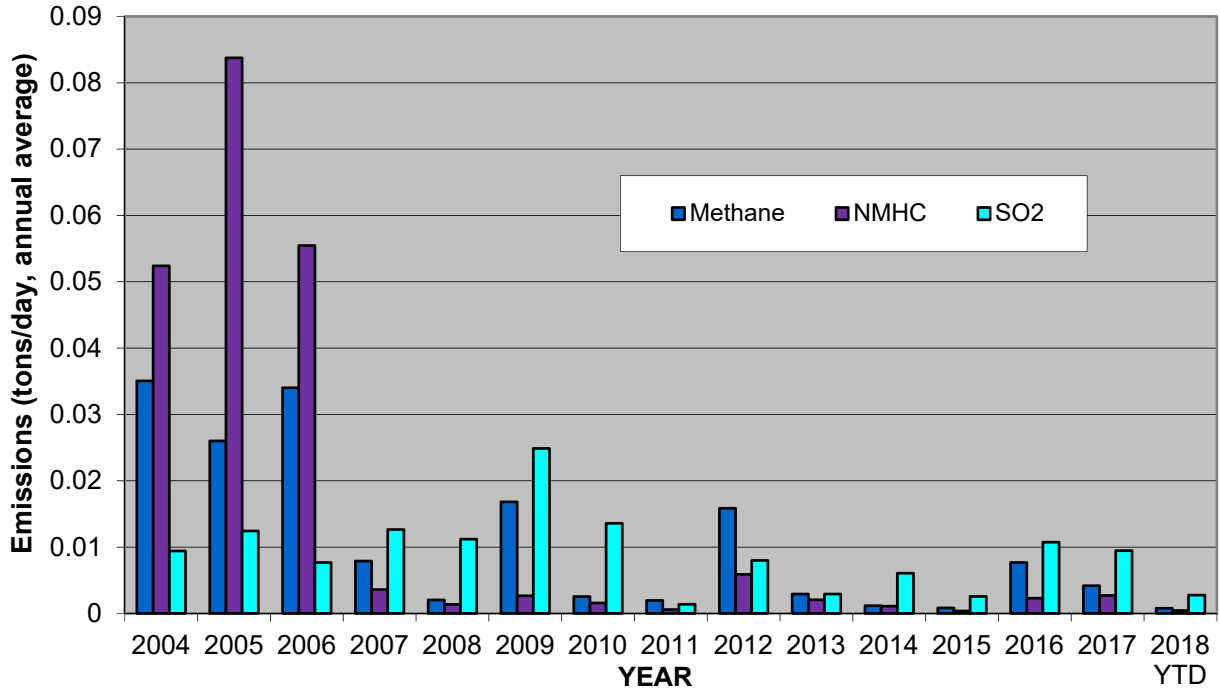
FIGURE ES-3

Figure ES-3 shows the methane, non-methane hydrocarbon and sulfur dioxide emissions from all four refinery process flares from 2004 through June 30 of this year.

**Shell Flare Emissions - All Flares
2004 - 2018 YTD**

Figure ES-3 shows the significant reduction in emissions that has occurred since the implementation of the Flare Minimization Plan in 2006 and highlights that even with large volumes of flexigas flaring during turnaround years, overall emissions from flaring are very low.

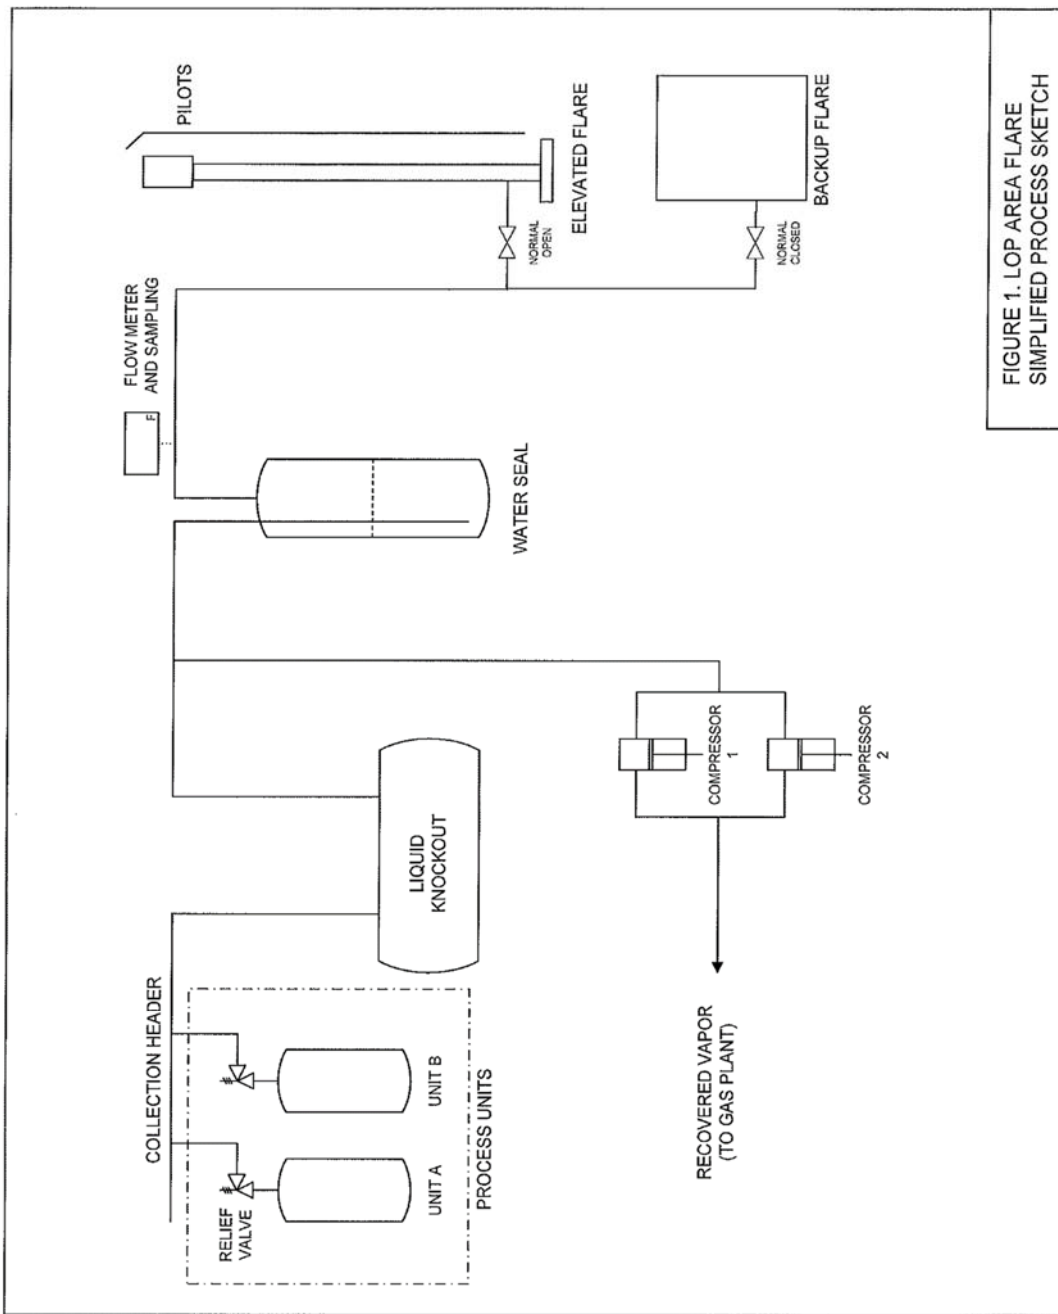
FIGURE 1. LOP AREA FLARE SIMPLIFIED PROCESS SKETCH

The LOP Flare system is comprised of collection headers, liquid knockout vessels, two flare vapor recovery compressors, piping to route recovered gas to fuel gas treaters, a water seal vessel, the flare header proper, and the flare stack. The LOP flare is an elevated, steam-assisted flare with nitrogen purge to prevent air intrusion. Piping and valves provide sufficient flexibility to operate in various configurations, allowing continuous and reliable operation during turnarounds, inspection and maintenance activities without flaring. Maintenance of the elevated flare (S#1471) is accomplished by putting an alternate flare in service. This alternate flare (Backup Flare, S#1472) is normally blinded and is only used when the elevated flare is out of service for inspection or repair. A sketch of the LOP Flare system is provided in Figure 1. Technical details of the system are provided in Appendix A².

Recovered flare gas is treated to remove hydrogen sulfide and condensable liquids. Treated gas is routed to the fuel gas system. The fuel gas treaters typically used for LOP recovered flare gas are located in the Catalytic Cracker Gas Plant (CGP). When this unit is unavailable for any reason, recovered gas may be routed to the Saturates Gas Plant (SGP). Sufficient capacity can be made available in both sets of treaters for the incremental flow up to the total capacity of both compressors of about 6.4 MMSCFD.

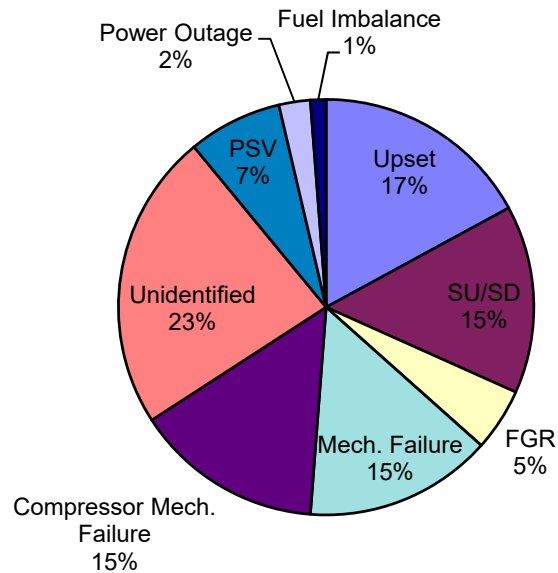
**Figure 2. LOP Area Flare Events
(2000-2005)**

Based on these data, about 65% of the flare events occurring from 2000 - 2005 are essentially evenly divided among the following categories: process upsets, process startup and shutdowns, mechanical failures of compressors and other equipment. Almost one quarter of the time the occurrences where the water seal was broken indicating that flaring occurred were so small, and of such brief duration, no cause could be reliably determined.

Figure 2 illustrates that there are a wide range of events that can cause flaring at LOP. The annual volume of gas flared could be reduced in two basic ways. One alternative is an increase in the capacity of the flare gas recovery system. The second is improved measures to limit the rate and volume of gas discharged to the flare gas header so that it does not exceed the capacity of the existing recovery system. These two alternative approaches are discussed below.

Figure 2 shows that activities that have occurred during startups and shutdowns have contributed to less than 15% of the flare events that occurred historically at the LOP flare. Analysis of the flaring back to 2005 indicate that flaring may have been prevented by changing operating practices, improved planning, or minor hardware revisions. The trend over the past years indicates that startup, shutdowns and maintenance-related flaring can be significantly reduced and largely eliminated with careful planning. Major turnarounds on units served by the LOP flare continue to be performed without planned flaring. That this work was performed without flaring is evidence of careful review and planning. We commit to continue this careful review and planning prior to planned major maintenance and expect to perform turnarounds with little or no planned flaring. If during the maintenance planning and review process we find that planned flaring is required, as was the case when preparing for the LOP flare pressure vessel inspections, then all appropriate prevention measures will be considered and feasible measures will be implemented to reduce or eliminate the planned flaring.

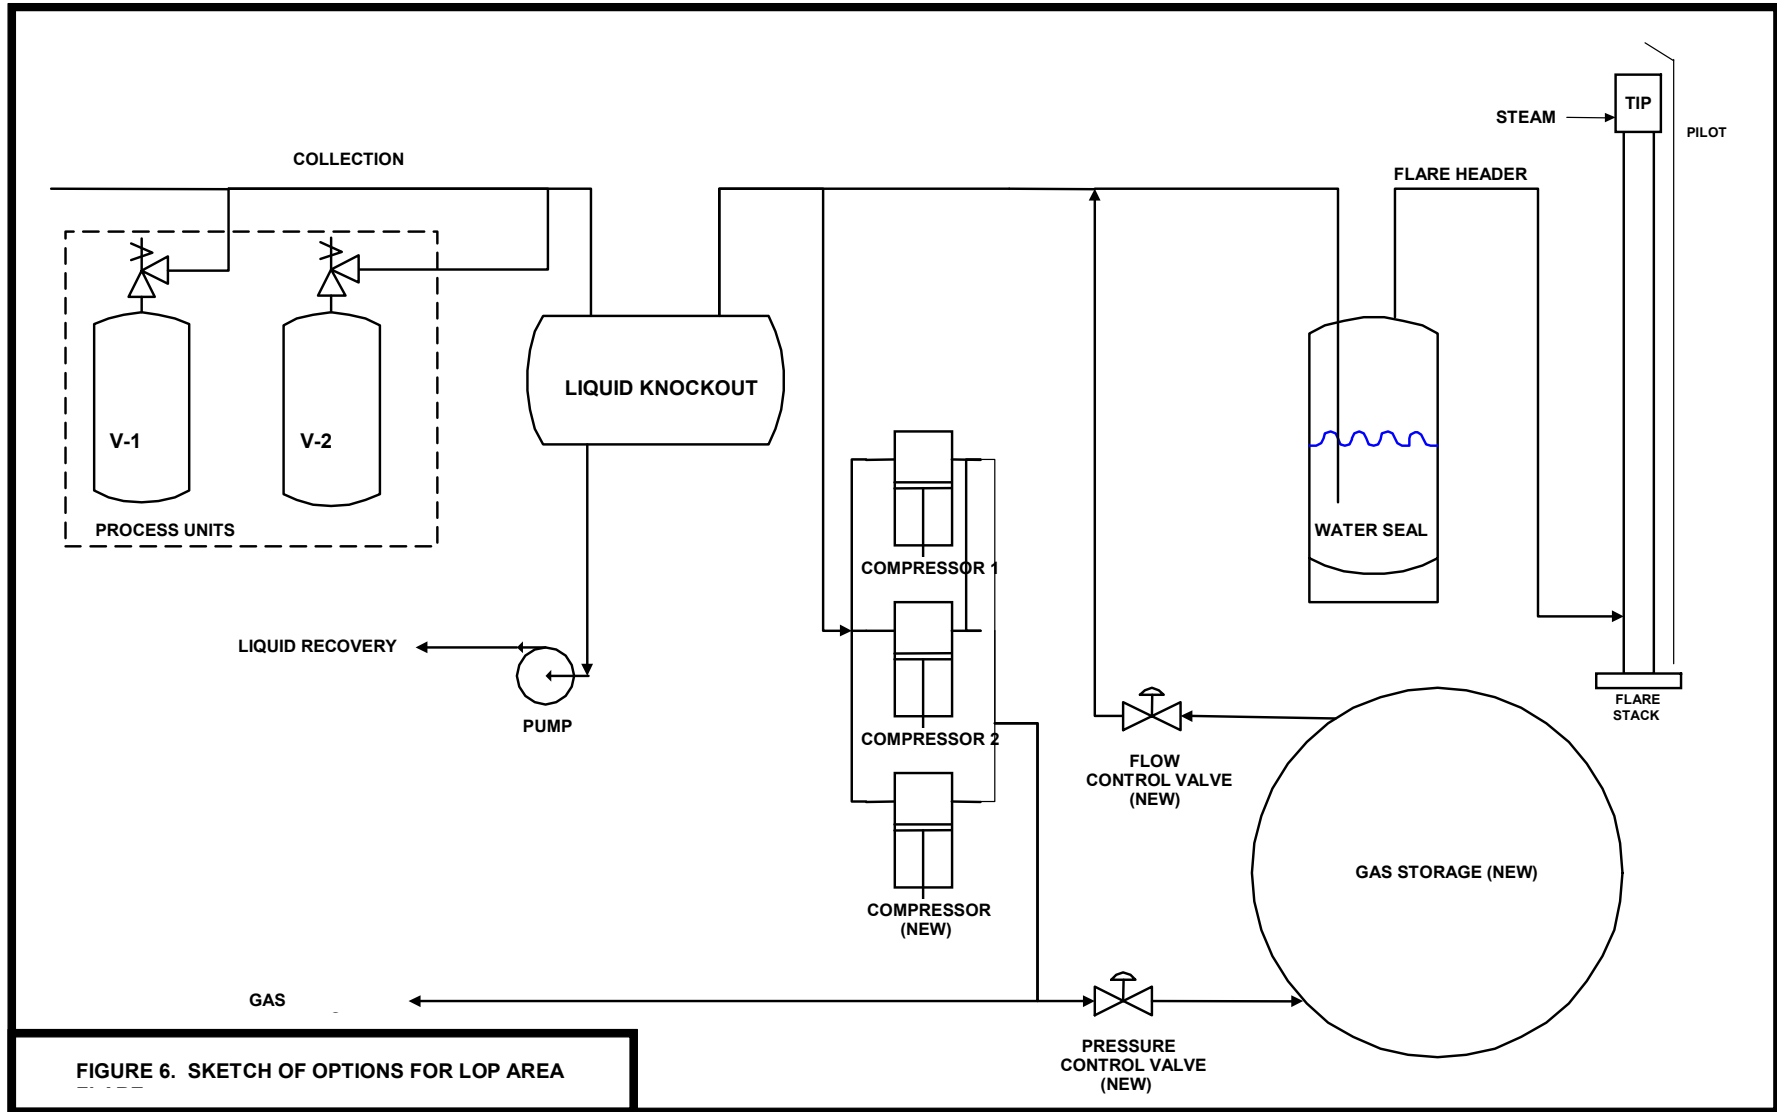
FIGURE 6. SKETCH OF OPTIONS FOR LOP AREA

Prevention Measure Options Considered for Recovery, Storage and Treatment: Costs and potential benefits of improving gas recovery and reducing flare emissions from the current 99.7% recovery efficiency are addressed by considering the addition of flare gas recovery compression and flare gas storage. Gas treating capacity is expected to be adequate for all options evaluated. A sketch of the potential options is provided in Figure 6.

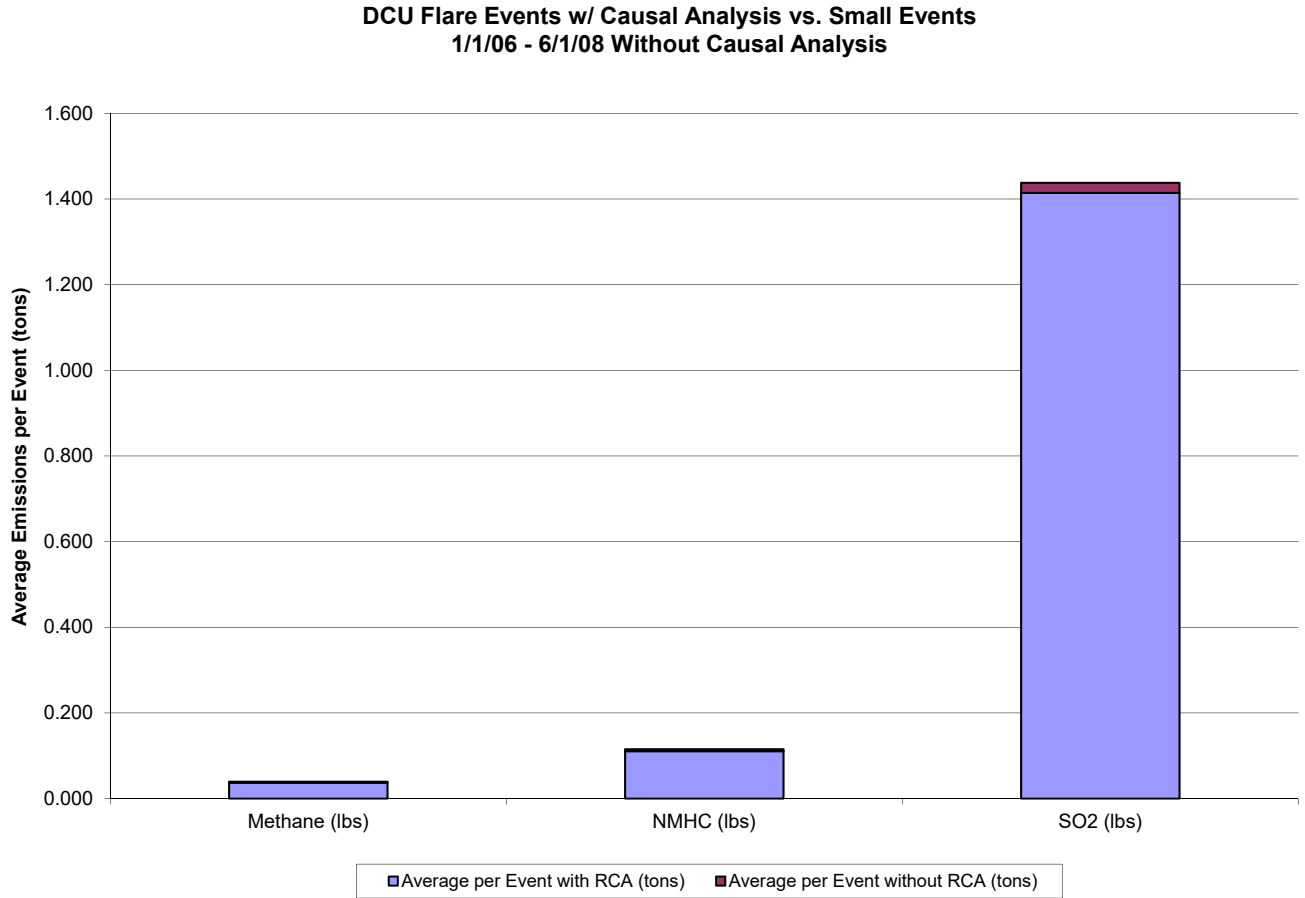
FIGURE 2008-2

of the causal analysis trigger of 0.5 MMSCF/ 500 lbs SO2 to ensure the resources to conduct a Causal Analysis are most effectively applied to address high emission events.

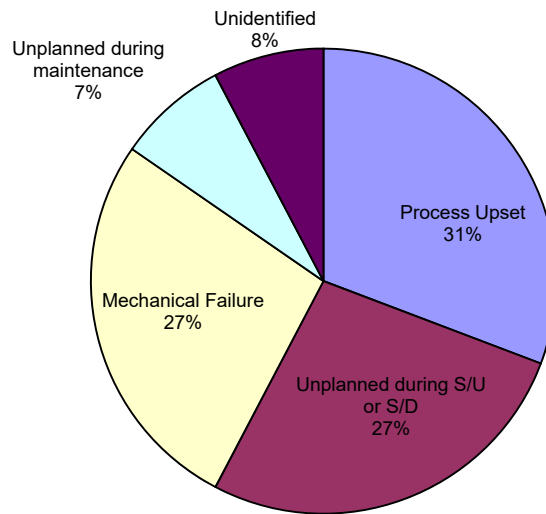
FIGURE 2008 - 3

The DCU flare events that occurred from 1/1/06 – 6/1/08 were categorized by probable cause in Figure 2008-3. None of the flaring was planned. Most of the events were < 10 minutes long. The majority of the events were caused by process upset, mechanical failure or were unplanned during startup and shutdowns.

**Probable Cause of Flaring on DCU Flare 1/1/06-6/1/08
26 Events**

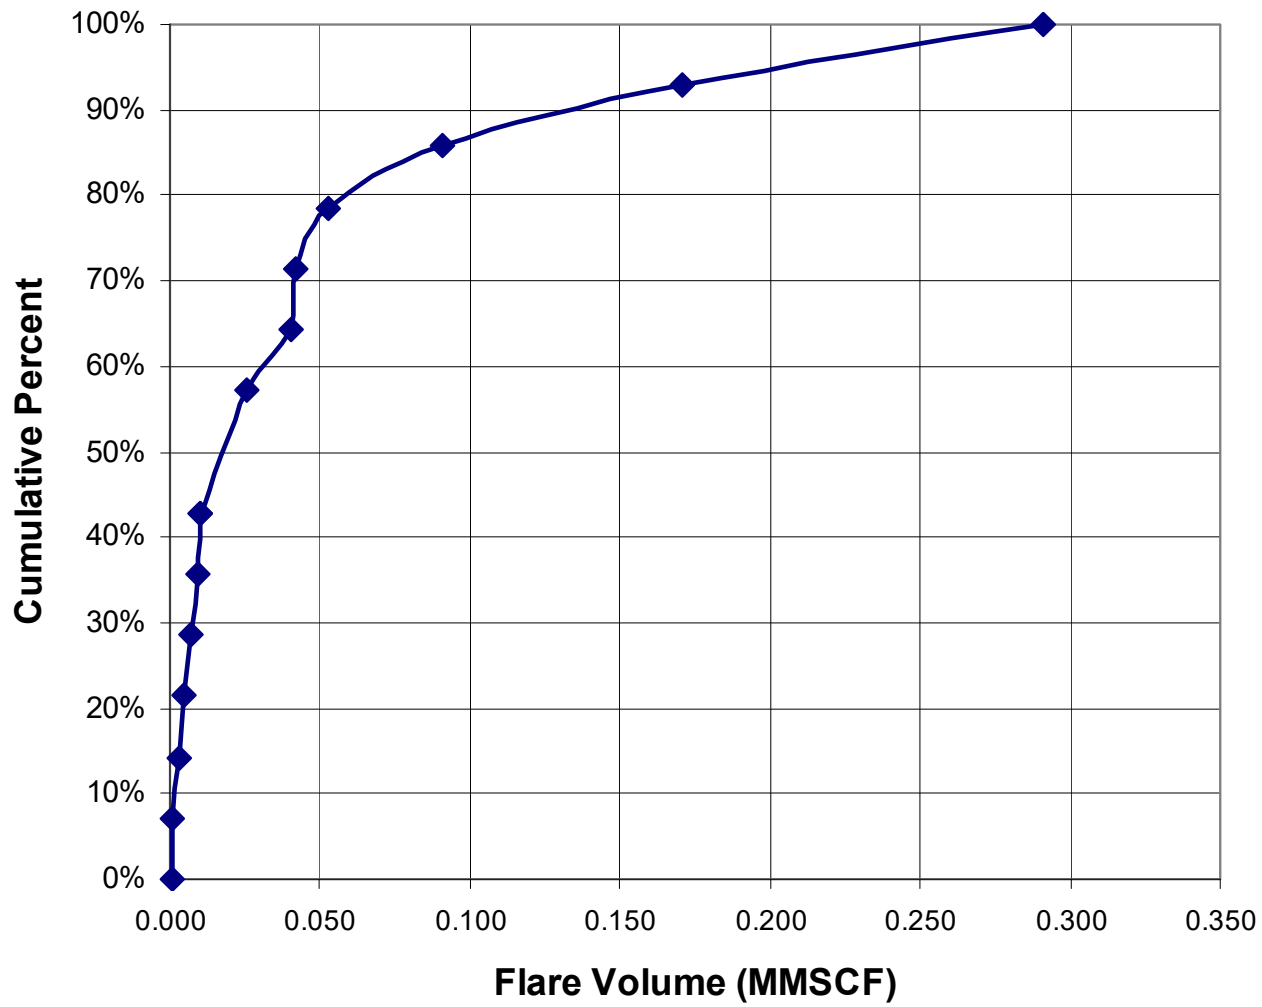
**Figure 9. Delayed Coking Area Flare Gas Volumes
(2005)**

Figure 9 depicts the amount of material flared during the reported incidents of flare activity in 2005. All flaring was below 500,000 scf. Approximately 70% of the incidents of reported flaring involved volumes of gas of 50,000 SCF or less. All were below 300,000 standard cubic feet.

Flaring during 2005. The highest quality data are available for the period from January 2005 to January 2006. Data is available during this period from flare flow meters and monthly BAAQMD flare reporting. Available data for flare event volumes and durations are provided in Figures 9 through 11 below.

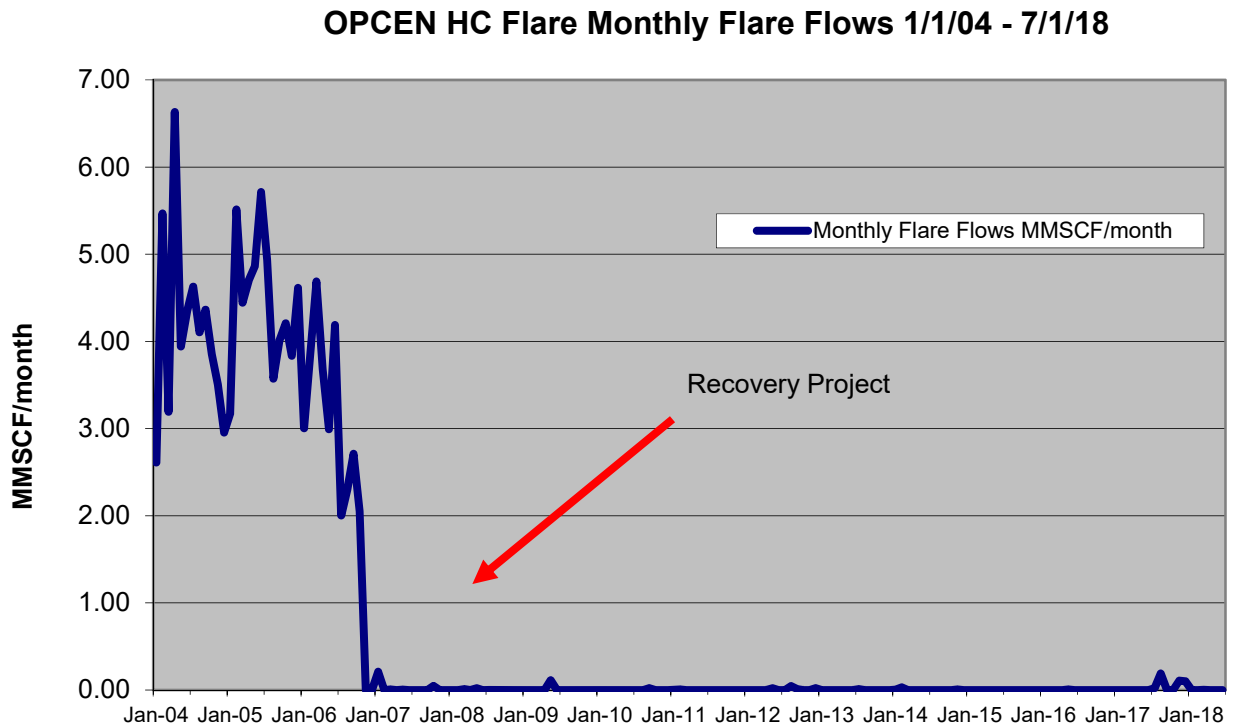
FIGURE 1

Figure 1 below has been updated through 7/1/18 and shows the continued success of the implementation of the flare recovery project that occurred in 2006 on this flare.

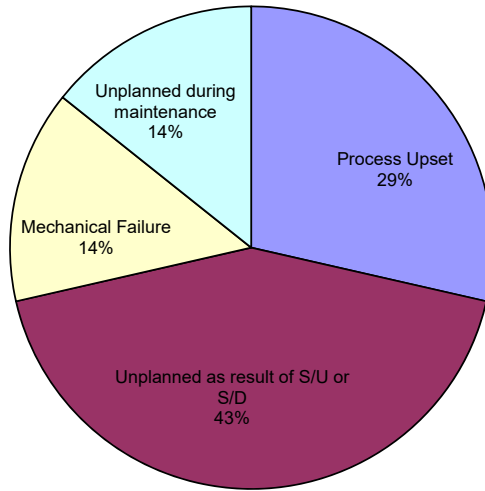
FIGURE 2008-4

The OPCEN HC flare events that occurred after the implementation of flare recovery from 11/1/06 – 6/1/08 were categorized by probable cause in Figure 2008-4. None of the flaring was planned. The cause of the events included process upset, mechanical failure or were unplanned during maintenance or startup and shutdown.

OPCEN HC Flare- Cause of Flaring 11/1/06 - 6/1/08
7 Events

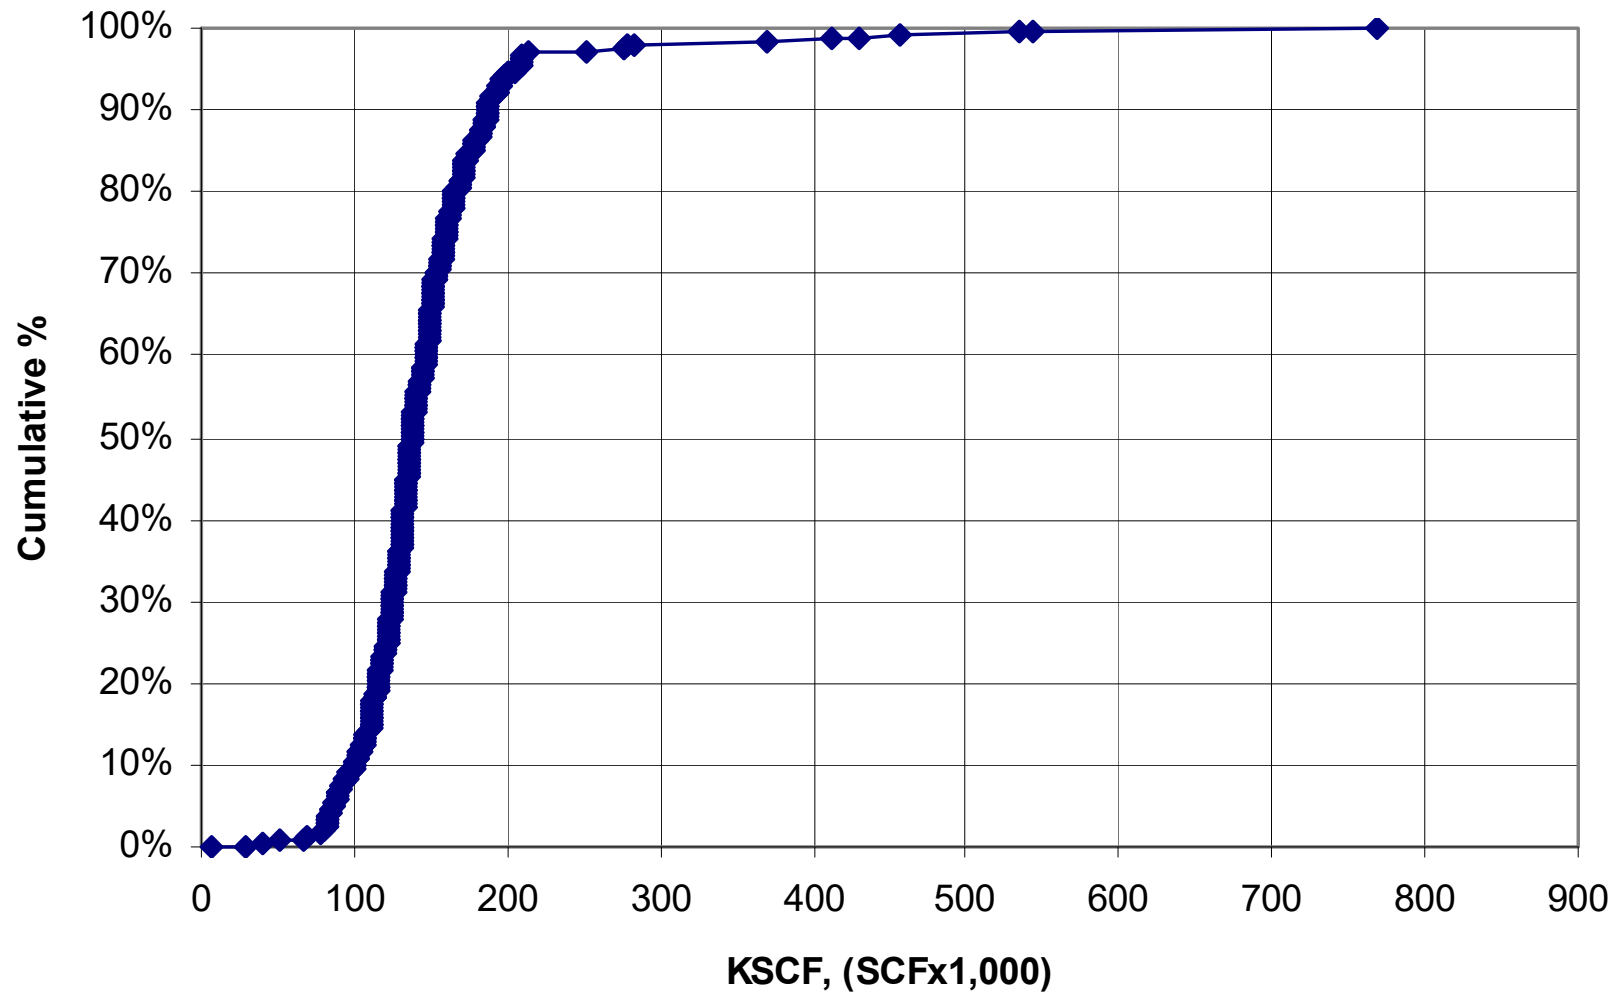
**Figure 13. OPCEN Hydrocarbon Flare Gas Volumes
(2005)**

With historical performance profoundly biased by absence of flare gas recovery, this review concentrated on calendar year 2005. Flare data are depicted in Figure 13. Total emissions of non-methane hydrocarbon during 2005 were approximately 30 tons. Emissions of SO₂ in 2005 were 0.3 tons.

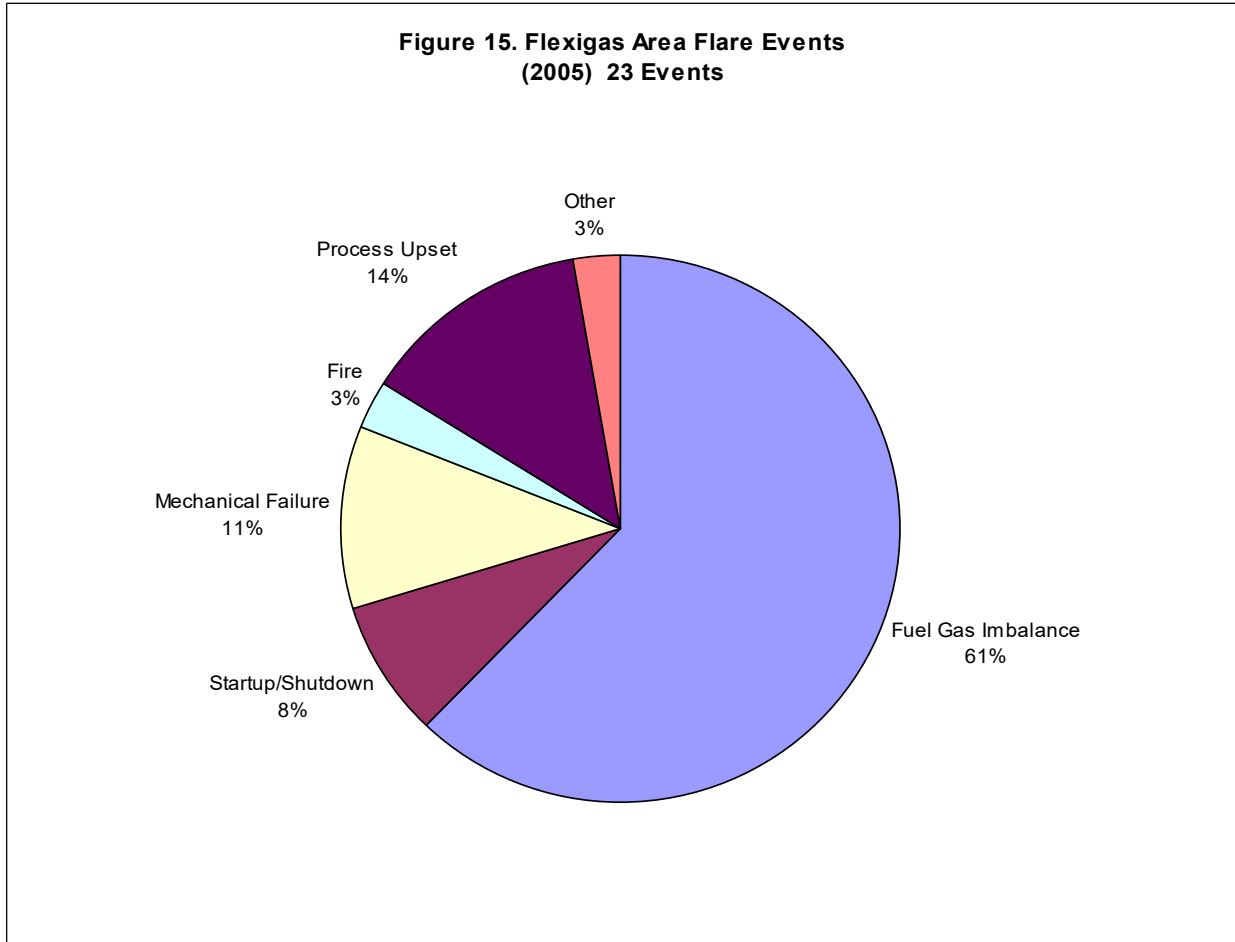
Historical flaring at the OPCEN Flexigas flare was reviewed to identify opportunities for potential mitigation. The highest quality data are available for the period from December 2003, to January 2006. This coincides with installation of the flare flow meter and BAAQMD flare reporting. Data for 2005 are plotted in Figure 15 and Figure 16.

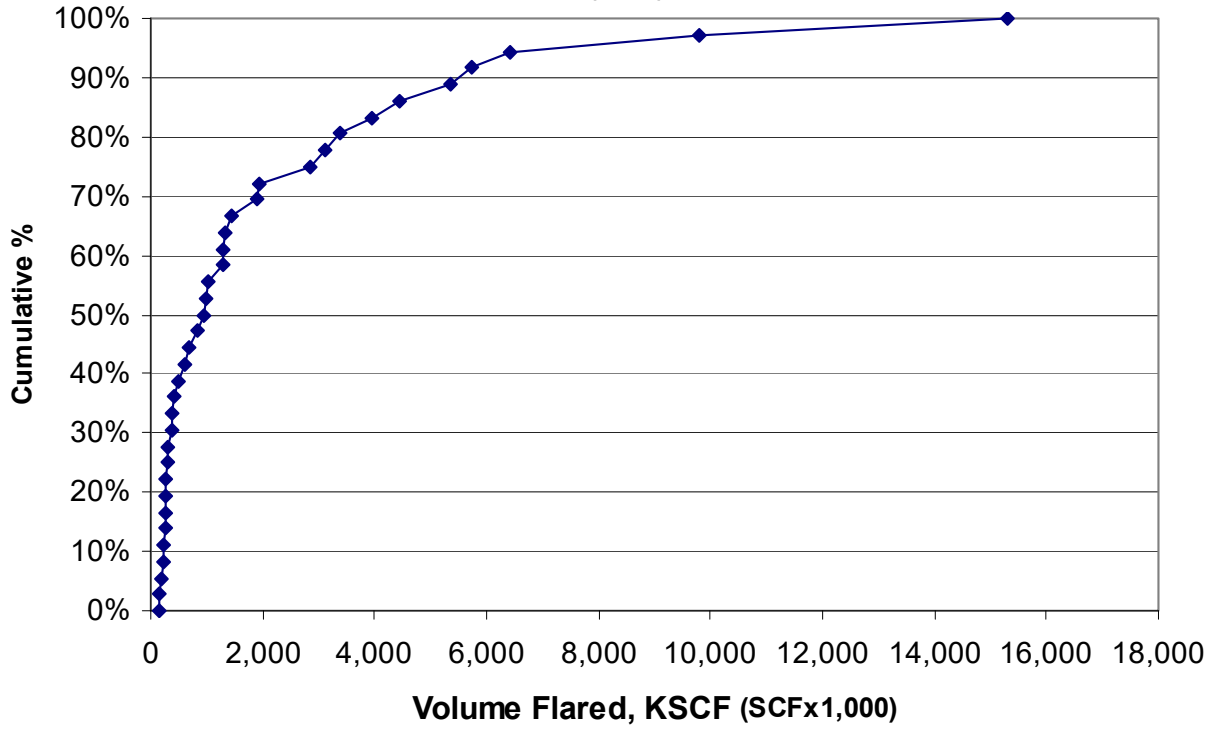
**Figure 16. Flexigas Flare Gas Volumes
(2005)**

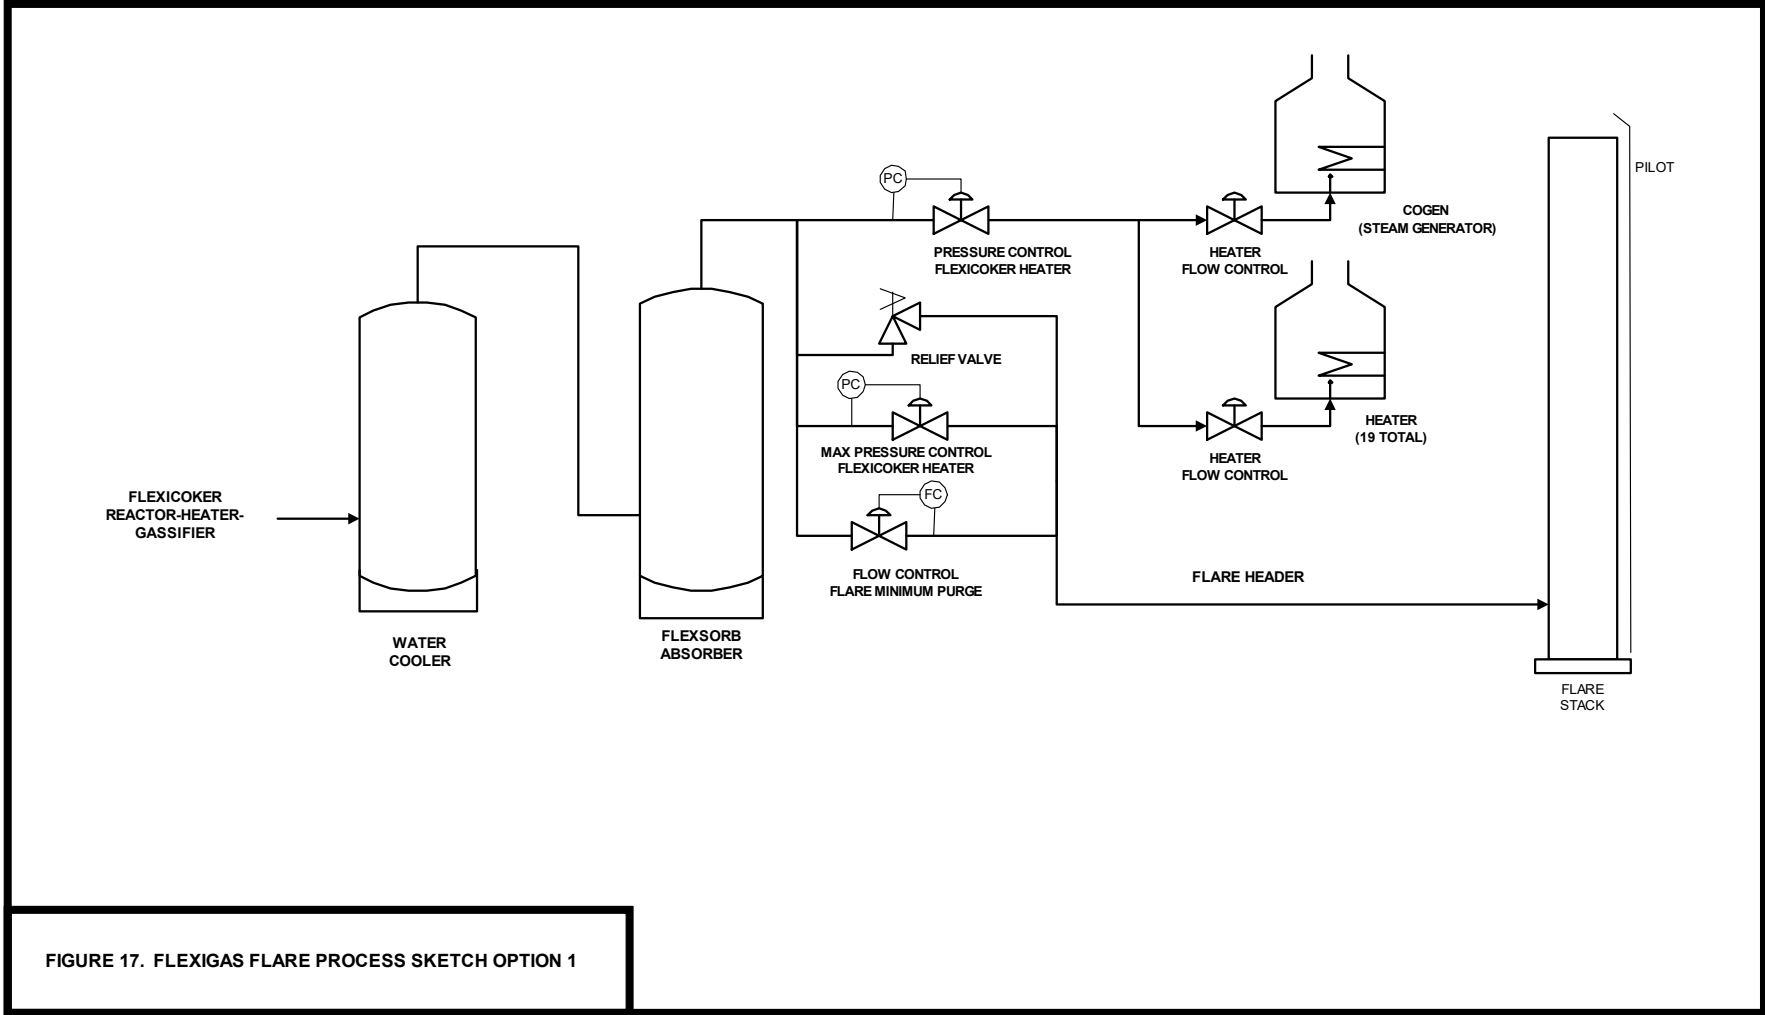
FIGURE 17. FLEXIGAS FLARE PROCESS SKETCH OPTION 1

OPTION 1: PROVIDE ADDITIONAL FLEXIGAS CONSUMERS (see Figure 17).

The objective of this project would be to provide an additional consumer that can rapidly pick up the Flexigas volumes made available by loss of another consumer (e.g., process heater) for any reason. Because excess Flexigas is available less than 10% of the time (based on the percent of days on which flaring occurred from Figure 16), and the current fuel system is roughly in balance, this consumer must essentially remain in hot standby until needed. This means it must be waiting to burn between 1 MMSCFD and 40 MMSCFD Flexigas when an existing consumer unexpectedly comes off line.

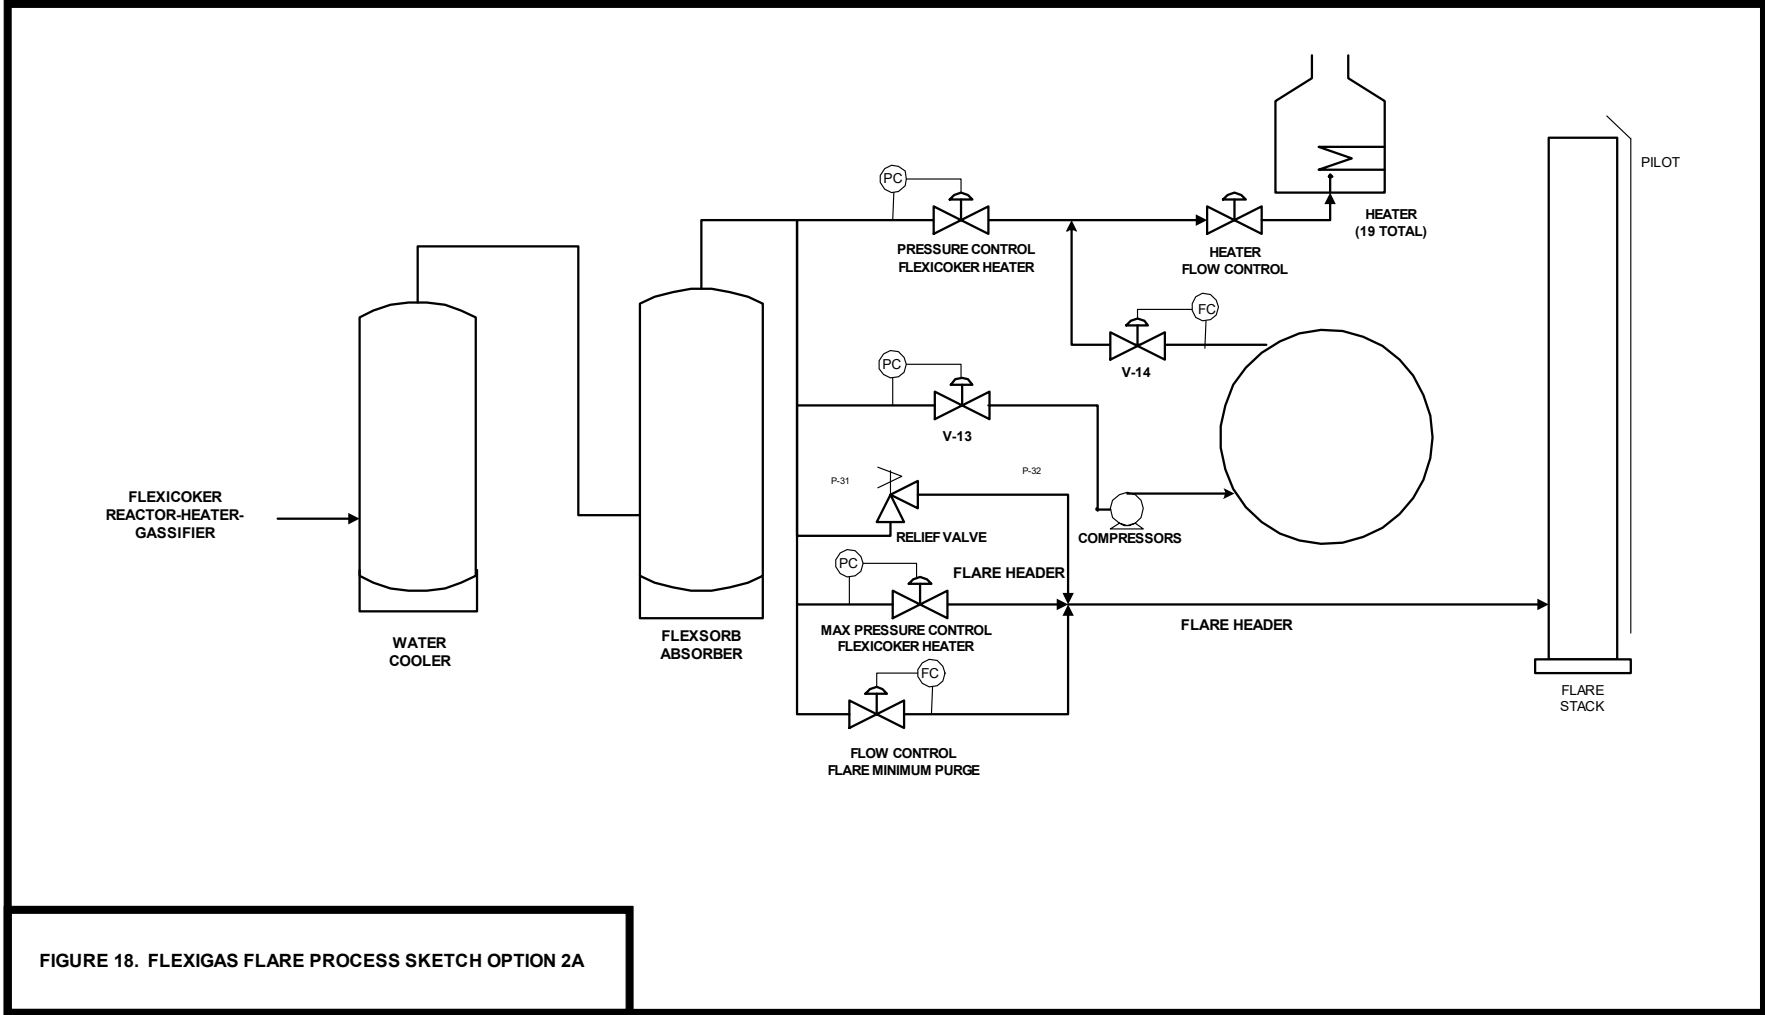
FIGURE 18. FLEXIGAS FLARE PROCESS SKETCH OPTION 2A

Option 2A consists of a pressurized vessel that would require a compressor with capacity ranging between 1 MMSCFD and 10 MMSCFD. This option is depicted in Figure 18. Flexigas in excess of consumer demand is routed to storage via compressor(s). A controlled flow is returned to the distribution system when enough consumers are available to avoid flaring. Due to the limited capacity of this storage, it has no real capability to accommodate prolonged fuel system imbalances. As a result, the expected best-case emission reductions are about the same as those available in 2005. A rough capital cost for the storage and large compressors is about \$27,000,000²². Annual electrical costs for the required compressors add another \$600,000. The annualized capital plus electrical costs to eliminate a ton of non-methane hydrocarbon result in a cost-effectiveness of approximately \$190 Million dollars per ton. Therefore, Option 2A is even less cost-effective for reducing flaring than Option 1.

²² Based on a nominal 1 MMSCF sphere (60' diameter) at 120 psig, and two 4 MMSCFD compressors. This system would handle only minor imbalances while the Flexicoker cuts rate.

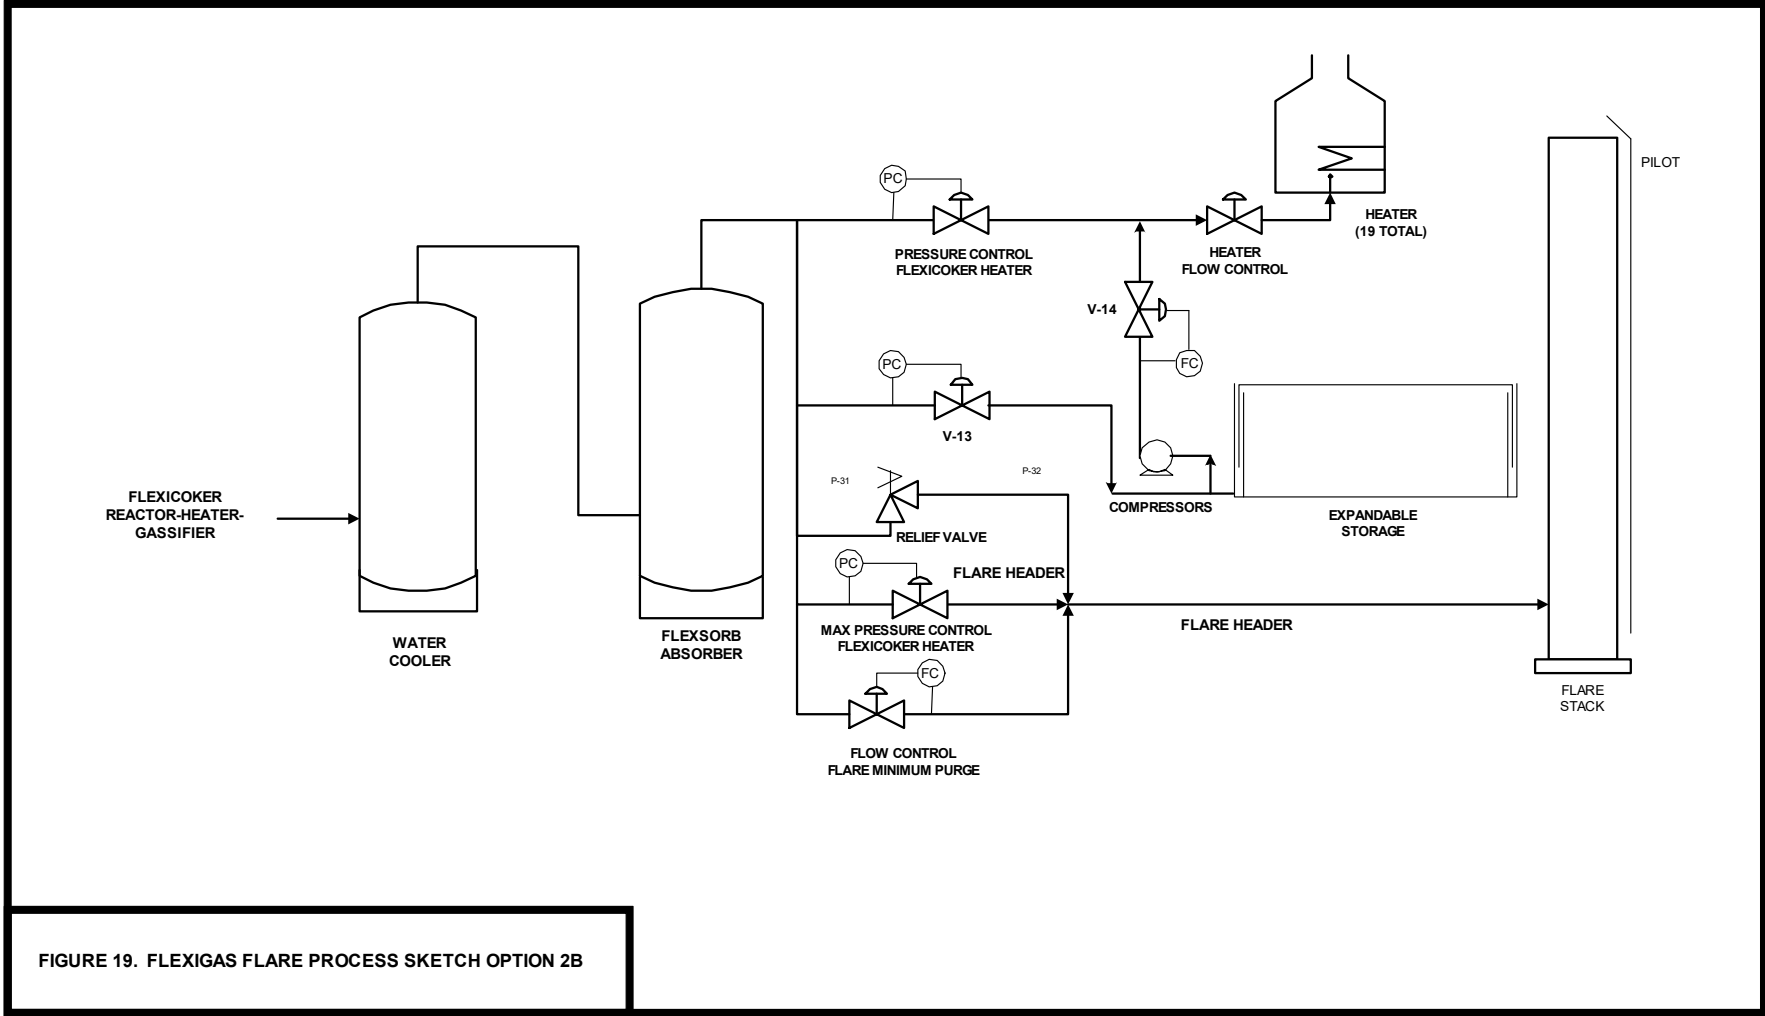
FIGURE 19. FLEXIGAS FLARE PROCESS SKETCH OPTION 2B

Option 2B uses low-pressure expandable gas storage. This option is depicted in Figure 19. This type of storage can be built significantly larger than the pressurized storage used in option 2A, and has the advantage of not requiring compressors in some cases. However, the concentration of carbon monoxide in the gas will likely require use of a water seal to limit leakage, restricting vessel height to a single lift. The requirement for a single lift, combined with low-pressure operation, significantly limits available storage volume²³. In any event, the installed cost is approximately \$21,000,000, providing cost-effectiveness of approximately \$276 Million dollars per ton of NMHC. As was the case for Option 2A, this option is even less cost-effective for reducing flaring than Option 1.
