**Shell Martinez Refinery**

**Regulation 12 Rule 12**

**FLARE MINIMIZATION PLAN**

**Updated January 21, 2020**

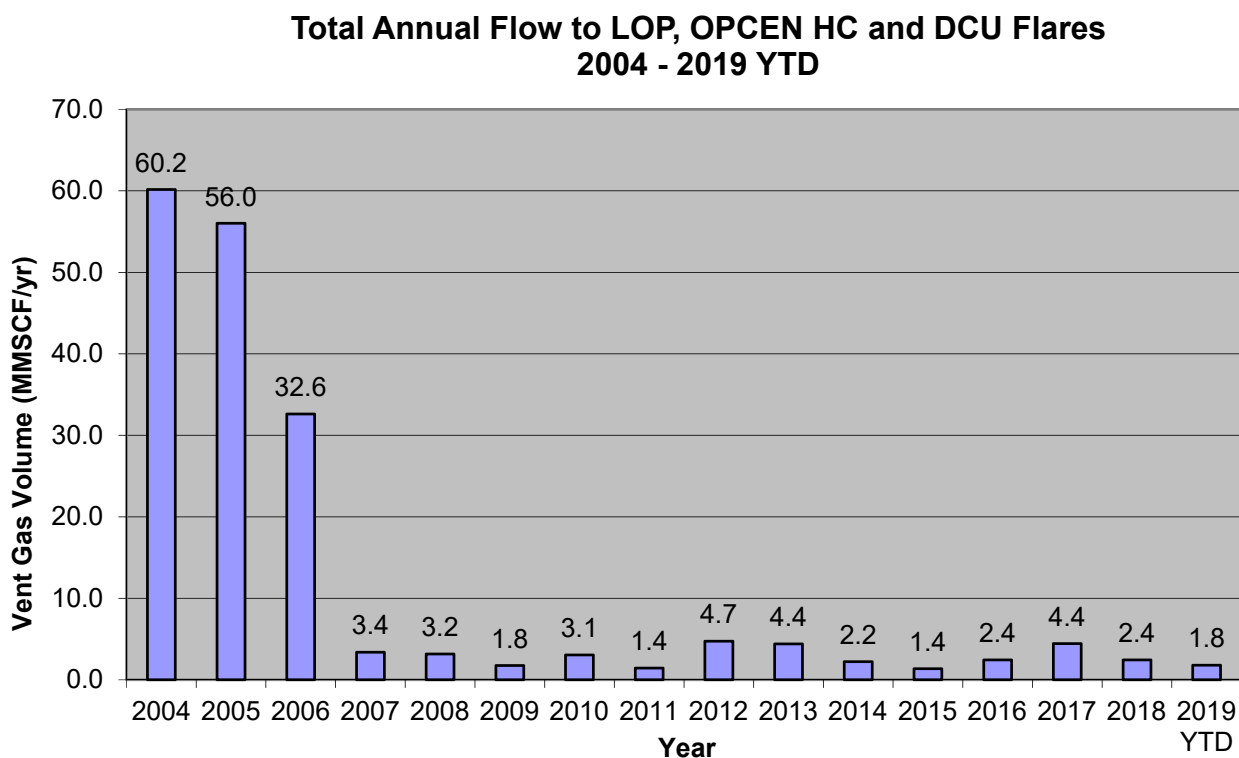
**FIGURE ES-1**

Figure ES-1 presents the total annual vent gas flow to the Light Oil Processing (LOP), Operations Central Hydrocarbon (OPCEN HC) and Delayed Coking Unit (DCU) Flares at the refinery from 2004 through June 30, 2019. Flare flow continues to be very low.

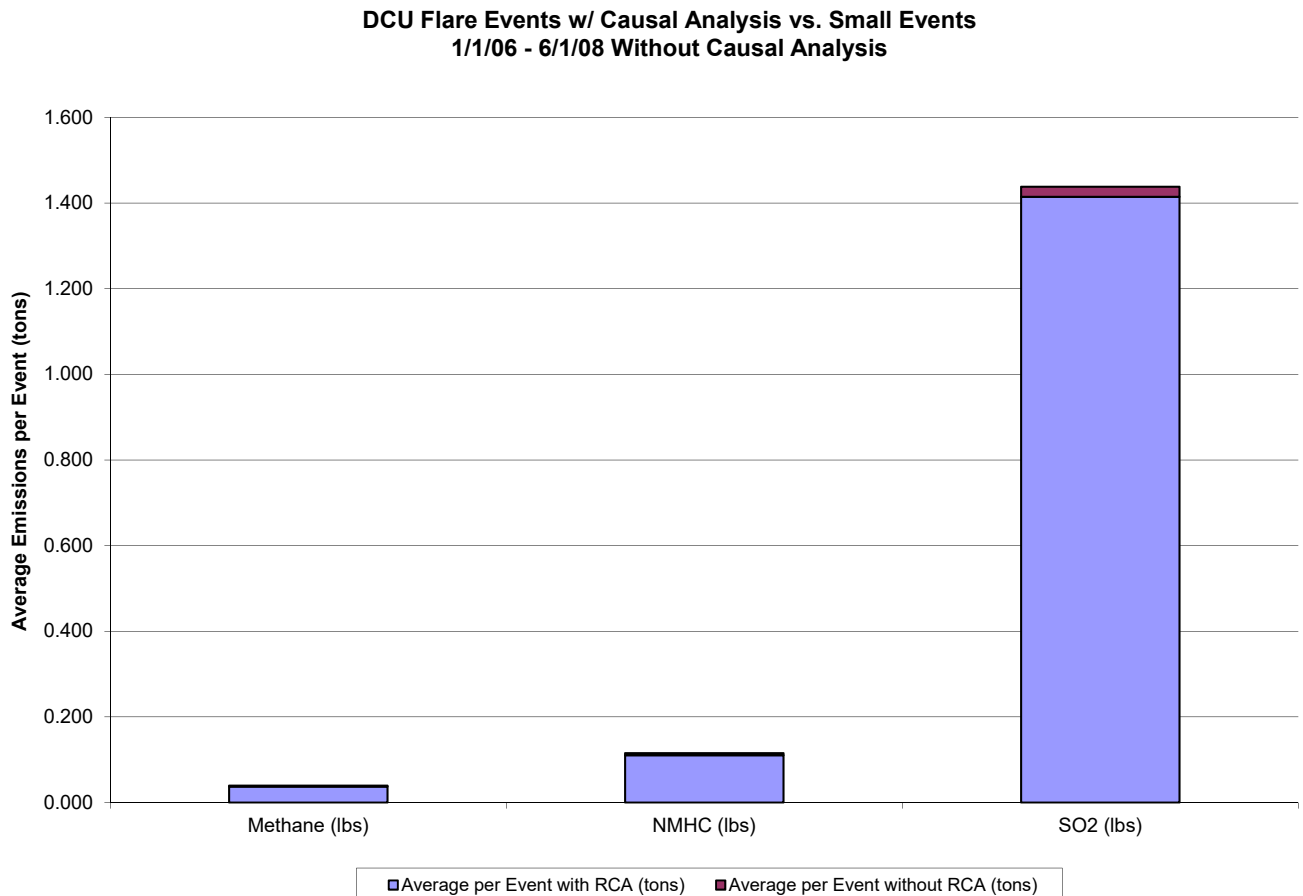
**FIGURE 2008-2**

Beginning in November 2006 with the adoption of the Flare Procedures described in the Common Measures Section, pertinent information, when available, was captured immediately after a flaring event to determine the cause of any flaring and what could be done to prevent it from happening again. Total emissions from all flaring during this 30-month period were: 0.17 tons of methane, 0.45 tons of non-methane hydrocarbon and 4.19 tons of SO<sub>2</sub>. Figure 2008-2 presents a comparison of the average emissions per large reportable events over this time period vs. the average emissions per small event for the DCU Flare. This figure shows that small events contributed < 6% of the emissions of a large event. Figure 2008-2 reinforces the appropriateness of the causal analysis trigger of 0.5 MMSCF/ 500 lbs SO<sub>2</sub> to ensure the resources to conduct a Causal Analysis are most effectively applied to address high emission events.

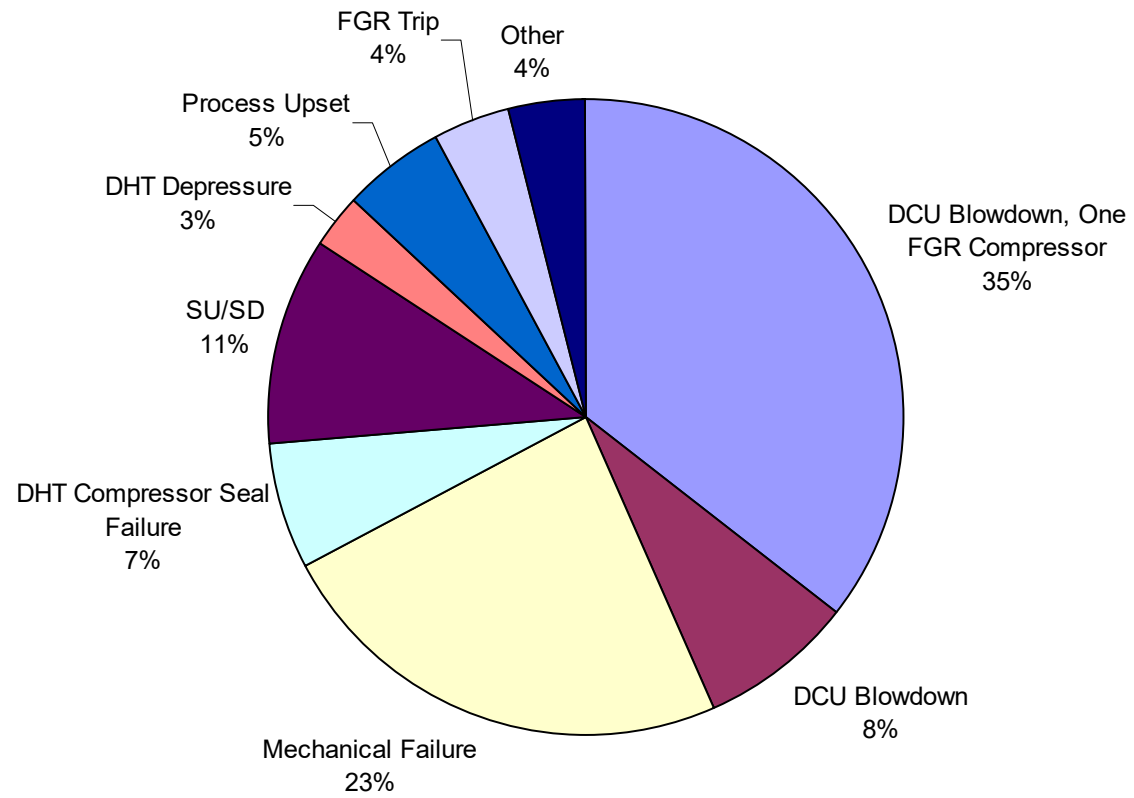
**Figure 8. Delayed Coking Area Flare Events  
(2000 - 2005) 76 Events**

**Flaring prior to January 2004.** Review of flare events prior to January 2004 provided little usable information. Without flow meters, neither durations nor volumes may be determined with accuracy approaching that with flowmeters installed. In many cases, even the proximate cause of flaring could not be reliably determined due to the limited documentation and time elapsed since the event. With these qualifications, a breakdown for general cause of Delayed Coking flare events for the previous five years is depicted in Figure 8. A description of the various categories listed is provided below:

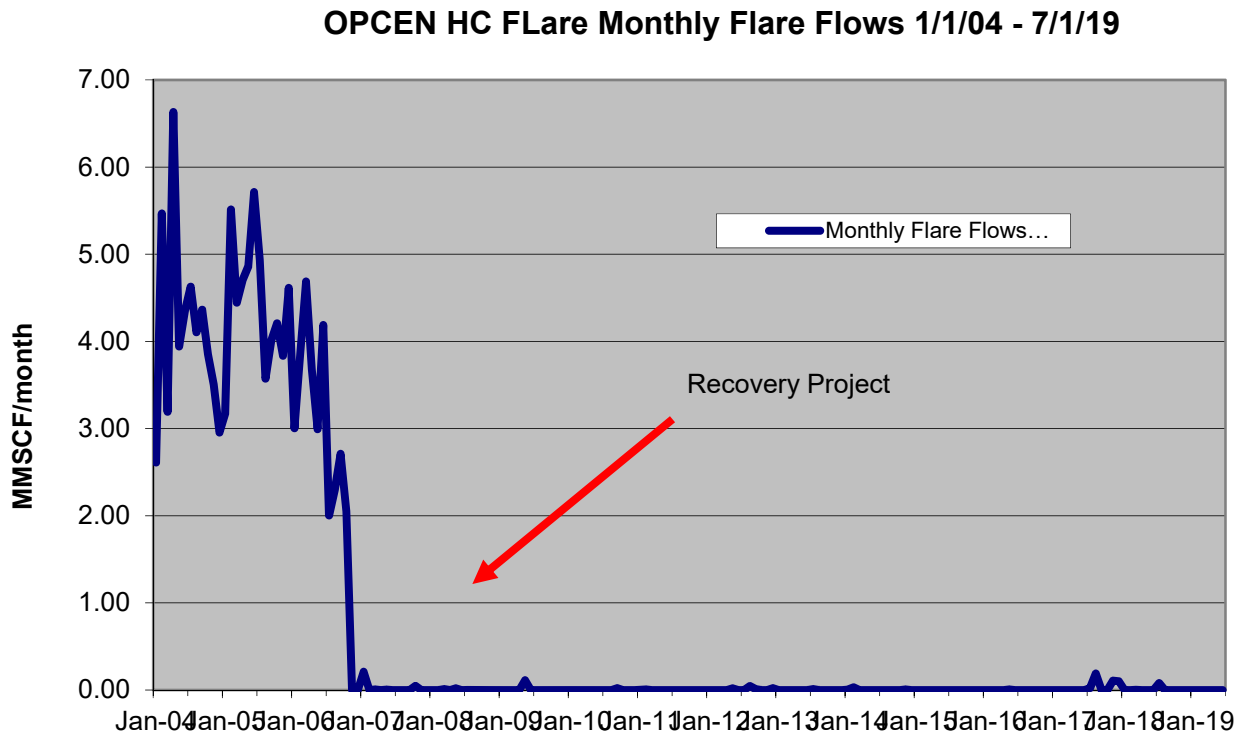
**FIGURE 1**

Figure 1 below has been updated through 7/1/18 and shows the continued success of the implementation of the flare recovery project that occurred in 2006 on this flare.

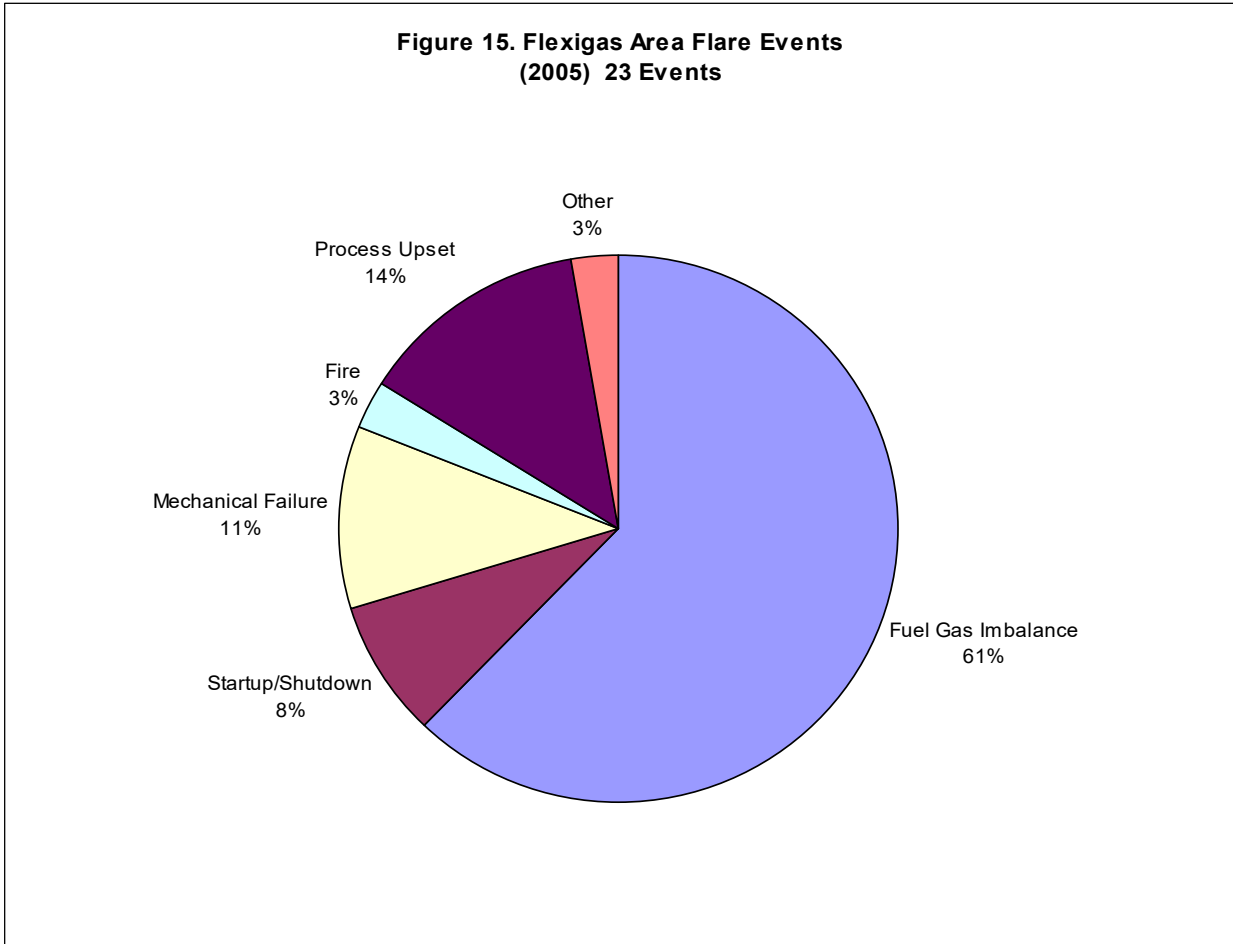
Historical flaring at the OPCEN Flexigas flare was reviewed to identify opportunities for potential mitigation. The highest quality data are available for the period from December 2003, to January 2006. This coincides with installation of the flare flow meter and BAAQMD flare reporting. Data for 2005 are plotted in Figure 15 and Figure 16.
