Annual Update of Flare Minimization Plan - Public
Chevron Richmond Refinery

Flare Minimization Plan

Chevron Products Company - Richmond Refinery

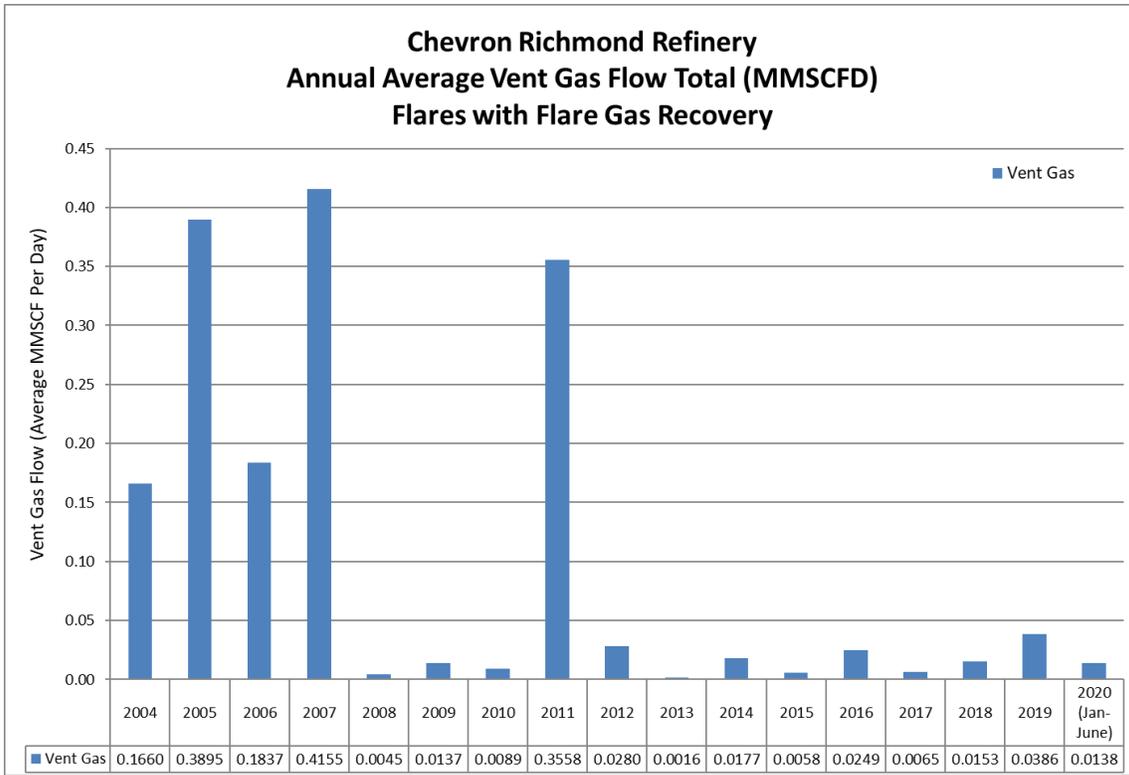
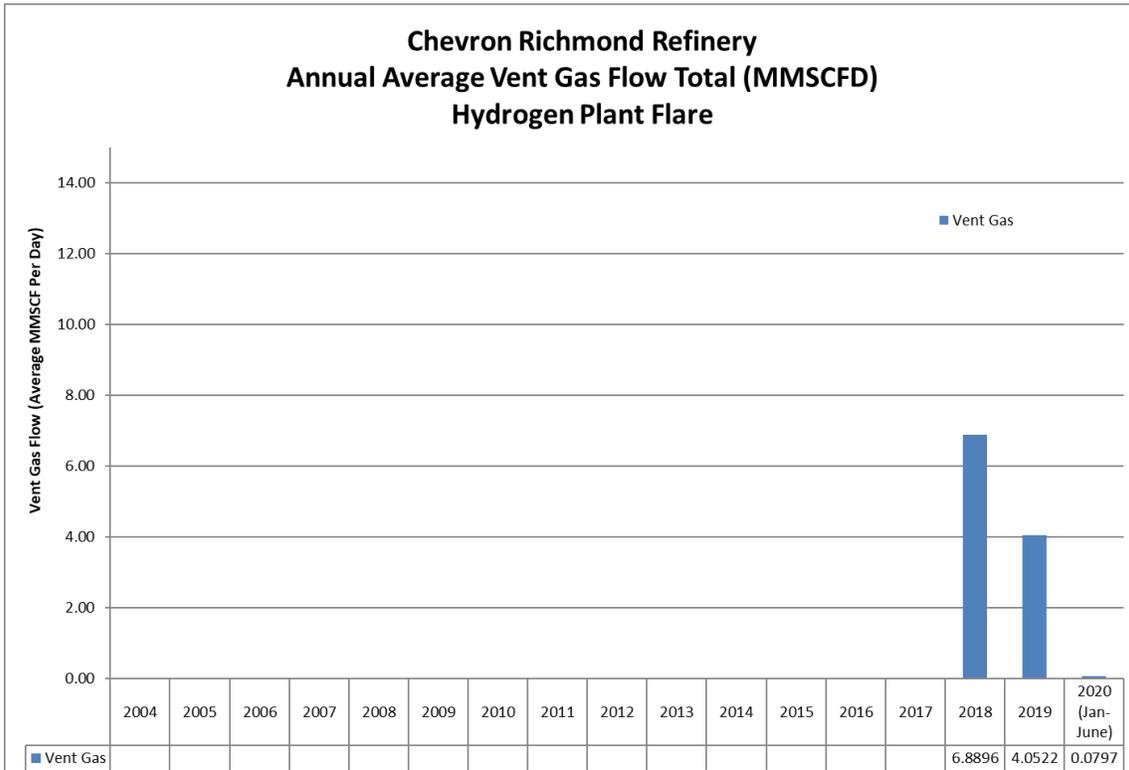
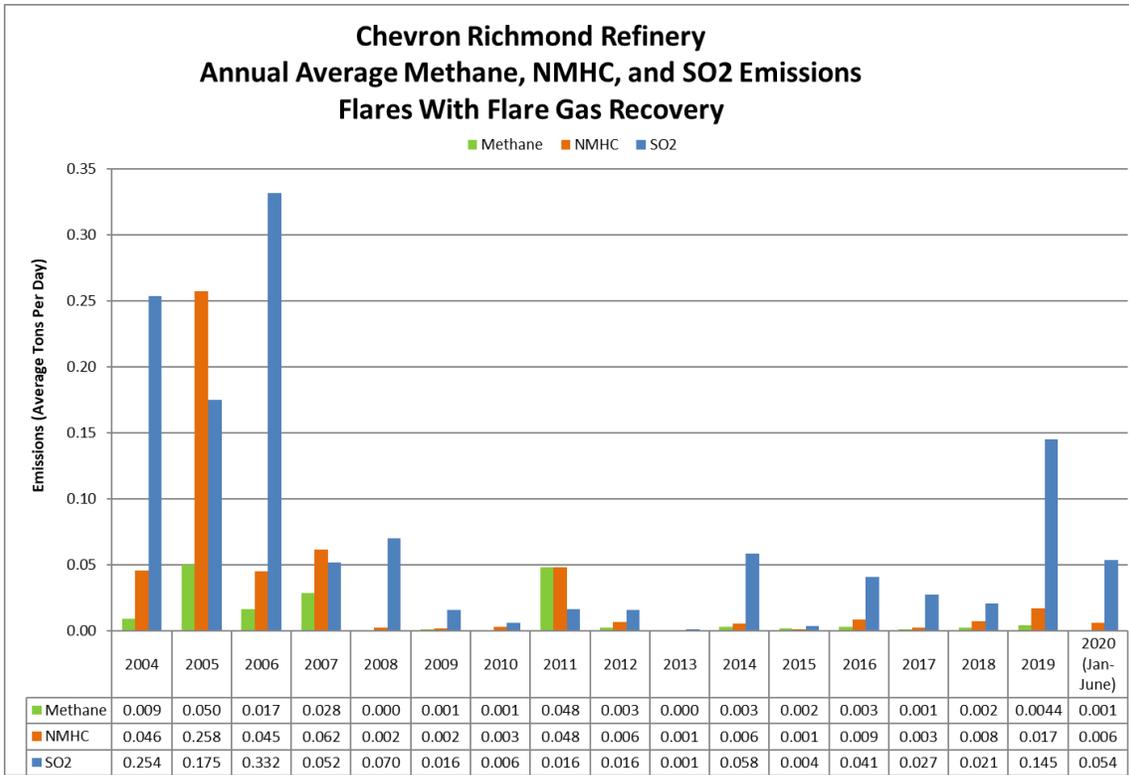
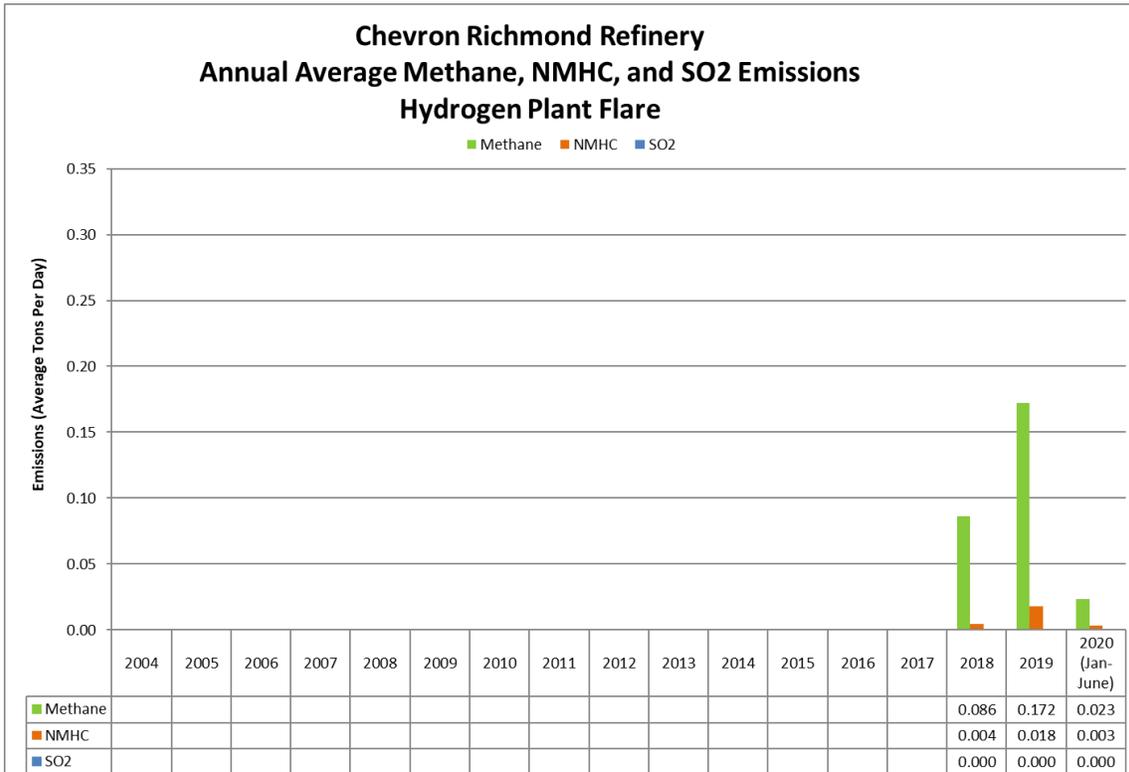
Graphics Depicting Progress of Flare Minimization

The following graphics demonstrate the reduction in flaring since 2004. The first two graphs display the annual average quantities of vent gas flow. The second two graphs display the annual average methane, non-methane hydrocarbon (NMHC), and sulfur dioxide (SO₂) emissions. Seven of the refinery flares have flare gas recovery and are reported in the same graphic. The Hydrogen Plant Flare does not have flare gas recovery and is designed to flare during scenarios including start-up and shutdown. In addition, the primary gases flared at the Hydrogen Plant differ from the gases flared at the other refinery flares. For these reasons, Hydrogen Plant Flare volumes and emissions are reported in separate graphs.

Hydrogen Plant Flare vent gas (primarily hydrogen) has significantly decreased since 2019 due to the completion of start-up and commissioning of the Hydrogen Plant. Flare volumes and emissions from the flares with water seals has also greatly decreased due to the completion of the start-up and commissioning of the Hydrogen Plant. The vent gas, methane, NMHC, and SO₂ reduced on a daily average basis from the 2019 calendar year to first half of 2020. Table 1 quantifies the change in vent gas and emissions from January-December 2019 to January-June 2020 on a daily average basis.

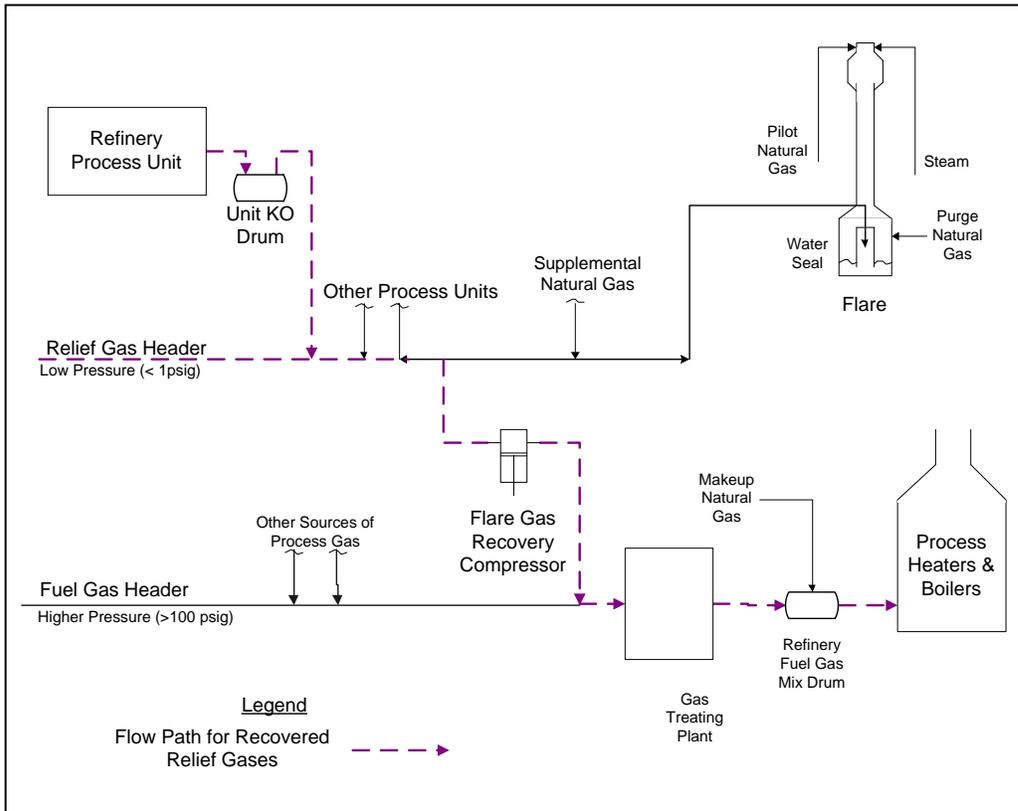
Figure 1-1, Simple Schematic - Flare System with Flare Gas Recovery

The following section describes how gases are generated and handled by refinery flare systems. A simplified schematic of a refinery flare system with flare gas recovery is shown in Figure 1-1.

A simplified diagram of the hypothetical design is shown in Figure 5-2. The diagram in Figure 5-2 highlights differences from the typical Flare Gas Recovery System shown previously in Figure 1-1. Results of this evaluation are provided for two system capacities for the North Yard Flare Gas Recovery System, and two system capacities for the South Yard Flare Gas Recovery System.

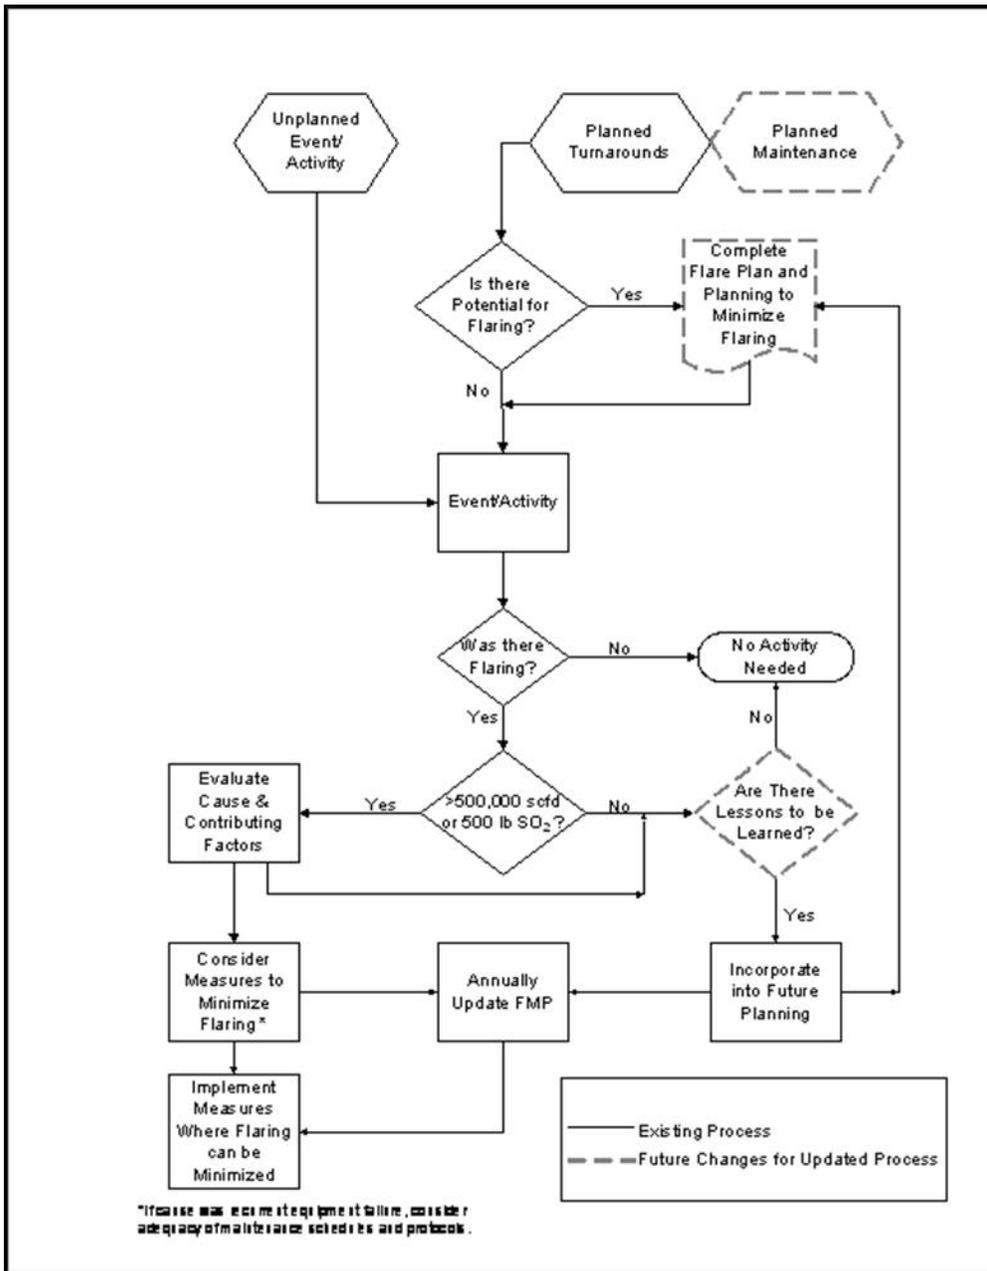
Figure 5-1, Flare Planning Process Flowchart

There are occasions, primarily as a result of equipment malfunction, where a relatively immediate decision is made to shutdown a block of the refinery, typically within a period of days, allowing little time for the kind of specific planning used for turnarounds and planned maintenance. In these cases, it is often not possible to make the same level of plant adjustments necessary to minimize flaring to the extent possible when a shutdown is planned far in advance. Despite this, there are actions that can be taken to minimize flaring even when there is very little advance notice. For these cases, the refinery utilizes general procedures to minimize flaring for unplanned events, as shown in Figure 5-1. Although there is less of an opportunity for scheduling shutdown procedures so as to ensure that there will be a home for all of the gas generated at each step of the process, many of the same general principles apply when the decision to bring the unit down is immediate. A flowchart of the Richmond Refinery's Flare Planning process is shown below, in Figure 5-1. This flowchart identifies aspects of the existing process, and highlights areas that will be updated.

Causal analyses of flaring events identified actions to maintain plant reliability that would reduce the likelihood of incidents which could cause potential flaring. These actions included the inspection and repair of equipment components that were either implemented as part of normal operations, or were scheduled for the next plant turnaround as described in Section 5.1.6 and Figure 5-1. Other actions are included in Table 4-1 below.

The development of flare plans under IMPACT SCS Task No. 27 is joint effort between the turnaround Operations Coordinator, Plant Process Engineer, and the IMPACT Planner. The improvements to this procedure are shown in figure 5-1 and listed in table 4-1.

The flowchart shown in Figure 5-1 covers the range of potential flaring events that the refinery might experience.
