Martinez Refining Company

FLARE MINIMIZATION PLAN

Updated October 1, 2020

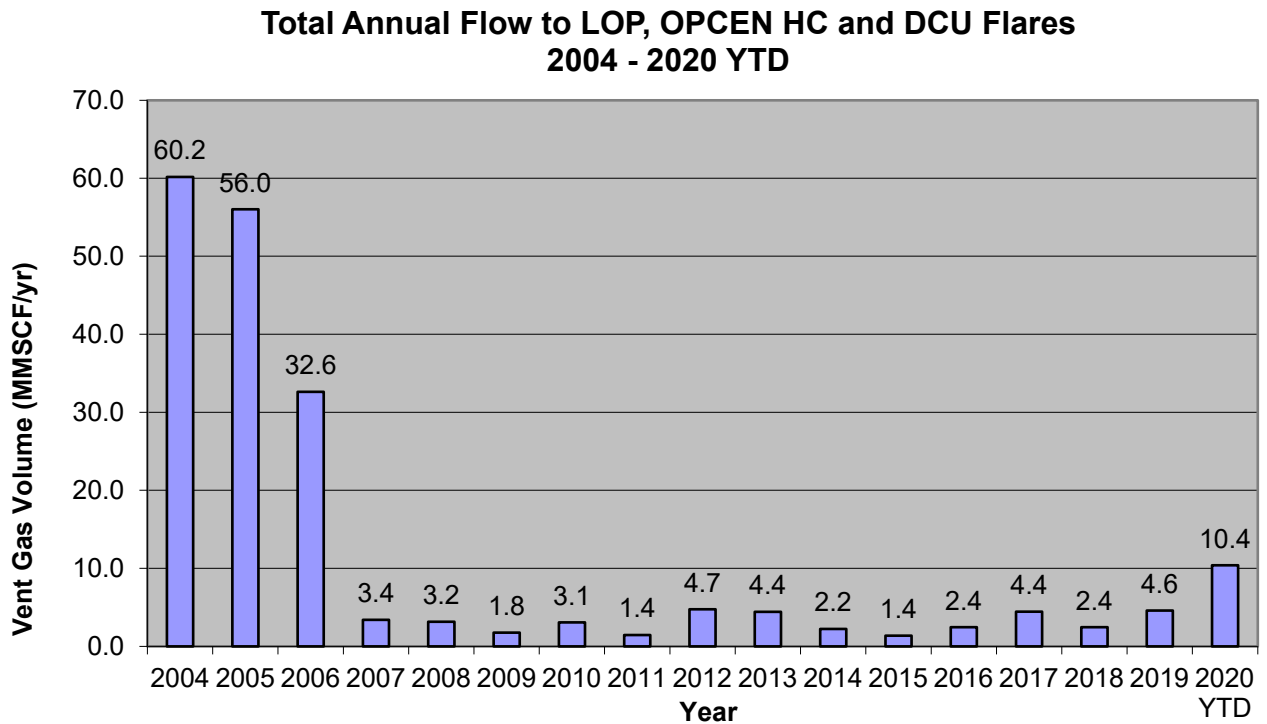
FIGURE ES-1

Figure ES-1 presents the total annual vent gas flow to the Light Oil Processing (LOP), Operations Central Hydrocarbon (OPCEN HC) and Delayed Coking Unit (DCU) Flares at the refinery from 2004 through June 30, 2020. Flare flow continues to be very low.

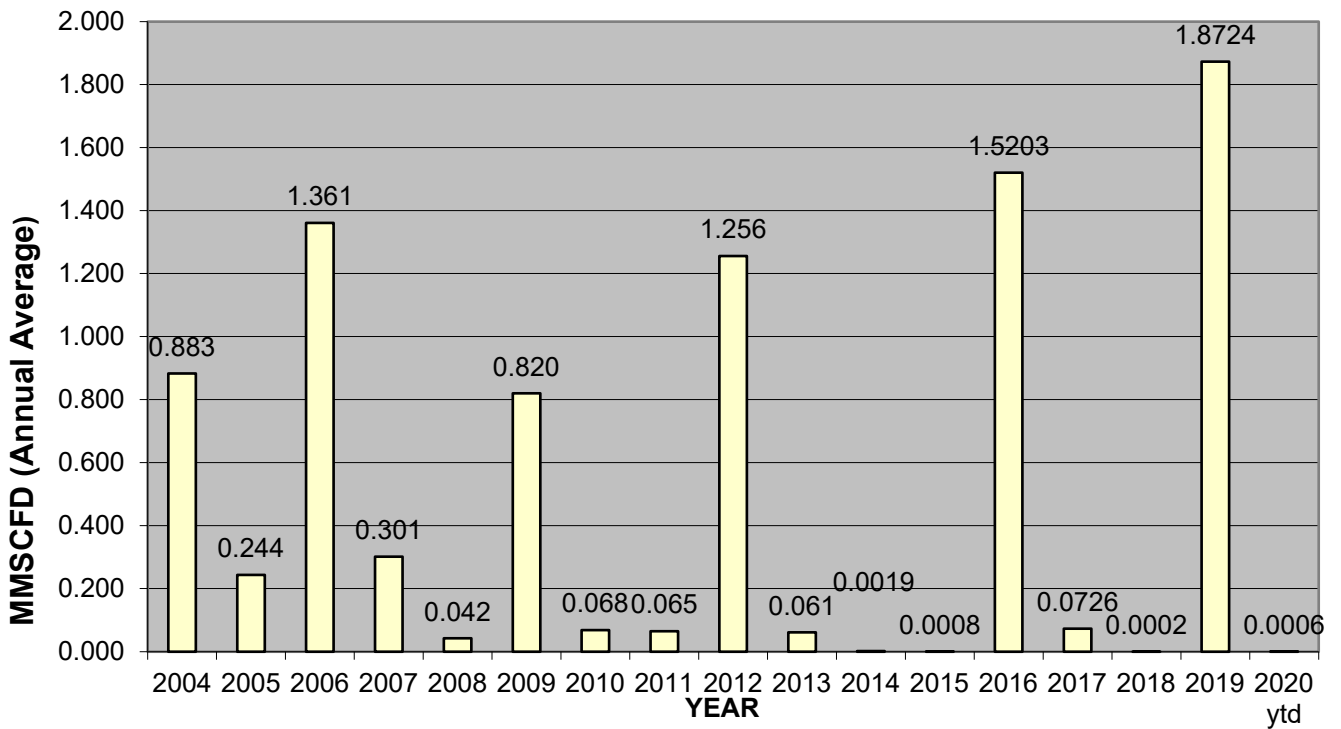
FIGURE ES-2

Figure ES-2 shows the annualized vent gas flow from the Flexigas Flare. This figure shows a cyclic increase in Flexigas flaring which occurs during years with startup and shutdown of the Flexicoker due to the nature of the Flexicoking and Flexsorb processes. The flaring of treated flexigas during startups and shutdowns of the Flexicoker is allowed up to specified limits in MRC's Title V permit. Flexigas is a very low BTU gas used as a supplemental refinery fuel gas in refinery process heaters. Flexigas is treated for sulfur removal in the Flexsorb Unit before being combusted either in refinery process heaters or if necessary, in the Flexigas Flare. When FXG is flared, the volume of gas is typically large compared to the volume flared in the other refinery process flares, but emissions are significantly less because Flexigas contains very low concentrations of non-methane hydrocarbon and sulfur.

Flexigas flaring can also occur due to refinery fuel gas imbalance. MRC continues to fine-tune the Flexigas pressure control scheme to minimize flexigas flaring due to small imbalances in fuel gas. Improvements in this system, most notably addition of COGEN to the pressure control scheme, contribute to the very low flexigas flare flow rate seen in non-turnaround years including 2013, 2014, 2015, 2017, and 2018.

**Flexigas Flare Flow
2004 - 2020 YTD**

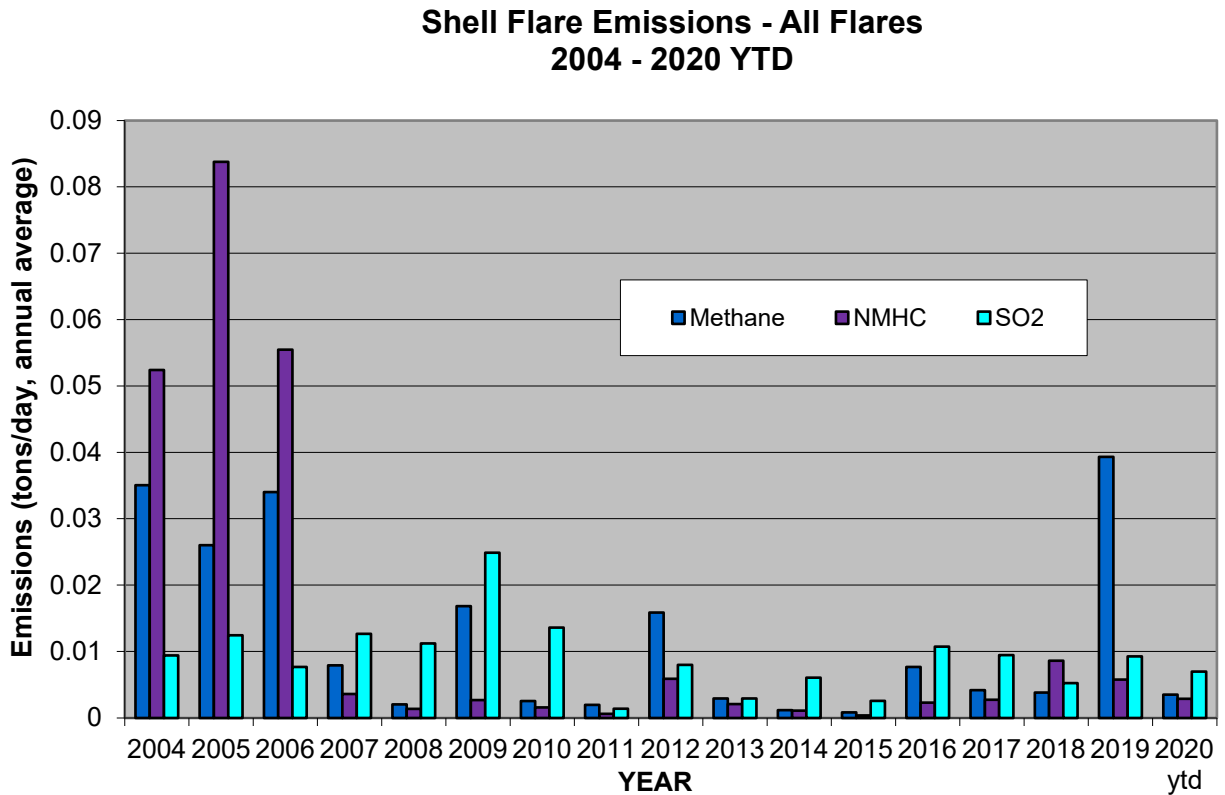
FIGURE ES-3

Figure ES-3 shows the methane, non-methane hydrocarbon and sulfur dioxide emissions from all four refinery process flares from 2004 through June 30 of this year.

Figure ES-3 shows the significant reduction in emissions that has occurred since the implementation of the Flare Minimization Plan in 2006 and highlights that even with large volumes of flexigas flaring during turnaround years, overall emissions from flaring are low.

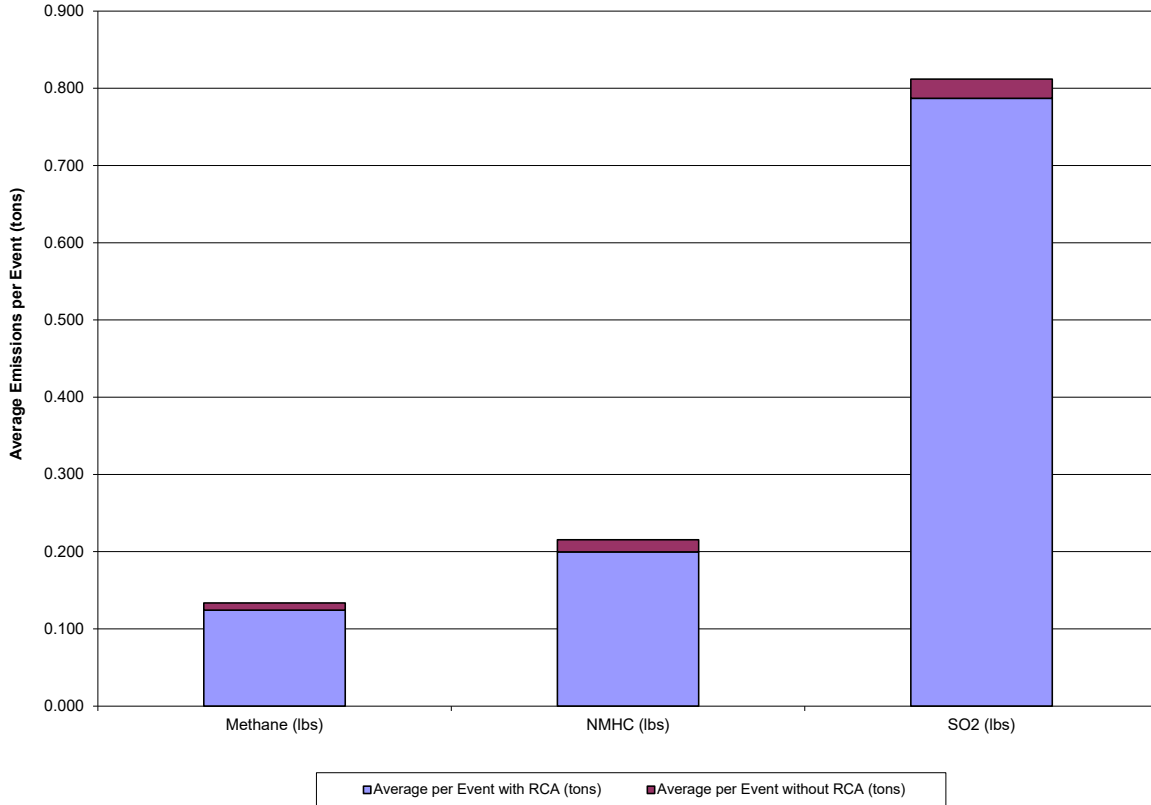
FIGURE 2008 –1

LOP Flare Events w/ Causal Analysis vs. Small Events
1/1/06 - 6/1/08

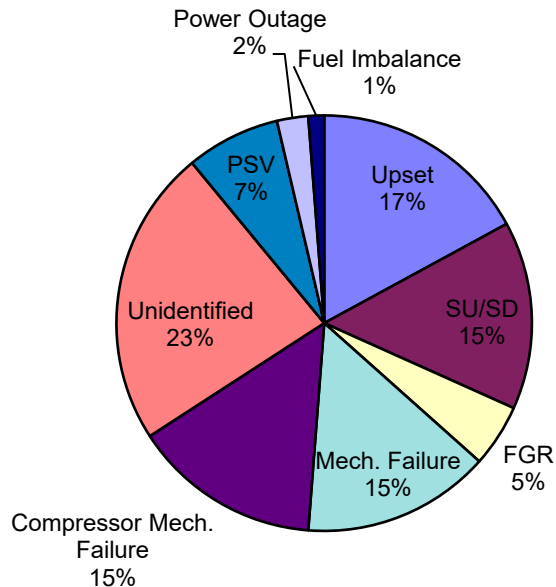
**Figure 2. LOP Area Flare Events
(2000-2005)**

Based on these data, about 65% of the flare events occurring from 2000 - 2005 are essentially evenly divided among the following categories: process upsets, process startup and shutdowns, mechanical failures of compressors and other equipment. Almost one quarter of the time the occurrences where the water seal was broken indicating that flaring occurred were so small, and of such brief duration, no cause could be reliably determined.

Figure 2 illustrates that there are a wide range of events that can cause flaring at LOP. The annual volume of gas flared could be reduced in two basic ways. One alternative is an increase in the capacity of the flare gas recovery system. The second is improved measures to limit the rate and volume of gas discharged to the flare gas header so that it does not exceed the capacity of the existing recovery system. These two alternative approaches are discussed below.

Figure 2 shows that activities that have occurred during startups and shutdowns have contributed to less than 15% of the flare events that occurred historically at the LOP flare. Analysis of the flaring back to 2005 indicate that flaring may have been prevented by changing operating practices, improved planning, or minor hardware revisions. The trend over the past years indicates that startup, shutdowns and maintenance-related flaring can be significantly reduced and largely eliminated with careful planning. Major turnarounds on units served by the LOP flare continue to be performed without planned flaring. That this work was performed without flaring is evidence of careful review and planning. MRC is committed to continue this careful review and planning prior to planned major maintenance and expect to perform turnarounds with little or no planned flaring. If during the maintenance planning and review process MRC finds that planned flaring is required, as was the case when preparing for the LOP flare pressure vessel inspections, then all appropriate prevention measures will be considered and feasible measures will be implemented to reduce or eliminate the planned flaring.

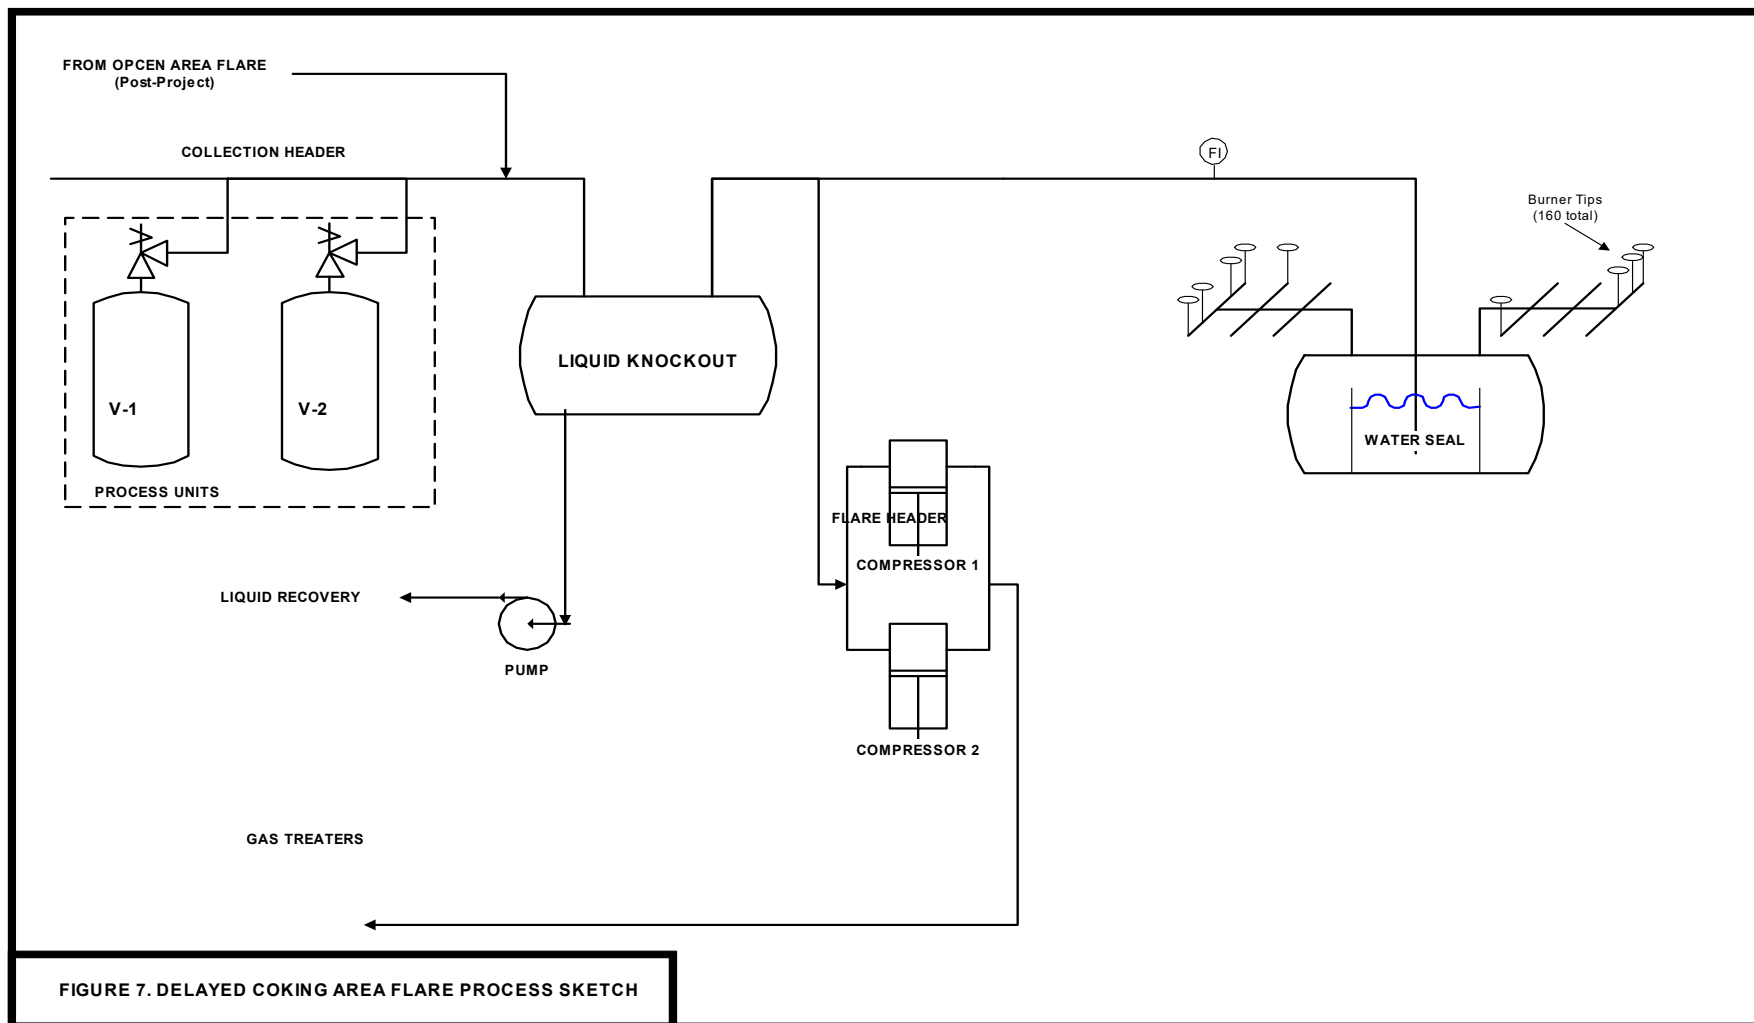
¹² The Delayed Coking Area flare uses an array of 160 separate tips instead of a single stack. This design allows smokeless combustion using very low rates of steam.

Recovered gas from the Delayed Coking and OPCEN HC flare headers is treated to remove sulfur in the Vent Gas Treater in Delayed Coking. Sufficient capacity is available in this gas treater for the incremental flow (up to the total capacity of about 8 MMSCFD). From the Vent Gas Treater, the treated gases may be routed to the refinery fuel gas blend drum for use as fuel in combustion devices throughout the refinery. In addition, the treated gas from the Vent Gas Treater may be used as feed to Hydrogen Plants 2 and 3. Having the option of using the treated fuel gas as feed to the hydrogen plants or fuel for heaters throughout the refinery increases the flexibility of the fuel gas system, reducing the potential for fuel gas imbalance that may cause flaring.

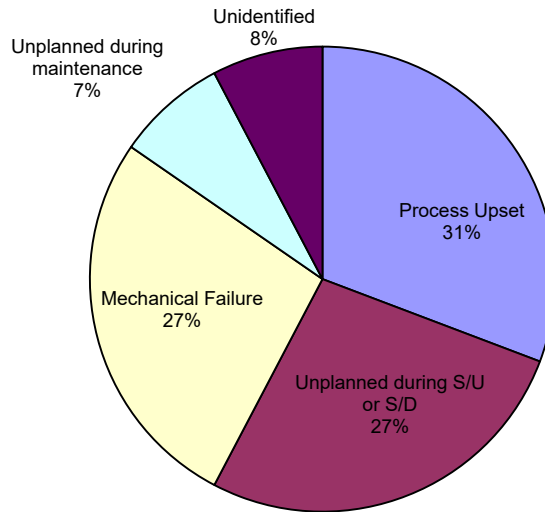
FIGURE 2008 - 3

The DCU flare events that occurred from 1/1/06 – 6/1/08 were categorized by probable cause in Figure 2008-3. None of the flaring was planned. Most of the events were < 10 minutes long. The majority of the events were caused by process upset, mechanical failure or were unplanned during startup and shutdowns.

**Probable Cause of Flaring on DCU Flare 1/1/06-6/1/08
26 Events**

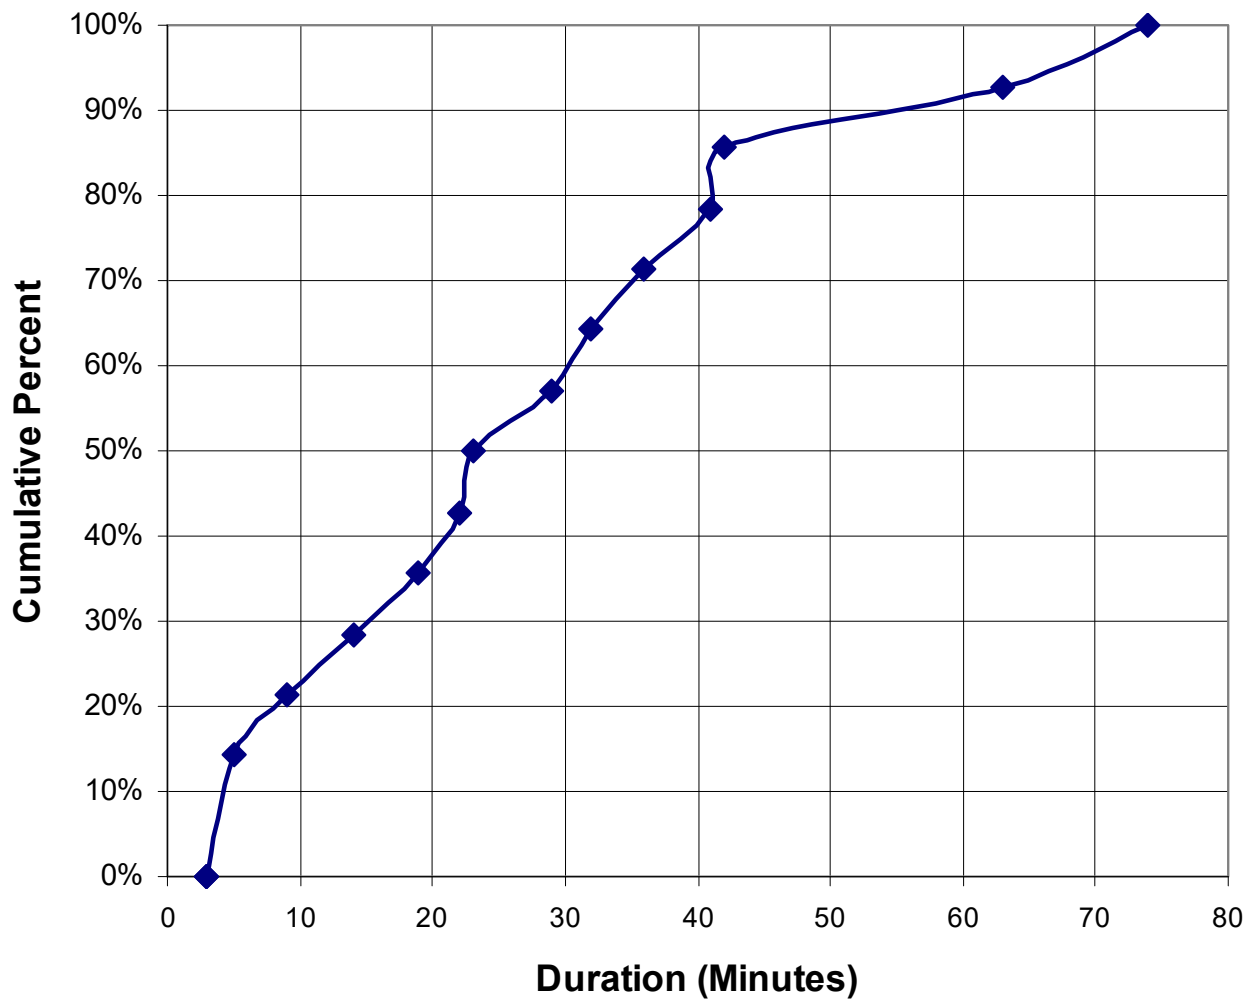
**Figure 11. Delayed Coking Area Flare Event Durations
(2005)**

Figure 11 depicts the distribution of flare event durations for 2005 where these data are available. 50% of the events lasted less than 30 minutes. This is consistent with other data characterizing the bulk of flare events being very brief.

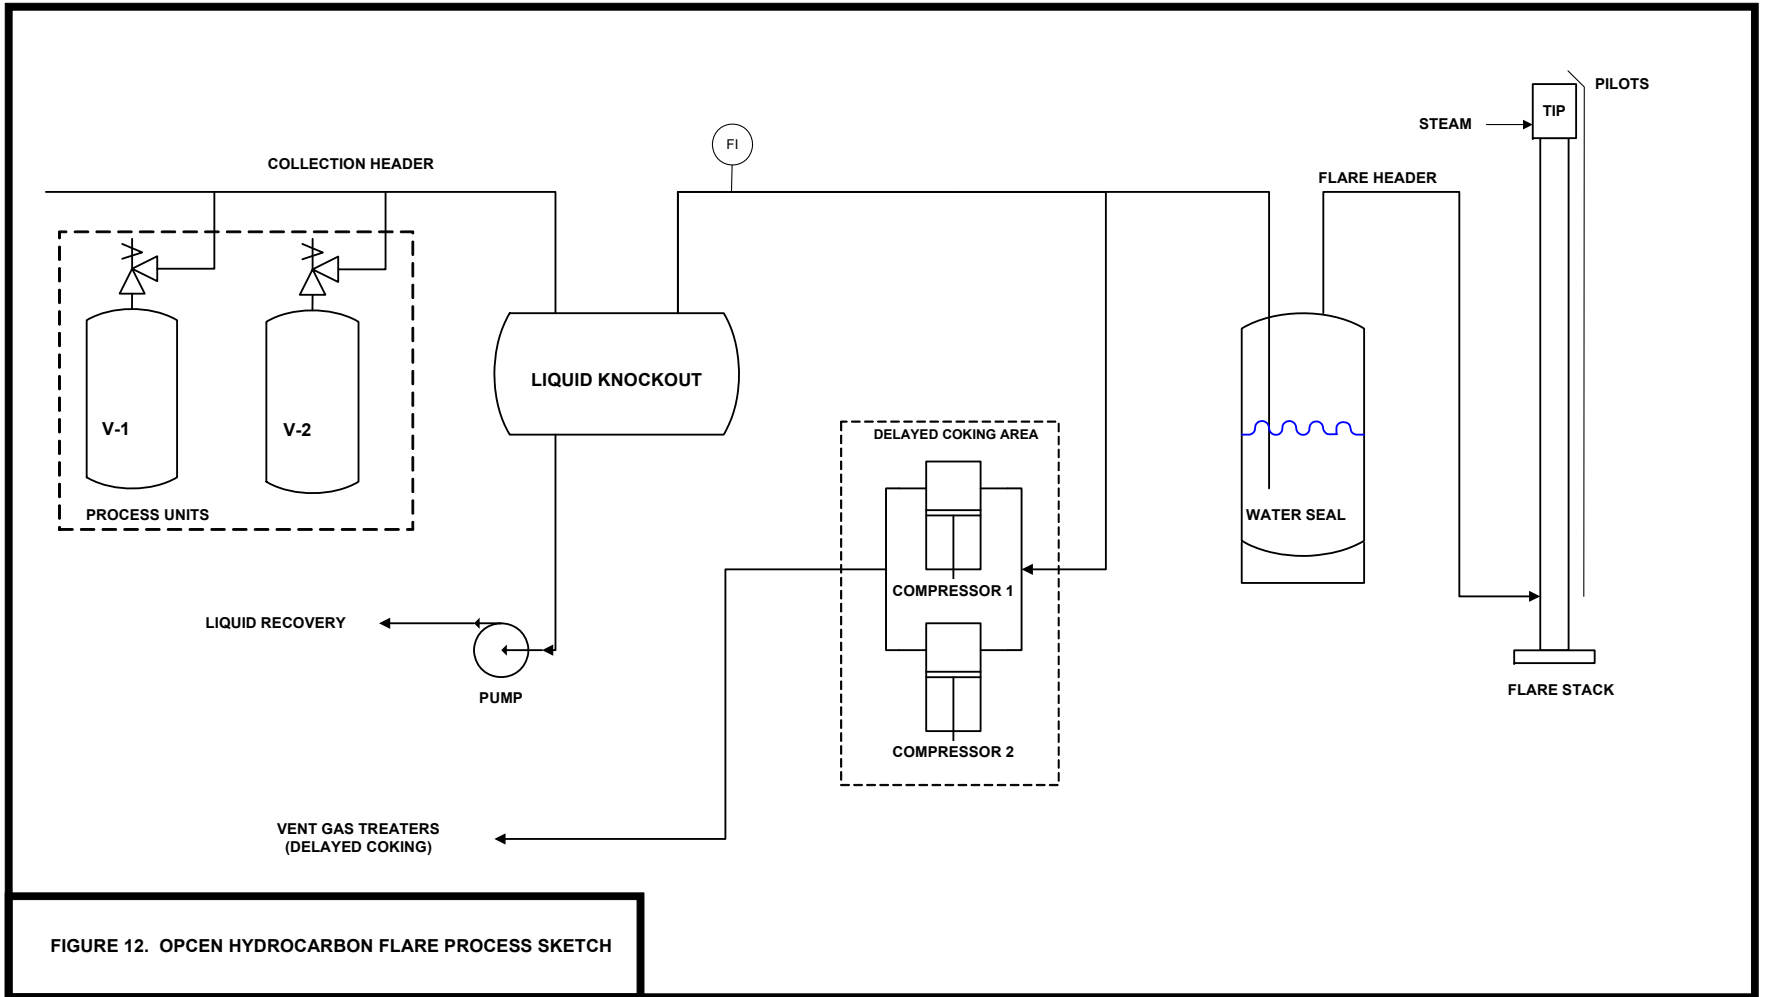
Recovered gas from OPCEN is treated to remove H₂S and routed to fuel and hydrogen plant feed along with the recovered gas from Delayed Coking. The normal routing for Delayed Coker Area recovered flare gas is the Vent Gas Treater. Sufficient capacity is available for the incremental flow (up to the total recovery compressor capacity of about 8 MMSCFD).

¹⁶ This figure includes the flare gas recovery system with the modification. Due to the need for a general shutdown of process units in the OPCEN area, the system was not operable in time for the August 1, 2006 original submittal of this plan. Post-project facilities are used as the basis for system description. However, the historical performance of this flare obviously provides little basis for evaluating mitigation options beyond the implemented flare gas recovery.

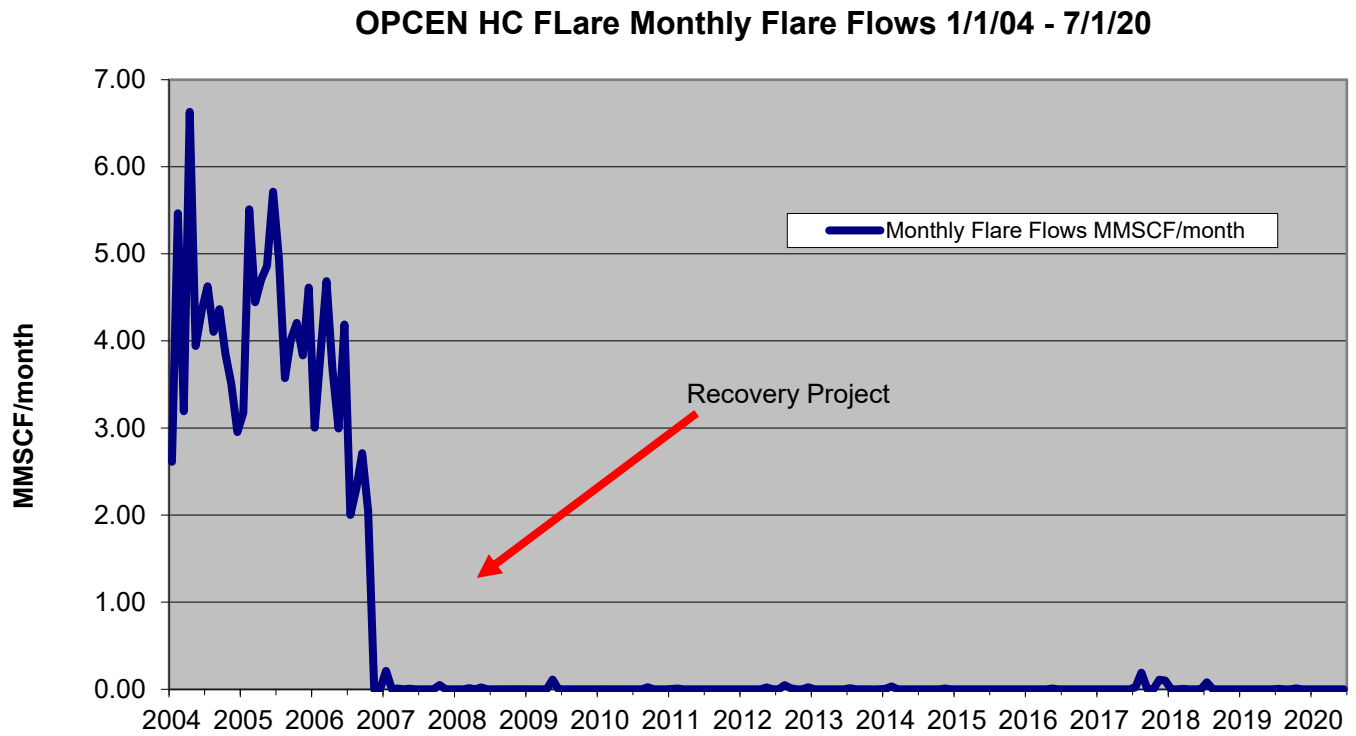
FIGURE 1

Figure 1 below has been updated through 7/1/18 and shows the continued success of the implementation of the flare recovery project that occurred in 2006 on this flare.

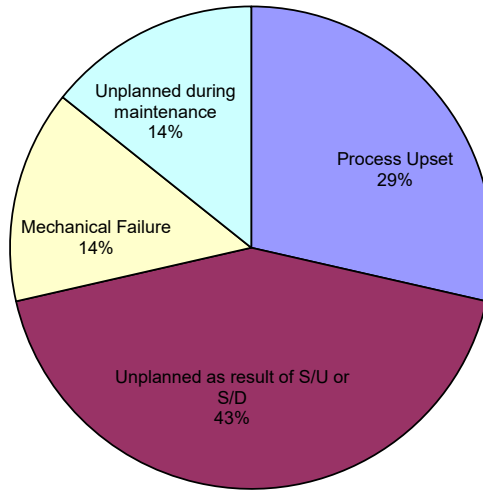
FIGURE 2008-4

The OPCEN HC flare events that occurred after the implementation of flare recovery from 11/1/06 – 6/1/08 were categorized by probable cause in Figure 2008-4. None of the flaring was planned. The cause of the events included process upset, mechanical failure or were unplanned during maintenance or startup and shutdown.

OPCEN HC Flare- Cause of Flaring 11/1/06 - 6/1/08
7 Events

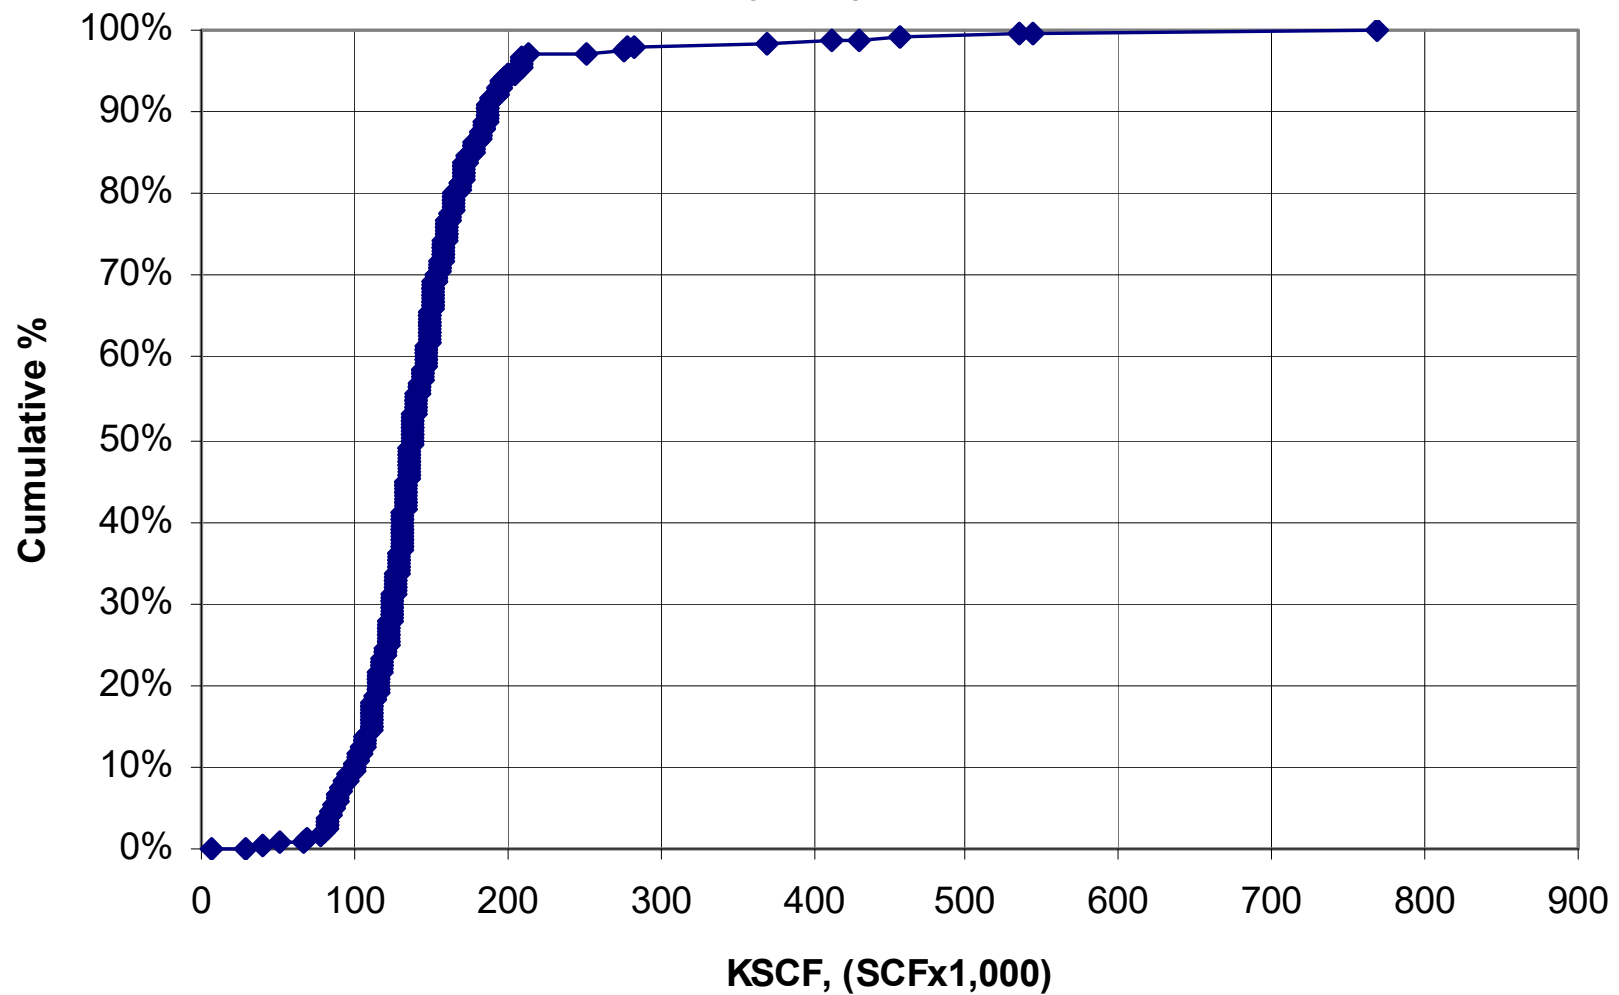
**Figure 13. OPCEN Hydrocarbon Flare Gas Volumes
(2005)**

With historical performance profoundly biased by absence of flare gas recovery, this review concentrated on calendar year 2005. Flare data are depicted in Figure 13. Total emissions of non-methane hydrocarbon during 2005 were approximately 30 tons. Emissions of SO₂ in 2005 were 0.3 tons.

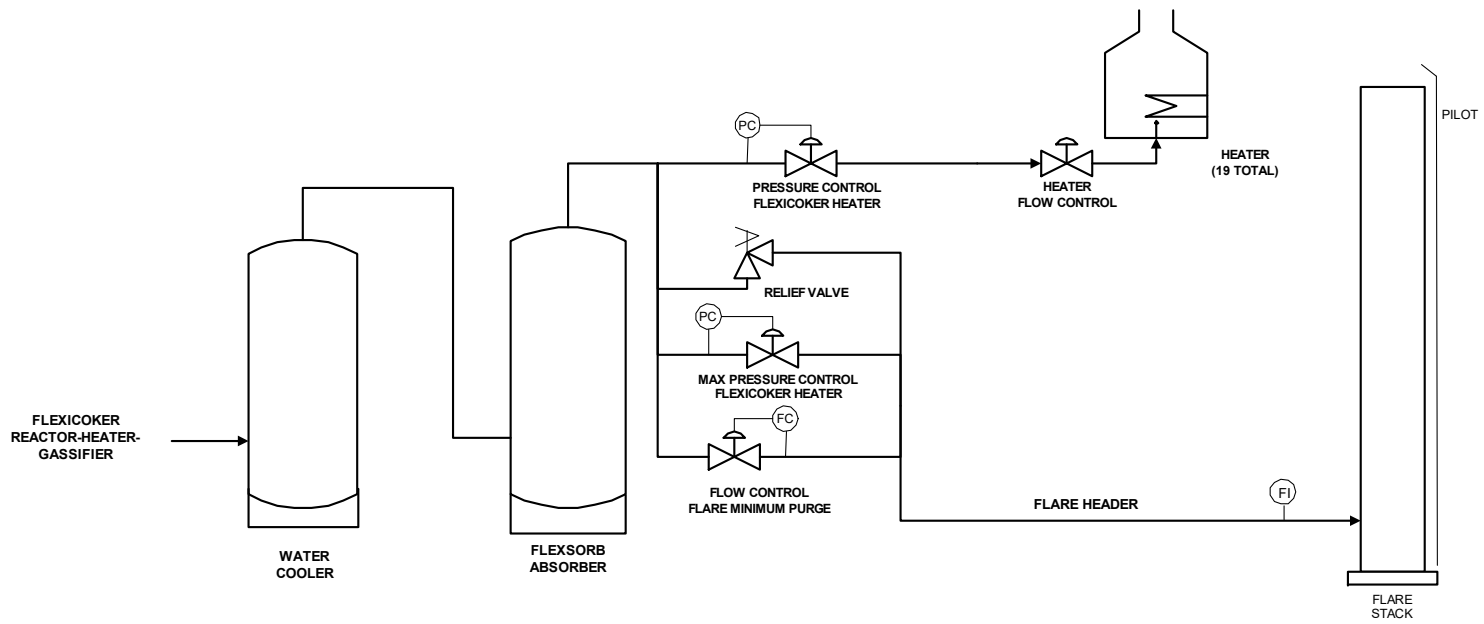
FIGURE 14. FLEXIGAS SUPPLY SYSTEM PROCESS SKETCH

All Flexigas emissions in permit cap: When a Flexigas user unexpectedly comes off-line, it can be difficult to rapidly take up the available gas. Because of the high flows involved, a volume of gas exceeding the Air District definition of flare "event" (0.5 MMSCF) may result before the Flexicoker can reduce production of this gas. In this case, treated Flexigas may be temporarily flared. Emissions from burning flexigas, whether in refinery heaters or the flare, are subject to the permit limits in our refinery emission cap.

¹⁸ Because of its low emissions of SO_x, NO_x and particulates, Flexigas is the fuel flared during those brief periods where a fuel system imbalance occurs as a result of process upset. This may increase the flaring at the Flexigas flare, but results in lower emissions than flaring any other fuel.

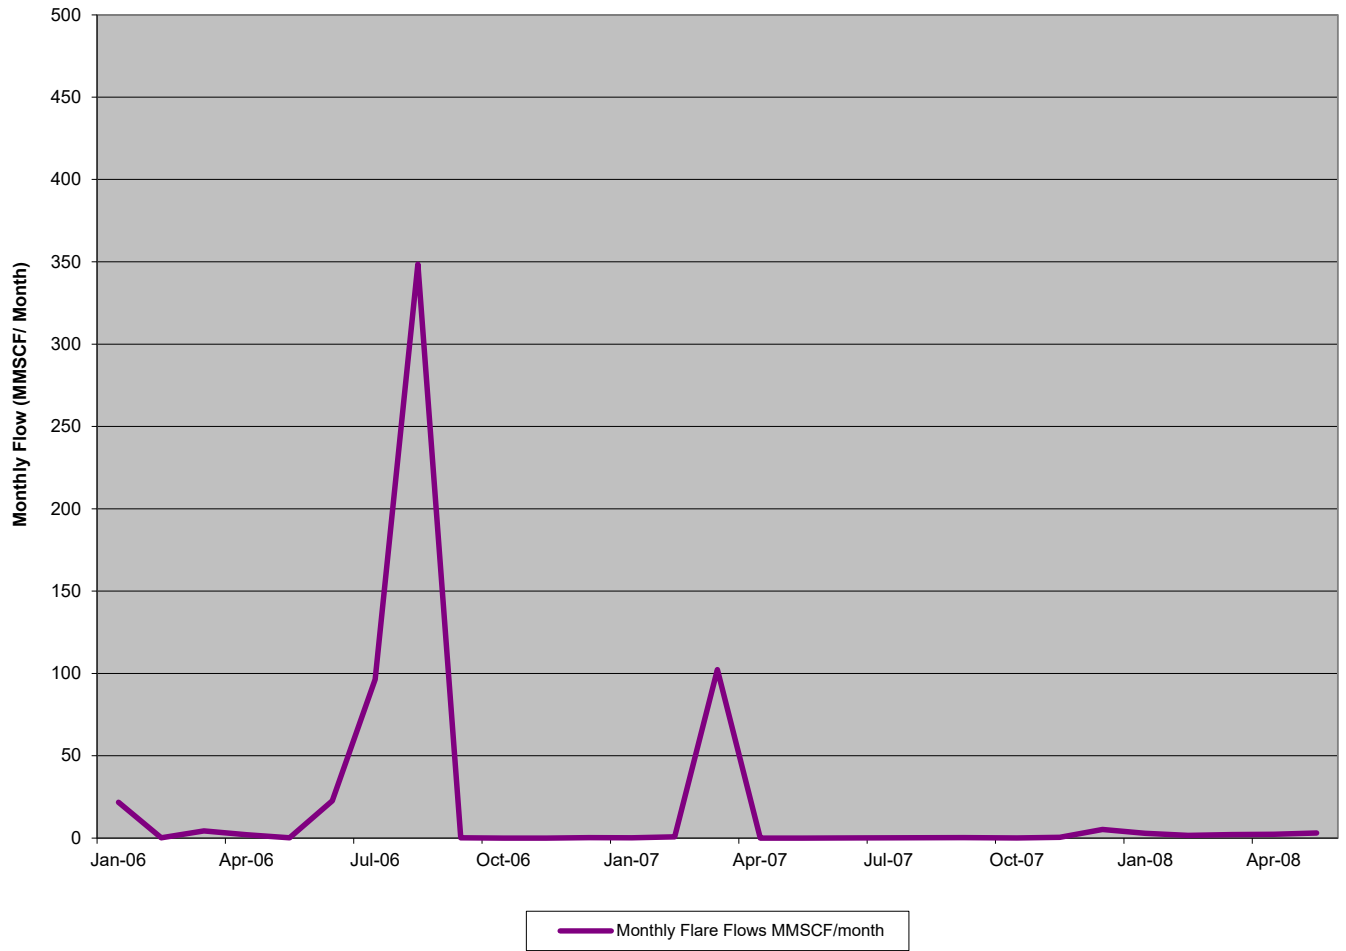
FIGURE 2008-5

Flexigas flare activity since 1/1/06 was reviewed for potential reduction opportunities. Figure 2008-5 shows the FXG flare flows over this time period. There were 11 events that required Causal Analysis. All of these flaring events were investigated and prevention measures identified and implemented (see Part 3 of this Section – Reductions Previously Realized). The results of the investigations into these events were reported to the District in Causal Analysis reports.

FXG Flare Flows 1/1/06 - 6/1/08

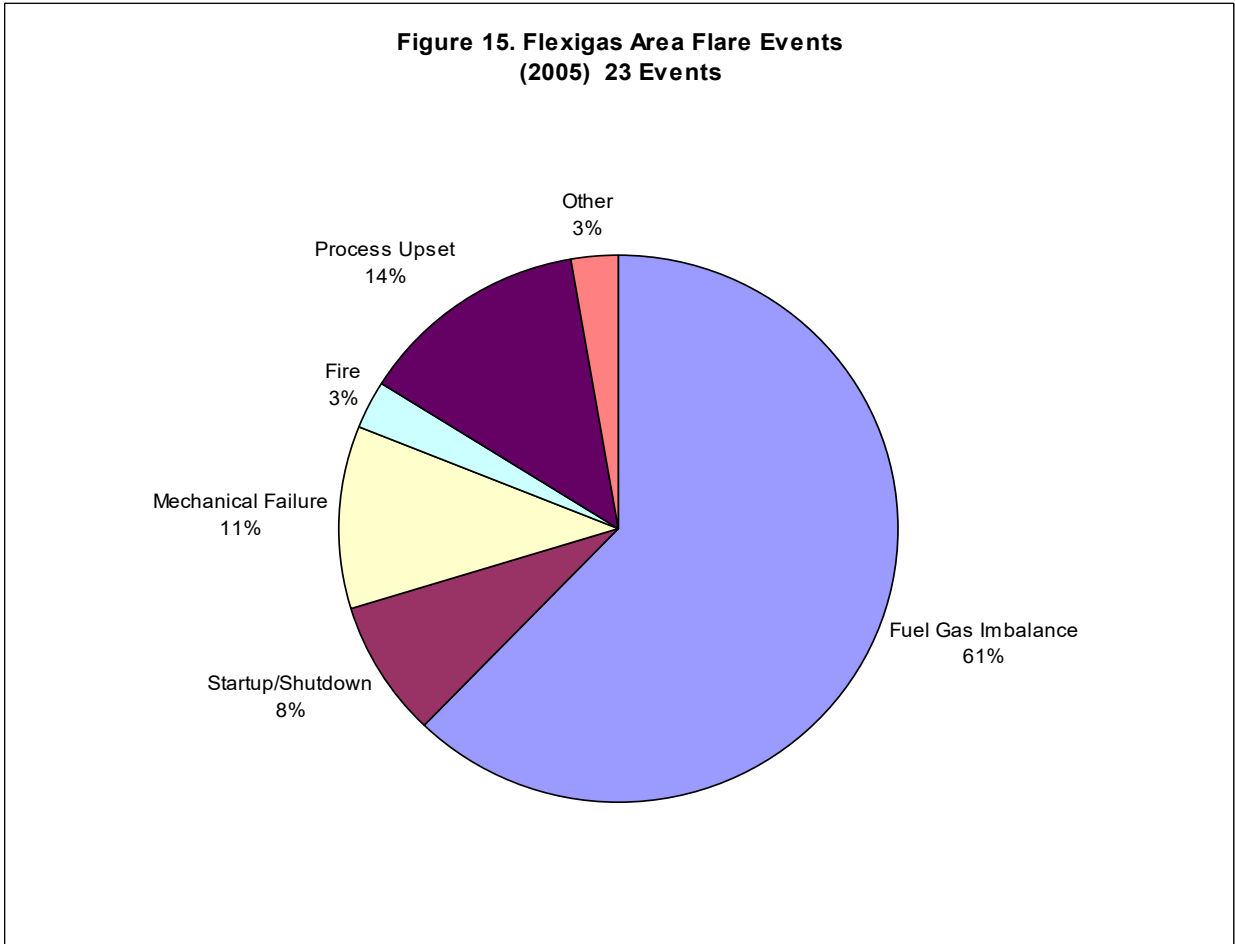
Historical flaring at the OPCEN Flexigas flare was reviewed to identify opportunities for potential mitigation. The highest quality data are available for the period from December 2003, to January 2006. This coincides with installation of the flare flow meter and BAAQMD flare reporting. Data for 2005 are plotted in Figure 15 and Figure 16.

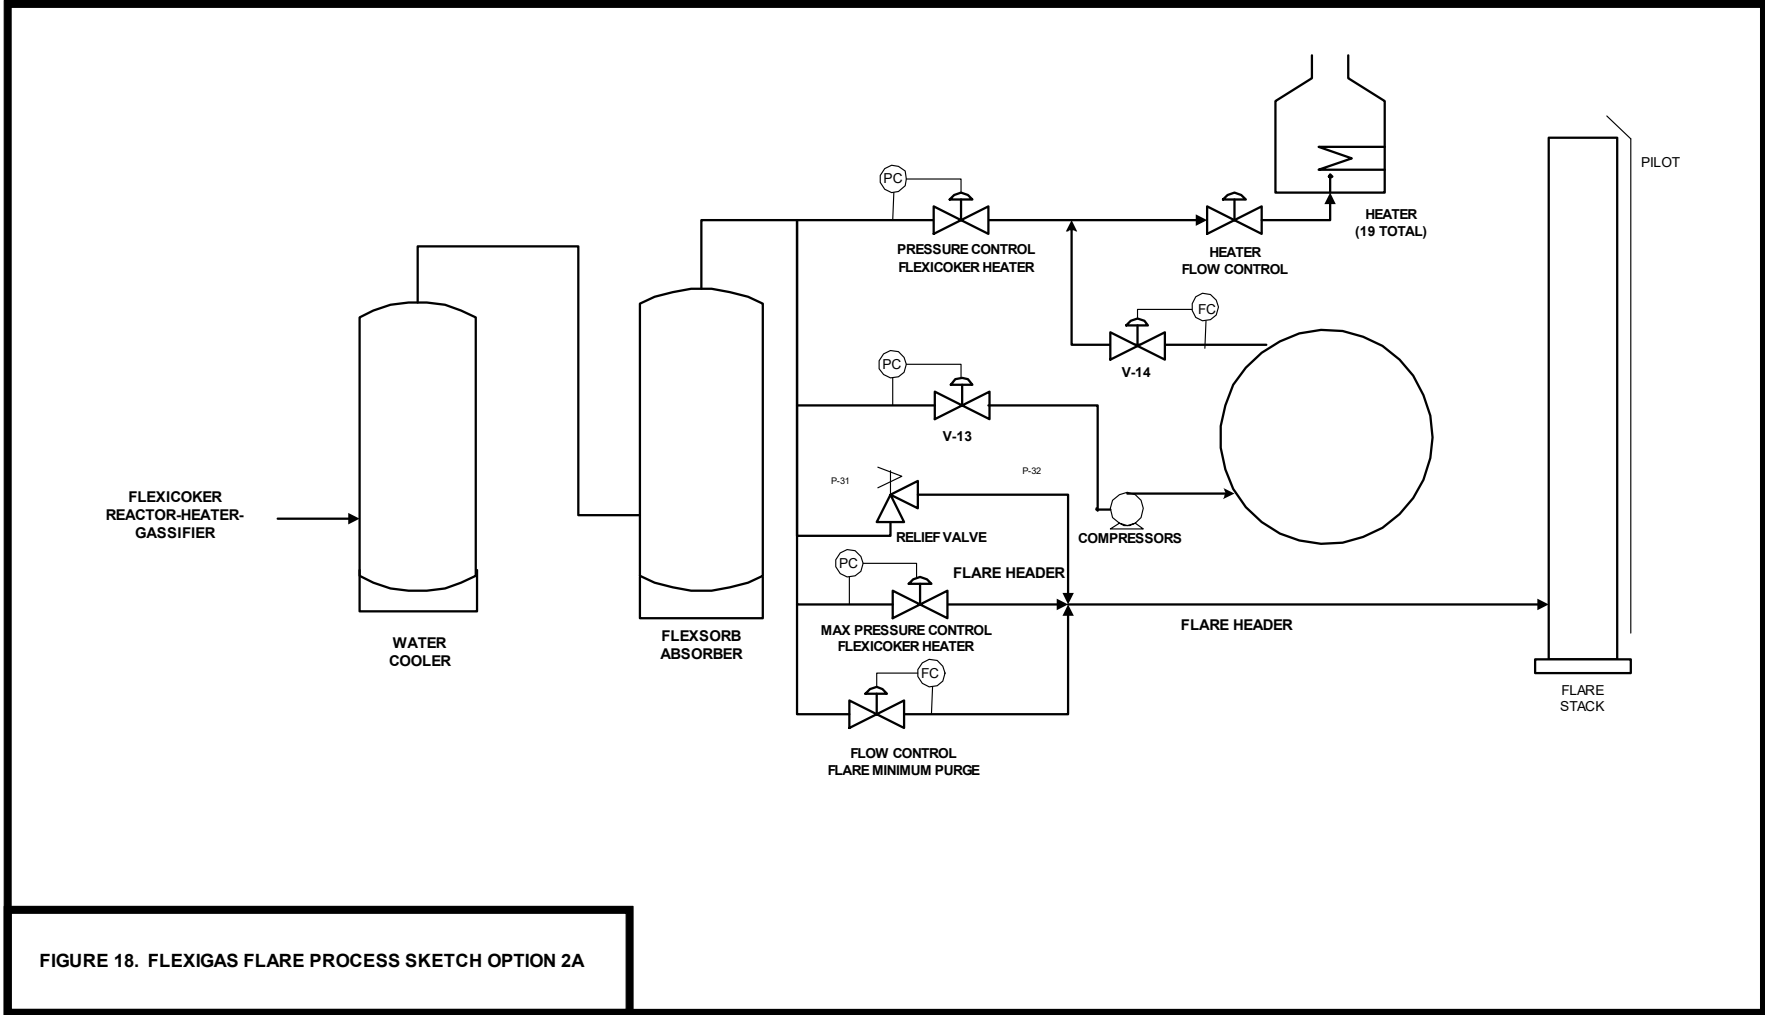
FIGURE 18. FLEXIGAS FLARE PROCESS SKETCH OPTION 2A

Option 2A consists of a pressurized vessel that would require a compressor with capacity ranging between 1 MMSCFD and 10 MMSCFD. This option is depicted in Figure 18. Flexigas in excess of consumer demand is routed to storage via compressor(s). A controlled flow is returned to the distribution system when enough consumers are available to avoid flaring. Due to the limited capacity of this storage, it has no real capability to accommodate prolonged fuel system imbalances. As a result, the expected best-case emission reductions are about the same as those available in 2005. A rough capital cost for the storage and large compressors is about \$27,000,000²². Annual electrical costs for the required compressors add another \$600,000. The annualized capital plus electrical costs to eliminate a ton of non-methane hydrocarbon result in a cost-effectiveness of approximately \$190 Million dollars per ton. Therefore, Option 2A is even less cost-effective for reducing flaring than Option 1.

²² Based on a nominal 1 MMSCF sphere (60' diameter) at 120 psig, and two 4 MMSCFD compressors. This system would handle only minor imbalances while the Flexicoker cuts rate.

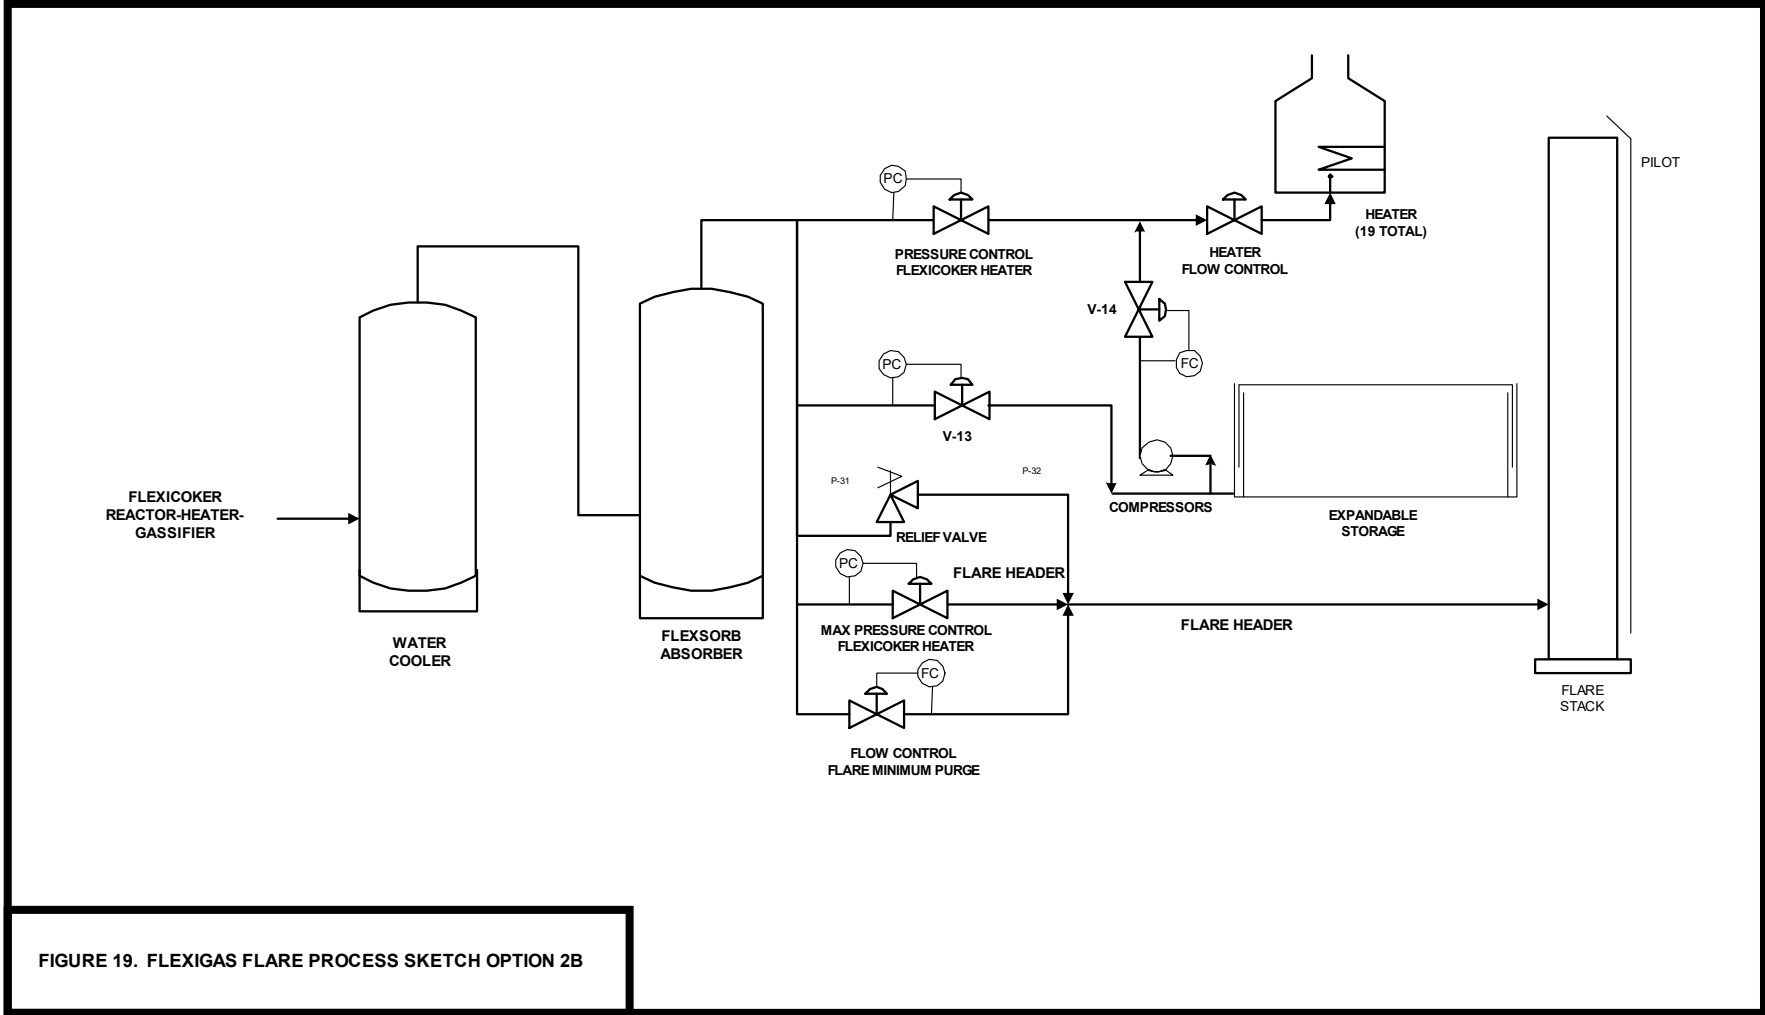
FIGURE 19. FLEXIGAS FLARE PROCESS SKETCH OPTION 2B

Option 2B uses low-pressure expandable gas storage. This option is depicted in Figure 19. This type of storage can be built significantly larger than the pressurized storage used in option 2A, and has the advantage of not requiring compressors in some cases. However, the concentration of carbon monoxide in the gas will likely require use of a water seal to limit leakage, restricting vessel height to a single lift. The requirement for a single lift, combined with low-pressure operation, significantly limits available storage volume²³. In any event, the installed cost is approximately \$21,000,000, providing cost-effectiveness of approximately \$276 Million dollars per ton of NMHC. As was the case for Option 2A, this option is even less cost-effective for reducing flaring than Option 1.

²³ The actual available storage volume is probably on the order of 1 MMSCFD, and will severely limit achievable emissions reductions. A 50% savings is premised for this analysis.
