Martinez Refining Company

FLARE MINIMIZATION PLAN

Updated October 1, 2021

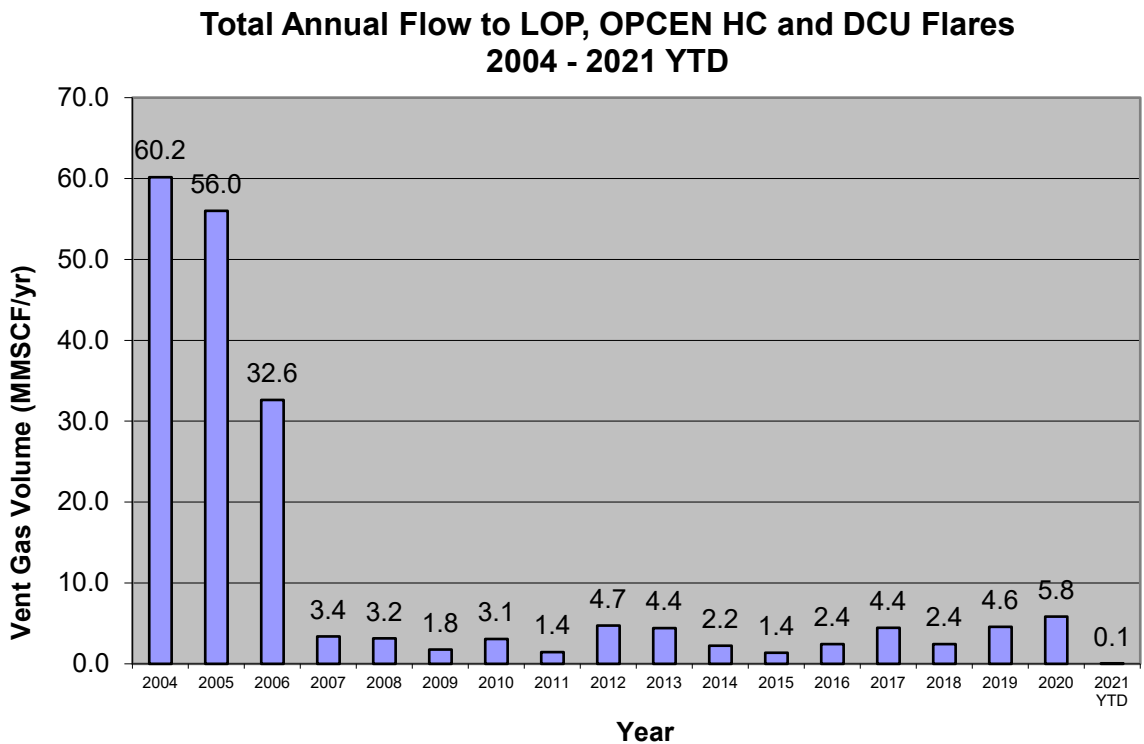
FIGURE ES-1

Figure ES-1 presents the total annual vent gas flow to the Light Oil Processing (LOP), Operations Central Hydrocarbon (OPCEN HC) and Delayed Coking Unit (DCU) Flares at the refinery from 2004 through June 30, 2021. Flare flow continues to be very low.

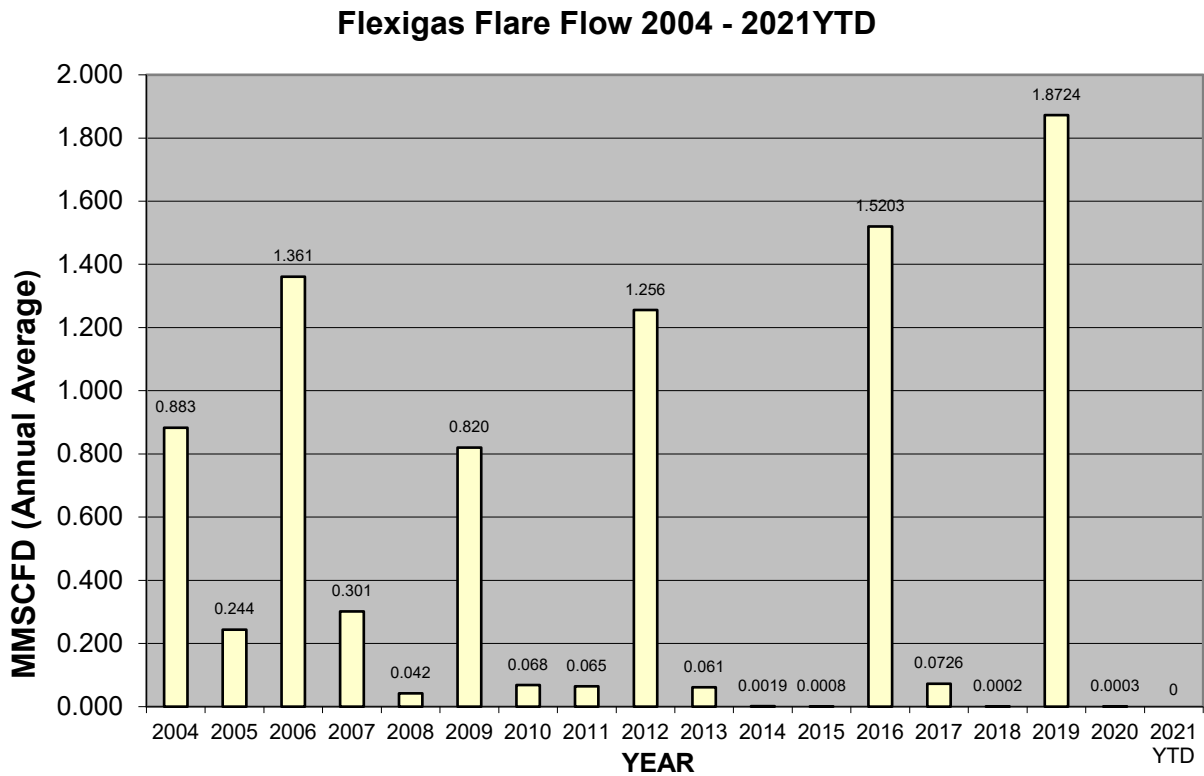
FIGURE ES-2

Figure ES-2 shows the annualized vent gas flow from the Flexigas Flare. This figure shows a cyclic increase in Flexigas flaring which occurs during years with startup and shutdown of the Flexicoker due to the nature of the Flexicoking and Flexsorb processes. The flaring of treated flexigas during startups and shutdowns of the Flexicoker is allowed up to specified limits in MRC's Title V permit. Flexigas is a very low BTU gas used as a supplemental refinery fuel gas in refinery process heaters. Flexigas is treated for sulfur removal in the Flexsorb Unit before being combusted either in refinery process heaters or if necessary, in the Flexigas Flare. When FXG is flared, the volume of gas is typically large compared to the volume flared in the other refinery process flares, but emissions are significantly less because Flexigas contains very low concentrations of non-methane hydrocarbon and sulfur.

Flexigas flaring can also occur due to refinery fuel gas imbalance. MRC continues to fine-tune the Flexigas pressure control scheme to minimize flexigas flaring due to small imbalances in fuel gas. Improvements in this system, most notably addition of COGEN to the pressure control scheme, contribute to the very low flexigas flare flow rate seen in non-turnaround years including 2013, 2014, 2015, 2017, 2018, and 2020.

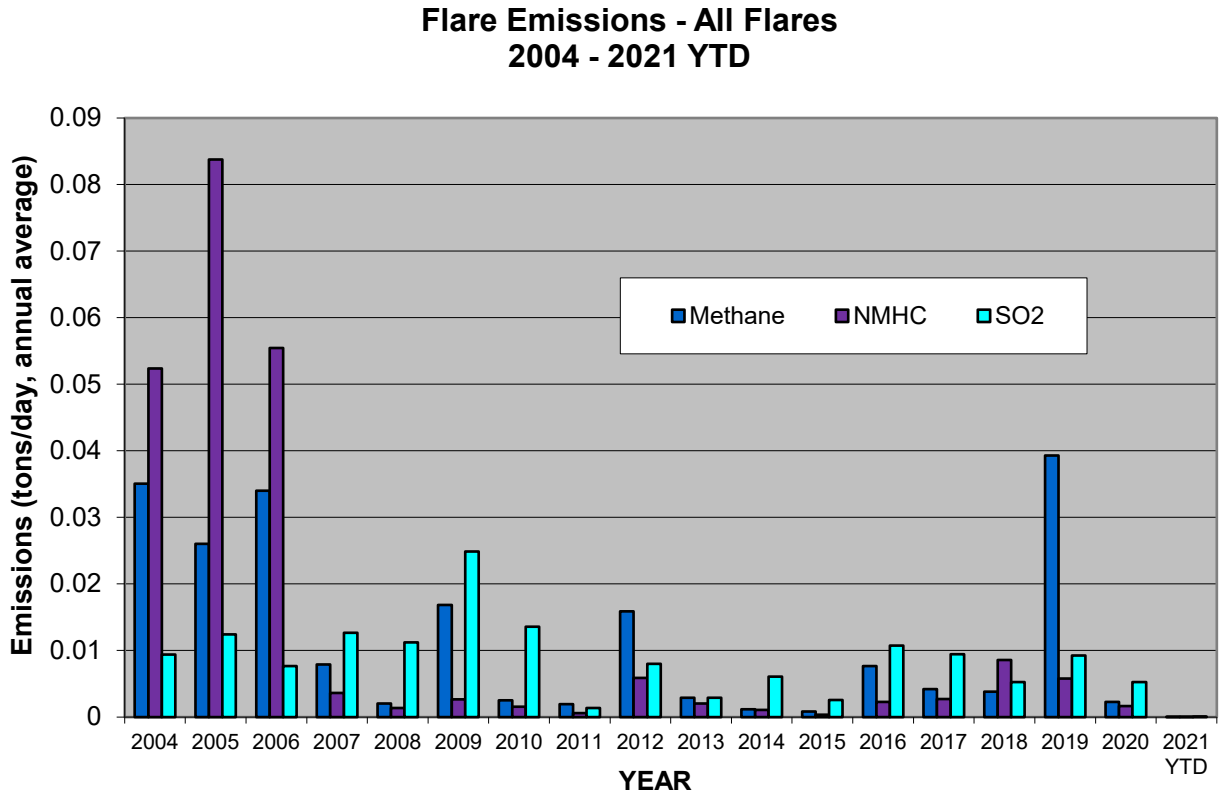
FIGURE ES-3

Figure ES-3 shows the methane, non-methane hydrocarbon, and sulfur dioxide emissions from all four refinery process flares from 2004 through June 30 of this year.

Figure ES-3 shows the significant reduction in emissions that has occurred since the implementation of the Flare Minimization Plan in 2006 and highlights that even with large volumes of flexigas flaring during turnaround years, overall emissions from flaring are low.

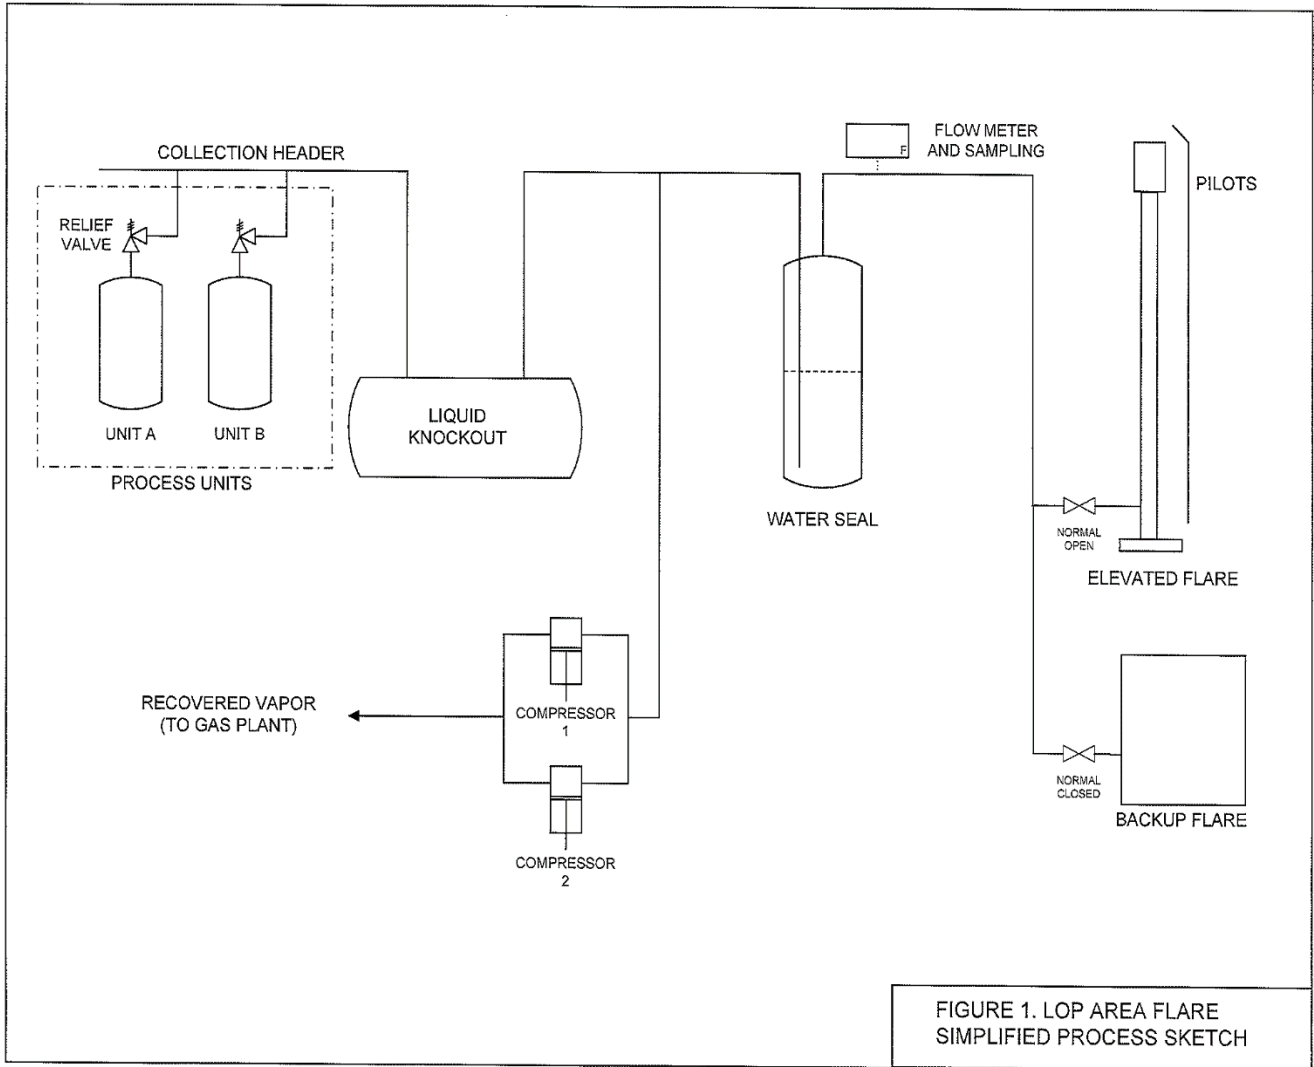
FIGURE 1. LOP AREA FLARE SIMPLIFIED PROCESS SKETCH

Recovered flare gas is treated to remove hydrogen sulfide and condensable liquids. Treated gas is routed to the fuel gas system. The fuel gas treaters typically used for LOP recovered flare gas are located in the Catalytic Cracker Gas Plant (CGP). When this unit is unavailable for any reason, recovered gas may be routed to the Saturates Gas Plant (SGP). Sufficient capacity can be made available in both sets of treaters for the incremental flow up to the total capacity of both compressors of about 6.4 MMSCFD.

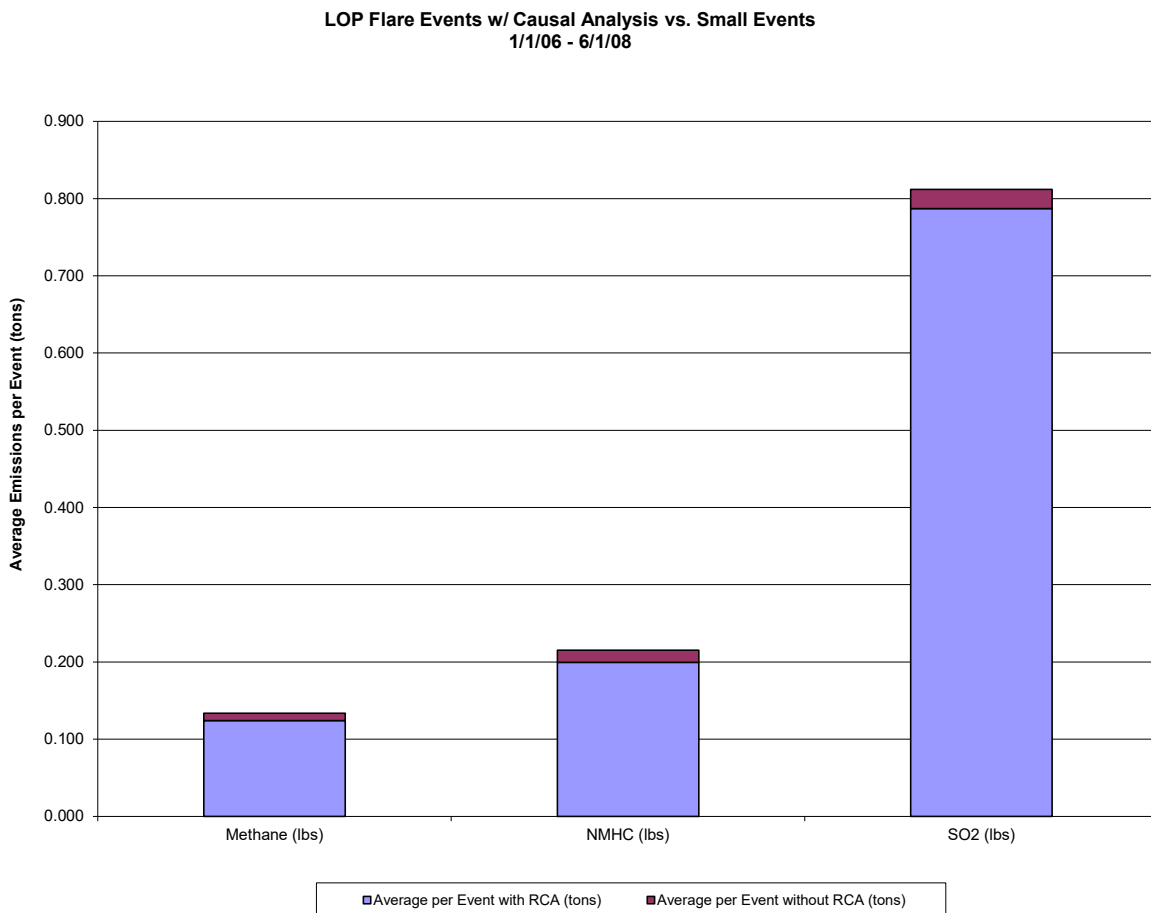
FIGURE 2008 –1

Beginning in November 2006 with the adoption of the Flare Procedures described in the Common Measures Section, pertinent information, when available, was captured immediately after a flaring event to determine the cause of any flaring and what could be done to prevent it from happening again. Total emissions from all flaring during the period from 12/1/06 through 6/1/08 were: 0.6 tons of methane, 0.99 tons of non-methane hydrocarbon and 2.5 tons of SO₂. Figure 2a presents a comparison of the average emissions per large reportable events over this time period vs. the average emissions per small event. This figure shows that small events contributed on average < 10% of the emissions of a large event. Figure 2a reinforces the appropriateness of the causal analysis trigger of 0.5 MMSCF/ 500 lbs SO₂ to ensure the resources to conduct a Causal Analysis are most effectively applied to address high emission events.

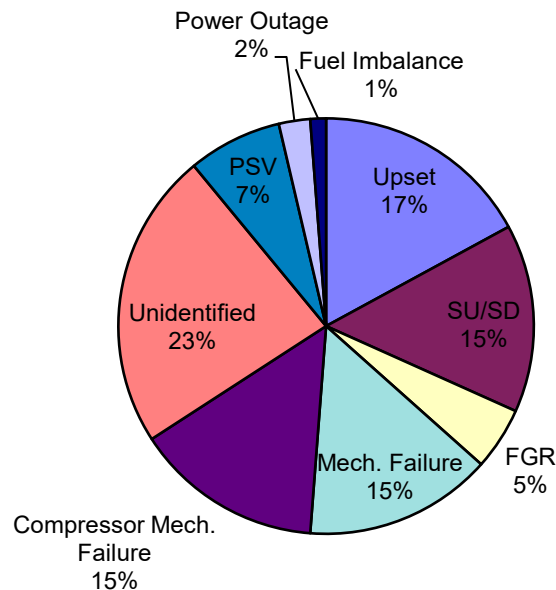
**Figure 2. LOP Area Flare Events
(2000-2005)**

Based on these data, about 65% of the flare events occurring from 2000 - 2005 are essentially evenly divided among the following categories: process upsets, process startup and shutdowns, mechanical failures of compressors and other equipment. Almost one quarter of the time the occurrences where the water seal was broken indicating that flaring occurred were so small, and of such brief duration, no cause could be reliably determined.

Review of flare events prior to January 2004 provided little usable information. Without flow meters, neither durations nor volumes could be accurately determined. In many cases, even the proximate cause of flaring could not be reliably determined due to the limited documentation and time elapsed since the event. With these qualifications, a breakdown of the general cause of LOP flare events for the previous five years is depicted in Figure 2. A description of the various categories listed is provided below:

Figure 2 illustrates that there are a wide range of events that can cause flaring at LOP. The annual volume of gas flared could be reduced in two basic ways. One alternative is an increase in the capacity of the flare gas recovery system. The second is improved measures to limit the rate and volume of gas discharged to the flare gas header so that it does not exceed the capacity of the existing recovery system. These two alternative approaches are discussed below.

Figure 2 shows that activities that have occurred during startups and shutdowns have contributed to less than 15% of the flare events that occurred historically at the LOP flare. Analysis of the flaring back to 2005 indicate that flaring may have been prevented by changing operating practices, improved planning, or minor hardware revisions. The trend over the past years indicates that startup, shutdowns and maintenance-related flaring can be significantly reduced and largely eliminated with careful planning. Major turnarounds on units served by the LOP flare continue to be performed without planned flaring. That this work was performed without flaring is evidence of careful review and planning. MRC is committed to continue this careful review and planning prior to planned major maintenance and expect to perform turnarounds with little or no planned flaring. If during the maintenance planning and review process MRC finds that planned flaring is required, as was the case when preparing for the LOP flare pressure vessel inspections, then all appropriate prevention measures will be considered and feasible measures will be implemented to reduce or eliminate the planned flaring.

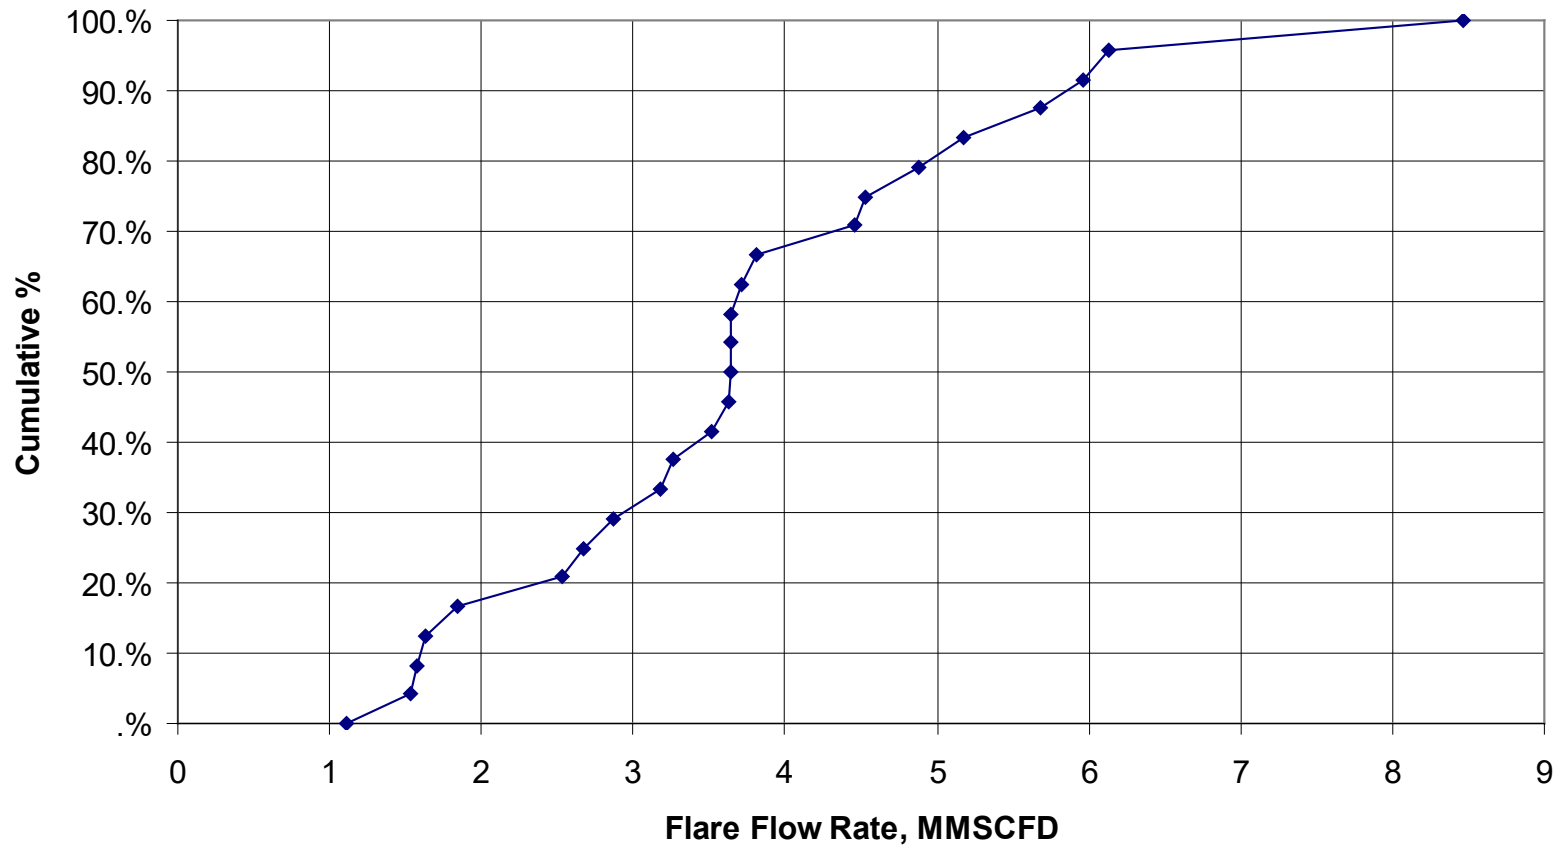
**Figure 4. LOP Flare Gas Flow Rates
(2005)**

An additional consideration is that the brief duration of many flare events makes it more difficult to determine their cause. Often excess flow to the flare gas header has stopped before significant troubleshooting activity can be undertaken to determine its source.

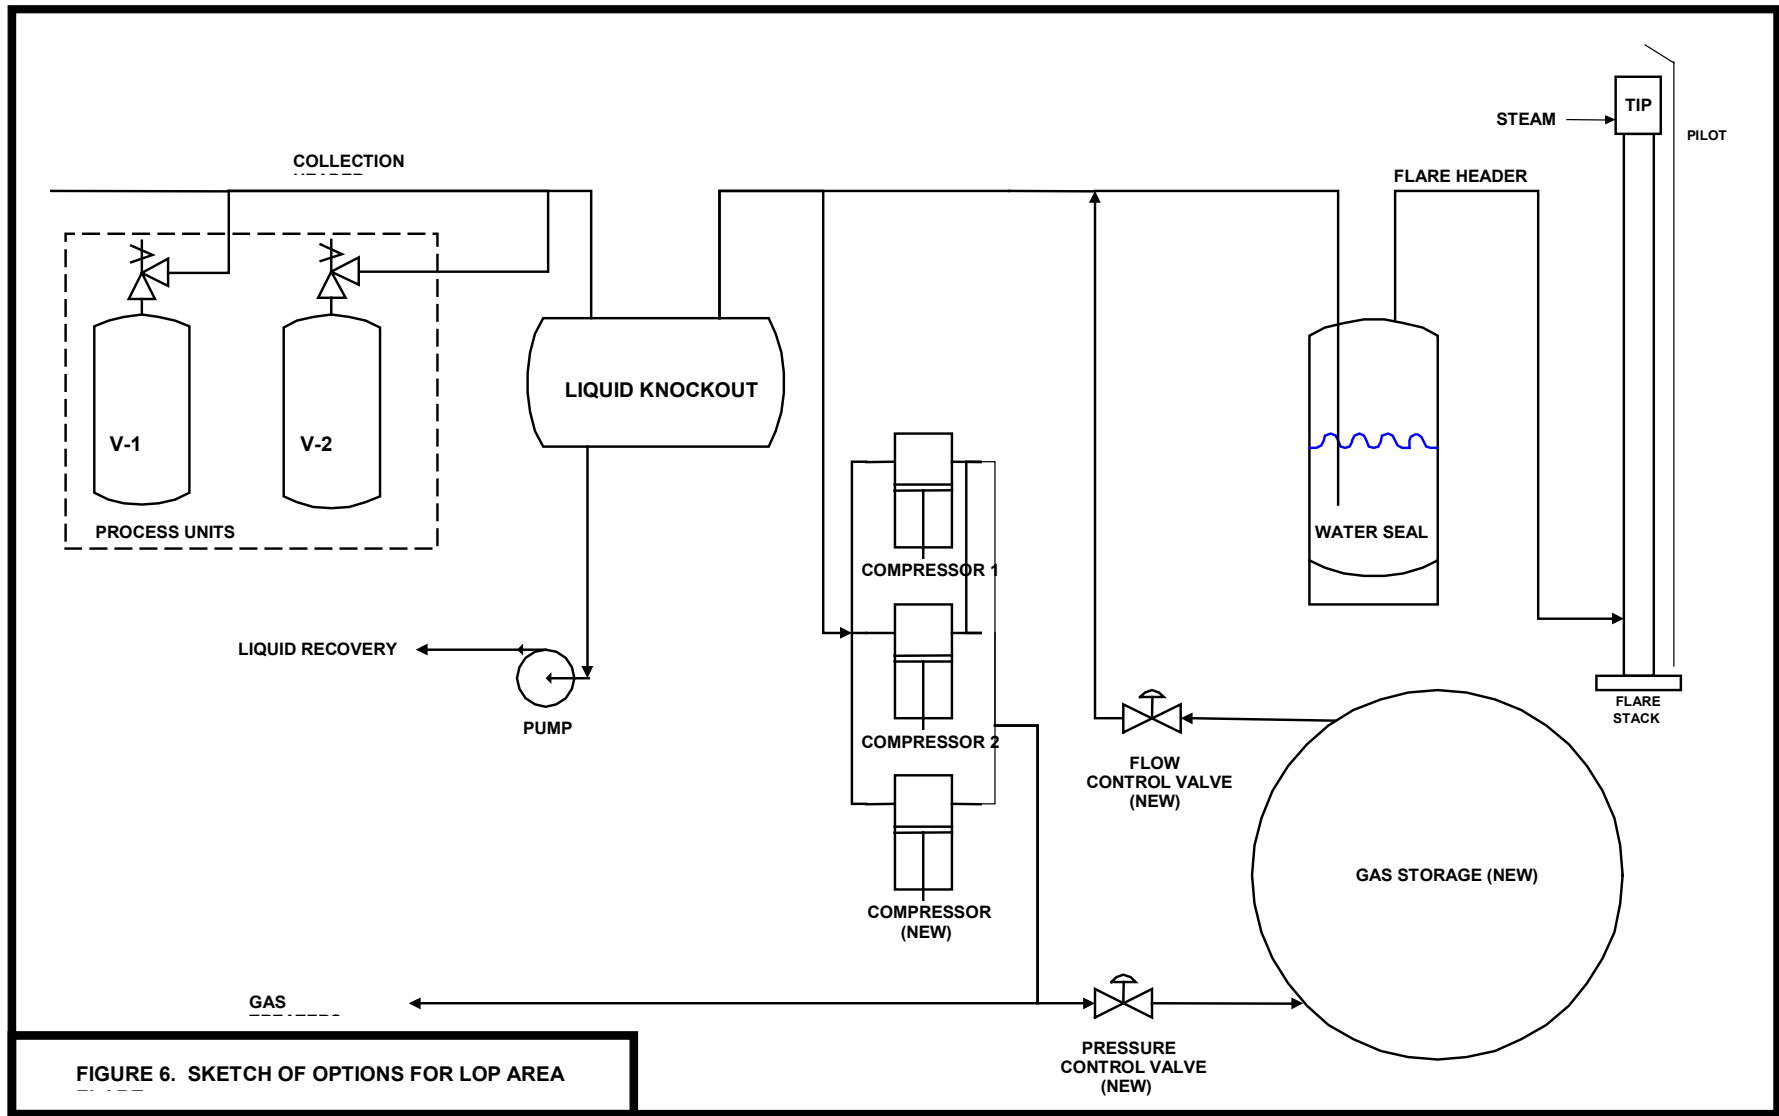
FIGURE 6. SKETCH OF OPTIONS FOR LOP AREA

Prevention Measure Options Considered for Recovery, Storage and Treatment: Costs and potential benefits of improving gas recovery and reducing flare emissions from the current 99.7% recovery efficiency are addressed by considering the addition of flare gas recovery compression and flare gas storage. Gas treating capacity is expected to be adequate for all options evaluated. A sketch of the potential options is provided in Figure 6.

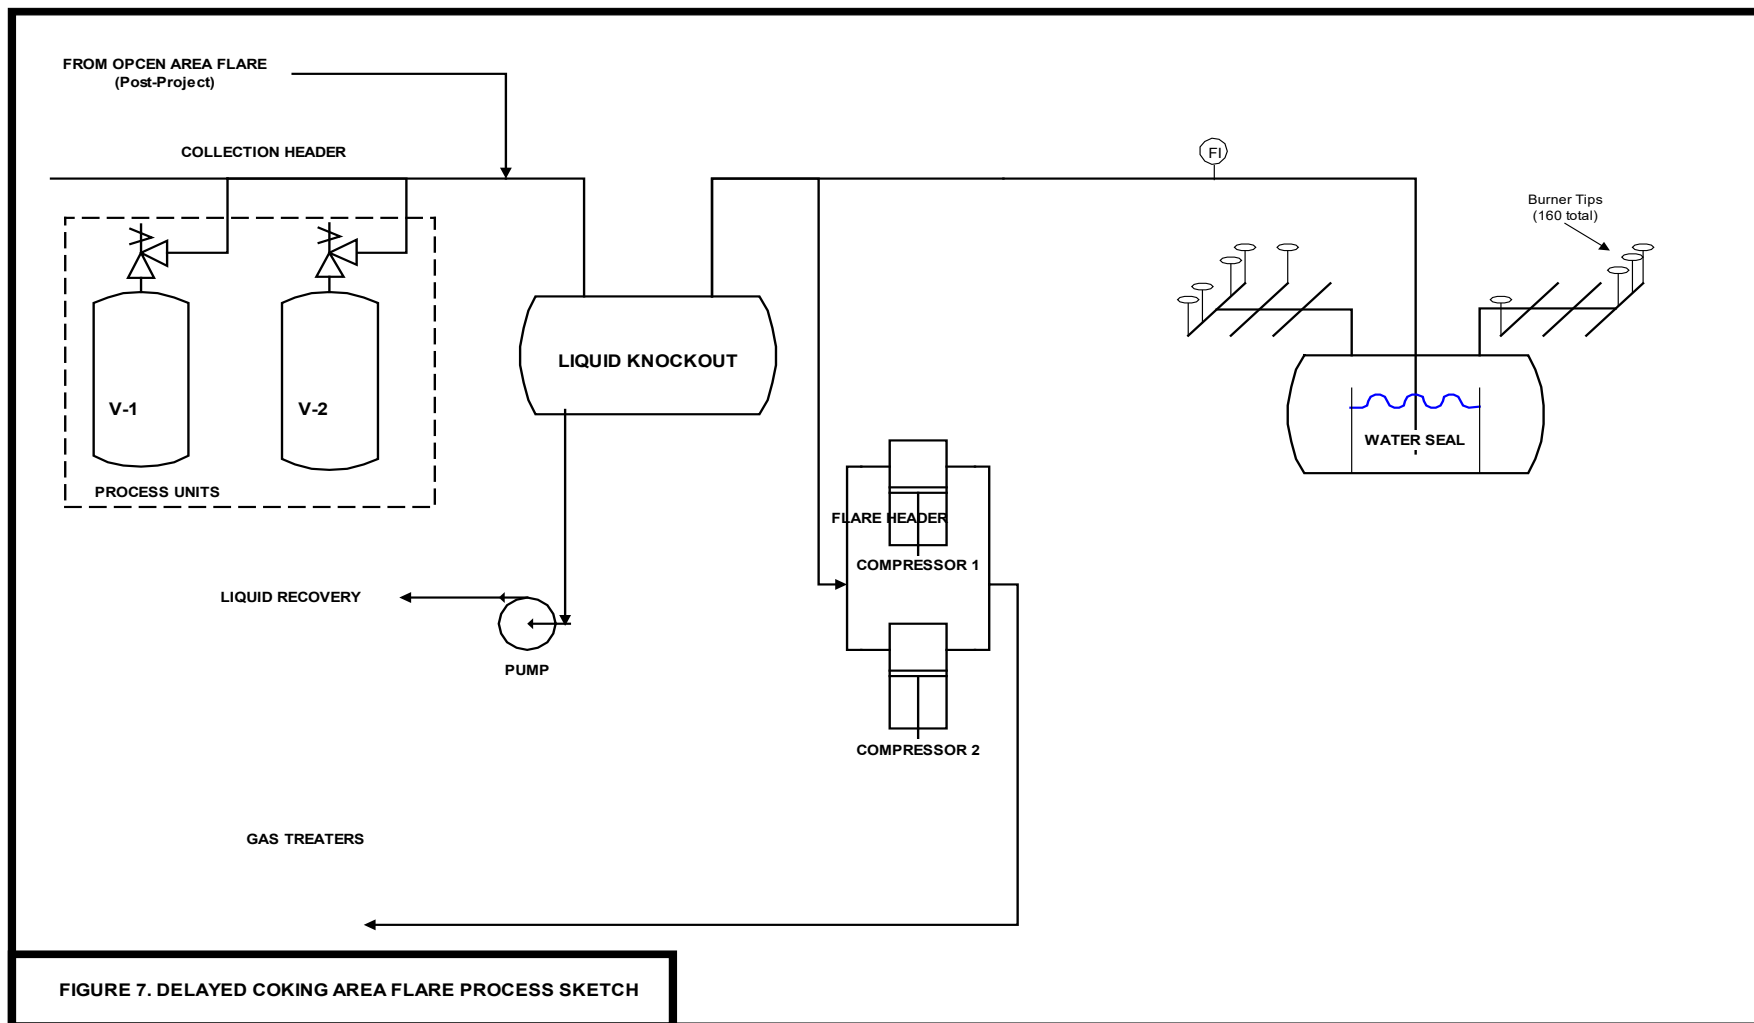
Recovered gas from the Delayed Coking and OPCEN HC flare headers is treated to remove sulfur in the Vent Gas Treater in Delayed Coking. Sufficient capacity is available in this gas treater for the incremental flow (up to the total capacity of about 8 MMSCFD). From the Vent Gas Treater, the treated gases may be routed to the refinery fuel gas blend drum for use as fuel in combustion devices throughout the refinery. In addition, the treated gas from the Vent Gas Treater may be used as feed to Hydrogen Plants 2 and 3. Having the option of using the treated fuel gas as feed to the hydrogen plants or fuel for heaters throughout the refinery increases the flexibility of the fuel gas system, reducing the potential for fuel gas imbalance that may cause flaring.

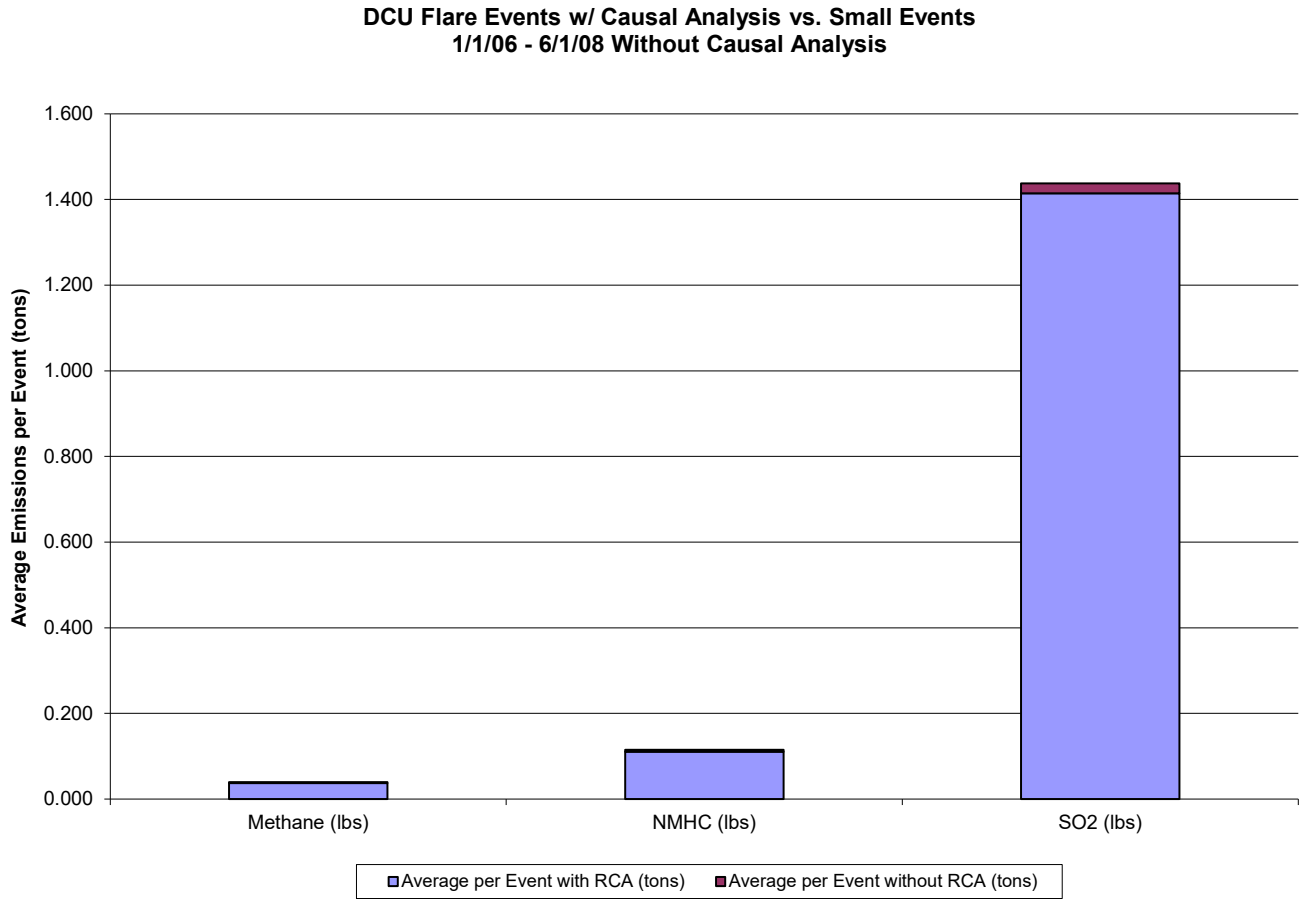
FIGURE 2008-2

Beginning in November 2006 with the adoption of the Flare Procedures described in the Common Measures Section, pertinent information, when available, was captured immediately after a flaring event to determine the cause of any flaring and what could be done to prevent it from happening again. Total emissions from all flaring during this 30-month period were: 0.17 tons of methane, 0.45 tons of non-methane hydrocarbon and 4.19 tons of SO₂. Figure 2008-2 presents a comparison of the average emissions per large reportable events over this time period vs. the average emissions per small event for the DCU Flare. This figure shows that small events contributed < 6% of the emissions of a large event. Figure 2008-2 reinforces the appropriateness of the causal analysis trigger of 0.5 MMSCF/ 500 lbs SO₂ to ensure the resources to conduct a Causal Analysis are most effectively applied to address high emission events.

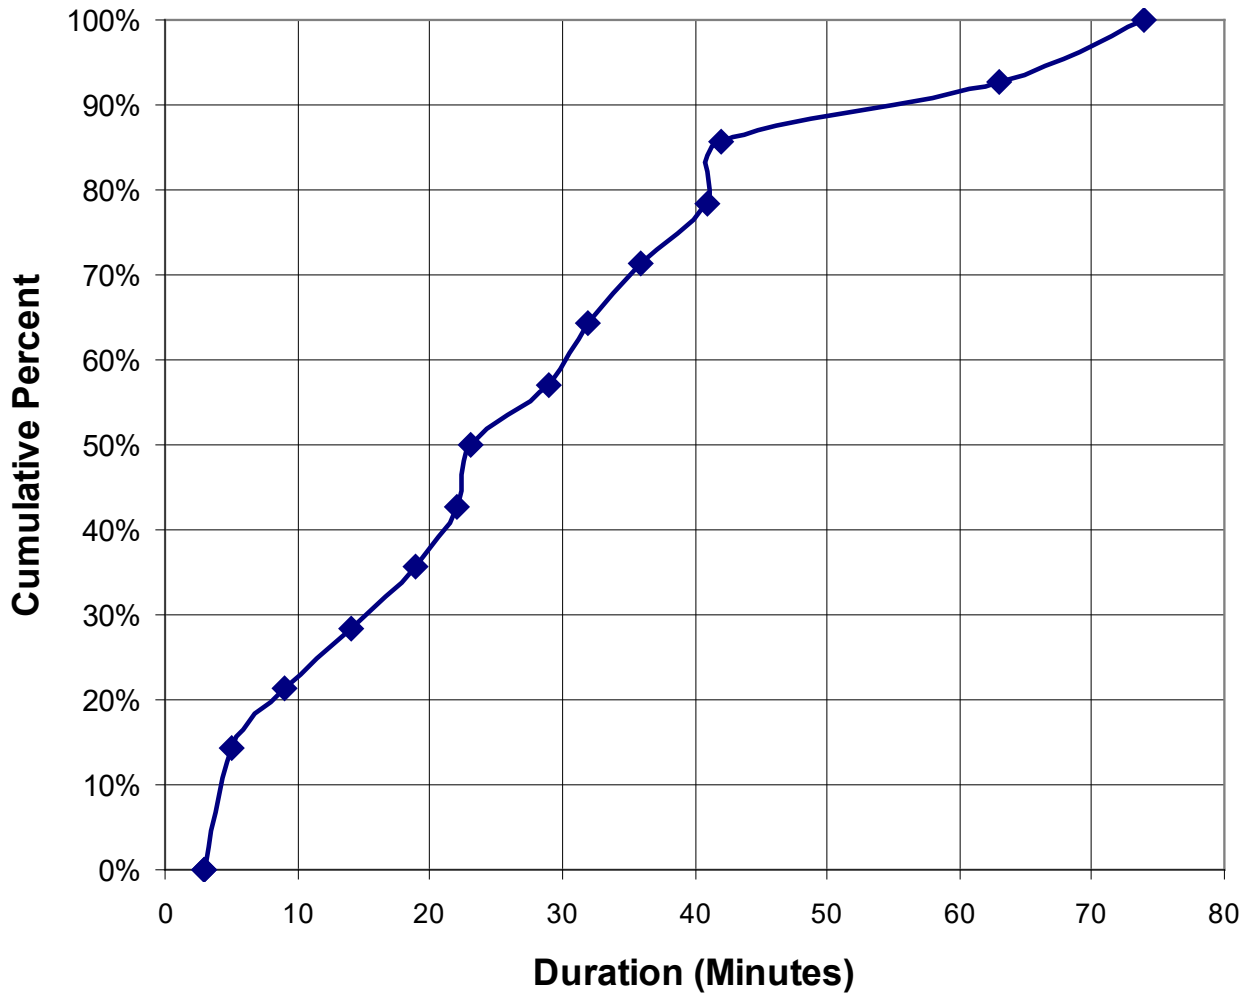
Figure 11 depicts the distribution of flare event durations for 2005 where these data are available. 50% of the events lasted less than 30 minutes. This is consistent with other data characterizing the bulk of flare events being very brief.

**Figure 11. Delayed Coking Area Flare Event Durations
(2005)**

Flaring during 2005. The highest quality data are available for the period from January 2005 to January 2006. Data is available during this period from flare flow meters and monthly BAAQMD flare reporting. Available data for flare event volumes and durations are provided in Figures 9 through 11 below.

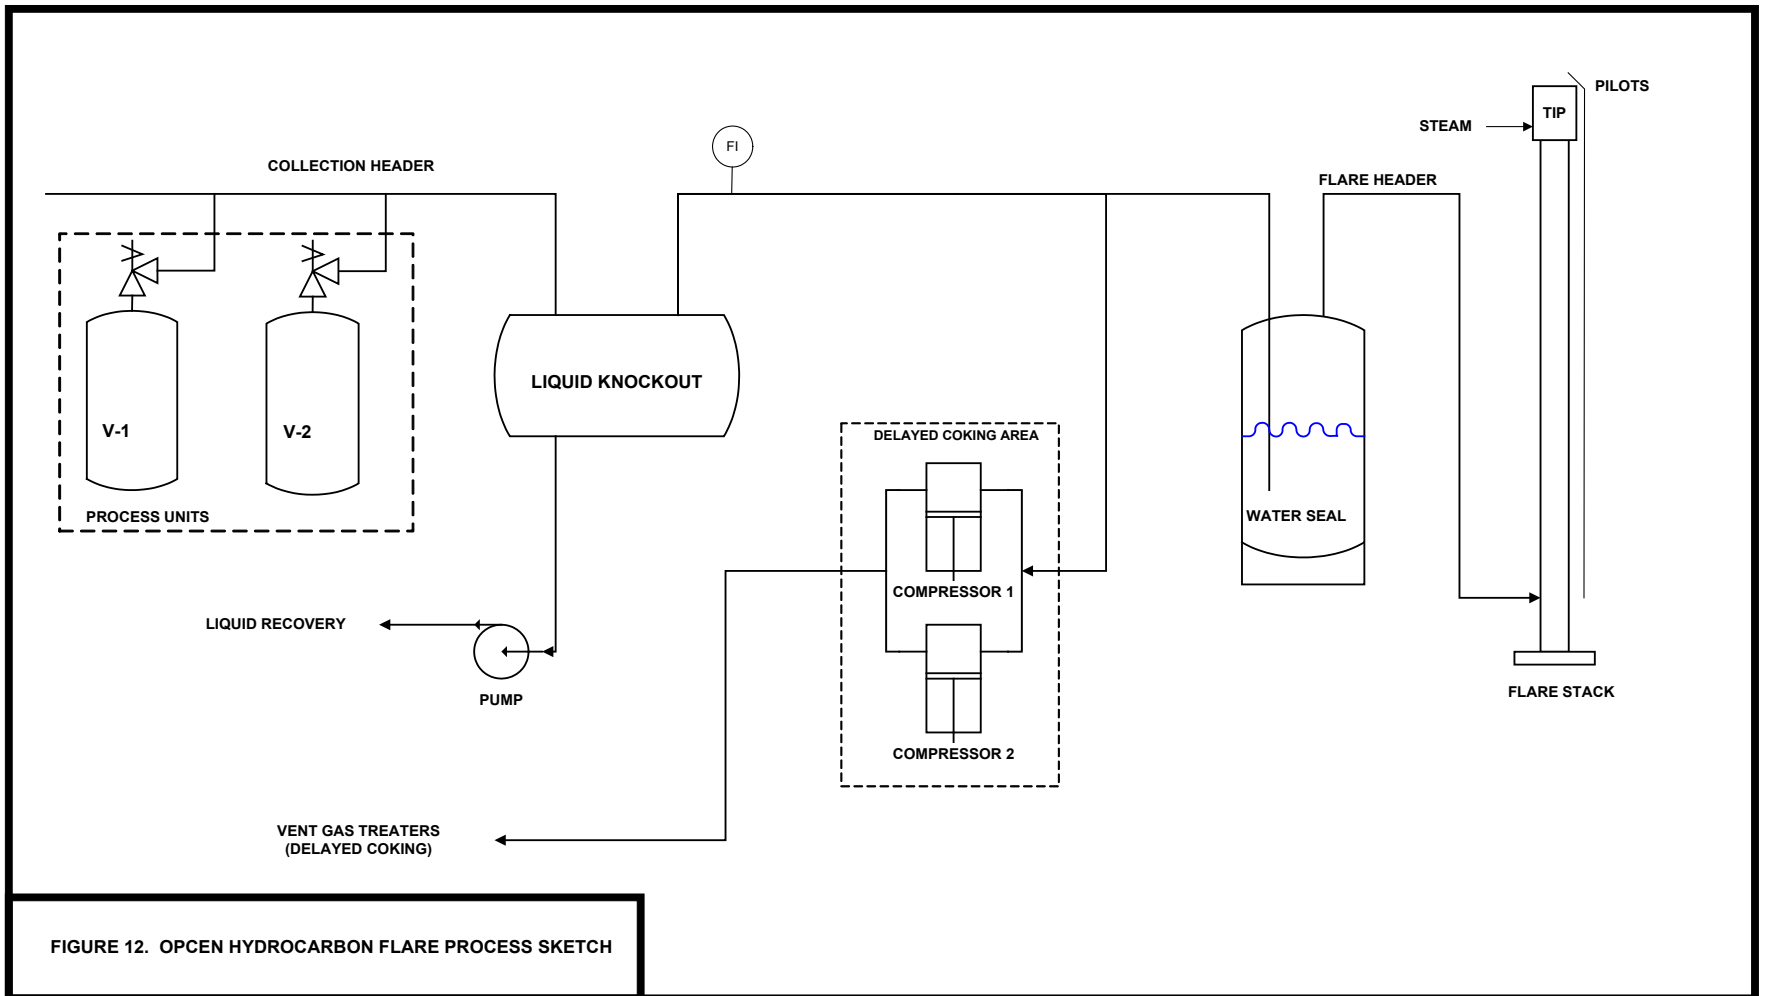
FIGURE 12. OPCEN HYDROCARBON FLARE PROCESS SKETCH

Recovered gas from OPCEN is treated to remove H₂S and routed to fuel and hydrogen plant feed along with the recovered gas from Delayed Coking. The normal routing for Delayed Coker Area recovered flare gas is the Vent Gas Treater. Sufficient capacity is available for the incremental flow (up to the total recovery compressor capacity of about 8 MMSCFD).

¹⁶ This figure includes the flare gas recovery system with the modification. Due to the need for a general shutdown of process units in the OPCEN area, the system was not operable in time for the August 1, 2006 original submittal of this plan. Post-project facilities are used as the basis for system description. However, the historical performance of this flare obviously provides little basis for evaluating mitigation options beyond the implemented flare gas recovery.

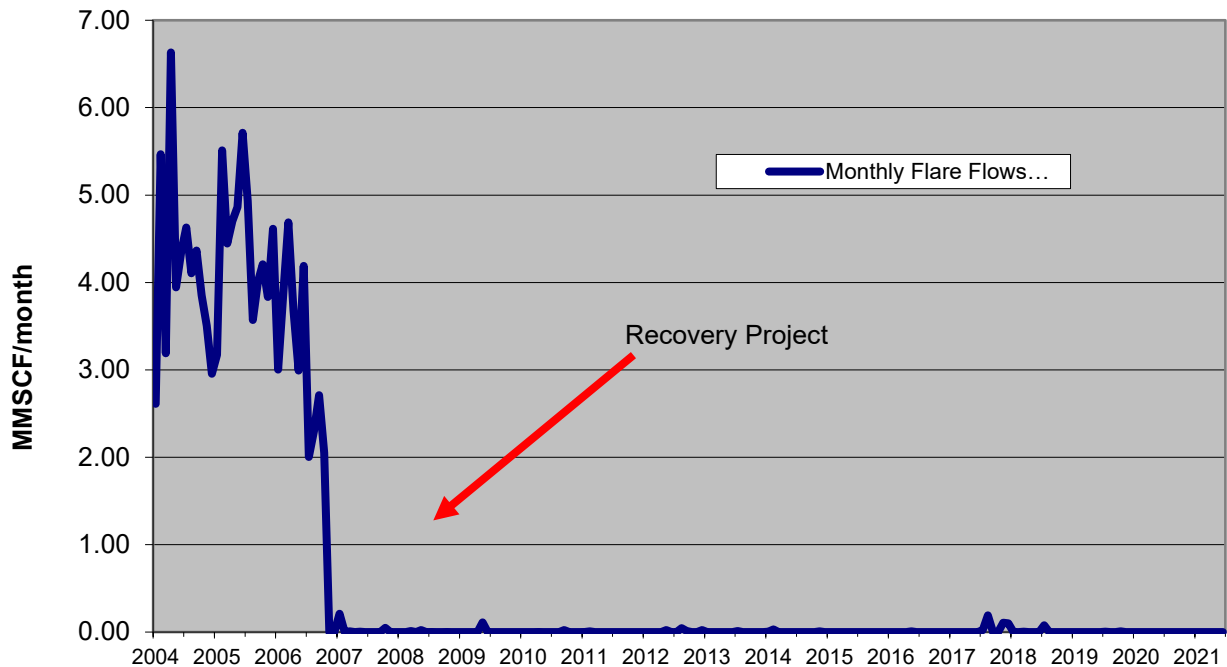
The figure below has been updated through 7/1/21 and shows the continued success of the implementation of the flare recovery project that occurred in 2006 on this flare.

Figure 2006-1 OPCEN HC Flare Monthly Flare Flows 1/1/04 - 7/1/21

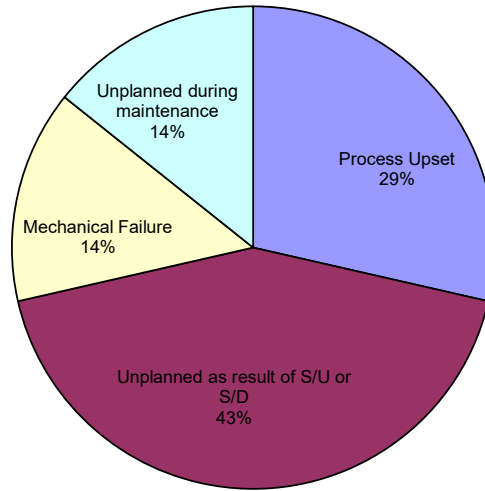
FIGURE 2008-4

The OPCEN HC flare events that occurred after the implementation of flare recovery from 11/1/06 – 6/1/08 were categorized by probable cause in Figure 2008-4. None of the flaring was planned. The cause of the events included process upset, mechanical failure or were unplanned during maintenance or startup and shutdown.

OPCEN HC Flare- Cause of Flaring 11/1/06 - 6/1/08
7 Events

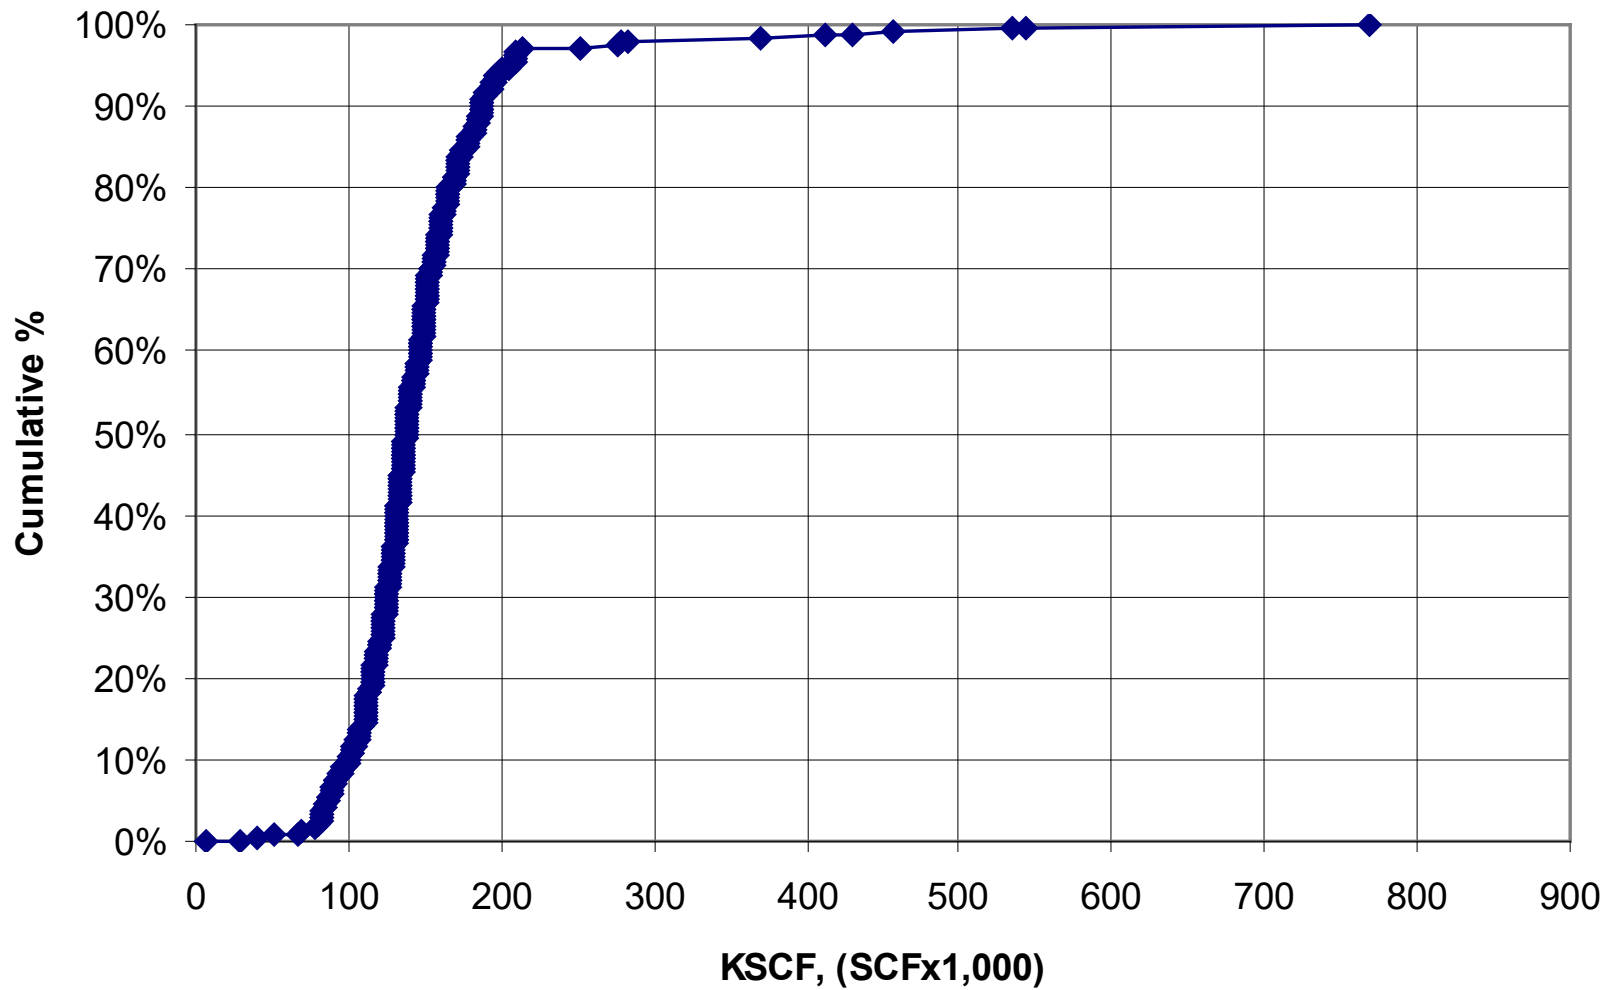
With historical performance profoundly biased by absence of flare gas recovery, this review concentrated on calendar year 2005. Flare data are depicted in Figure 13. Total emissions of non-methane hydrocarbon during 2005 were approximately 30 tons. Emissions of SO₂ in 2005 were 0.3 tons.

**Figure 13. OPCEN Hydrocarbon Flare Gas Volumes
(2005)**

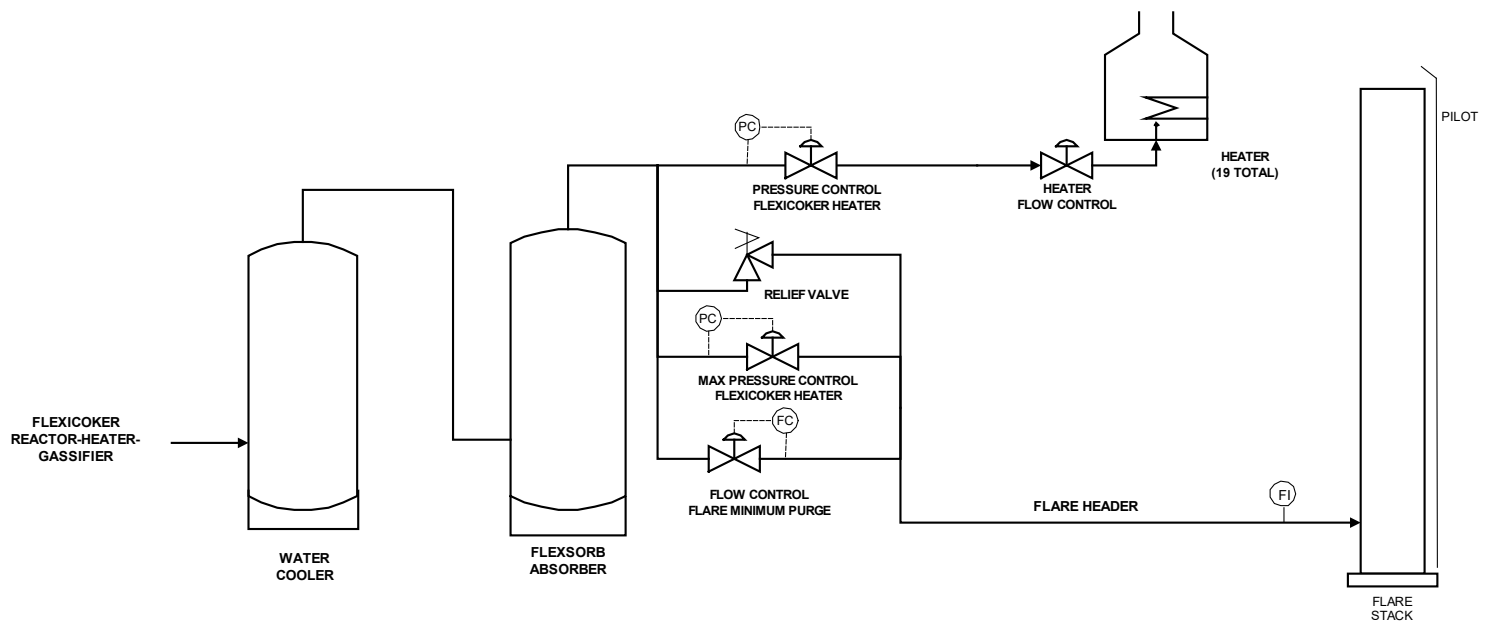
FIGURE 14. FLEXIGAS SUPPLY SYSTEM PROCESS SKETCH

All Flexigas emissions in permit cap: When a Flexigas user unexpectedly comes off-line, it can be difficult to rapidly take up the available gas. Because of the high flows involved, a volume of gas exceeding the Air District definition of flare "event" (0.5 MMSCF) may result before the Flexicoker can reduce production of this gas. In this case, treated Flexigas may be temporarily flared. Emissions from burning flexigas, whether in refinery heaters or the flare, are subject to the permit limits in our refinery emission cap.
