Martinez Refining Company

FLARE MINIMIZATION PLAN

Updated October 1, 2021

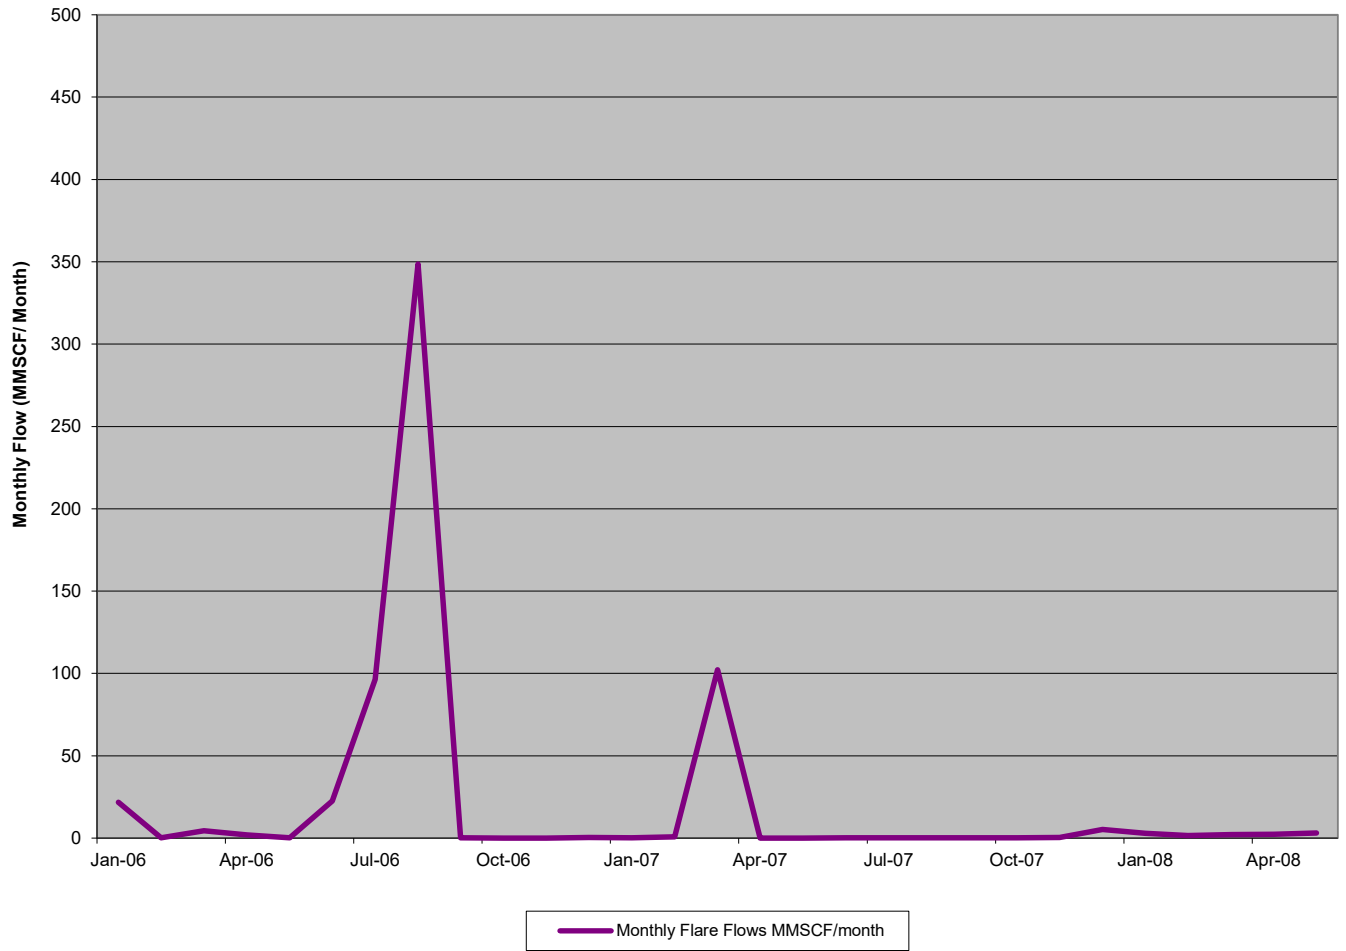
FIGURE 2008-5

Flexigas flare activity since 1/1/06 was reviewed for potential reduction opportunities. Figure 2008-5 shows the FXG flare flows over this time period. There were 11 events that required Causal Analysis. All of these flaring events were investigated and prevention measures identified and implemented (see Part 3 of this Section – Reductions Previously Realized). The results of the investigations into these events were reported to the District in Causal Analysis reports.

FXG Flare Flows 1/1/06 - 6/1/08

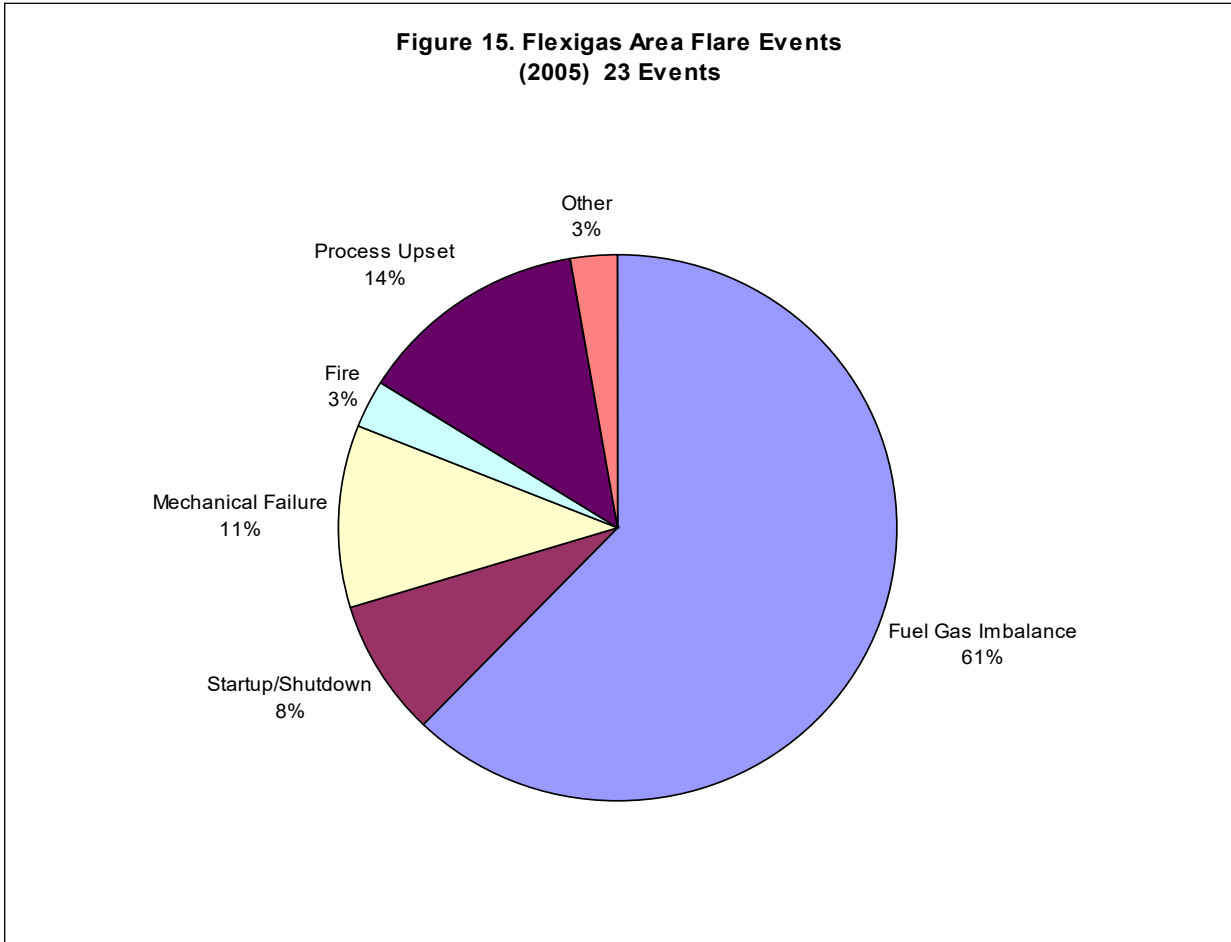
Historical flaring at the OPCEN Flexigas flare was reviewed to identify opportunities for potential mitigation. The highest quality data are available for the period from December 2003, to January 2006. This coincides with installation of the flare flow meter and BAAQMD flare reporting. Data for 2005 are plotted in Figure 15 and Figure 16.

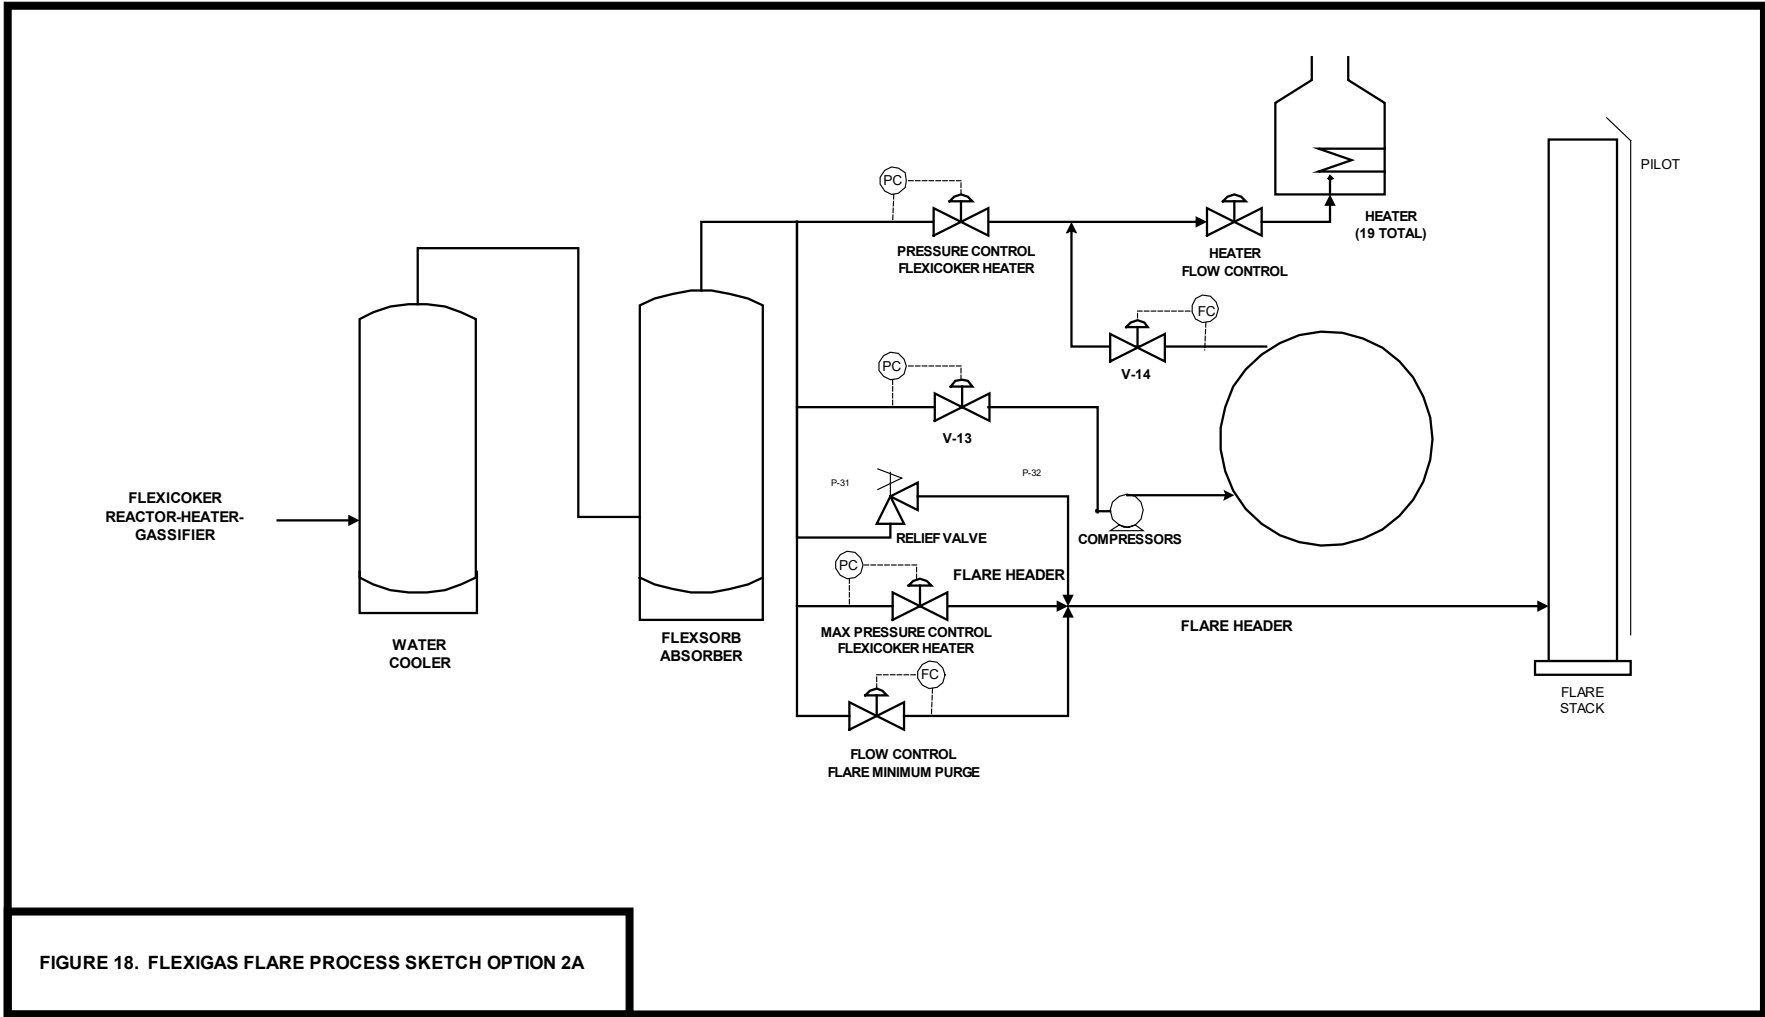
FIGURE 18. FLEXIGAS FLARE PROCESS SKETCH OPTION 2A

Option 2A consists of a pressurized vessel that would require a compressor with capacity ranging between 1 MMSCFD and 10 MMSCFD. This option is depicted in Figure 18. Flexigas in excess of consumer demand is routed to storage via compressor(s). A controlled flow is returned to the distribution system when enough consumers are available to avoid flaring. Due to the limited capacity of this storage, it has no real capability to accommodate prolonged fuel system imbalances. As a result, the expected best-case emission reductions are about the same as those available in 2005. A rough capital cost for the storage and large compressors is about \$27,000,000²². Annual electrical costs for the required compressors add another \$600,000. The annualized capital plus electrical costs to eliminate a ton of non-methane hydrocarbon result in a cost-effectiveness of approximately \$190 Million dollars per ton. Therefore, Option 2A is even less cost-effective for reducing flaring than Option 1.

²² Based on a nominal 1 MMSCF sphere (60' diameter) at 120 psig, and two 4 MMSCFD compressors. This system would handle only minor imbalances while the Flexicoker cuts rate.

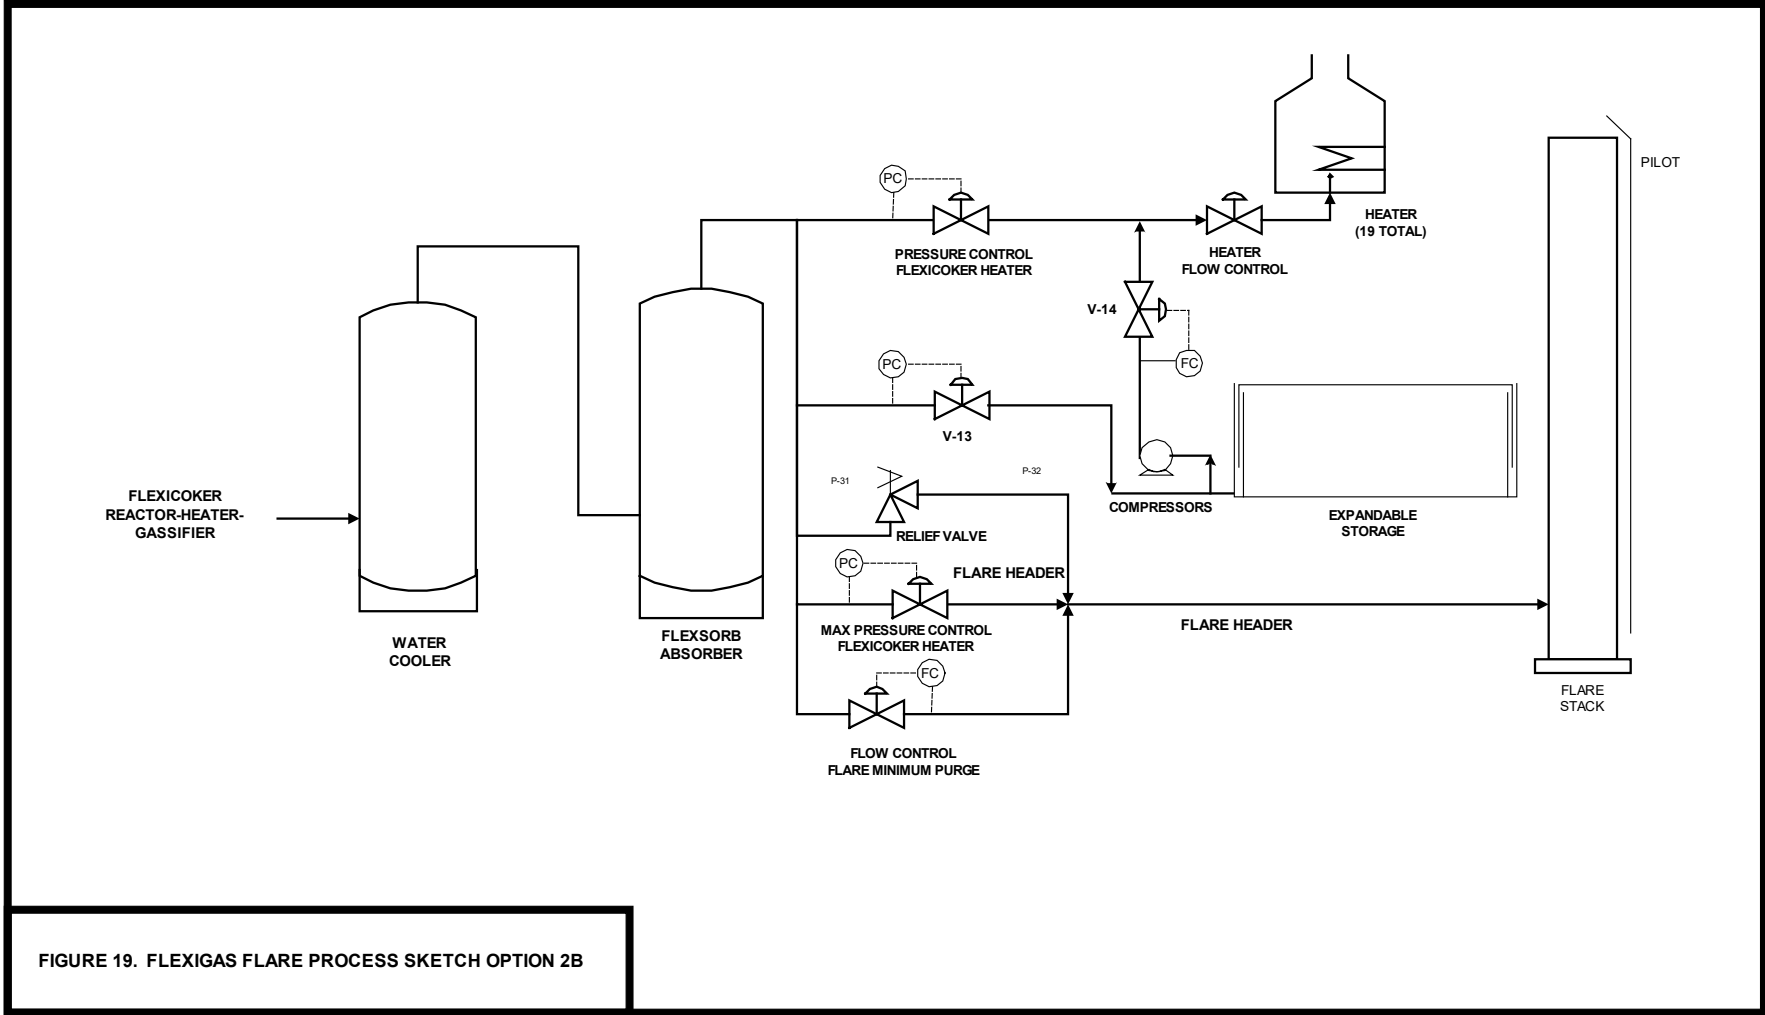
FIGURE 19. FLEXIGAS FLARE PROCESS SKETCH OPTION 2B

Option 2B uses low-pressure expandable gas storage. This option is depicted in Figure 19. This type of storage can be built significantly larger than the pressurized storage used in option 2A, and has the advantage of not requiring compressors in some cases. However, the concentration of carbon monoxide in the gas will likely require use of a water seal to limit leakage, restricting vessel height to a single lift. The requirement for a single lift, combined with low-pressure operation, significantly limits available storage volume²³. In any event, the installed cost is approximately \$21,000,000, providing cost-effectiveness of approximately \$276 Million dollars per ton of NMHC. As was the case for Option 2A, this option is even less cost-effective for reducing flaring than Option 1.

²³ The actual available storage volume is probably on the order of 1 MMSCFD, and will severely limit achievable emissions reductions. A 50% savings is premised for this analysis.
