**Martinez Refining Company**

**Regulation 12 Rule 12**

**FLARE MINIMIZATION PLAN**

**Updated September 30, 2025**

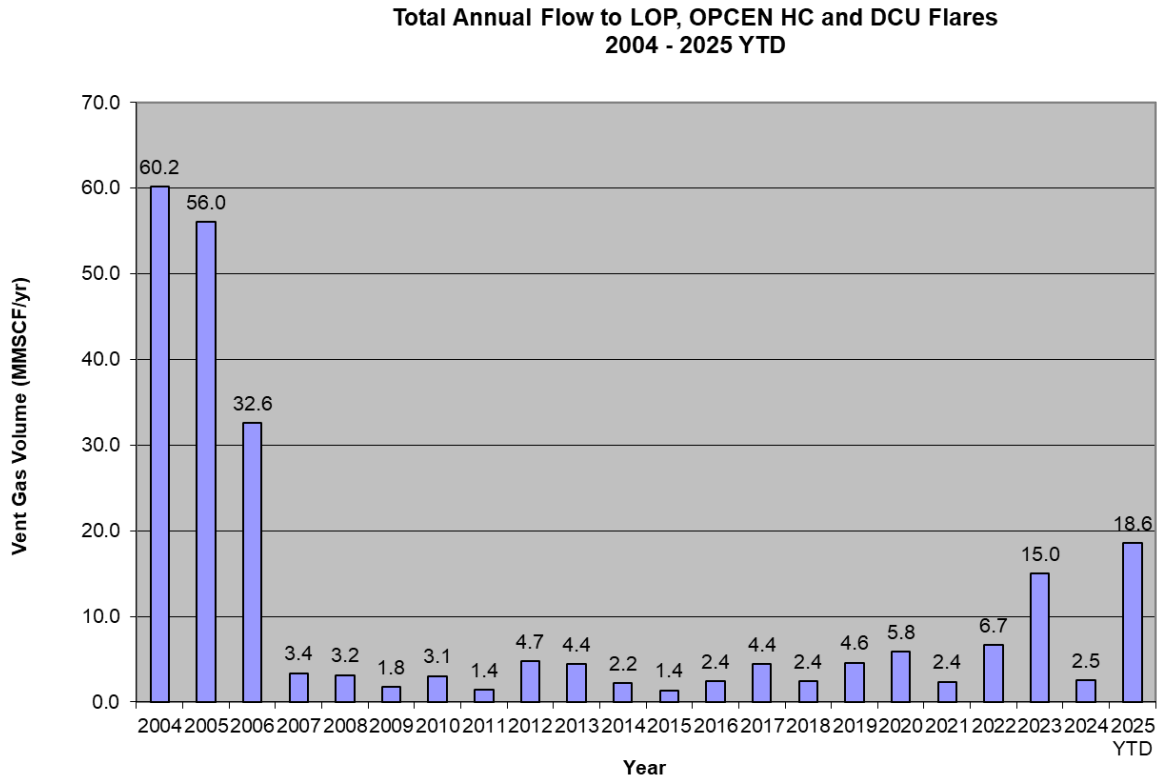
**FIGURE ES-1**

Figure ES-1 presents the total annual vent gas flow to the Light Oil Processing (LOP), Operations Central Hydrocarbon (OPCEN HC) and Delayed Coking Unit (DCU) Flares at the refinery from 2004 through June 30, 2025. Flare flow continues to be very low.

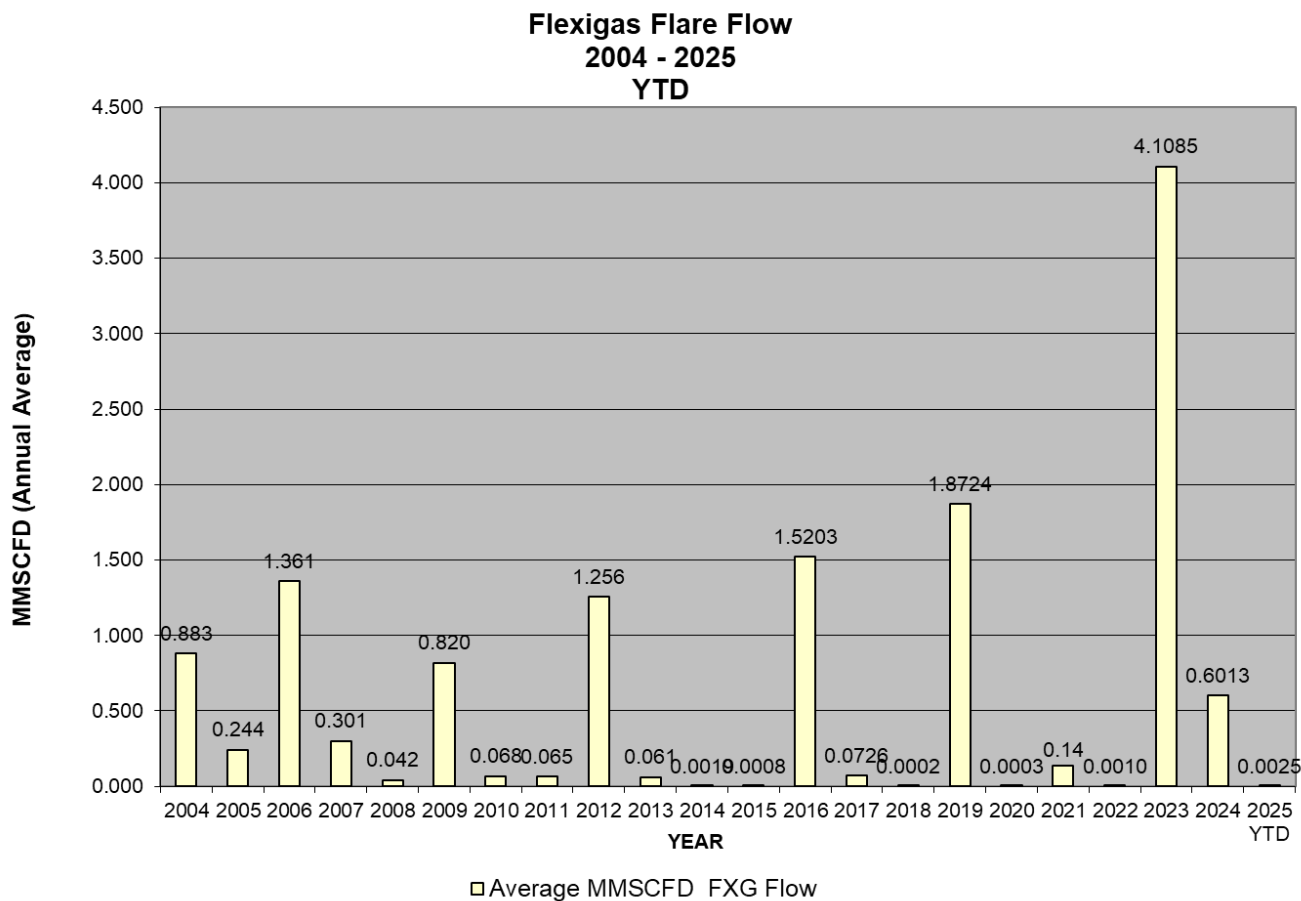
## **FIGURE ES-2**

Figure ES-2 shows the annualized vent gas flow from the Flexigas Flare. This figure shows a cyclic increase in Flexigas flaring which occurs during years with startup and shutdown of the Flexicoker due to the nature of the Flexicoking and Flexsorb processes. The flaring of treated flexigas during startups and shutdowns of the Flexicoker is allowed up to specified limits in MRC's Title V permit. Flexigas is a very low BTU gas used as a supplemental refinery fuel gas in refinery process heaters. Flexigas is treated for sulfur removal in the Flexsorb Unit before being combusted either in refinery process heaters or if necessary, in the Flexigas Flare. When FXG is flared, the volume of gas is typically large compared to the volume flared in the other refinery process flares, but emissions are significantly less because Flexigas contains very low concentrations of non-methane hydrocarbon and sulfur.

Flexigas flaring can also occur due to refinery fuel gas imbalance. MRC continues to fine-tune the Flexigas pressure control scheme to minimize flexigas flaring due to small imbalances in fuel gas. Improvements in this system, most notably addition of COGEN to the pressure control scheme, contribute to the very low flexigas flare flow rate seen in non-turnaround years including 2013, 2014, 2015, 2017, 2018, 2020, 2021, and 2022.

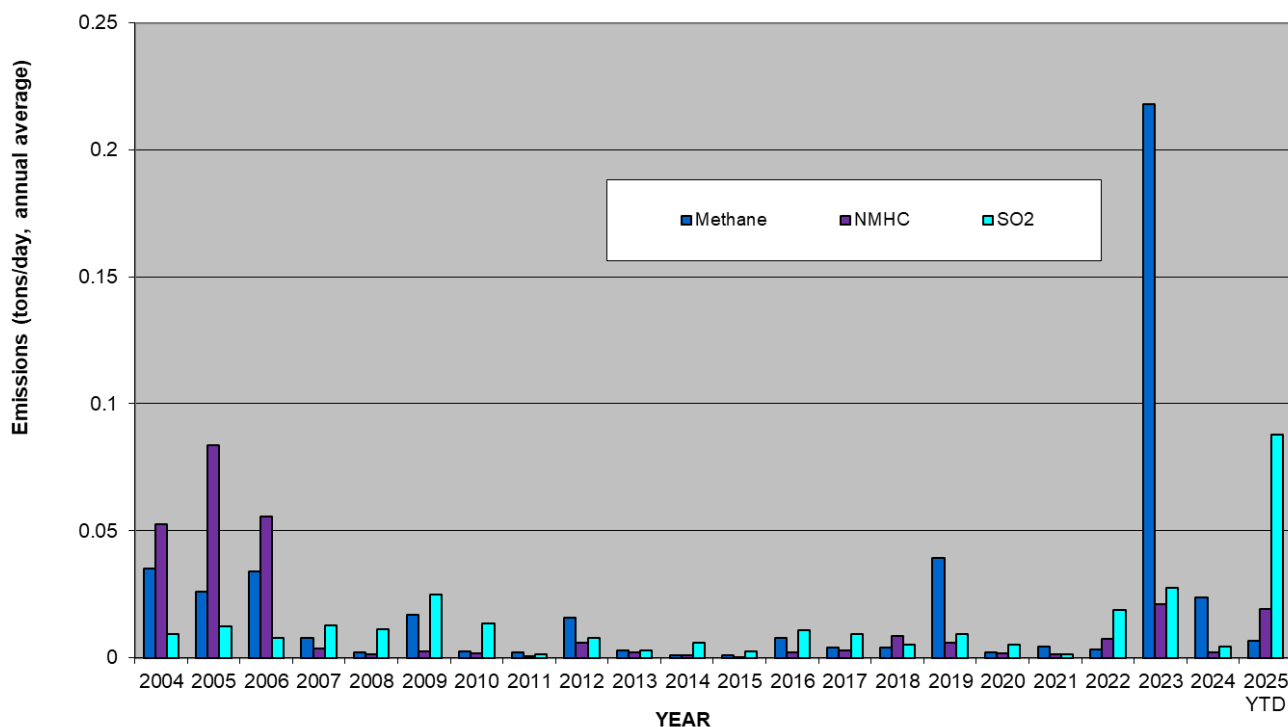
**FIGURE ES-3**

Figure ES-3 shows the methane, non-methane hydrocarbon, and sulfur dioxide emissions from all four refinery process flares from 2004 through June 30 of this year.

**MRC Flare Emissions - All Flares  
2004 - 2025 YTD**

Figure ES-3 shows the overall significant reduction in emissions that has occurred since the implementation of the Flare Minimization Plan in 2006 and highlights that even with large volumes of flexigas flaring during turnaround years, overall emissions from flaring are low.

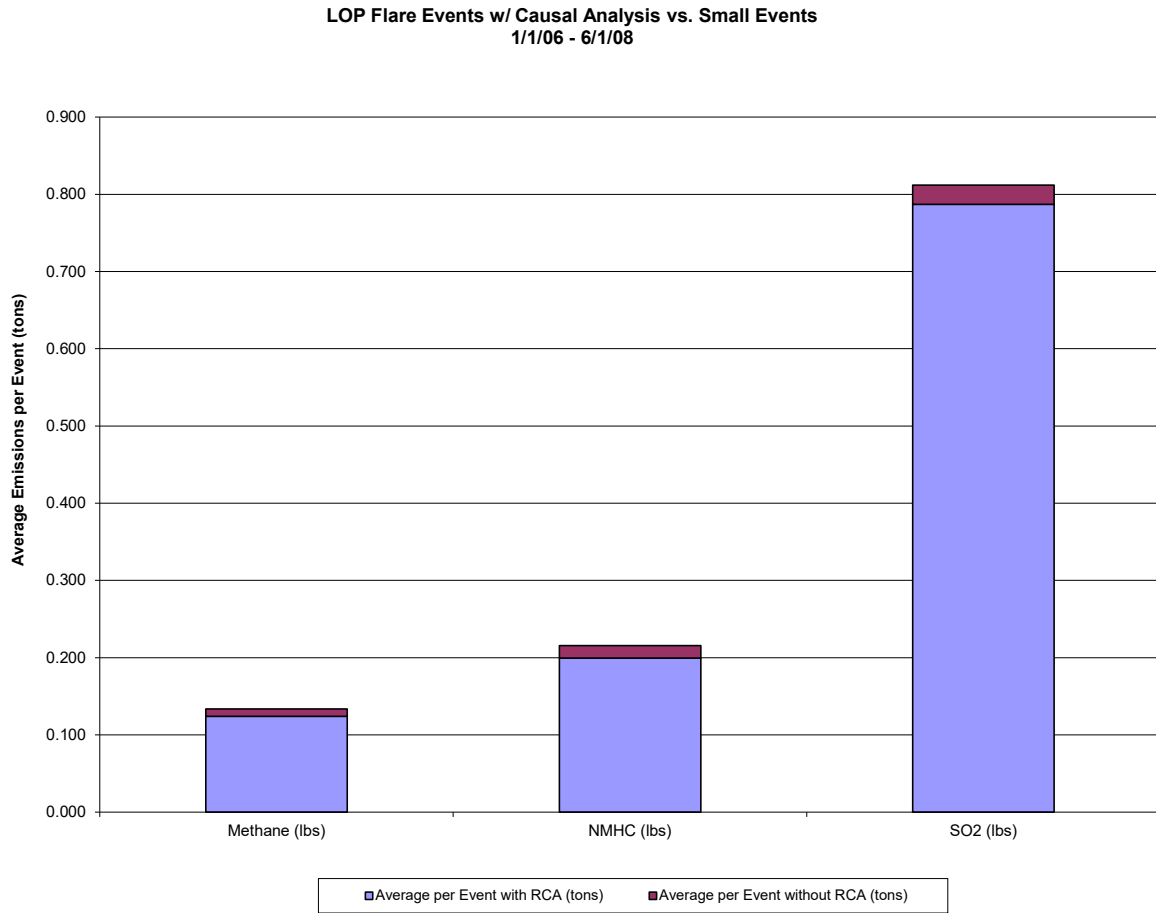
**FIGURE 2008 –1**

Beginning in November 2006 with the adoption of the Flare Procedures described in the Common Measures Section, pertinent information, when available, was captured immediately after a flaring event to determine the cause of any flaring and what could be done to prevent it from happening again. Total emissions from all flaring during the period from 12/1/06 through 6/1/08 were: 0.6 tons of methane, 0.99 tons of non-methane hydrocarbon and 2.5 tons of SO<sub>2</sub>. Figure 2a presents a comparison of the average emissions per large reportable events over this time period vs. the average emissions per small event. This figure shows that small events contributed on average < 10% of the emissions of a large event. Figure 2a reinforces the appropriateness of the causal analysis trigger of 0.5 MMSCF/ 500 lbs SO<sub>2</sub> to ensure the resources to conduct a Causal Analysis are most effectively applied to address high emission events.

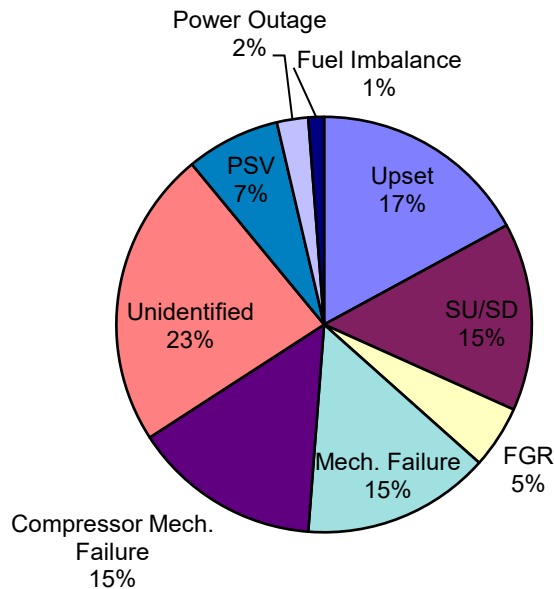
**Figure 2. LOP Area Flare Events  
(2000-2005)**

Review of flare events prior to January 2004 provided little usable information. Without flow meters, neither durations nor volumes could be accurately determined. In many cases, even the proximate cause of flaring could not be reliably determined due to the limited documentation and time elapsed since the event. With these qualifications, a breakdown of the general cause of LOP flare events for the previous five years is depicted in Figure 2. A description of the various categories listed is provided below:

There has been a significant decrease in the number of flare events caused by fuel system imbalance and startup/shutdown in recent years. This is a direct reflection of the increased emphasis on reducing flaring. Regardless of historical performance, major turnarounds in the recent past on units served by this flare have been performed without planned flaring. That this work was performed without planned flaring is evidence of careful review and planning. MRC is committed to continue this careful review and planning prior to planned major maintenance and expect to perform turnarounds with little or no planned flaring. Therefore there is no predicted flaring resulting from planned major maintenance for which to evaluate prevention measures against. If during the maintenance planning and review process MRC finds that planned flaring is required, all appropriate prevention measures will be considered and feasible measures will be implemented to reduce or eliminate the planned flaring.

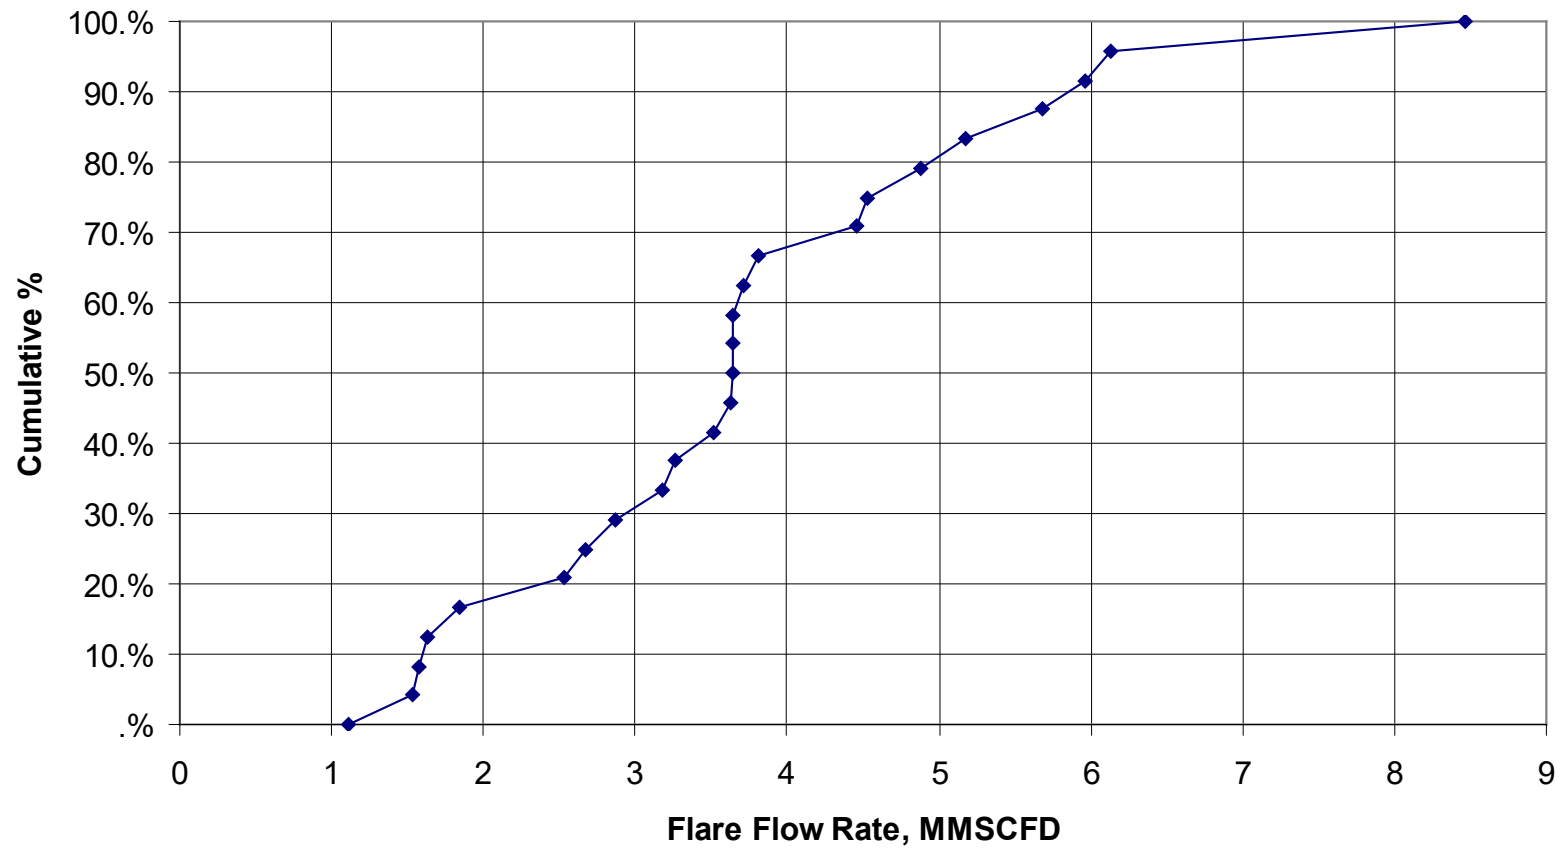
**Figure 4. LOP Flare Gas Flow Rates  
(2005)**

Figure 4 depicts the average rates of flow to the flare for events occurring in 2005. These data indicate that approximately 30% of the flare events had event-average flow rates of less than 3 million standard cubic feet per day. Actual instantaneous rates are generally higher – often significantly – than these average rates. This difference between the average rate for an event and instantaneous flare gas rate during an event is important because once the instantaneous rate exceeds the available compressor capacity the water seal is typically broken and flaring occurs. Once flaring begins, backpressure in the flare header provided by the water seal is significantly reduced. Due to the lower header pressure, flare gas recovery rates are typically significantly reduced from their rated capacity.

Data from Figure 4 were used to evaluate the leverage provided by additional flare gas recovery in LOP. As each increment of compressor capacity was added, the corresponding events with average flows within the newly revised total capacity were considered to be recovered rather than flared. Similarly, the reported emissions for these events were presumed not to occur. This provided the basis for emissions reductions as a function of compressor capacity.

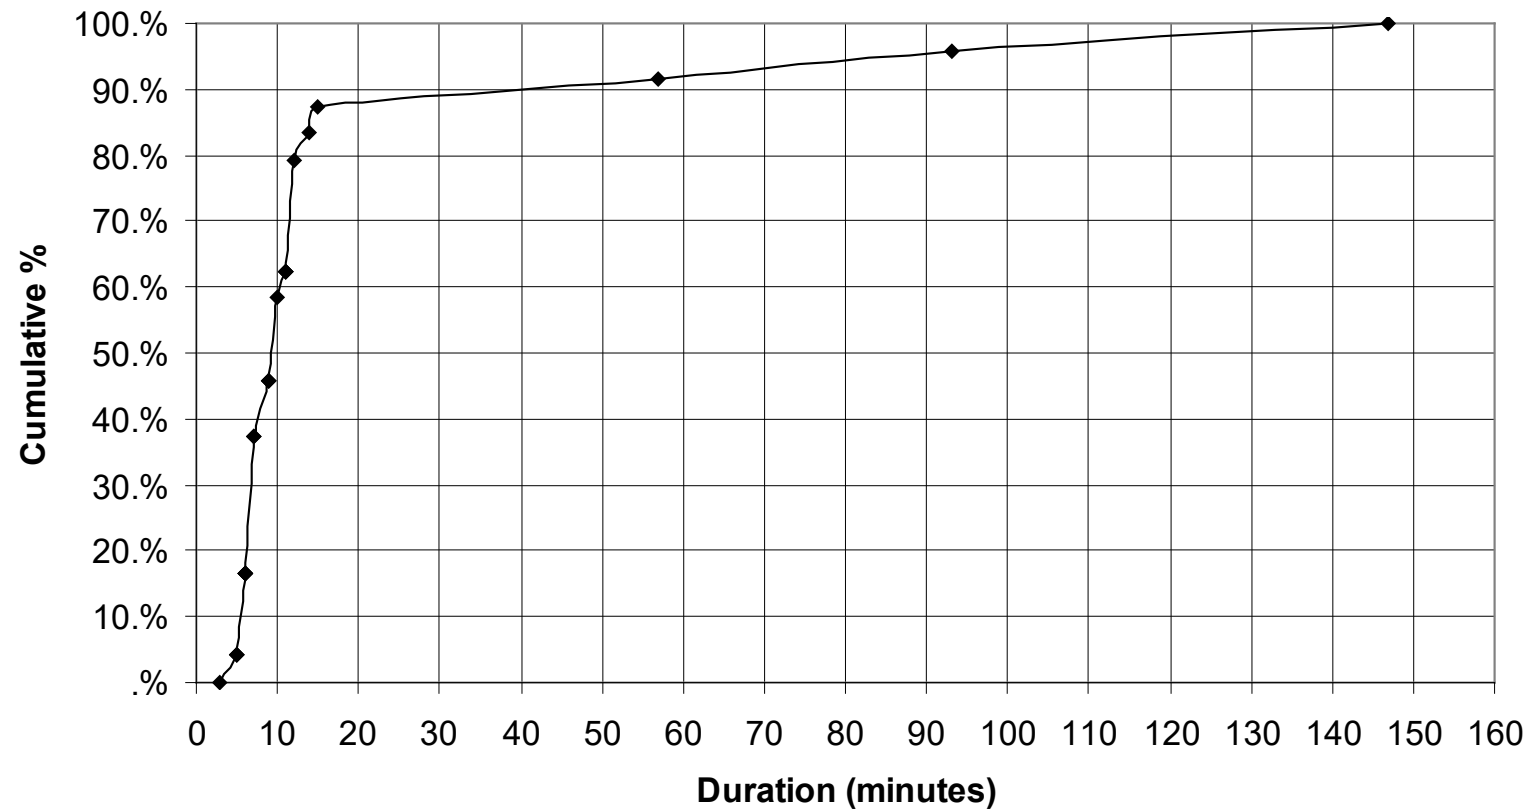
**Figure 5. LOP Flare Durations**  
(2005 - 25 Events)

Figure 5 depicts the distribution of flare event durations for 2005, the year for which these data are available. Most flare events have very short durations with small volumes of gas flared. From

Figure 5 it can be seen that half of the flare events had durations of less than 10 minutes. By combining event durations with additional data on the volume flared during each event, it can be shown that the 50% of events with durations less than 10 minutes contributed less than 10% to the total volume of gas flared. The 85% of events which lasted 15 minutes or less contributed less than 40% to the total volume flared. Only three of the flare events during this period lasted longer than one hour. All of the event durations were less than three hours.

<sup>9</sup> The requirement for continuous compressor operation derives from actual data showing that most events in the LOP flare last less than 10 minutes. It is impractical to expect a compressor of this size to go from shutdown to full operation rapidly enough to capture such events.

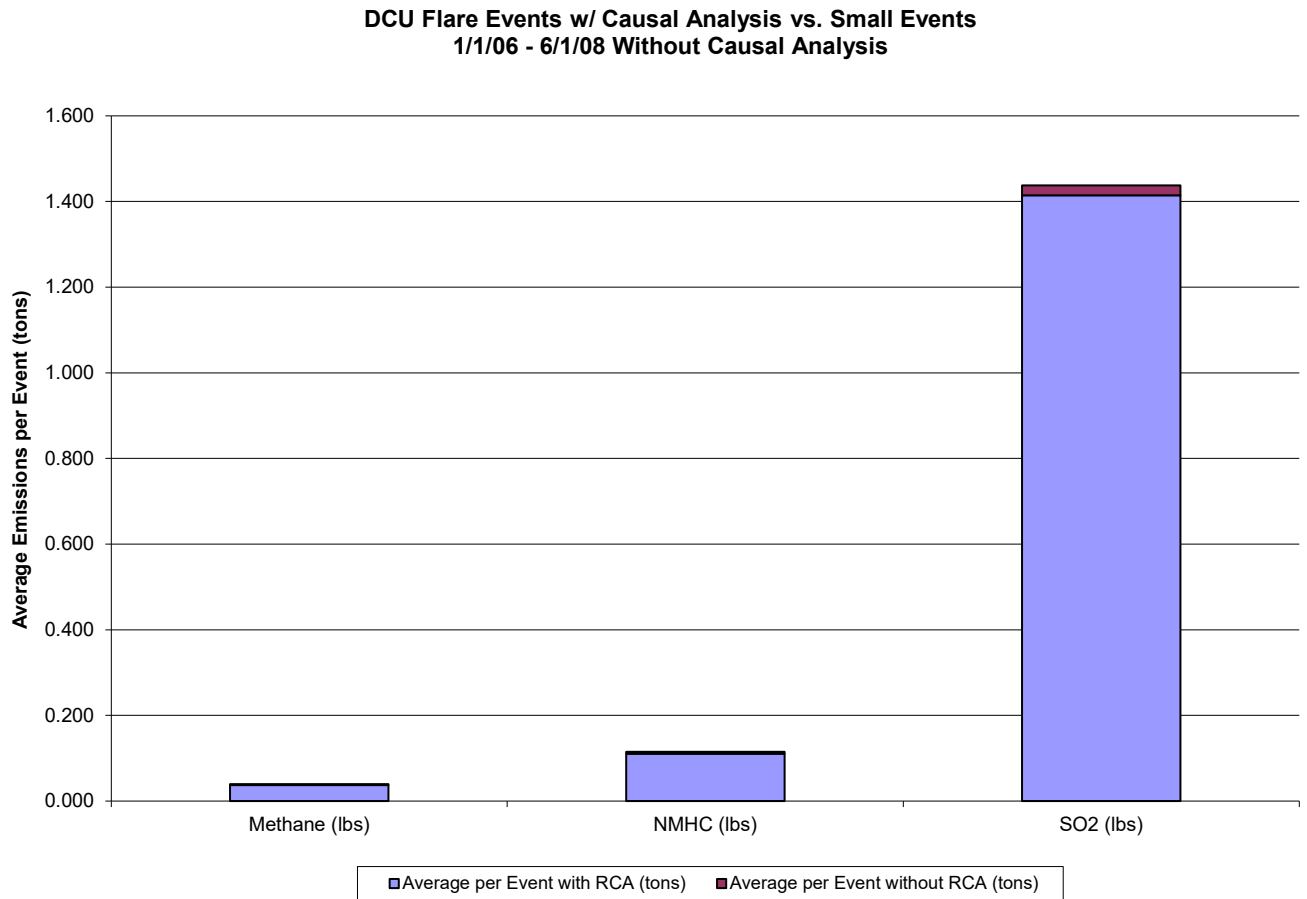
**FIGURE 2008-2**

Beginning in November 2006 with the adoption of the Flare Procedures described in the Common Measures Section, pertinent information, when available, was captured immediately after a flaring event to determine the cause of any flaring and what could be done to prevent it from happening again. Total emissions from all flaring during this 30-month period were: 0.17 tons of methane, 0.45 tons of non-methane hydrocarbon and 4.19 tons of SO<sub>2</sub>. Figure 2008-2 presents a comparison of the average emissions per large reportable events over this time period vs. the average emissions per small event for the DCU Flare. This figure shows that small events contributed < 6% of the emissions of a large event. Figure 2008-2 reinforces the appropriateness of the causal analysis trigger of 0.5 MMSCF/ 500 lbs SO<sub>2</sub> to ensure the resources to conduct a Causal Analysis are most effectively applied to address high emission events.

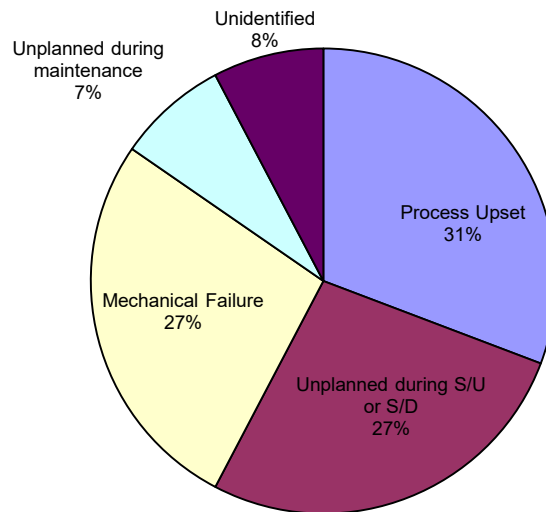
**FIGURE 2008 - 3**

The DCU flare events that occurred from 1/1/06 – 6/1/08 were categorized by probable cause in Figure 2008-3. None of the flaring was planned. Most of the events were < 10 minutes long. The majority of the events were caused by process upset, mechanical failure or were unplanned during startup and shutdowns.

**Probable Cause of Flaring on DCU Flare 1/1/06-6/1/08  
26 Events**

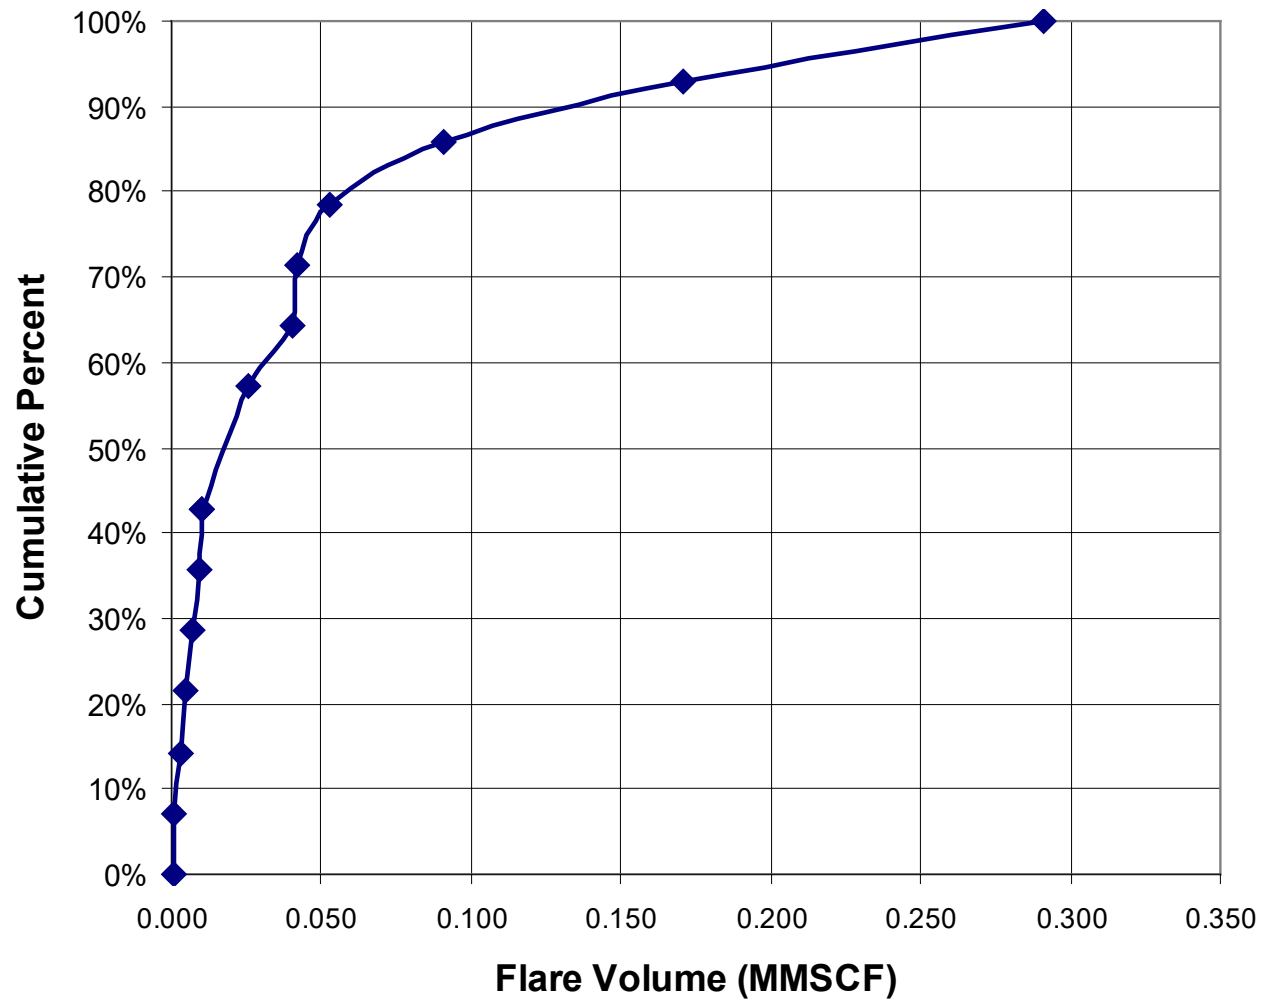
**Figure 9. Delayed Coking Area Flare Gas Volumes  
(2005)**

Figure 9 depicts the amount of material flared during the reported incidents of flare activity in 2005. All flaring was below 500,000 scf. Approximately 70% of the incidents of reported flaring involved volumes of gas of 50,000 SCF or less. All were below 300,000 standard cubic feet.

**Flaring during 2005.** The highest quality data are available for the period from January 2005 to January 2006. Data is available during this period from flare flow meters and monthly BAAQMD flare reporting. Available data for flare event volumes and durations are provided in Figures 9 through 11 below.

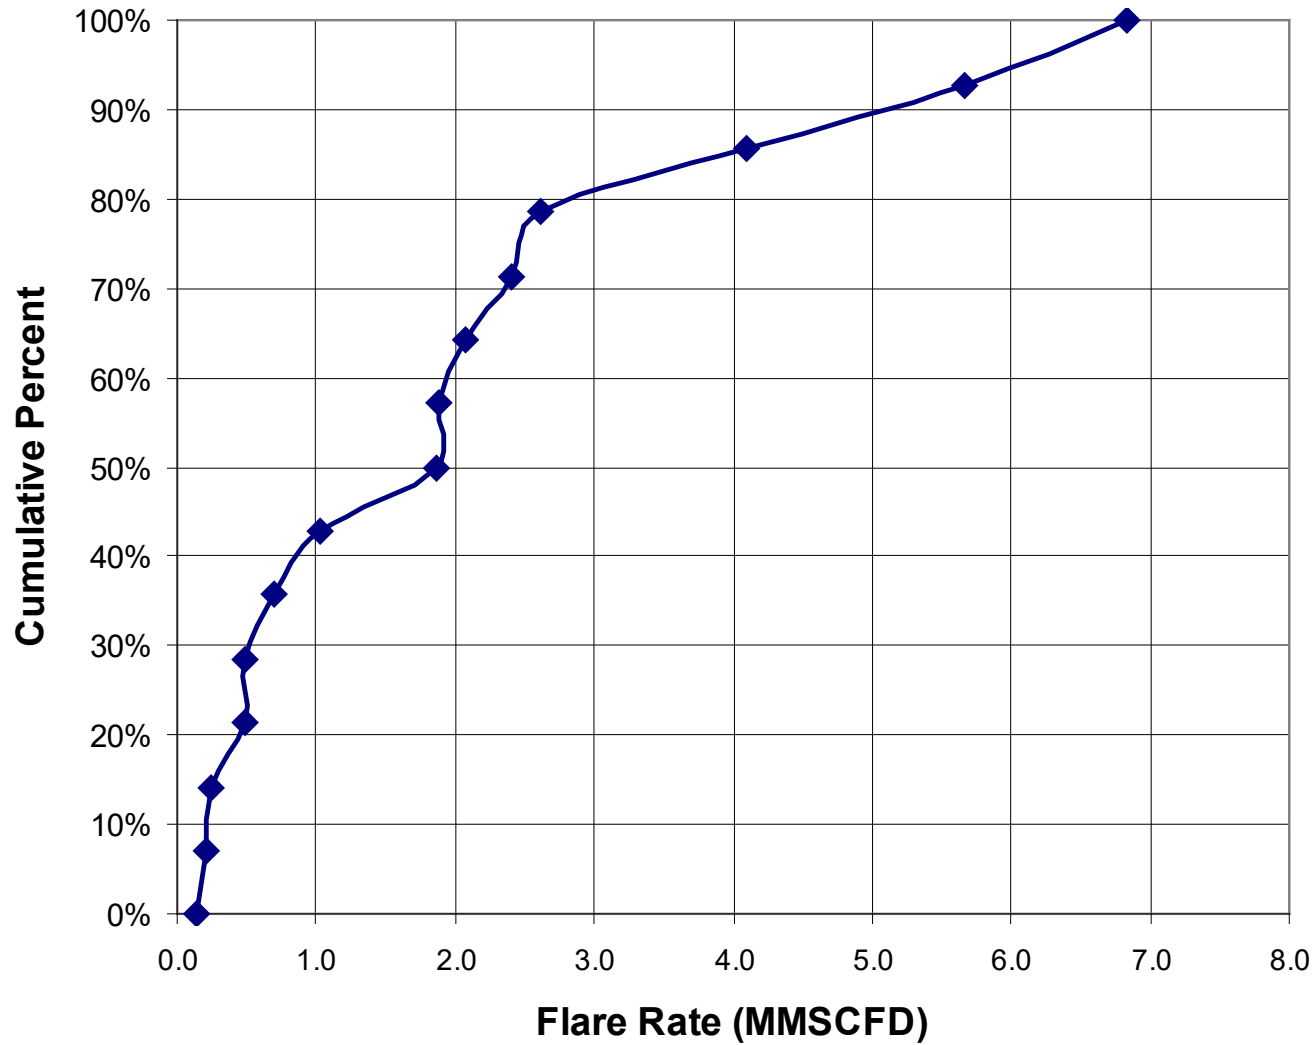
**Figure 10. Delayed Coking Area Flare Gas Flow Rates  
(2005)**

Figure 10 depicts the average rates of flow to the flare for events occurring in 2005. These data indicate that approximately 80% of the flare events had event-average flow rates less than 3 million standard cubic feet per day. Actual instantaneous rates comprising the average are generally higher – often significantly – than these average rates.

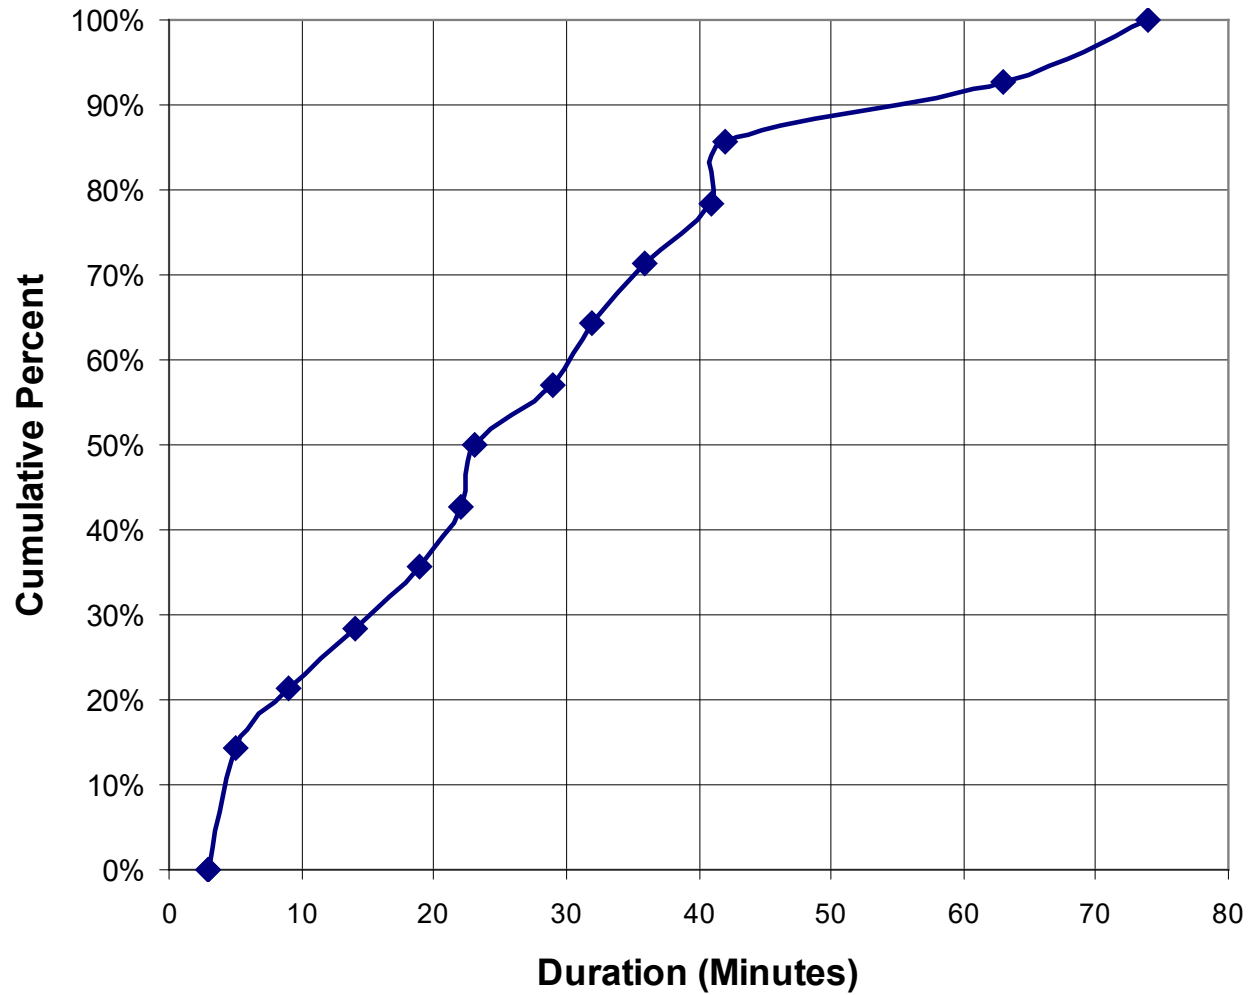
**Figure 11. Delayed Coking Area Flare Event Durations  
(2005)**

Figure 11 depicts the distribution of flare event durations for 2005 where these data are available. 50% of the events lasted less than 30 minutes. This is consistent with other data characterizing the bulk of flare events being very brief.

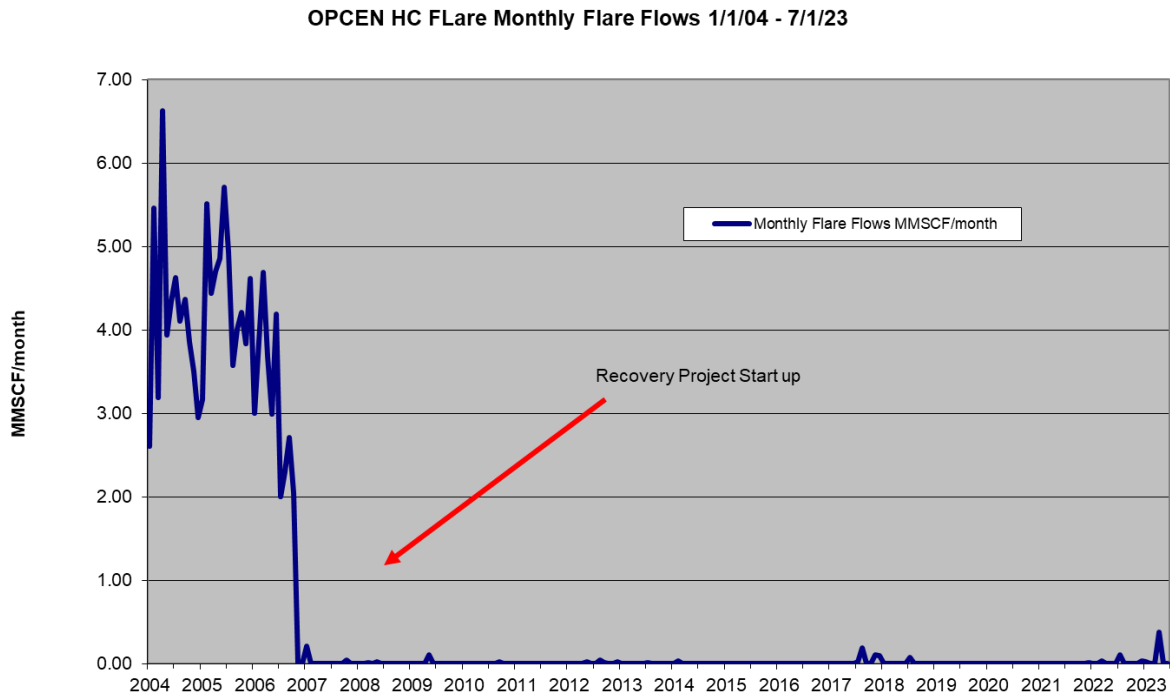
The figure below has been updated through 6/30/23 and shows the continued success of the implementation of the flare recovery project that occurred in 2006 for this flare.

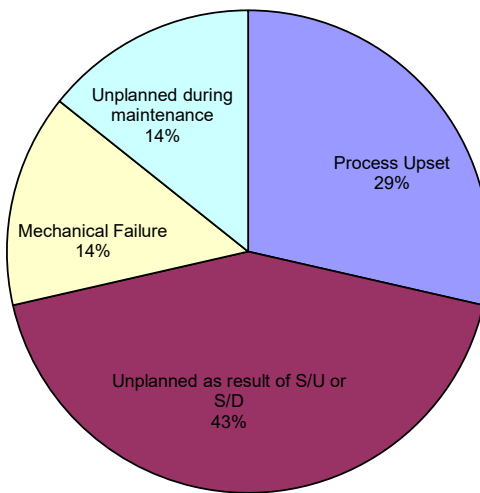
**FIGURE 2008-4**

The OPCEN HC flare events that occurred after the implementation of flare recovery from 11/1/06 – 6/1/08 were categorized by probable cause in Figure 2008-4. None of the flaring was planned. The cause of the events included process upset, mechanical failure or were unplanned during maintenance or startup and shutdown.

**OPCEN HC Flare- Cause of Flaring 11/1/06 - 6/1/08  
7 Events**

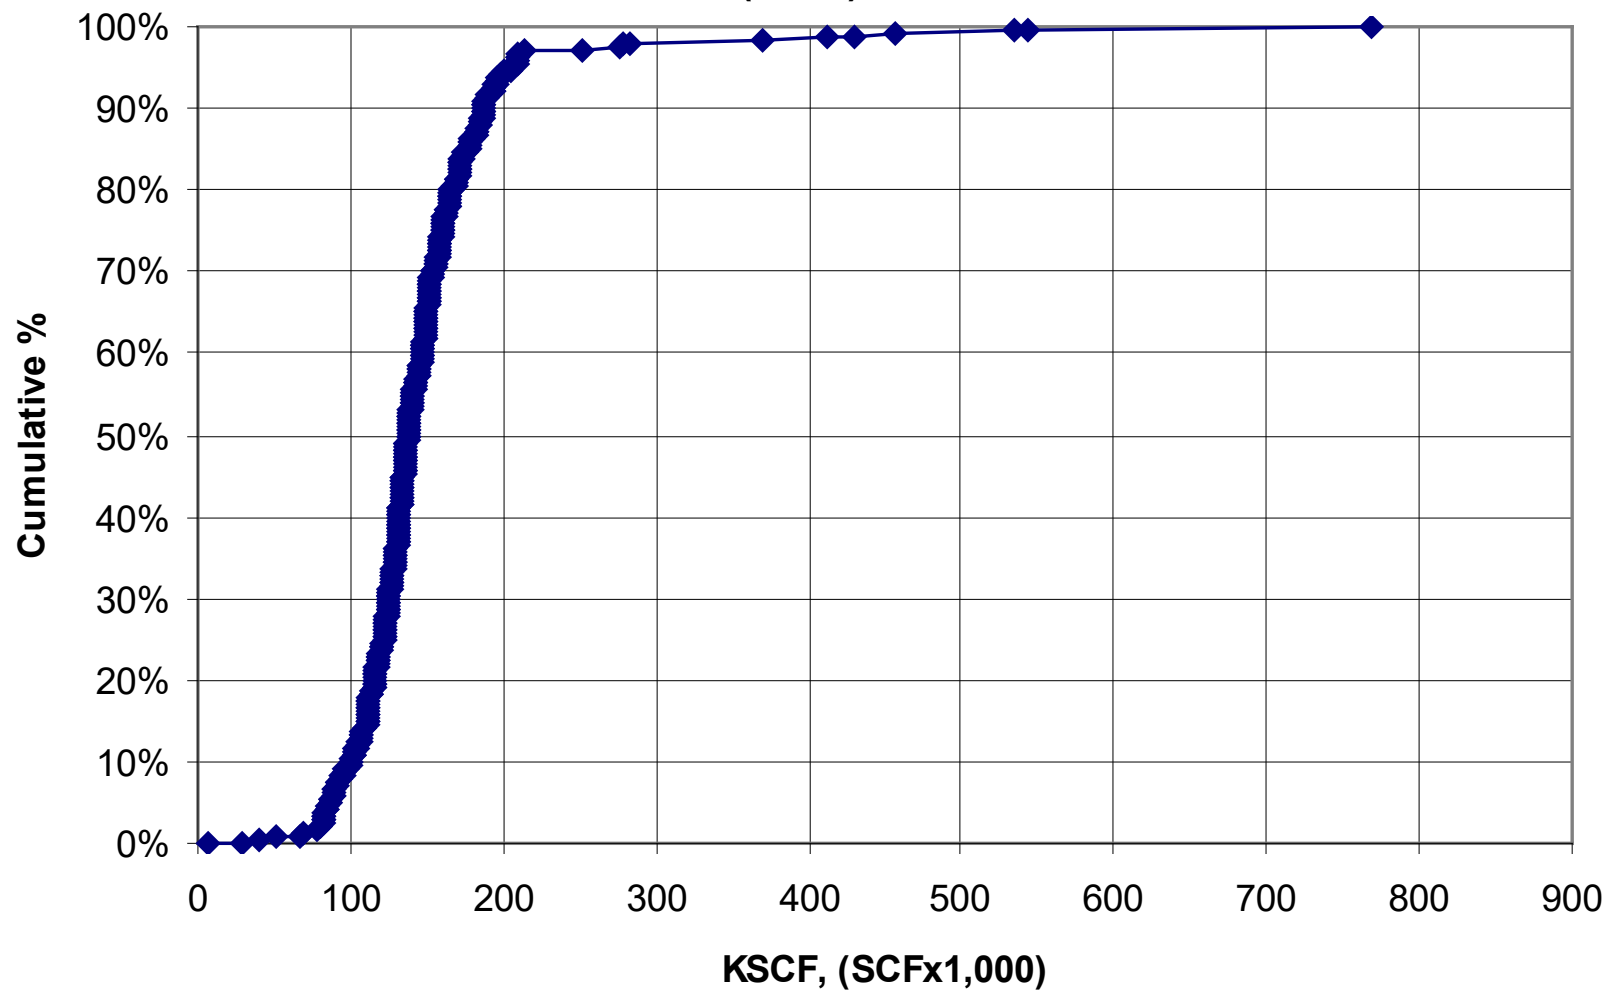
**Figure 13. OPCEN Hydrocarbon Flare Gas Volumes  
(2005)**

With historical performance profoundly biased by absence of flare gas recovery, this review concentrated on calendar year 2005. Flare data are depicted in Figure 13. Total emissions of non-methane hydrocarbon during 2005 were approximately 30 tons. Emissions of SO<sub>2</sub> in 2005 were 0.3 tons.

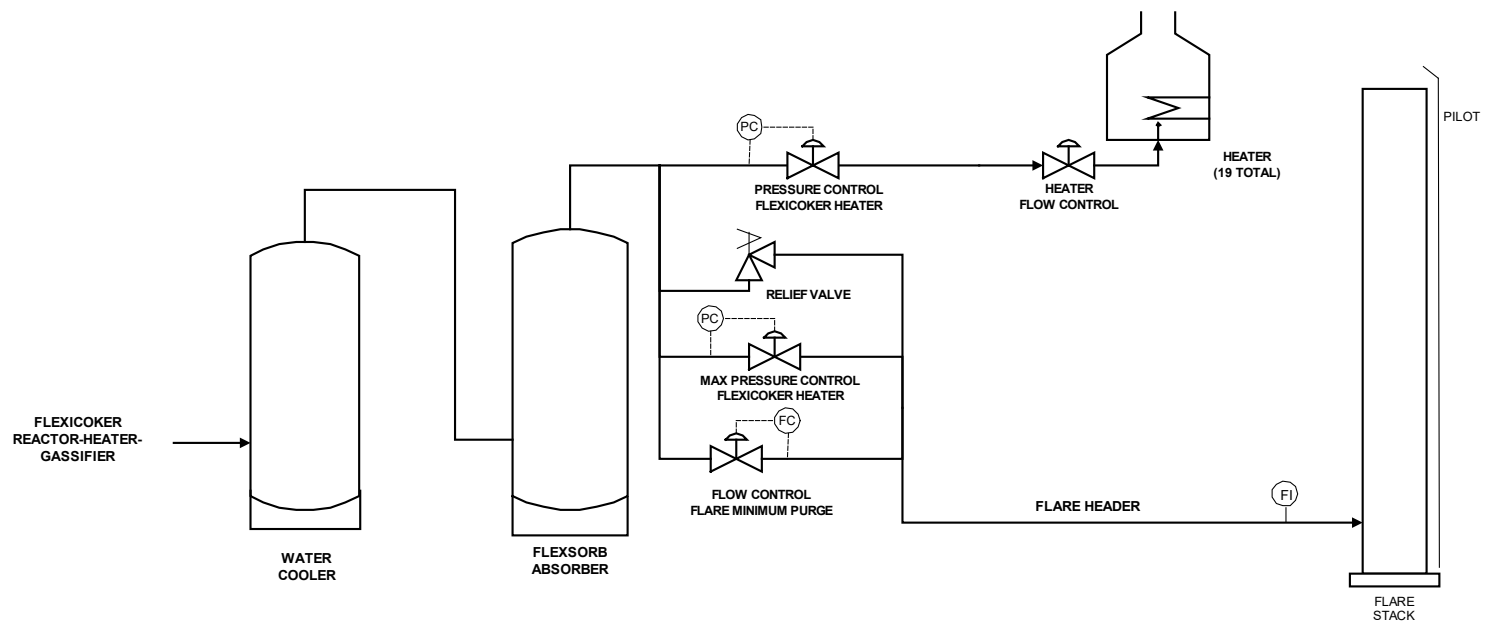
FIGURE 14. FLEXIGAS SUPPLY SYSTEM PROCESS SKETCH

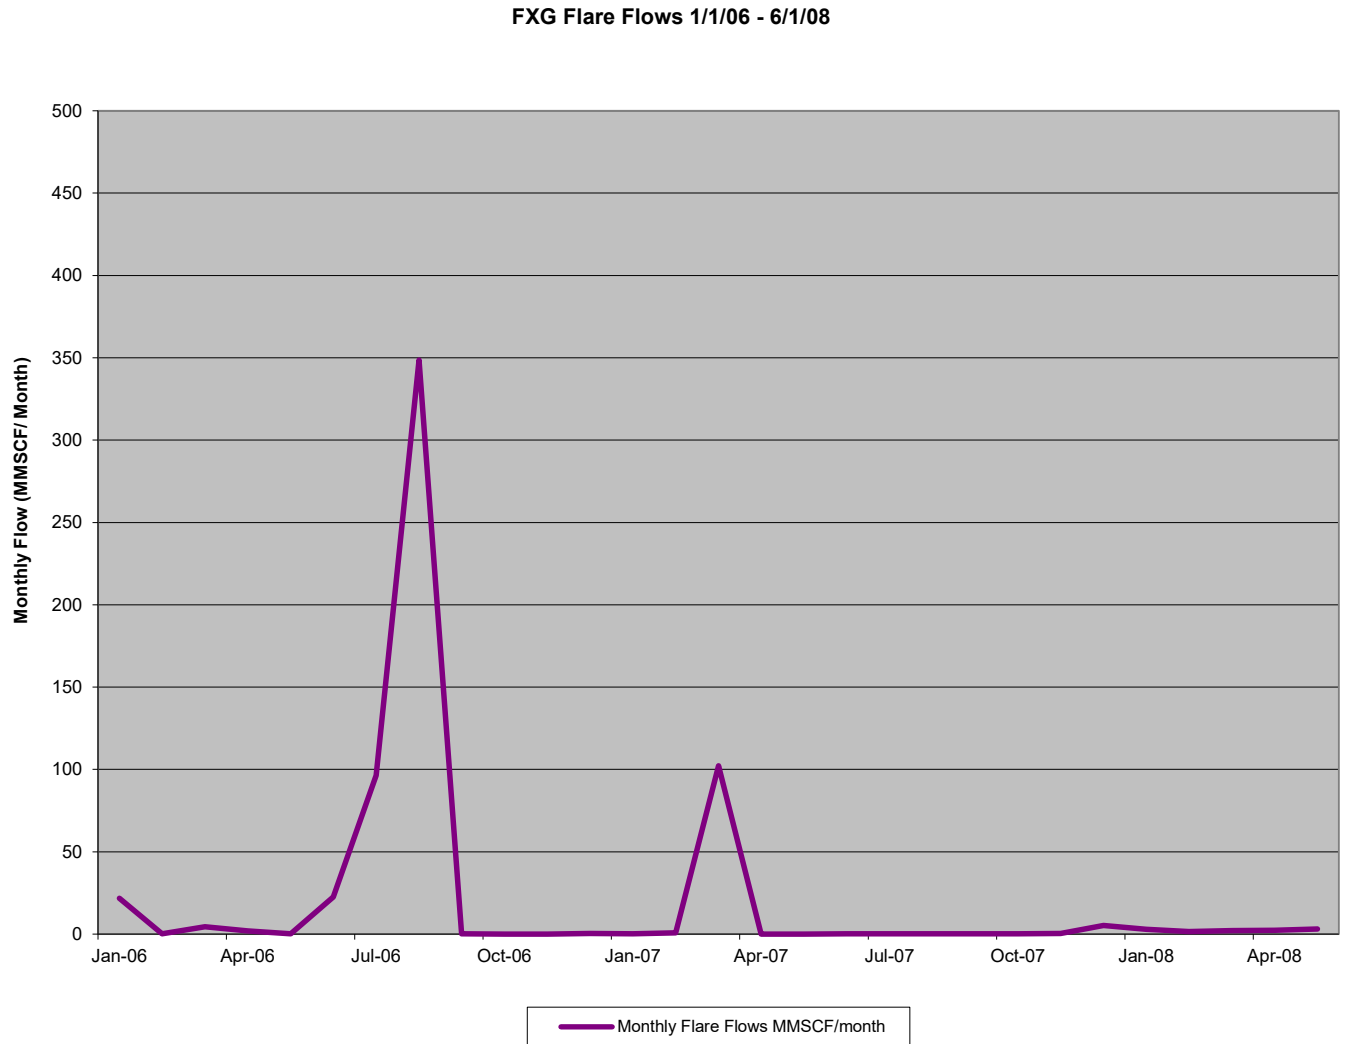
**FIGURE 2008-5**

The other flexigas flaring events that triggered Causal Analyses were smaller events. Most of these flexigas flaring events occurred as a result of fuel gas imbalance. Because there is currently not a flexigas consumer which can quickly change consumption without process or utility steam impacts, any excess flexigas is flared until the Flexicoker can be slowed down enough to reduce flexigas production. A flexigas consumer that could be quickly ramped up or down could reduce some of the flexigas that currently would have to be flared.

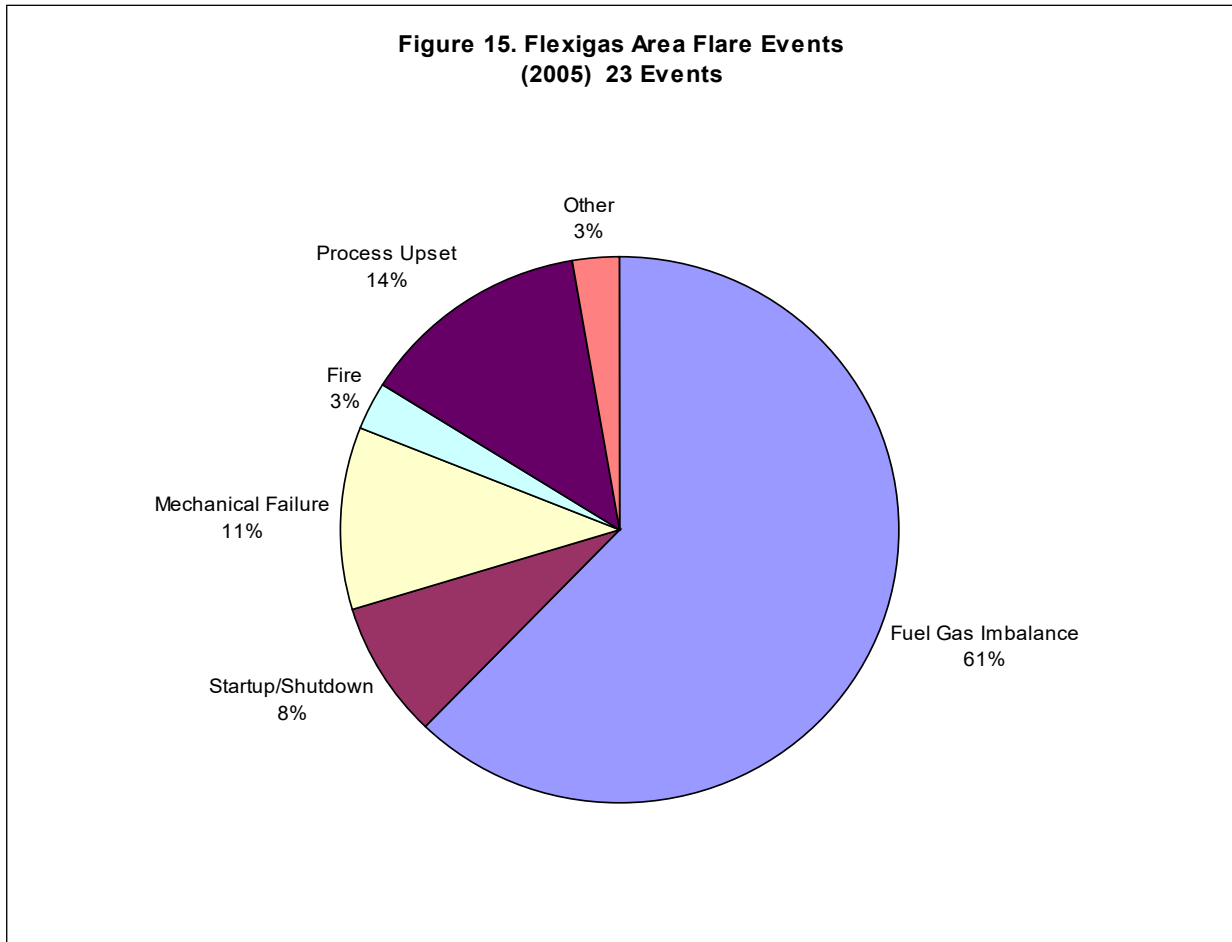
Historical flaring at the OPCEN Flexigas flare was reviewed to identify opportunities for potential mitigation. The highest quality data are available for the period from December 2003, to January 2006. This coincides with installation of the flare flow meter and BAAQMD flare reporting. Data for 2005 are plotted in Figure 15 and Figure 16.

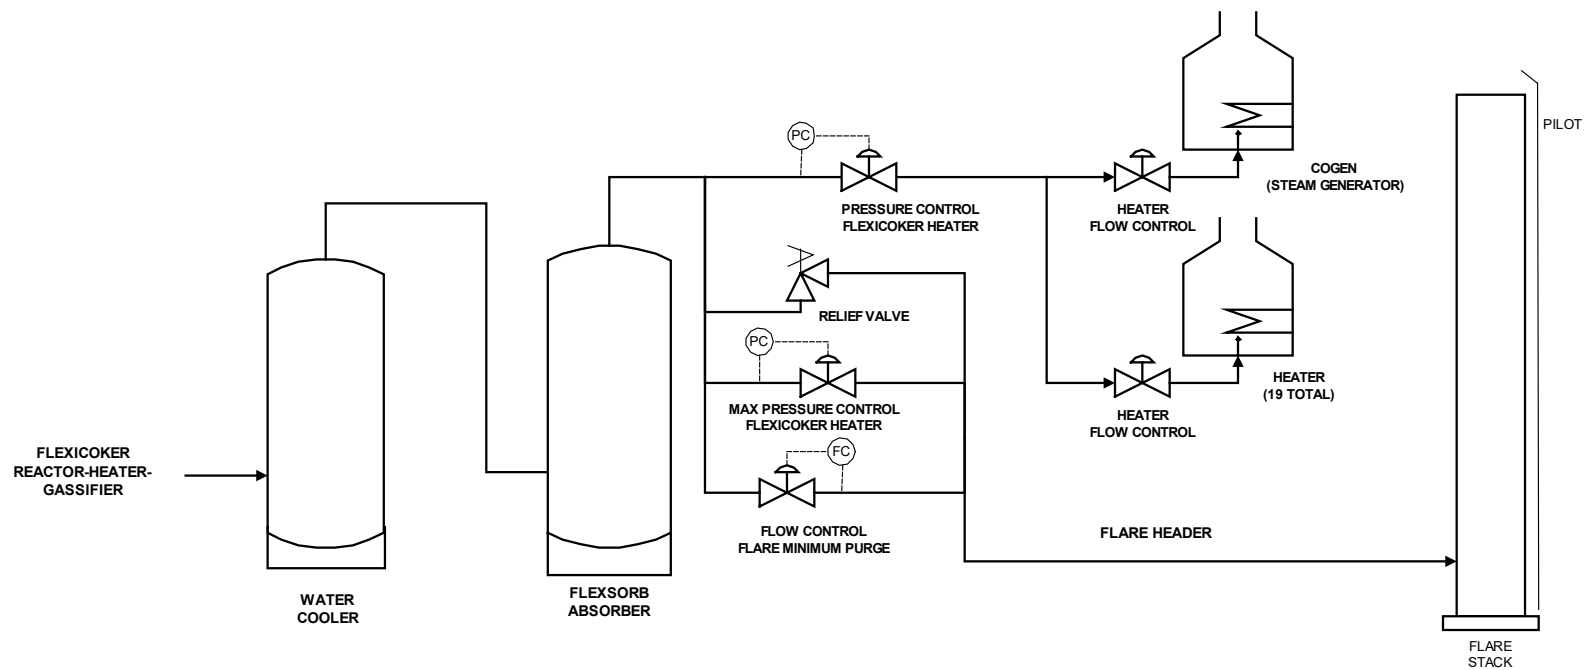
FIGURE 17. FLEXIGAS FLARE PROCESS SKETCH OPTION 1

##### **OPTION 1: PROVIDE ADDITIONAL FLEXIGAS CONSUMERS (see Figure 17).**

The objective of this project would be to provide an additional consumer that can rapidly pick up the Flexigas volumes made available by loss of another consumer (e.g., process heater) for any reason. Because excess Flexigas is available less than 10% of the time (based on the percent of days on which flaring occurred from Figure 16), and the current fuel system is roughly in balance, this consumer must essentially remain in hot standby until needed. This means it must be waiting to burn between 1 MMSCFD and 40 MMSCFD Flexigas when an existing consumer unexpectedly comes off line.
