**Martinez Refining Company**

**Regulation 12 Rule 12**

**FLARE MINIMIZATION PLAN**

**Updated September 30, 2025**

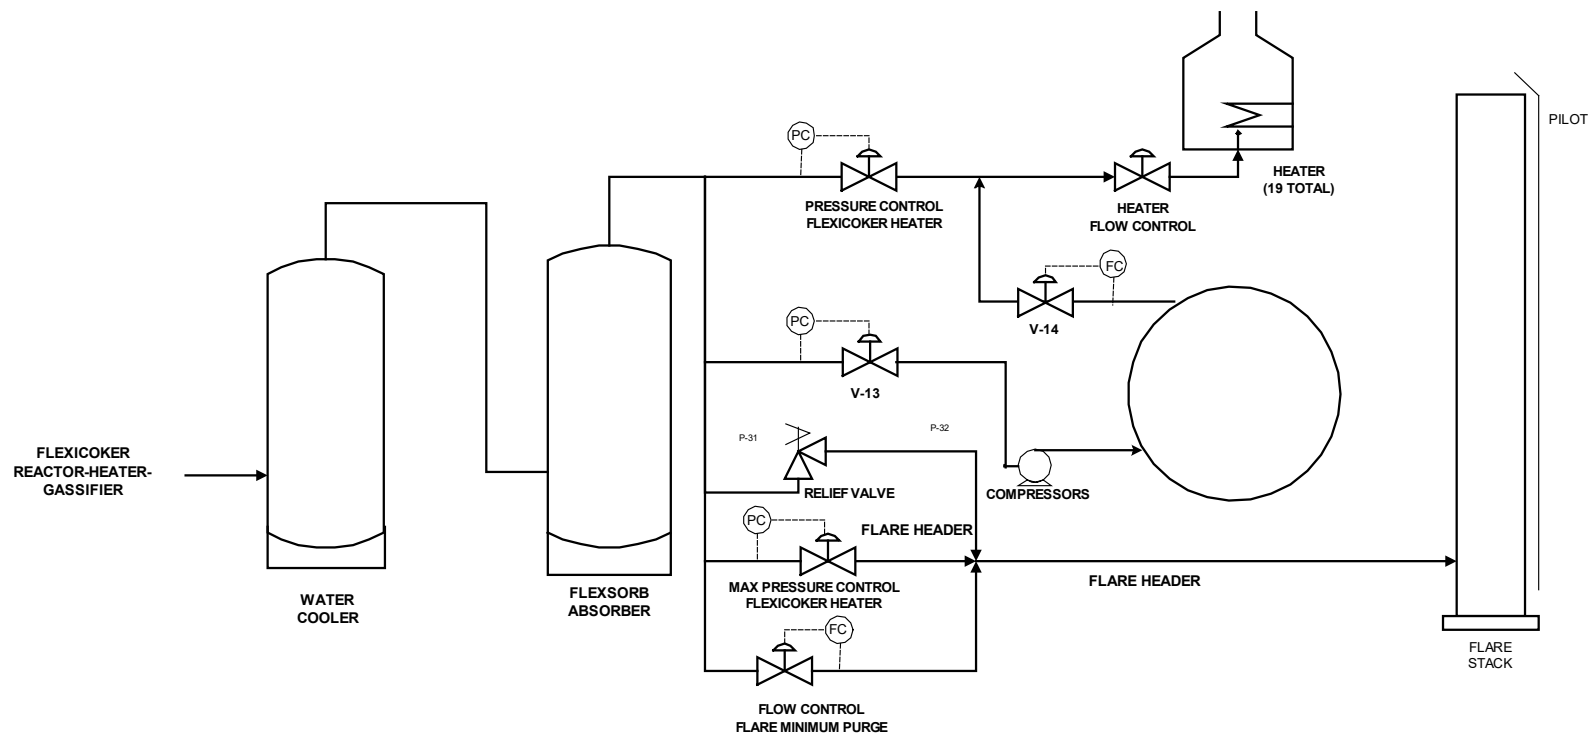
FIGURE 18. FLEXIGAS FLARE PROCESS SKETCH OPTION 2A

**Option 2A** consists of a pressurized vessel that would require a compressor with capacity ranging between 1 MMSCFD and 10 MMSCFD. This option is depicted in Figure 18. Flexigas in excess of consumer demand is routed to storage via compressor(s). A controlled flow is returned to the distribution system when enough consumers are available to avoid flaring. Due to the limited capacity of this storage, it has no real capability to accommodate prolonged fuel system imbalances. As a result, the expected best-case emission reductions are about the same as those available in 2005. A rough capital cost for the storage and large compressors is about \$27,000,000<sup>22</sup>. . Annual electrical costs for the required compressors add another \$600,000. The annualized capital plus electrical costs to eliminate a ton of non-methane hydrocarbon result in a cost-effectiveness of approximately \$190 Million dollars per ton. Therefore, Option 2A is even less cost-effective for reducing flaring than Option 1.

<sup>22</sup> Based on a nominal 1 MMSCF sphere (60' diameter) at 120 psig, and two 4 MMSCFD compressors. This system would handle only minor imbalances while the Flexicoker cuts rate.
