**Annual Update of Flare Minimization Plan - Public**  
**Chevron Richmond Refinery**

## **Chevron Products Company - Richmond Refinery**

# **Flare Minimization Plan**

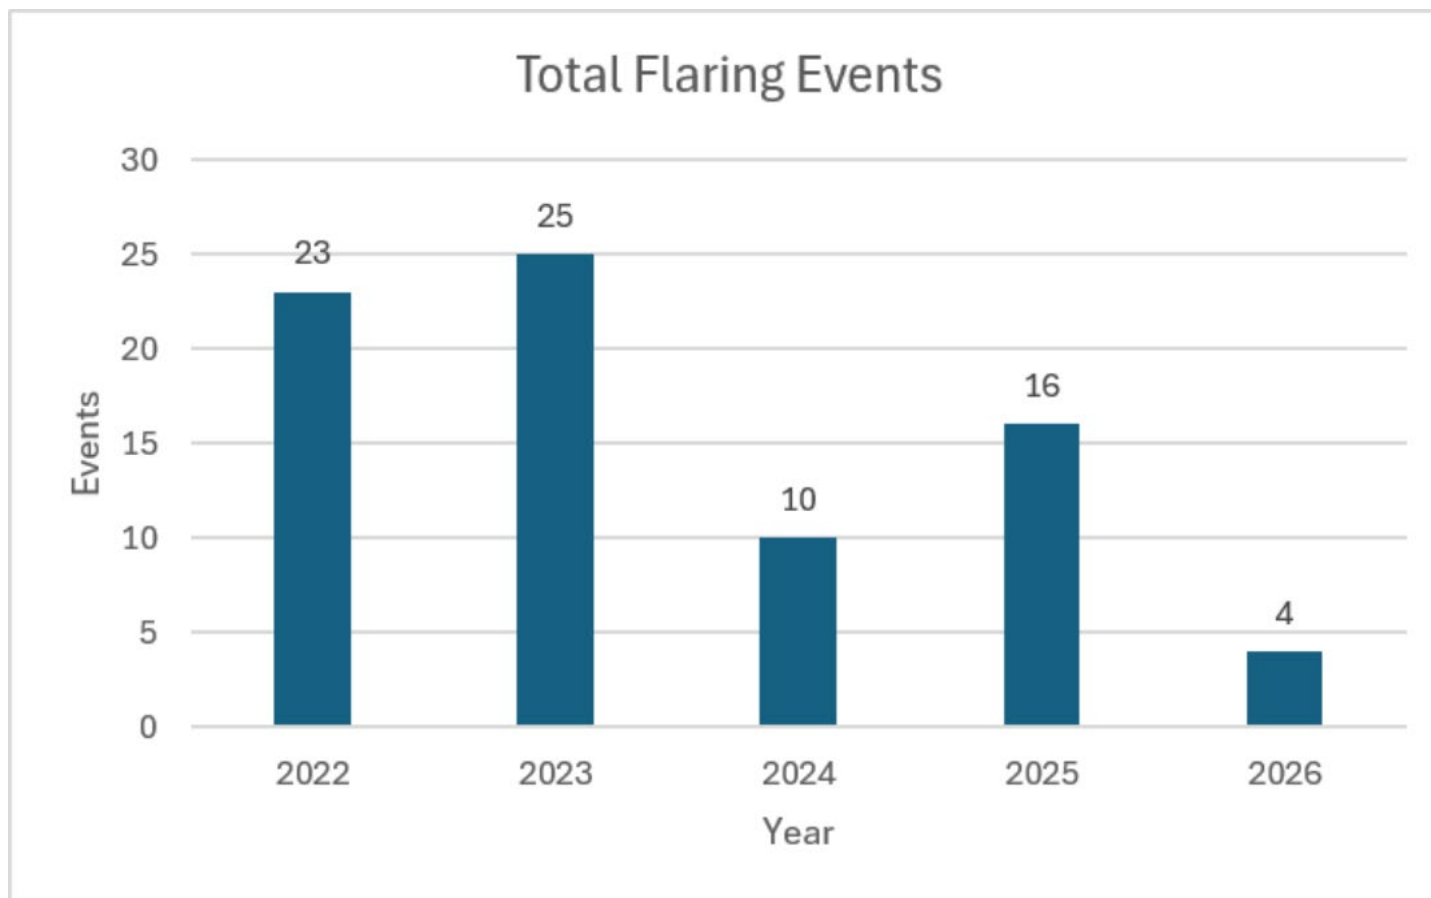
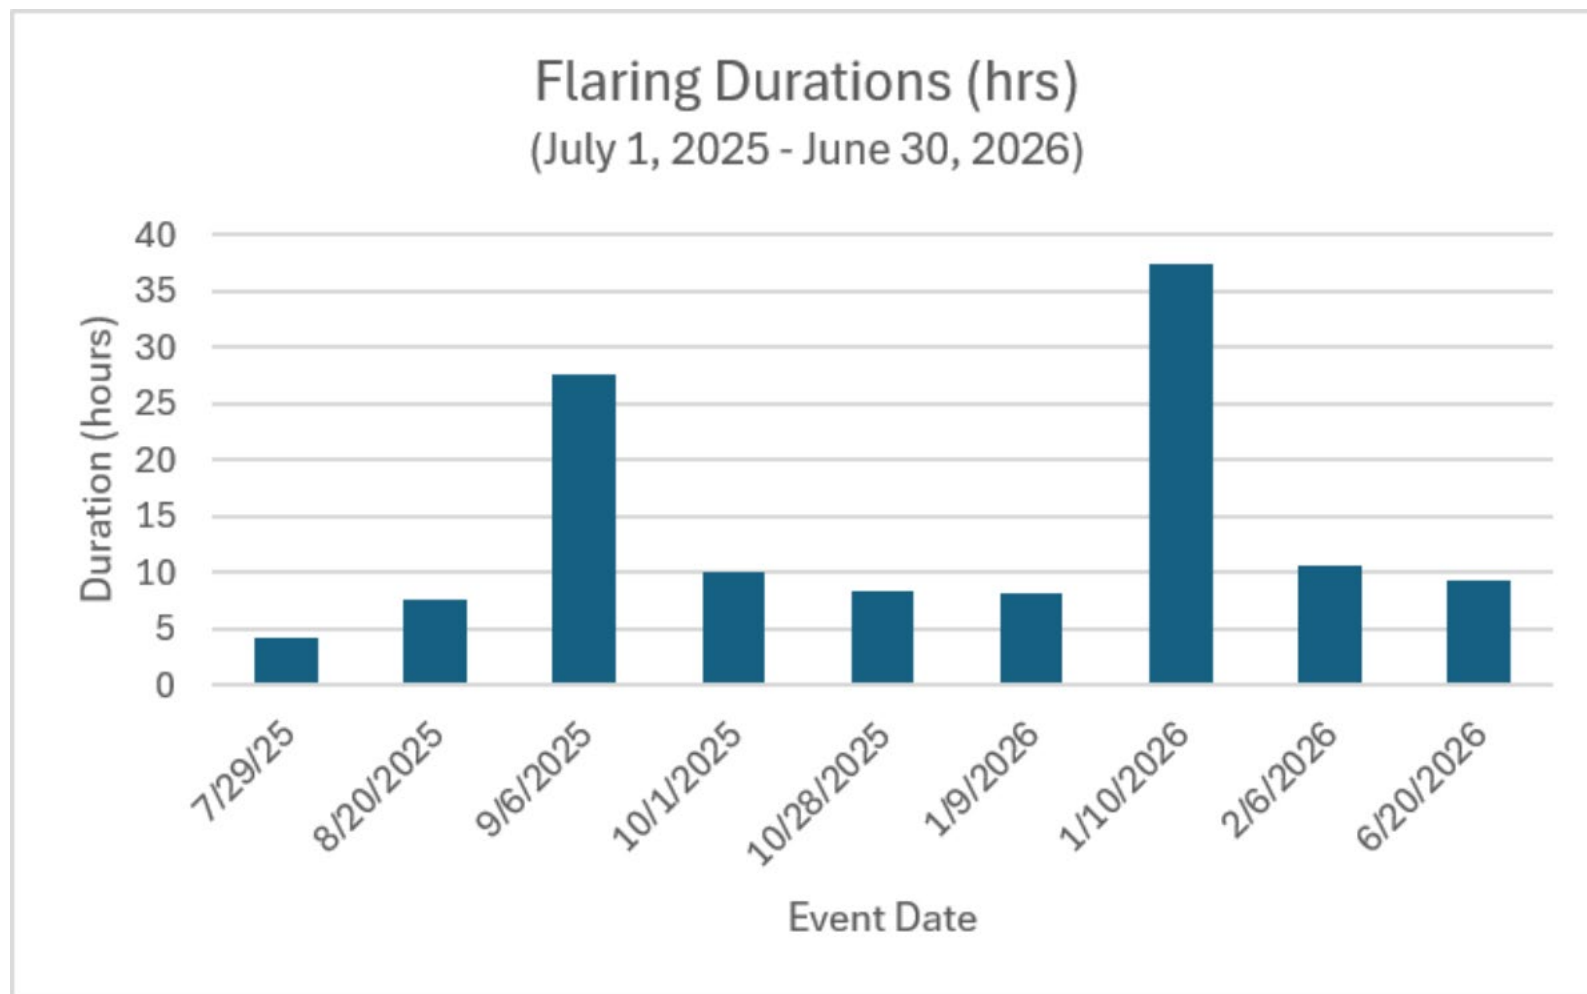
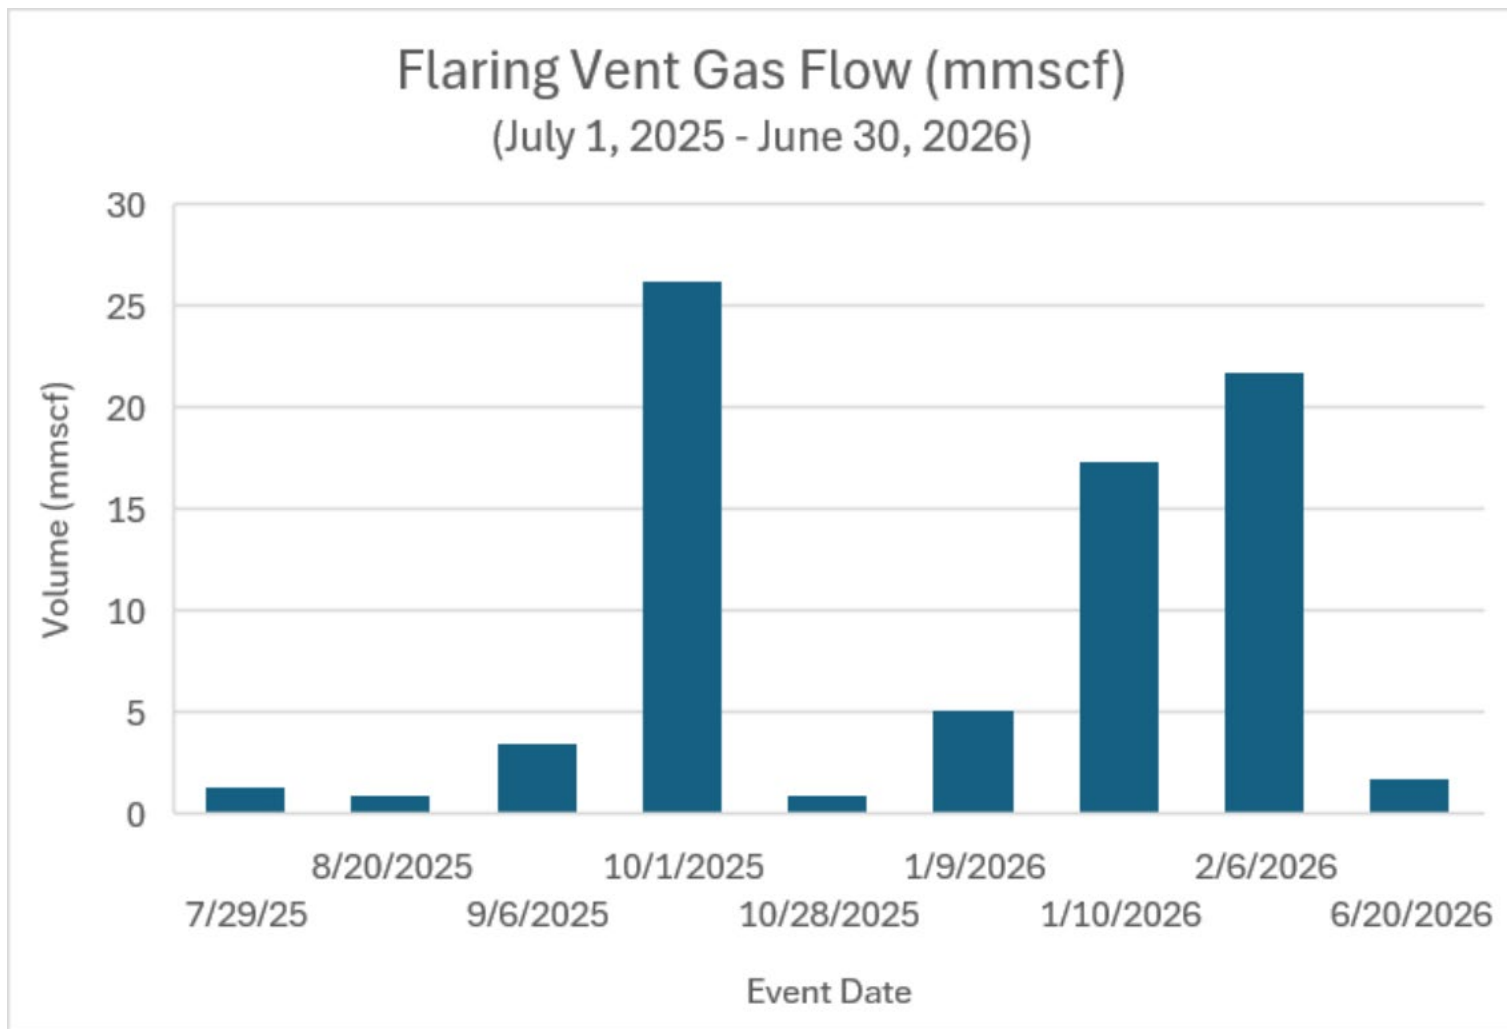
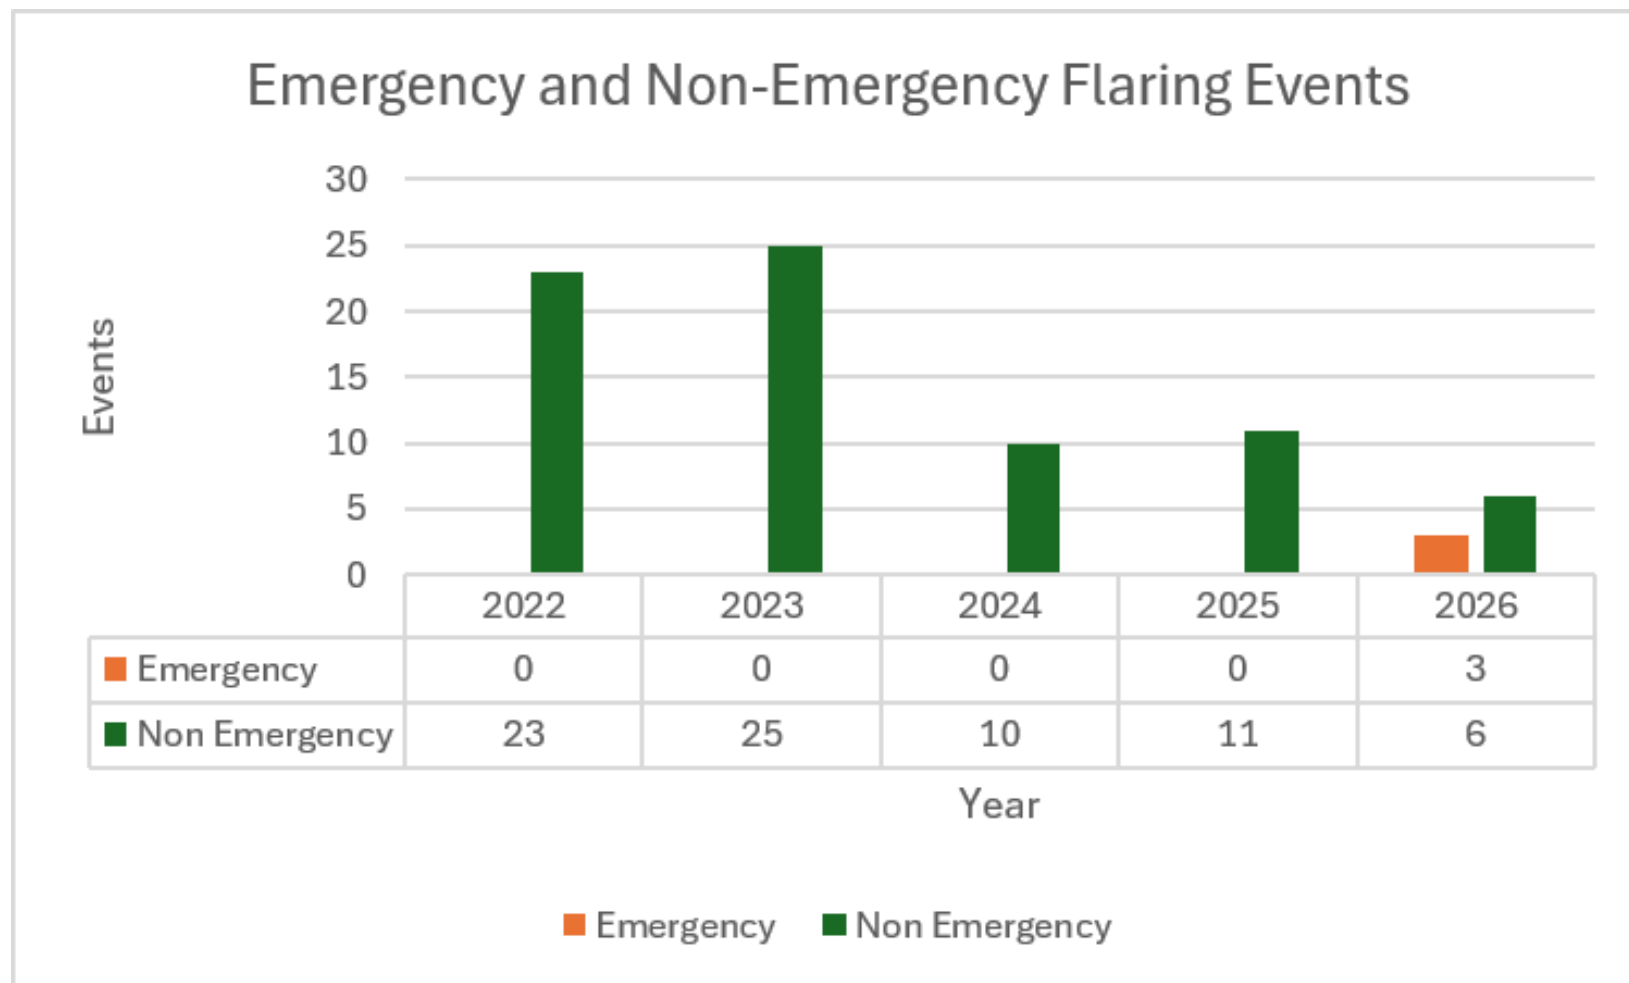
The first graph displays the number of reportable flaring events per Regulation 12-12 for the last 5 years. The second graph displays the flaring duration, in hours, of each reportable flaring event that occurred from July 1, 2025 to June 30, 2026. The third graph displays the total flared vent gas volume of each reportable flaring event that occurred from July 1, 2025 to June 30, 2026. The fourth graph displays the total methane, non-methane hydrocarbon (NMHC), and sulfur dioxide (SO<sub>2</sub>) emissions for each reportable flaring event that occurred from July 1, 2025 to June 30, 2026. The last graph displays the frequency of emergency versus non-emergency flaring events occurred during the last 5 years.

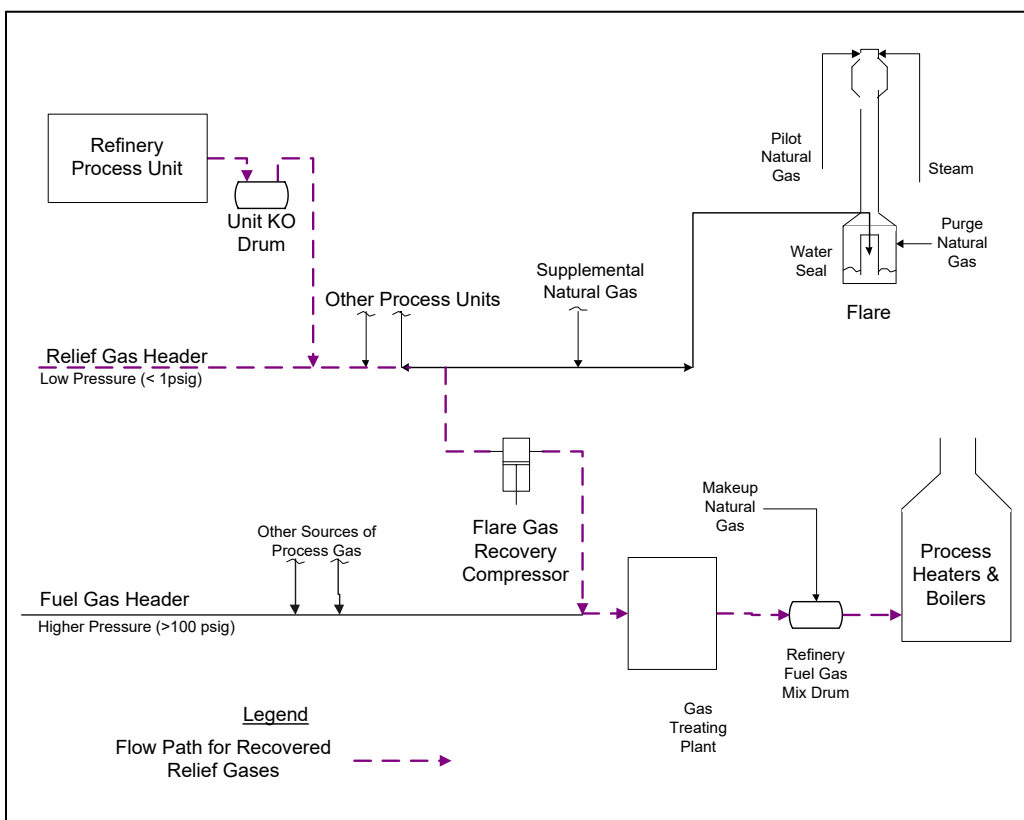
**Figure 1-1, Simple Schematic - Flare System with Flare Gas Recovery**

The following section describes how gases are generated and handled by refinery flare systems. A simplified schematic of a refinery flare system with flare gas recovery is shown in Figure 1-1.

A header for collection of vapor streams is included as an essential element of nearly every refinery process unit. At the Richmond Refinery, these are typically referred to as "relief gas headers", since the system, which is generally at near-atmospheric pressure conditions, receives gases "relieved" from higher pressure operations within the unit. The primary function of the relief gas header is safety. It provides the process unit with a readily available and controlled means of releasing gases to prevent over-pressurization of equipment (routing them to controlled locations for destruction by combustion). It also provides a controlled outlet for any excess vapor flow, nearly all of which is flammable, making it an essential safety feature of every refinery. Each relief gas header has connections for equipment depressurization and purging related to maintenance turnaround, startup, and shutdown, as well as pressure relief devices and other safety control valves to handle upsets, malfunctions, and emergency releases.

It is common practice for the process unit's relief gas header to incorporate a knockout drum for separation of entrained liquid at the unit boundary. This minimizes the possibility of liquid being carried forward to the flare or flare gas compressor. Liquids cause serious damage to most types of compressors and cannot be safely and completely burned in a flare. Liquids (condensed water and any entrained hydrocarbon liquids) from the unit knockout drum are sent to sour water handling facilities. The vapor stream from the knockout drum is routed to a flare gas recovery system.

flare stack. The depth of liquid maintained in the seal determines the pressure that the gas must reach in the relief gas header before it can exit the flare. The flare seal creates a positive barrier between the header and the flare, ensuring that gas from the relief gas header will not go to the flare if the flare gas recovery system can keep pace with the net gas production. It also guarantees a positive pressure at all points along the relief gas header, eliminating the possibility of air leakage into the system. Finally, it provides a positive seal to isolate the top of the flare, which is an ignition source, from the relief gas header and the process units. Some flare systems combine multiple flares with a range of water seal depths, effectively “staging” operation of the various flares. At the Richmond Refinery, such staging is configured to favor the recovery of relief gases with the highest sulfur concentrations so that the first gases flared would be those lower in sulfur content.

Gases exit the flare via a tip, which is designed to promote proper combustion over a range of gas flow rates. Steam is used to increase mixing between air and hydrocarbon vapors at the flare tip, so as to improve the efficiency of combustion and reduce smoking. The combustion efficiency for steam-assisted flares is high even when some smoking is present – generally over 97% according to some references. A continuous flow of natural gas to the flare is required for two reasons. Natural gas pilot flames are kept burning at all times at the flare tip to ignite any gas exiting the flare. Additionally, a small flow of “purge” gas is required to maintain a positive upwards flow and prevent air from being sucked back into the flare stack where it could create an explosive environment. Purge gas is generally either nitrogen (an inert gas) or an easily combusted gas – the Richmond Refinery uses natural gas for its purge flows.

A simplified diagram of the hypothetical design is shown in Figure 5-2. The diagram in Figure 5-2 highlights differences from the typical Flare Gas Recovery System shown previously in Figure 1-1. Results of this evaluation are provided for two system capacities for the North Yard

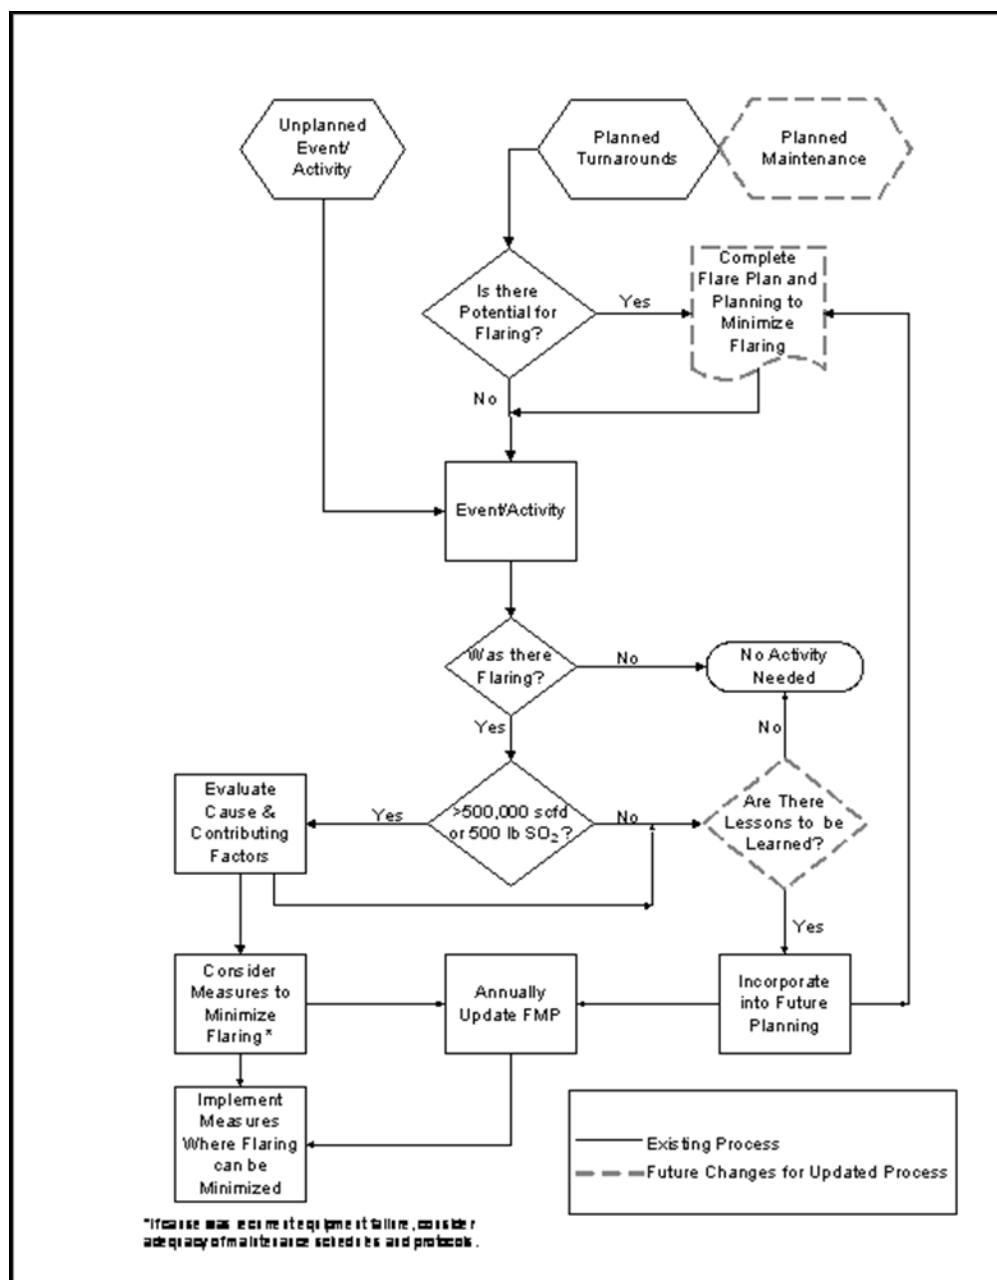
Figure 5-1, Flare Planning Process Flowchart

There are occasions, primarily as a result of equipment malfunction, where a relatively immediate decision is made to shutdown a block of the refinery, typically within a period of days, allowing little time for the kind of specific planning used for turnarounds and planned maintenance. In these cases, it is often not possible to make the same level of plant adjustments necessary to minimize flaring to the extent possible when a shutdown is planned far in advance. Despite this, there are actions that can be taken to minimize flaring even when there is very little advance notice. For these cases, the refinery utilizes general procedures to minimize flaring for unplanned events, as shown in Figure 5-1. Although there is less of an opportunity for scheduling shutdown procedures so as to ensure that there will be a home for all of the gas generated at each step of the process, many of the same general principles apply when the decision to bring the unit down is immediate. A flowchart of the Richmond Refinery's Flare Planning process is shown below, in Figure 5-1. This flowchart identifies aspects of the existing process, and highlights areas that will be updated.

Causal analyses of flaring events identified actions to maintain plant reliability that would reduce the likelihood of incidents which could cause potential flaring. These actions included the inspection and repair of equipment components that were either implemented as part of normal operations, or were scheduled for the next plant turnaround as described in Section 5.1.6 and Figure 5-1. Other actions are included in Table 4-1 below.

The development of flare plans under IMPACT SCS Task No. 27 is joint effort between the turnaround Operations Coordinator, Plant Process Engineer, and the IMPACT Planner. The improvements to this procedure are shown in figure 5-1 and listed in table 4-1.

The flowchart shown in Figure 5-1 covers the range of potential flaring events that the refinery might experience.

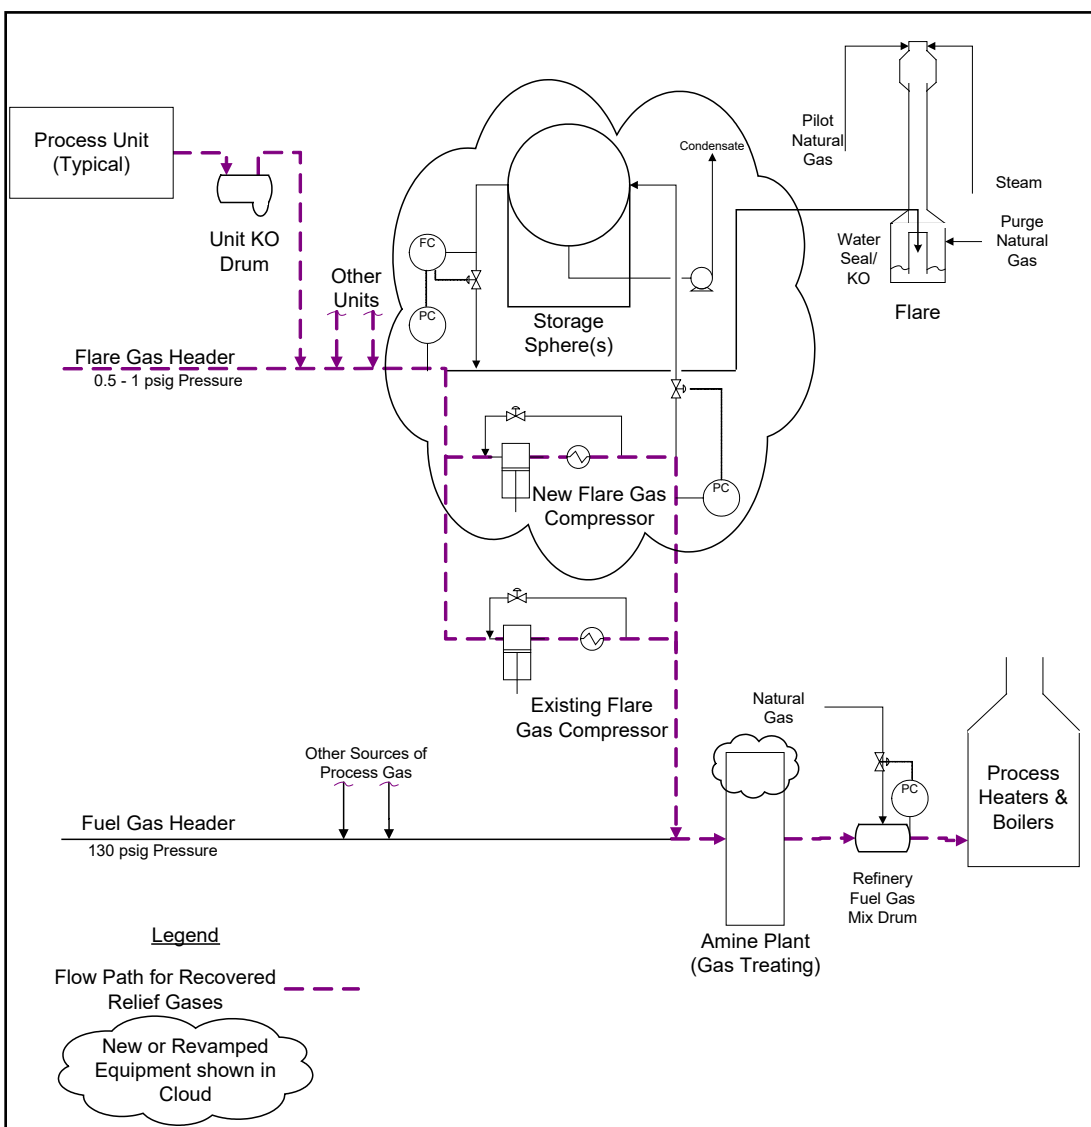
**Figure 5-2, Flare Gas Recovery System with Additional Capacity**

Flare Gas Recovery System, and two system capacities for the South Yard Flare Gas Recovery System.

A few specific cases for changes to the refinery's capacity to recover relief gases were evaluated. The cases evaluated correspond to several increments of additional capacity for recovering relief gases, the major equipment installations required to achieve that recovery, and the estimated total installed cost for the additional equipment. Budgetary level (order of magnitude) cost information for each of the cases evaluated is shown in Table 5-3.
