**Martinez Refining Company**

**FLARE MINIMIZATION PLAN**

**Updated September 30, 2026**

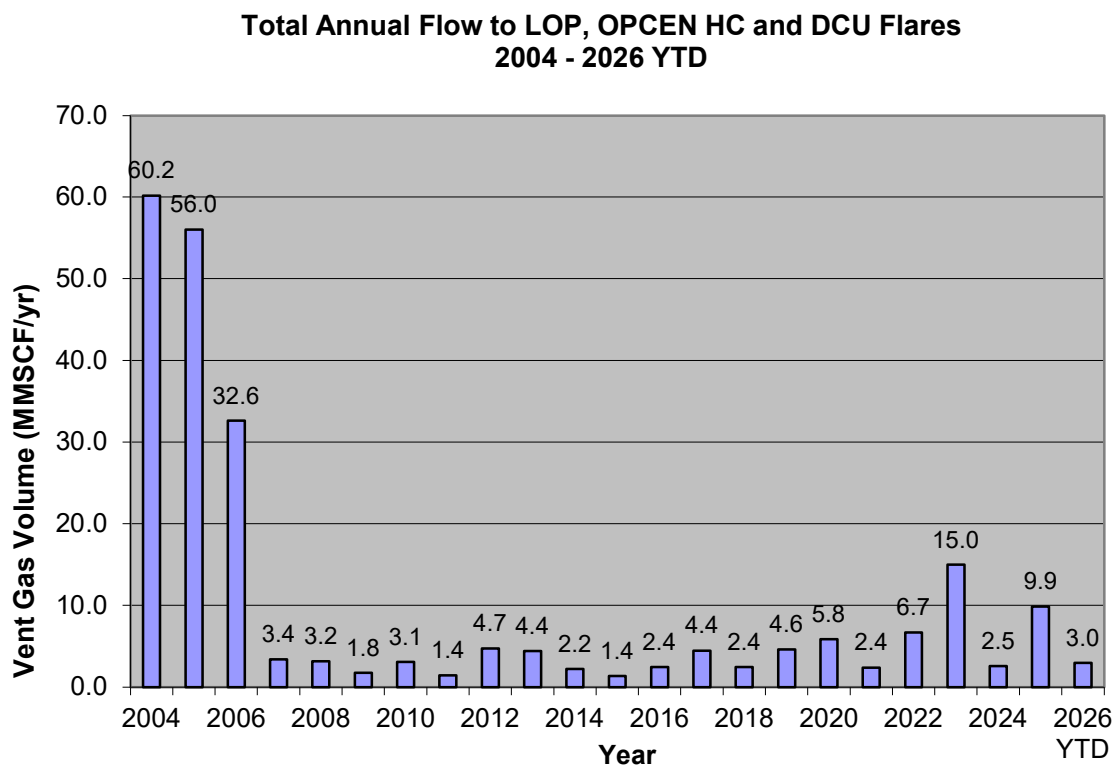
**FIGURE ES-1**

Figure ES-1 presents the total annual vent gas flow to the Light Oil Processing (LOP), Operations Central Hydrocarbon (OPCEN HC) and Delayed Coking Unit (DCU) Flares at the refinery from 2004 through June 30, 2026. Flare flow continues to be very low.

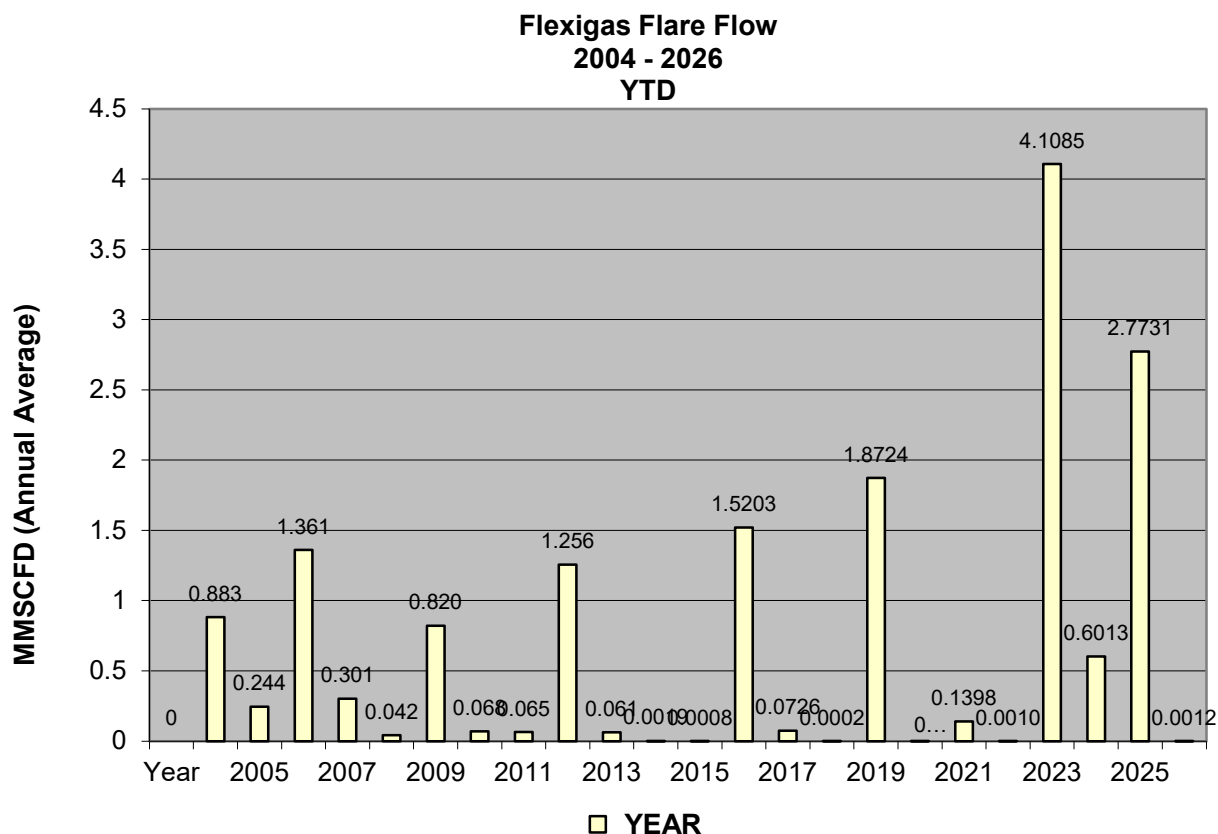
## **FIGURE ES-2**

Figure ES-2 shows the annualized vent gas flow from the Flexigas Flare. This figure shows a cyclic increase in Flexigas flaring which occurs during years with startup and shutdown of the Flexicoker due to the nature of the Flexicoking and Flexsorb processes. The flaring of treated flexigas during startups and shutdowns of the Flexicoker is allowed up to specified limits in MRC's Title V permit. Flexigas is a very low BTU gas used as a supplemental refinery fuel gas in refinery process heaters. Flexigas is treated for sulfur removal in the Flexsorb Unit before being combusted either in refinery process heaters or if necessary, in the Flexigas Flare. When FXG is flared, the volume of gas is typically large compared to the volume flared in the other refinery process flares, but emissions are significantly less because Flexigas contains very low concentrations of non-methane hydrocarbon and sulfur.

Flexigas flaring can also occur due to refinery fuel gas imbalance. MRC continues to fine-tune the Flexigas pressure control scheme to minimize flexigas flaring due to small imbalances in fuel gas. Improvements in this system, most notably addition of COGEN to the pressure control scheme, contribute to the very low flexigas flare flow rate seen in non-turnaround years including 2013, 2014, 2015, 2017, 2018, 2020, 2021, and 2022.

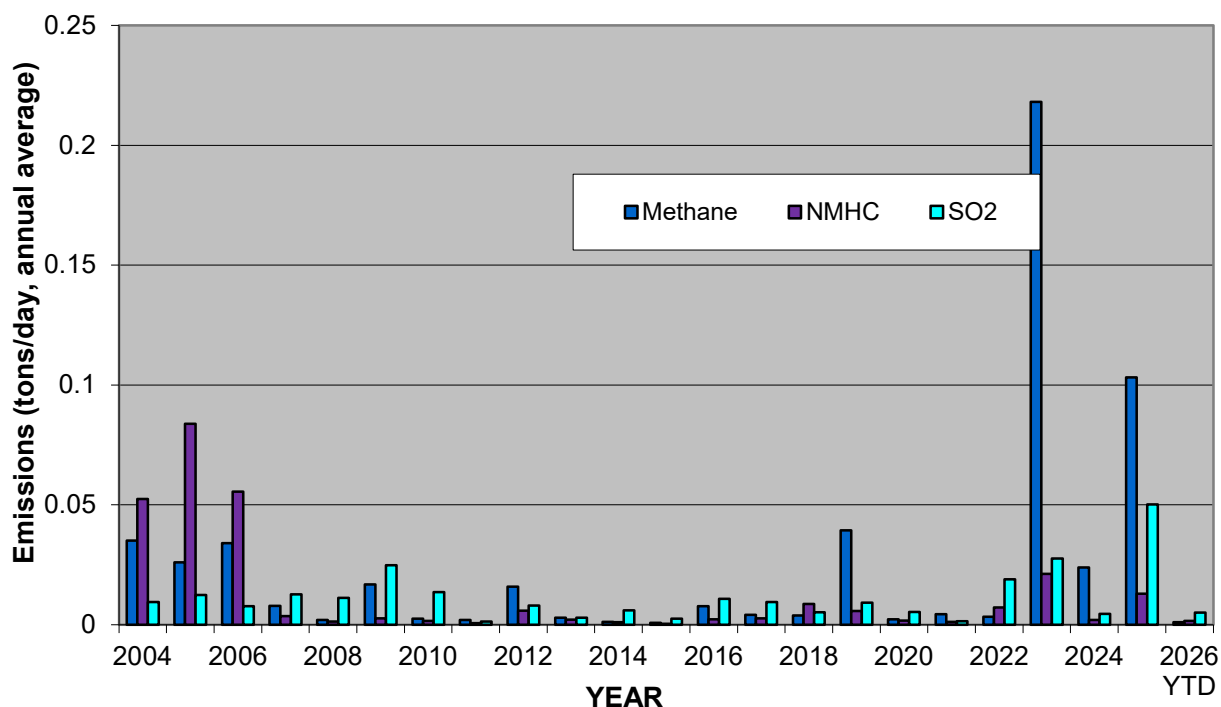
**FIGURE ES-3**

Figure ES-3 shows the methane, non-methane hydrocarbon, and sulfur dioxide emissions from all four refinery process flares from 2004 through June 30 of this year.

### MRC Flare Emissions - All Flares 2004 - 2026 YTD

Figure ES-3 shows the overall significant reduction in emissions that has occurred since the implementation of the Flare Minimization Plan in 2006 and highlights that even with large volumes of flexigas flaring during turnaround years, overall emissions from flaring are low.

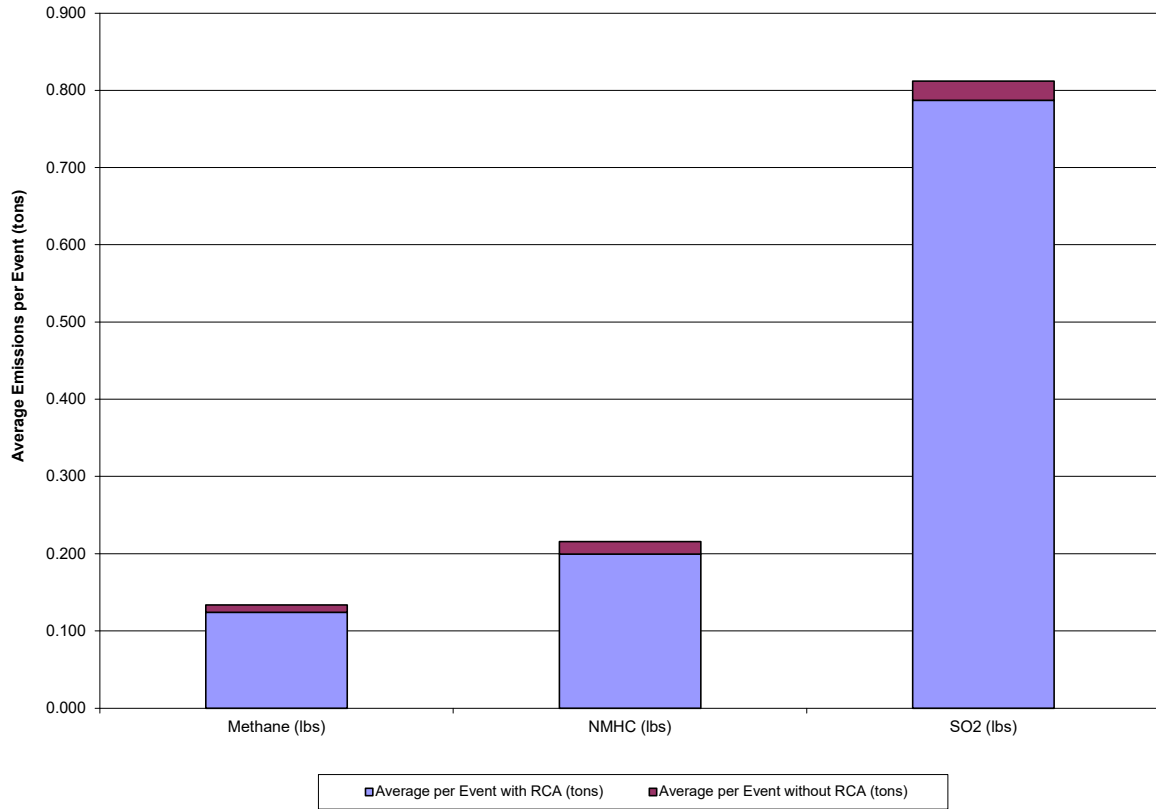
**FIGURE 2008 –1**

Beginning in November 2006 with the adoption of the Flare Procedures described in the Common Measures Section, pertinent information, when available, was captured immediately after a flaring event to determine the cause of any flaring and what could be done to prevent it from happening again. Total emissions from all flaring during the period from 12/1/06 through 6/1/08 were: 0.6 tons of methane, 0.99 tons of non-methane hydrocarbon and 2.5 tons of SO<sub>2</sub>. Figure 2a presents a comparison of the average emissions per large reportable events over this time period vs. the average emissions per small event. This figure shows that small events contributed on average < 10% of the emissions of a large event. Figure 2a reinforces the appropriateness of the causal analysis trigger of 0.5 MMSCF/ 500 lbs SO<sub>2</sub> to ensure the resources to conduct a Causal Analysis are most effectively applied to address high emission events.

**LOP Flare Events w/ Causal Analysis vs. Small Events**  
**1/1/06 - 6/1/08**

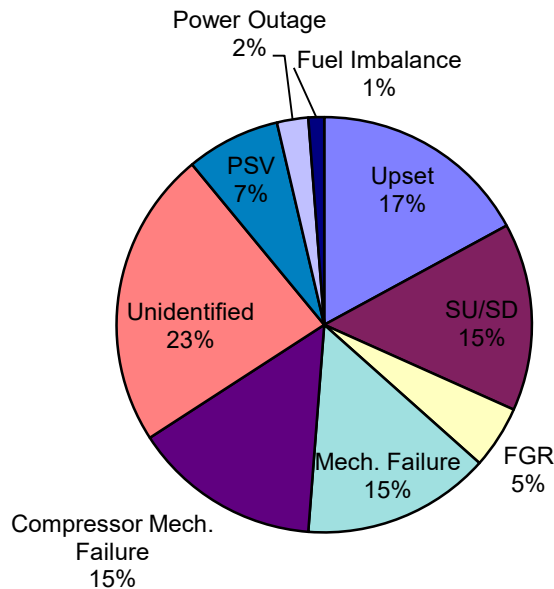
**Figure 2. LOP Area Flare Events  
(2000-2005)**

occurrences where the water seal was broken indicating that flaring occurred were so small, and of such brief duration, no cause could be reliably determined.

There has been a significant decrease in the number of flare events caused by fuel system imbalance and startup/shutdown in recent years. This is a direct reflection of the increased emphasis on reducing flaring. Regardless of historical performance, major turnarounds in the recent past on units served by this flare have been performed without planned flaring. That this work was performed without planned flaring is evidence of careful review and planning. MRC is committed to continue this careful review and planning prior to planned major maintenance and expect to perform turnarounds with little or no planned flaring. Therefore there is no predicted flaring resulting from planned major maintenance for which to evaluate prevention measures against. If during the maintenance planning and review process MRC finds that planned flaring is required, all appropriate prevention measures will be considered and feasible measures will be implemented to reduce or eliminate the planned flaring.

Review of flare events prior to January 2004 provided little usable information. Without flow meters, neither durations nor volumes could be accurately determined. In many cases, even the proximate cause of flaring could not be reliably determined due to the limited documentation and time elapsed since the event. With these qualifications, a breakdown of the general cause of LOP flare events for the previous five years is depicted in Figure 2. A description of the various categories listed is provided below:

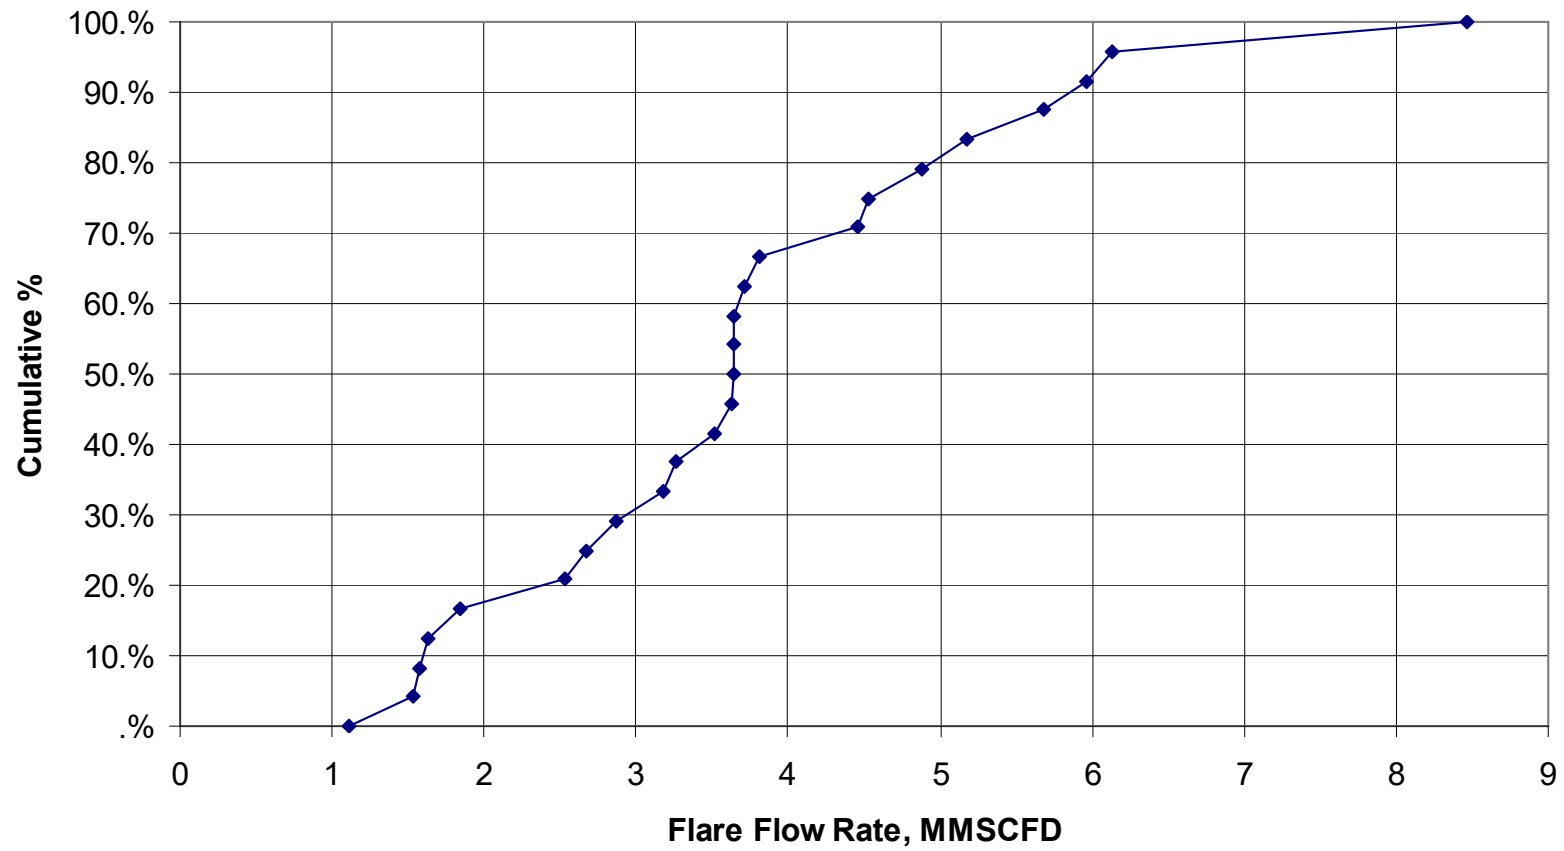
**Figure 4. LOP Flare Gas Flow Rates  
(2005)**

Figure 4 depicts the average rates of flow to the flare for events occurring in 2005. These data indicate that approximately 30% of the flare events had event-average flow rates of less than 3 million standard cubic feet per day. Actual instantaneous rates are generally higher – often significantly – than these average rates. This difference between the average rate for an event and instantaneous flare gas rate during an event is important because once the instantaneous rate exceeds the available compressor capacity the water seal is typically broken and flaring occurs. Once flaring begins, backpressure in the flare header provided by the water seal is significantly reduced. Due to the lower header pressure, flare gas recovery rates are typically significantly reduced from their rated capacity.

Data from Figure 4 were used to evaluate the leverage provided by additional flare gas recovery in LOP. As each increment of compressor capacity was added, the corresponding events with average flows within the newly revised total capacity were considered to be recovered rather than flared. Similarly, the reported emissions for these events were presumed not to occur. This provided the basis for emissions reductions as a function of compressor capacity.

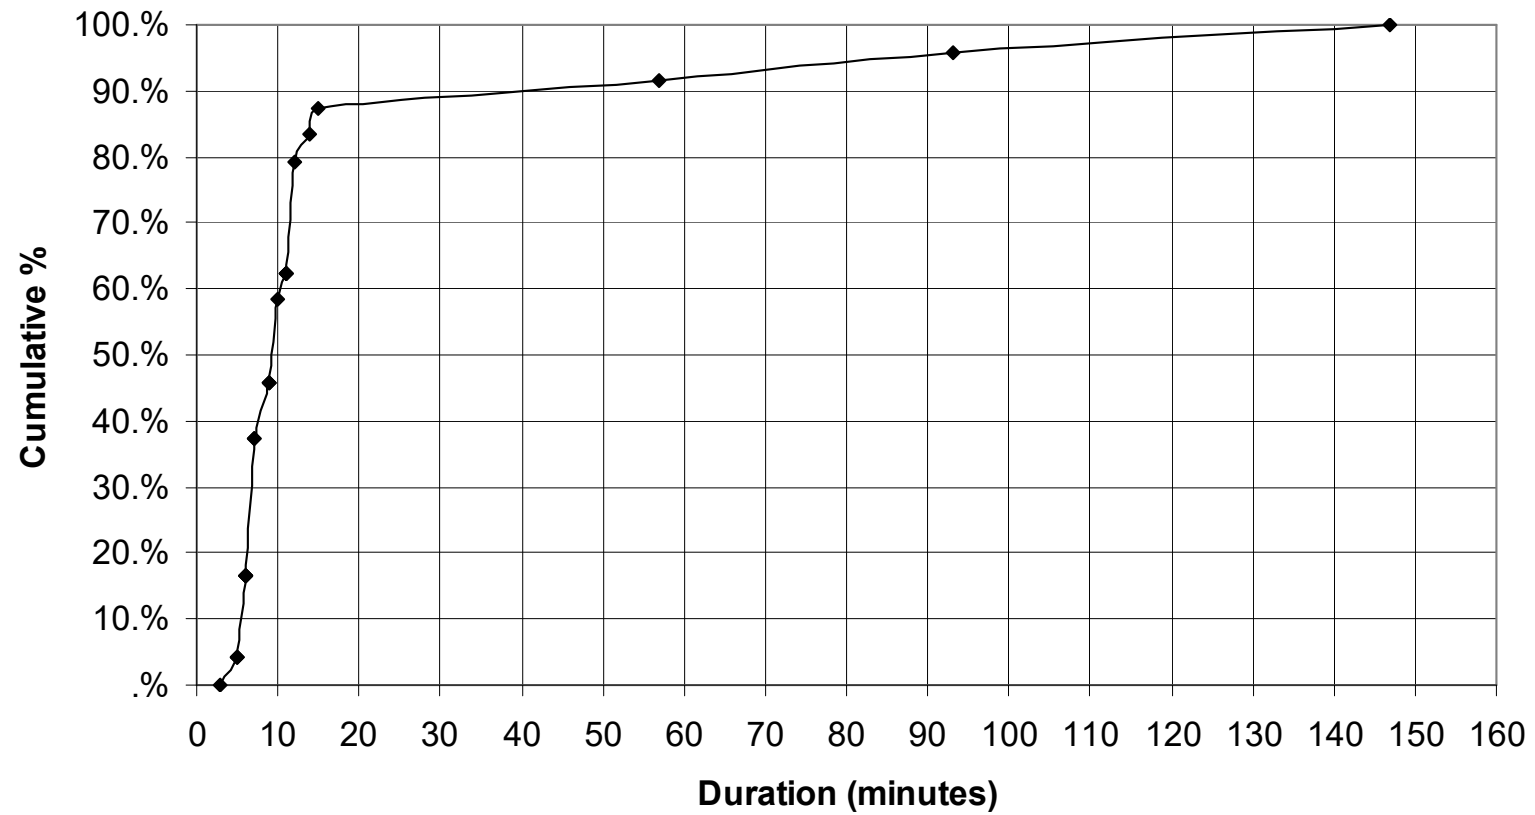
**Figure 5. LOP Flare Durations**  
(2005 - 25 Events)

Figure 5 depicts the distribution of flare event durations for 2005, the year for which these data are available. Most flare events have very short durations with small volumes of gas flared. From

Figure 5 it can be seen that half of the flare events had durations of less than 10 minutes. By combining event durations with additional data on the volume flared during each event, it can be shown that the 50% of events with durations less than 10 minutes contributed less than 10% to the total volume of gas flared. The 85% of events which lasted 15 minutes or less contributed less than 40% to the total volume flared. Only three of the flare events during this period lasted longer than one hour. All of the event durations were less than three hours.

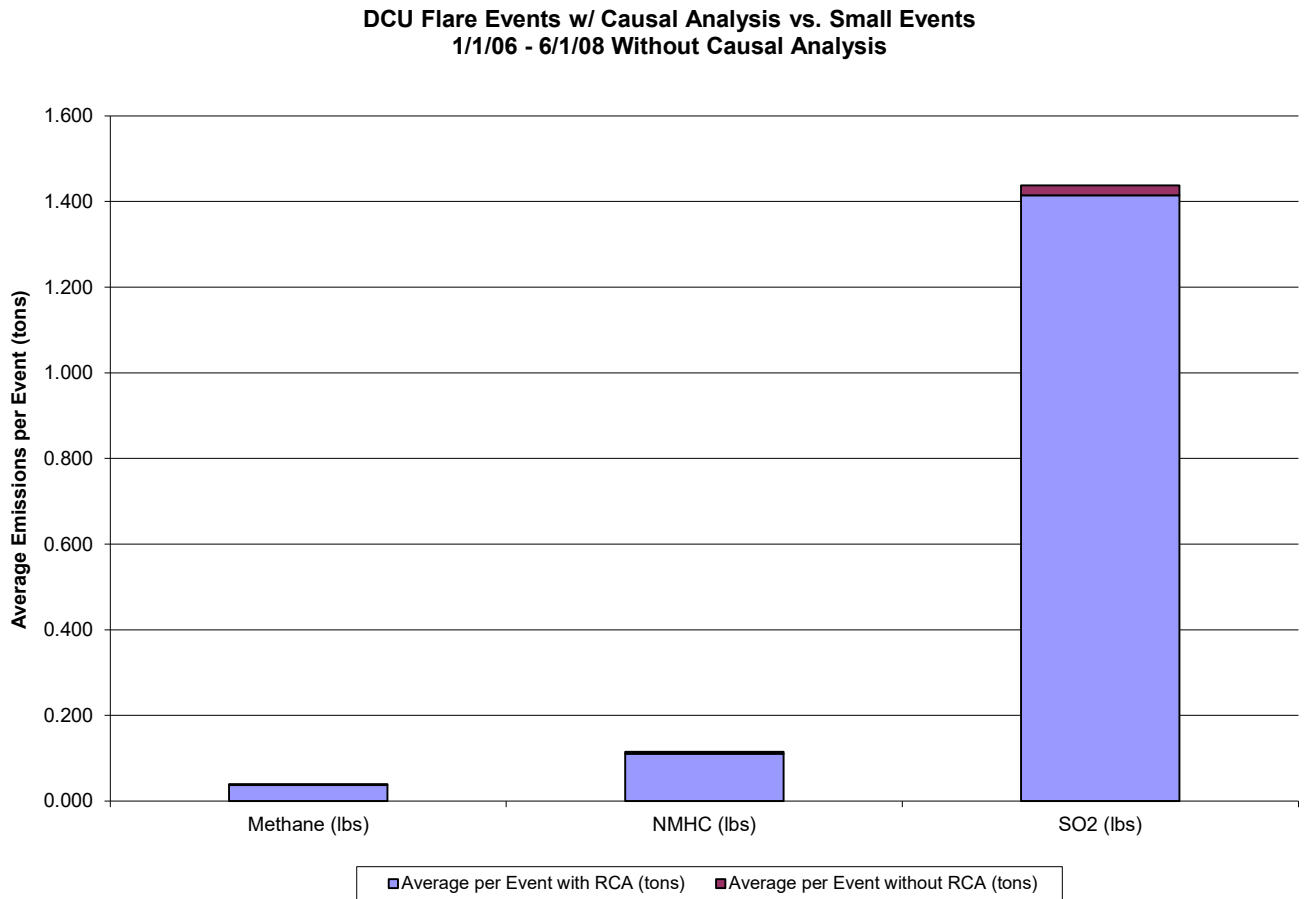
**FIGURE 2008-2**

Beginning in November 2006 with the adoption of the Flare Procedures described in the Common Measures Section, pertinent information, when available, was captured immediately after a flaring event to determine the cause of any flaring and what could be done to prevent it from happening again. Total emissions from all flaring during this 30-month period were: 0.17 tons of methane, 0.45 tons of non-methane hydrocarbon and 4.19 tons of SO<sub>2</sub>. Figure 2008-2 presents a comparison of the average emissions per large reportable events over this time period vs. the average emissions per small event for the DCU Flare. This figure shows that small events contributed < 6% of the emissions of a large event. Figure 2008-2 reinforces the appropriateness of the causal analysis trigger of 0.5 MMSCF/ 500 lbs SO<sub>2</sub> to ensure the resources to conduct a Causal Analysis are most effectively applied to address high emission events.

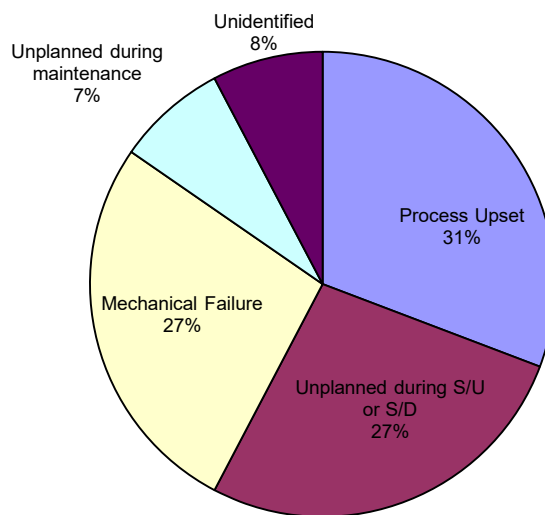
**FIGURE 2008 - 3**

The DCU flare events that occurred from 1/1/06 – 6/1/08 were categorized by probable cause in Figure 2008-3. None of the flaring was planned. Most of the events were < 10 minutes long. The majority of the events were caused by process upset, mechanical failure or were unplanned during startup and shutdowns.

**Probable Cause of Flaring on DCU Flare 1/1/06-6/1/08  
26 Events**

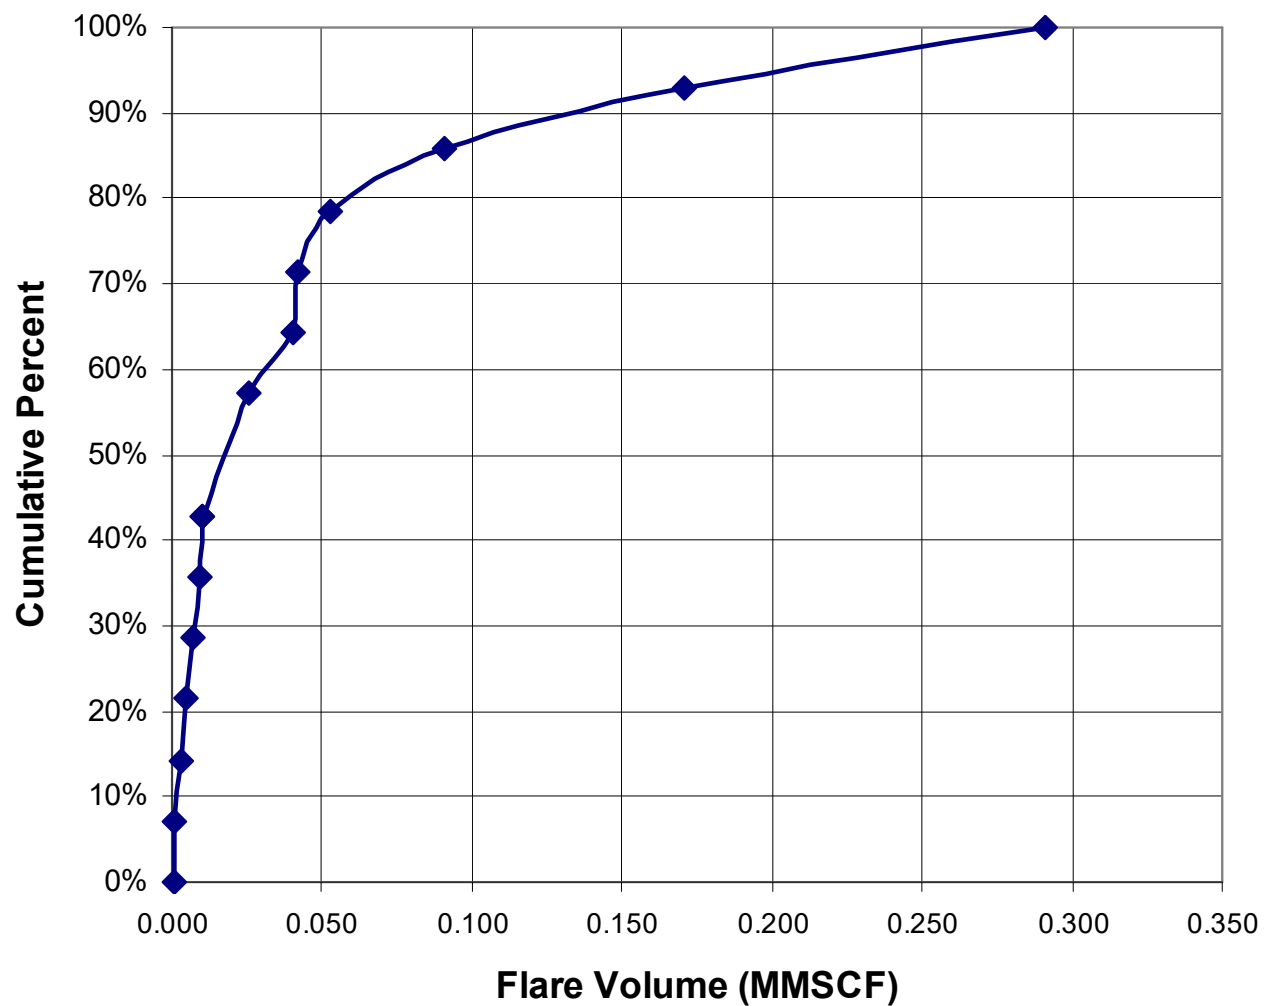
**Figure 9. Delayed Coking Area Flare Gas Volumes  
(2005)**

Figure 9 depicts the amount of material flared during the reported incidents of flare activity in 2005. All flaring was below 500,000 scf. Approximately 70% of the incidents of reported flaring involved volumes of gas of 50,000 SCF or less. All were below 300,000 standard cubic feet.

**Flaring during 2005.** The highest quality data are available for the period from January 2005 to January 2006. Data is available during this period from flare flow meters and monthly BAAQMD flare reporting. Available data for flare event volumes and durations are provided in Figures 9 through 11 below.

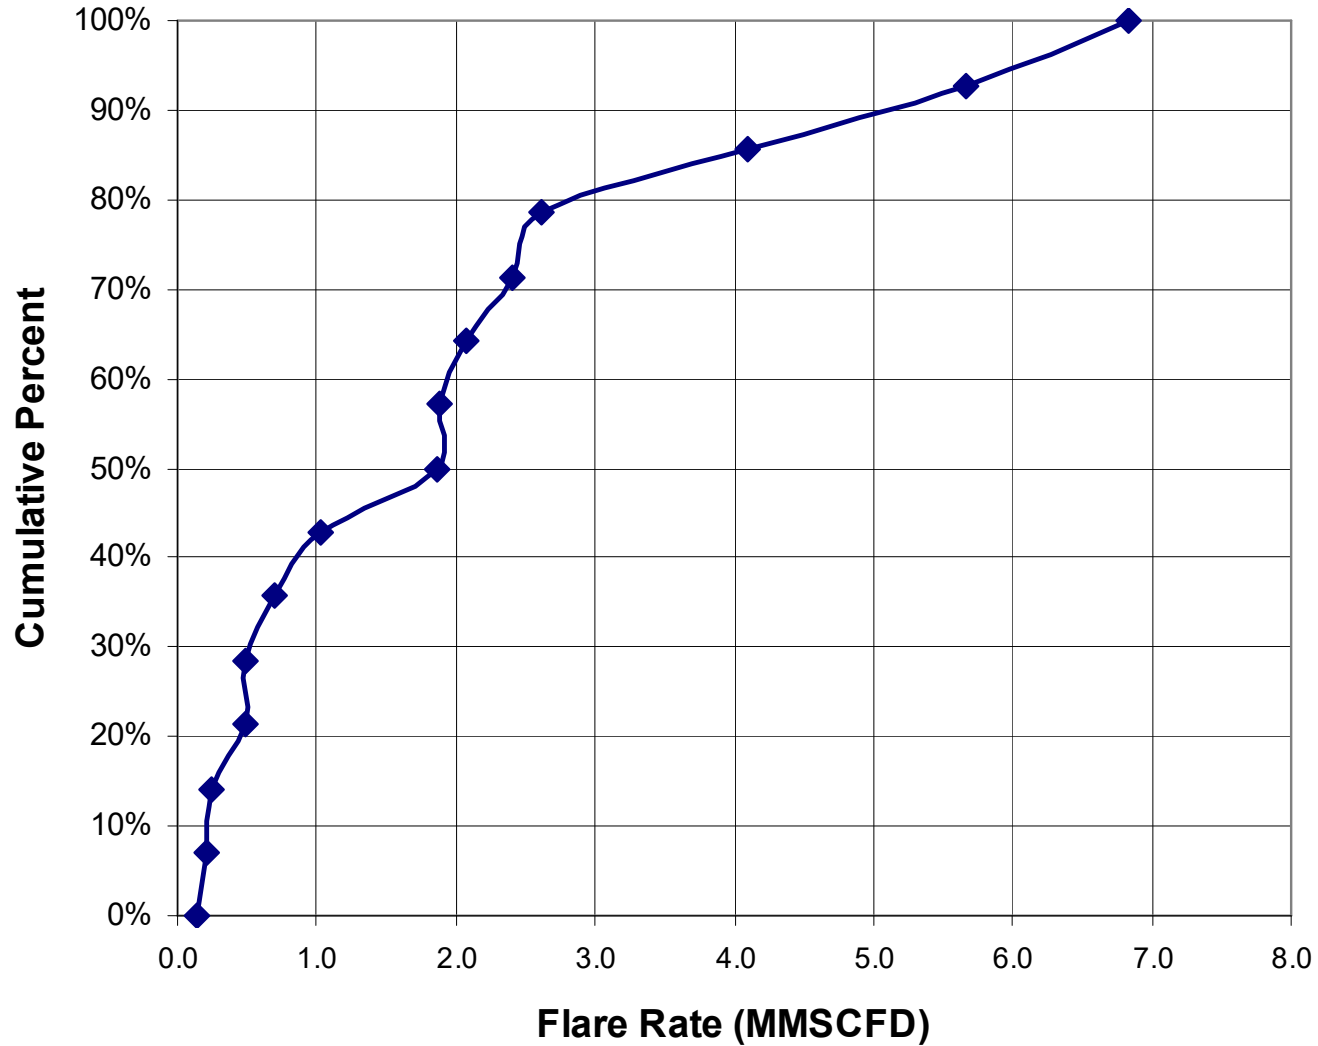
**Figure 10. Delayed Coking Area Flare Gas Flow Rates  
(2005)**

Figure 10 depicts the average rates of flow to the flare for events occurring in 2005. These data indicate that approximately 80% of the flare events had event-average flow rates less than 3 million standard cubic feet per day. Actual instantaneous rates comprising the average are generally higher – often significantly – than these average rates.

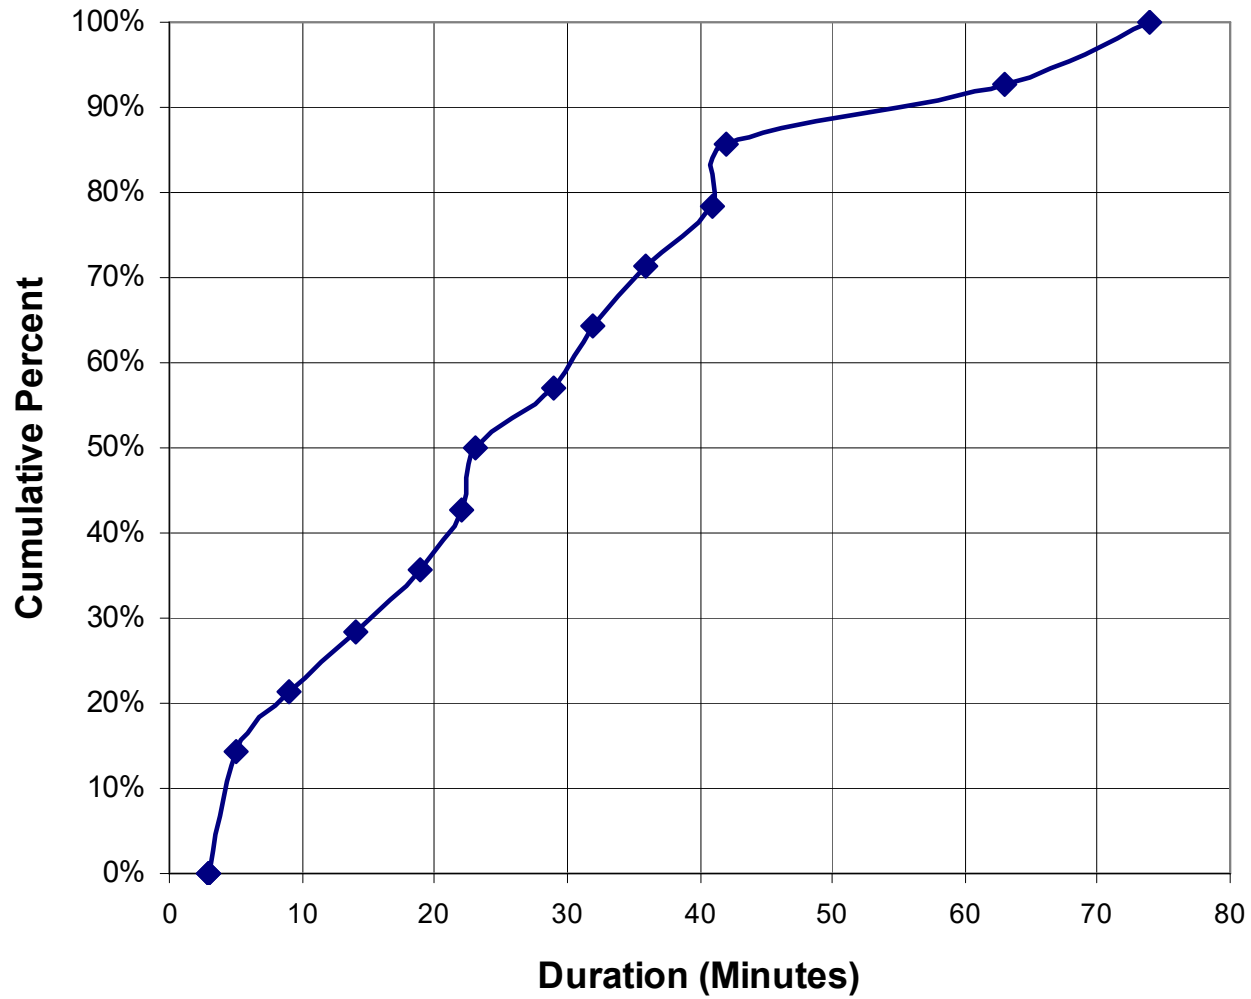
**Figure 11. Delayed Coking Area Flare Event Durations  
(2005)**

Figure 11 depicts the distribution of flare event durations for 2005 where these data are available. 50% of the events lasted less than 30 minutes. This is consistent with other data characterizing the bulk of flare events being very brief.

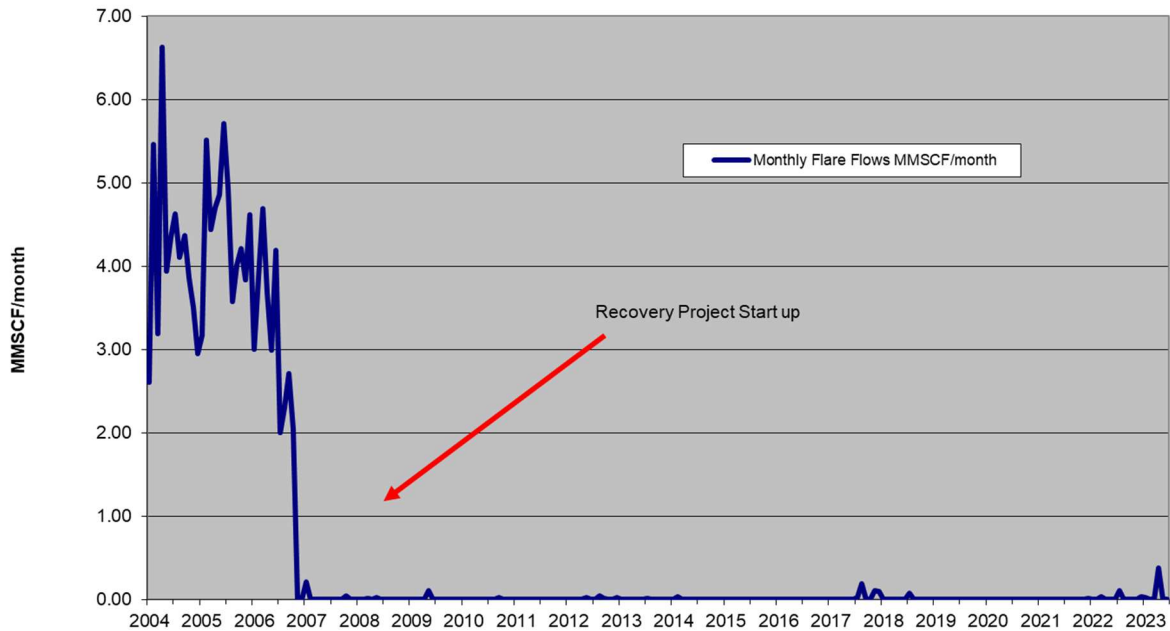
The figure below has been updated through 6/30/23 and shows the continued success of the implementation of the flare recovery project that occurred in 2006 for this flare.

OPCEN HC FLare Monthly Flare Flows 1/1/04 - 7/1/23

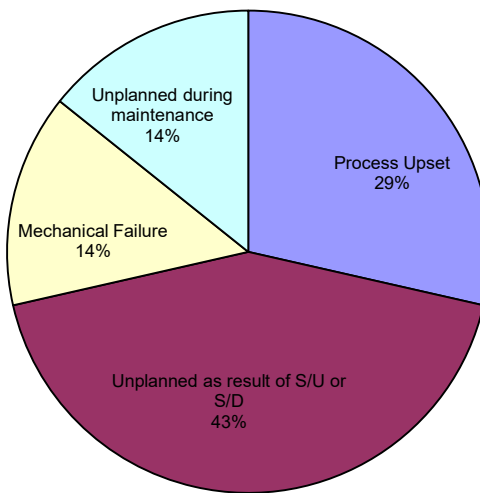
**FIGURE 2008-4**

The OPCEN HC flare events that occurred after the implementation of flare recovery from 11/1/06 – 6/1/08 were categorized by probable cause in Figure 2008-4. None of the flaring was planned. The cause of the events included process upset, mechanical failure or were unplanned during maintenance or startup and shutdown.

**OPCEN HC Flare- Cause of Flaring 11/1/06 - 6/1/08  
7 Events**

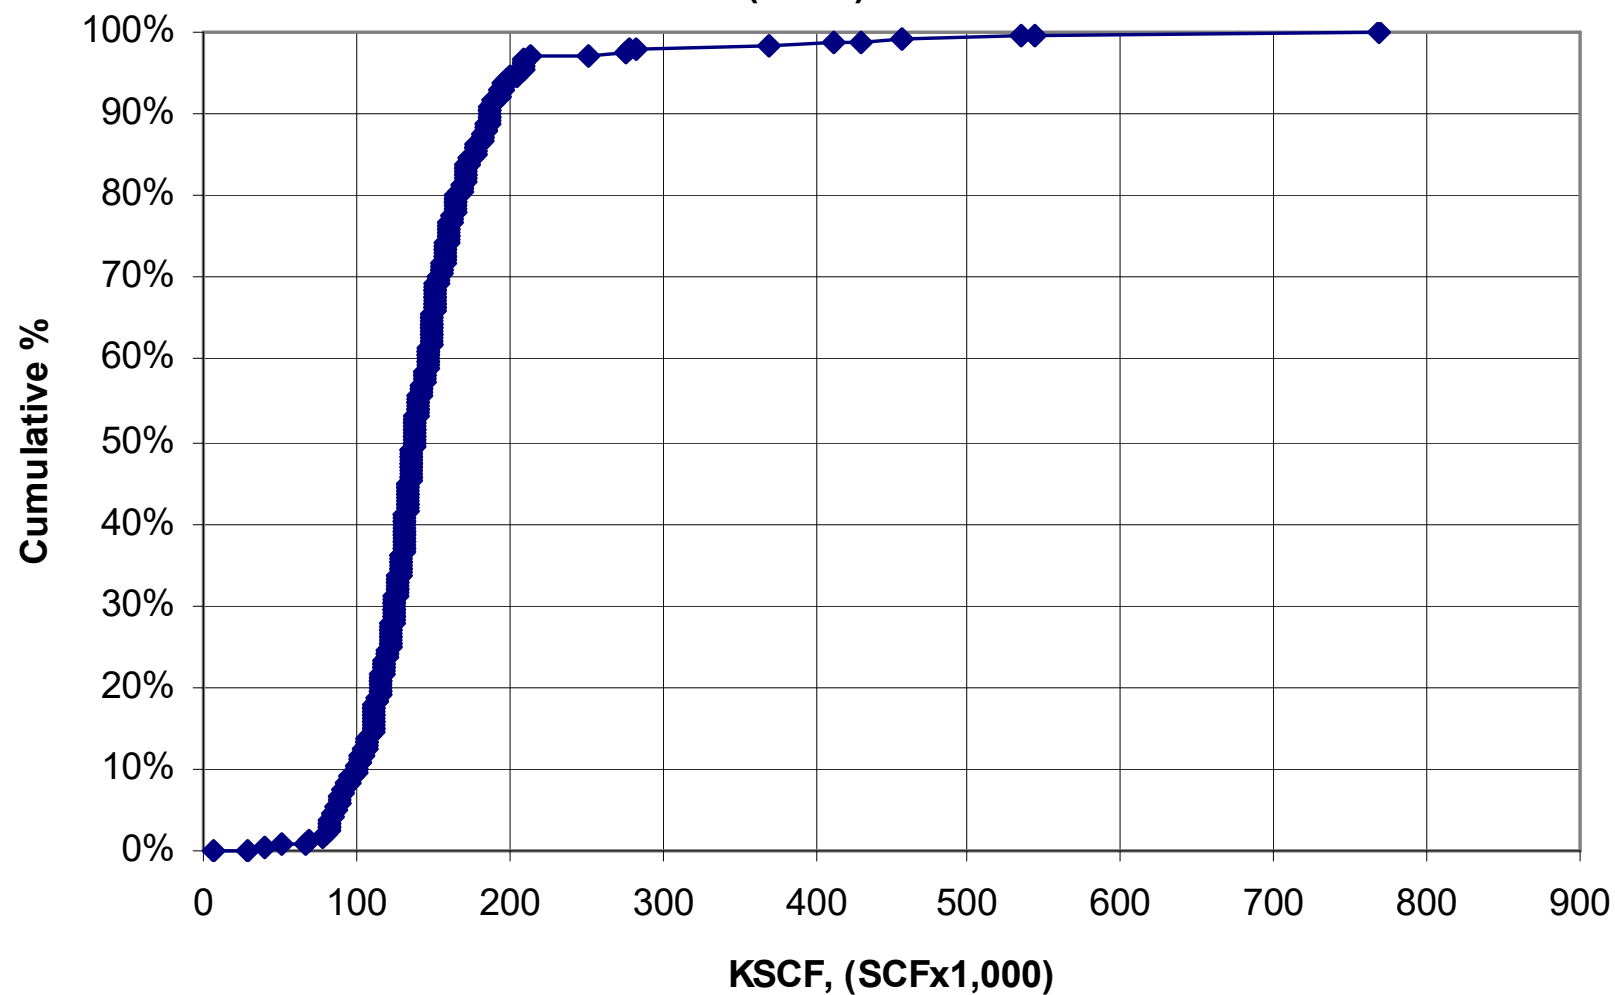
**Figure 13. OPCEN Hydrocarbon Flare Gas Volumes  
(2005)**

With historical performance profoundly biased by absence of flare gas recovery, this review concentrated on calendar year 2005. Flare data are depicted in Figure 13. Total emissions of non-methane hydrocarbon during 2005 were approximately 30 tons. Emissions of SO<sub>2</sub> in 2005 were 0.3 tons.

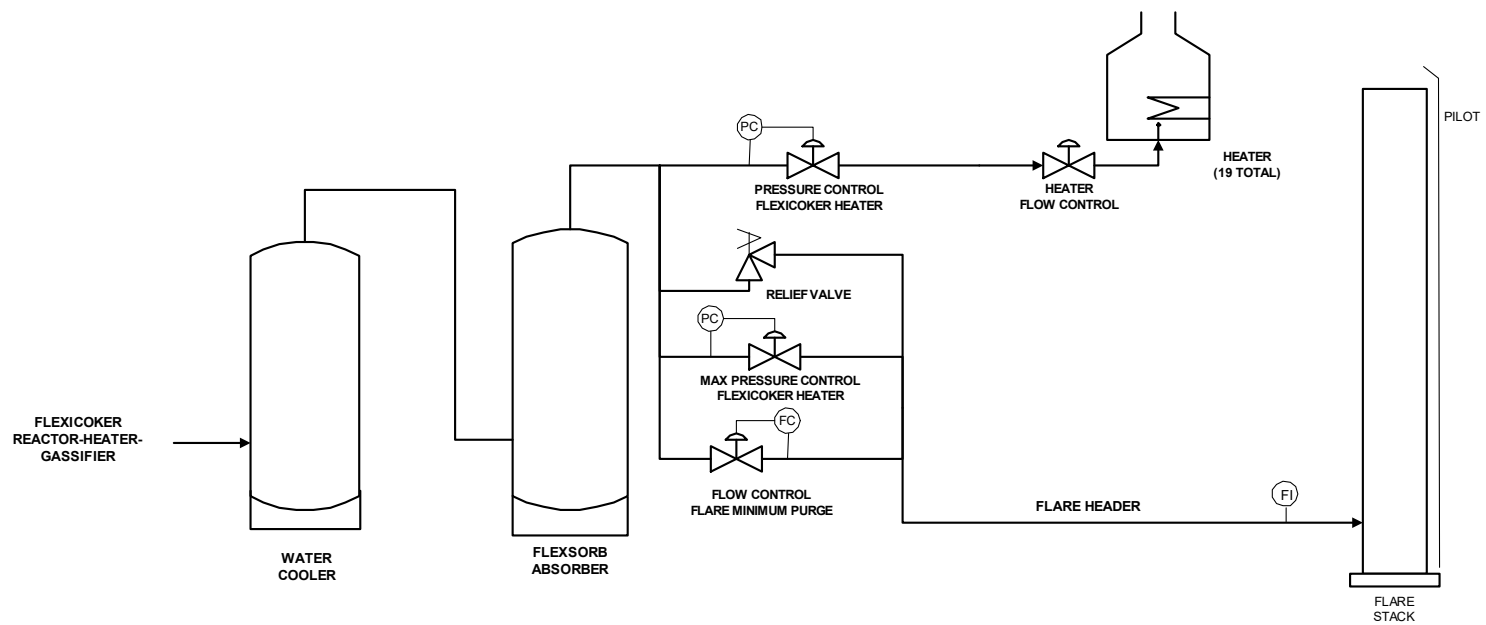
FIGURE 14. FLEXIGAS SUPPLY SYSTEM PROCESS SKETCH

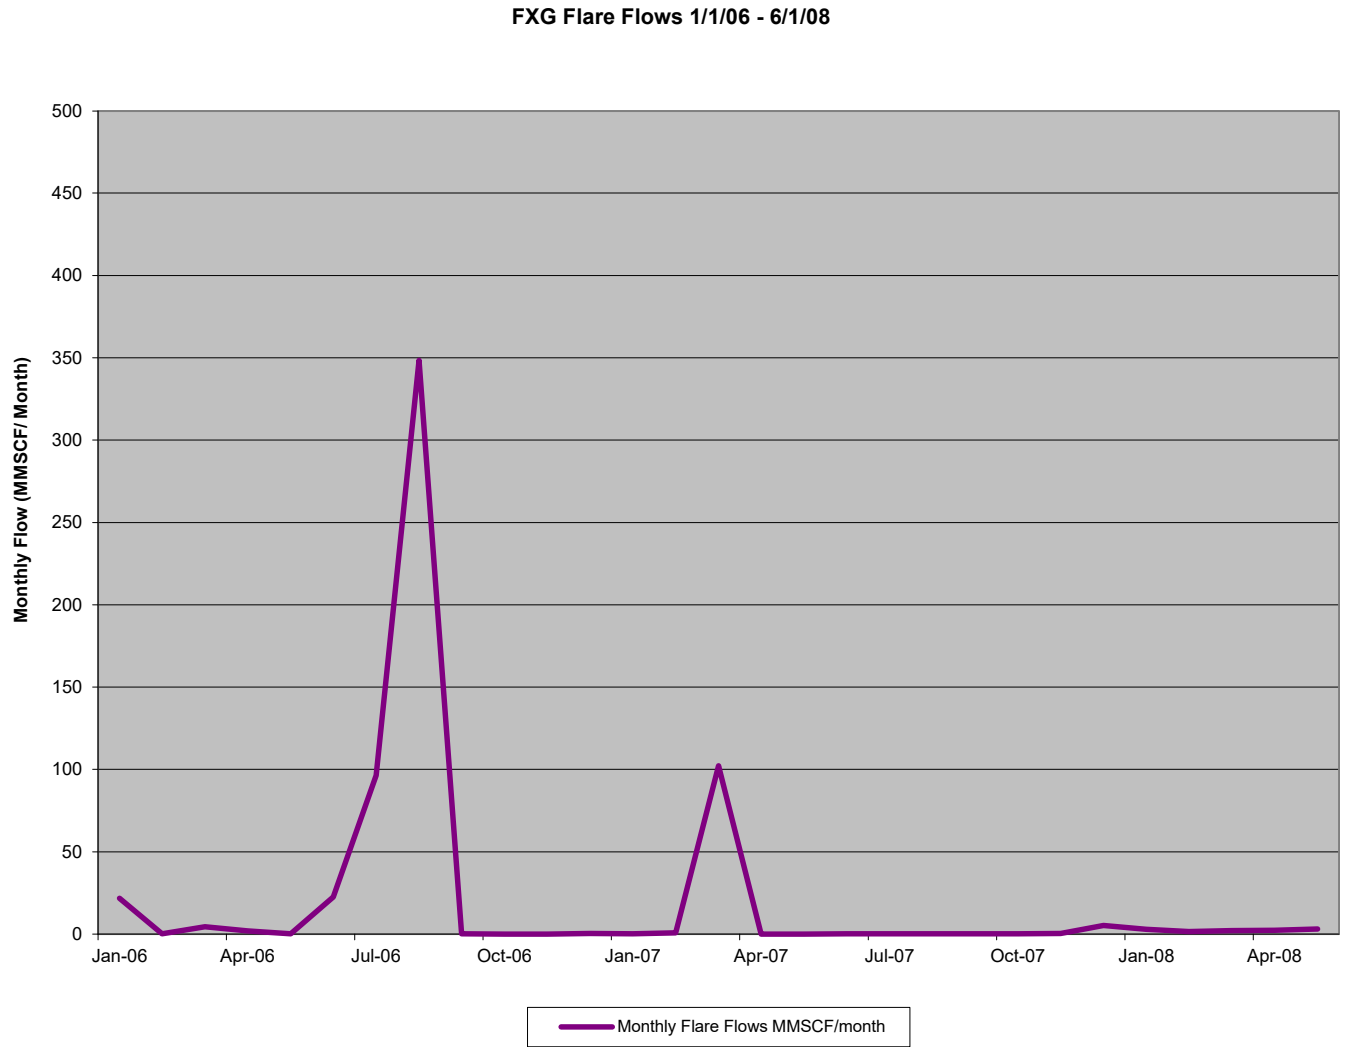
FIGURE 2008-5

The other flexigas flaring events that triggered Causal Analyses were smaller events. Most of these flexigas flaring events occurred as a result of fuel gas imbalance. Because there is currently not a flexigas consumer which can quickly change consumption without process or utility steam impacts, any excess flexigas is flared until the Flexicoker can be slowed down enough to reduce flexigas production. A flexigas consumer that could be quickly ramped up or down could reduce some of the flexigas that currently would have to be flared.

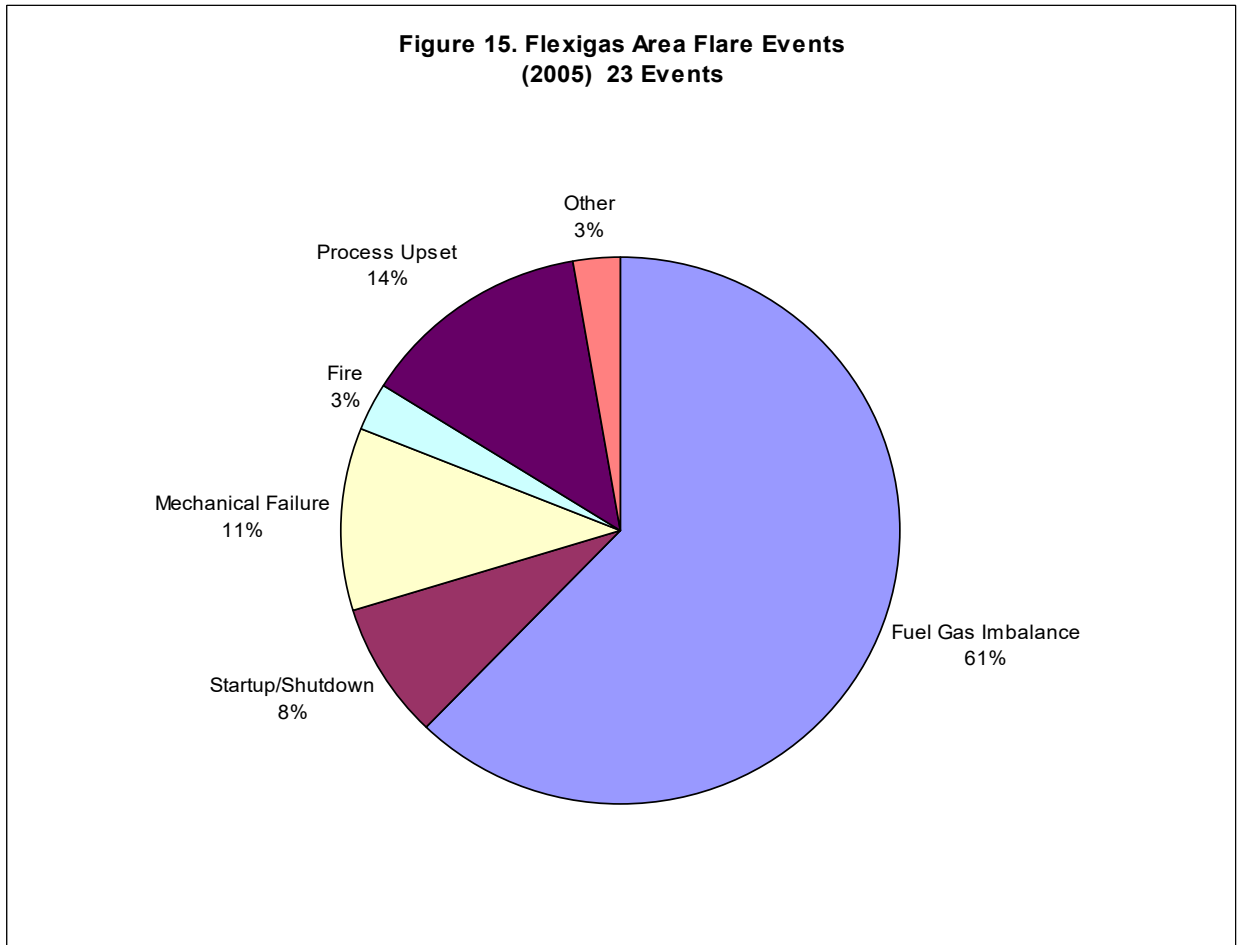
Historical flaring at the OPCEN Flexigas flare was reviewed to identify opportunities for potential mitigation. The highest quality data are available for the period from December 2003, to January 2006. This coincides with installation of the flare flow meter and BAAQMD flare reporting. Data for 2005 are plotted in Figure 15 and Figure 16.

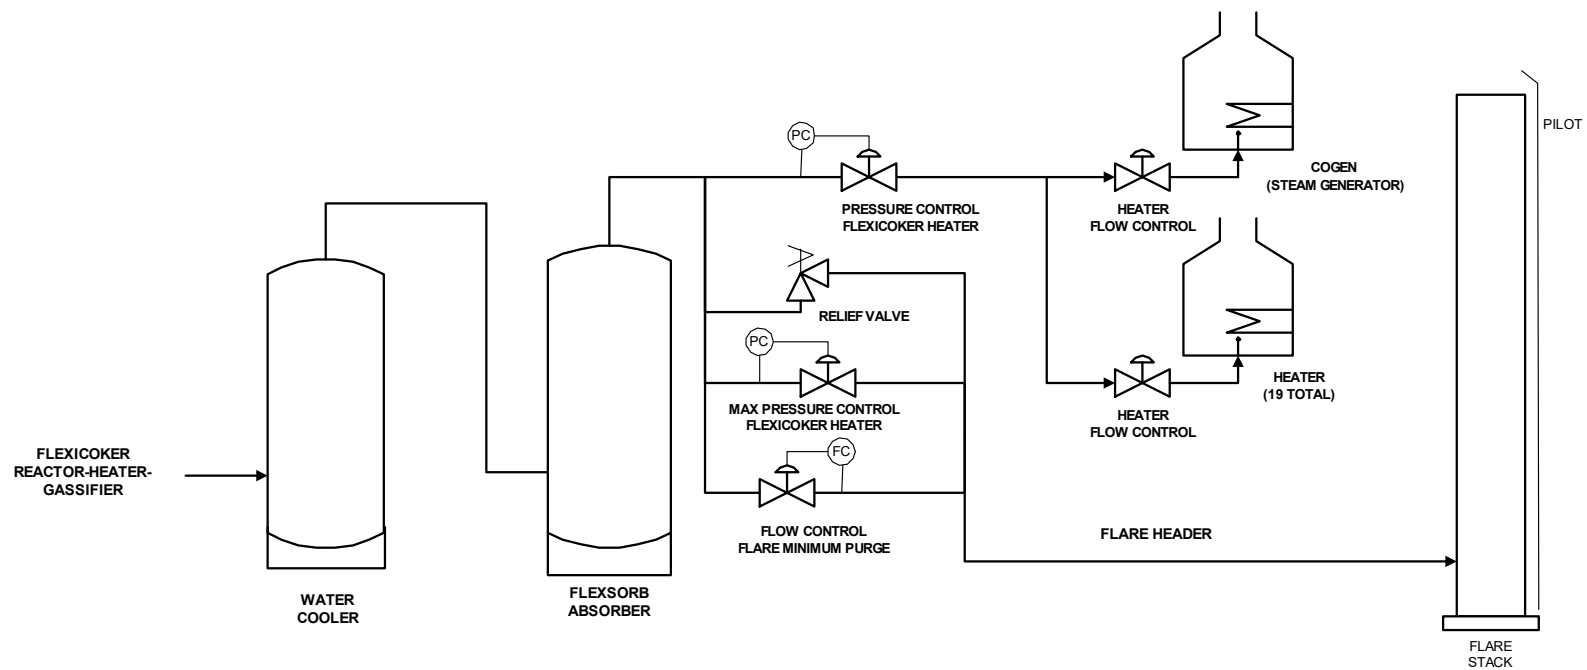
FIGURE 17. FLEXIGAS FLARE PROCESS SKETCH OPTION 1

##### **OPTION 1: PROVIDE ADDITIONAL FLEXIGAS CONSUMERS (see Figure 17).**

The objective of this project would be to provide an additional consumer that can rapidly pick up the Flexigas volumes made available by loss of another consumer (e.g., process heater) for any reason. Because excess Flexigas is available less than 10% of the time (based on the percent of days on which flaring occurred from Figure 16), and the current fuel system is roughly in balance, this consumer must essentially remain in hot standby until needed. This means it must be waiting to burn between 1 MMSCFD and 40 MMSCFD Flexigas when an existing consumer unexpectedly comes off line.
