**Martinez Refining Company**

**FLARE MINIMIZATION PLAN**

**Updated September 30, 2026**

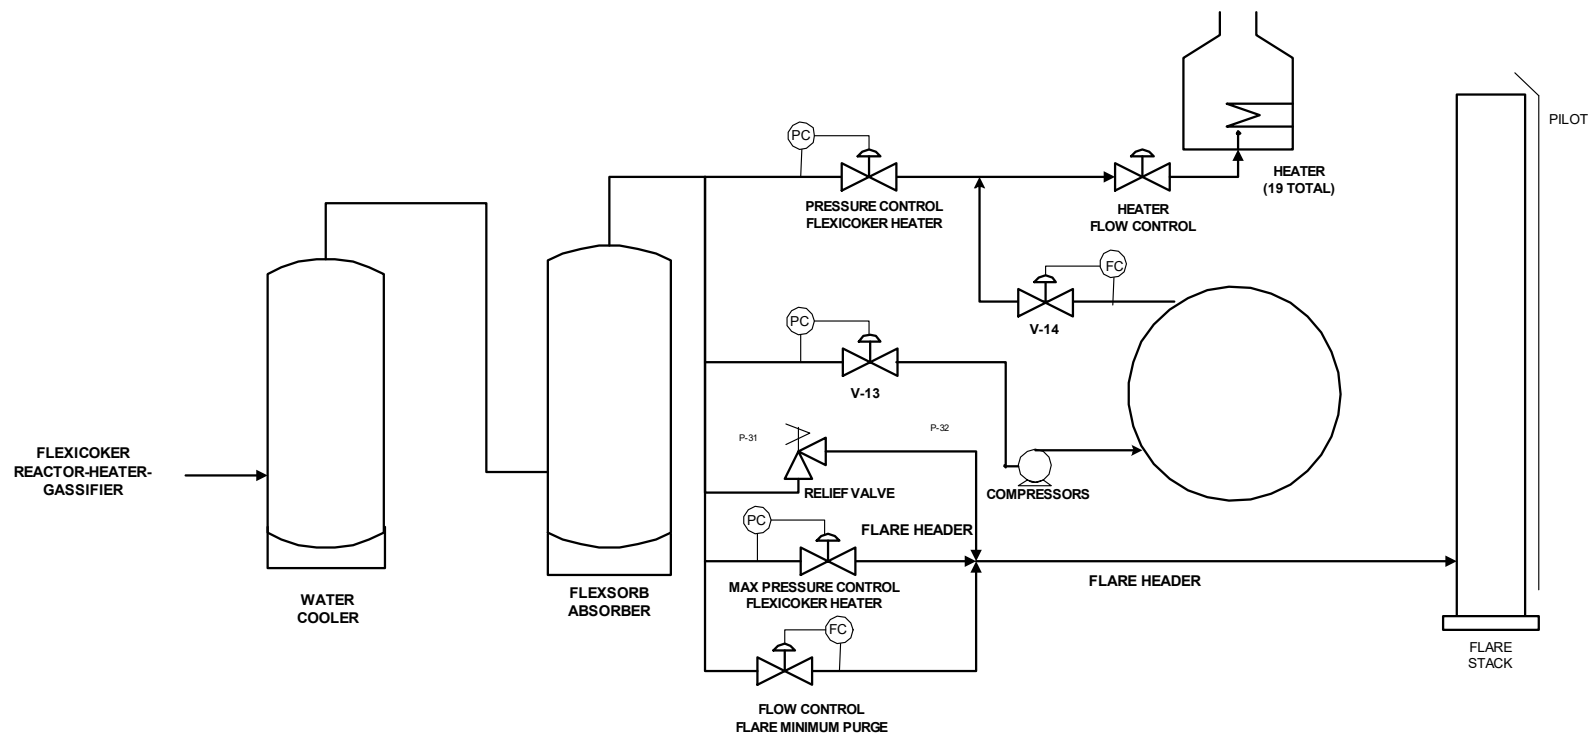
FIGURE 18. FLEXIGAS FLARE PROCESS SKETCH OPTION 2A

<sup>22</sup> Based on a nominal 1 MMSCF sphere (60' diameter) at 120 psig, and two 4 MMSCFD compressors. This system would handle only minor imbalances while the Flexicoker cuts rate.

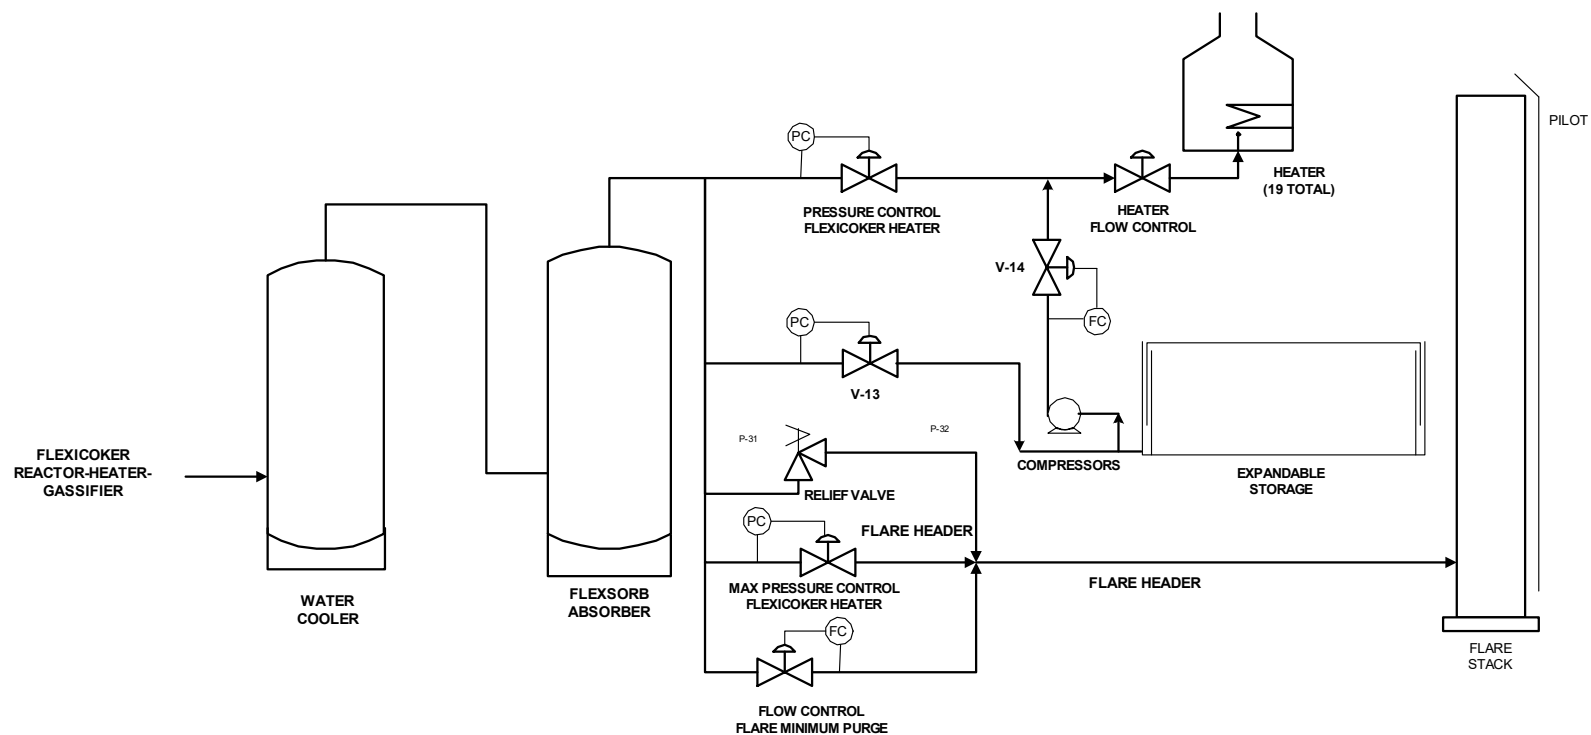
FIGURE 19. FLEXIGAS FLARE PROCESS SKETCH OPTION 2B
