Chevron Oil Spill Summary February 9, 2021

Chevron Richmond Refinery February 9, 2021 Spill Summary

Phillips 66 Refinery Hydrogen Sulfide Release February 23, 2021

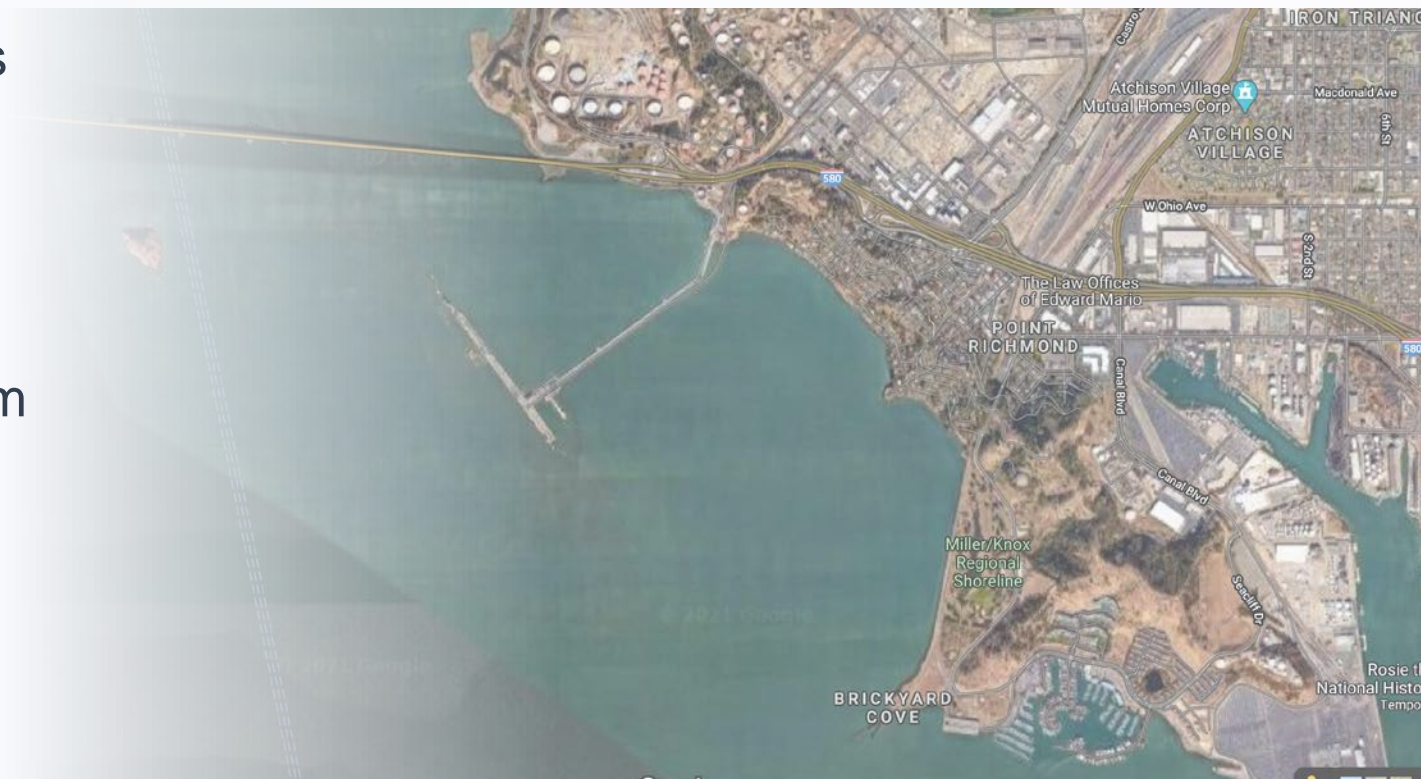
- Chevron's Long Wharf is where vessels dock to bring crude to the refinery and load up with finished product including gasoline and diesel fuel
- The wharf extends about a mile out from shore, with several pipelines extending that length to convey organic liquids to and from tanks on shore

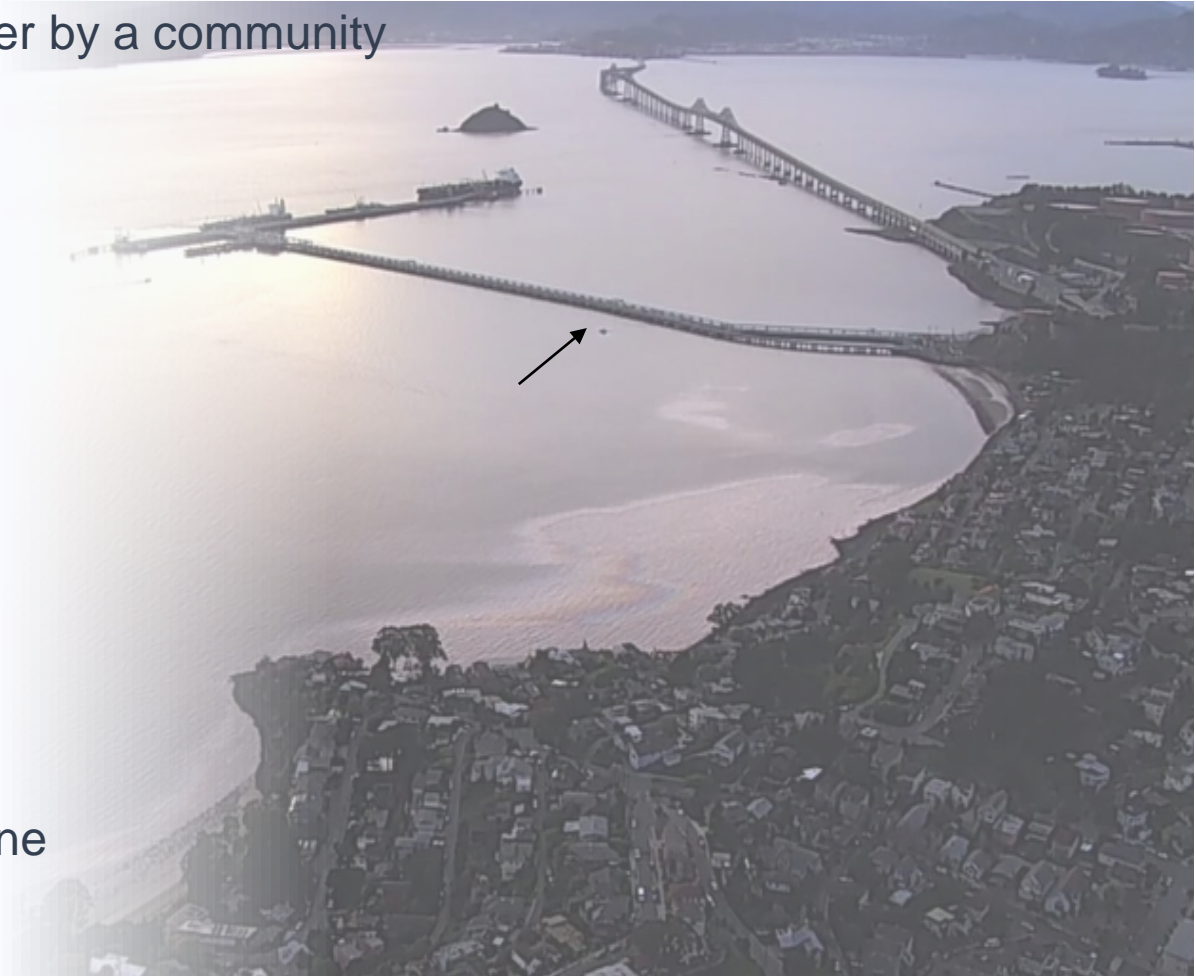
- 2:32 *pm* - Chevron was alerted to an oil sheen on the water by a community member
- Spill location: 16” ballast line on the refinery long wharf
 - “nickel-sized hole” in the line
 - Black arrow on photo details leak point
- Reported Amount spilled into the bay: 500-750 gallons
- California Department of Fish and Wildlife lab results
 - Mixture of diesel and water in the Bay
- 3:43 *pm* -Contra Costa County Early Warning System Level 2 called
- 4:30 *pm* - Chevron reports the leak was stopped
 - Temporary clamp placed on pipe to repair hole
 - The line was emptied, and Chevron will not use the line until a permanent repair is made.

- Inspection staff at Chevron Refinery to investigate ballast line and spill location
 - Toxic vapor analyzer (TVA) used to check for hydrocarbon vapor leaks and determine compliance with applicable Air District Regulation emissions standards (Regulation 8 Rule 18 Equipment Leaks)
 - No emissions above background concentrations were found (2 parts per million (ppm))
